Field Testing and Evaluation of a Demonstration Timber Bridge

# Field Testing and Evaluation of a Demonstration Timber Bridge

tech transfer summary

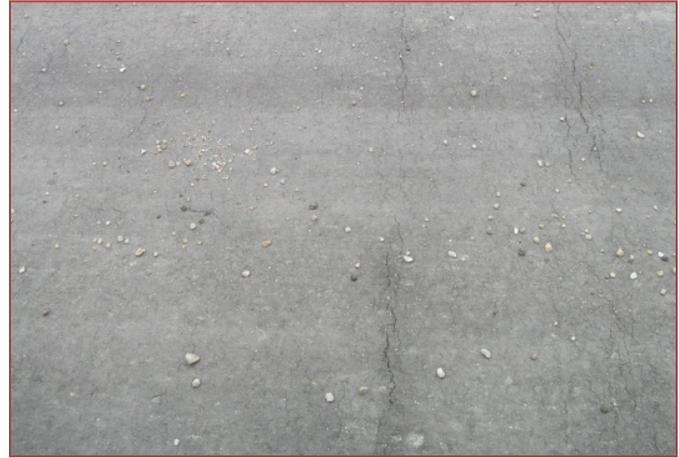
Inspection of the wearing surface one month following bridge construction noted transverse cracking at the deck panel joints on Span 2 with less noticeable cracks on Span 1 over the deck panel joints. However, cracking over the plywood joints was also observed in Span 1.

*Transverse cracking on Span 1 (with plywood) two months post construction*

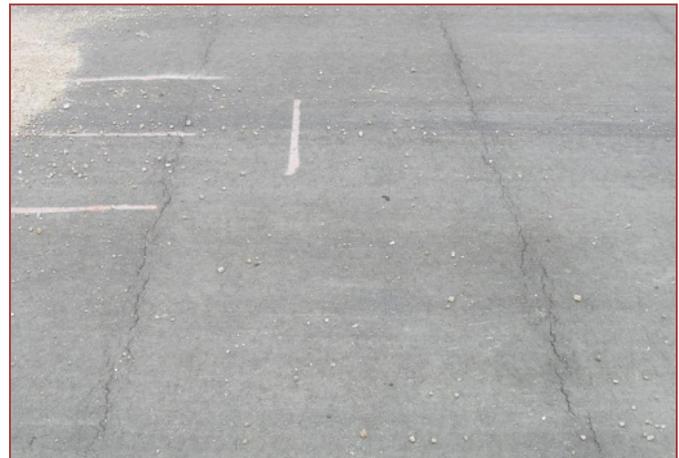
Wearing surface inspection in 2010 noted that the cracking at the panel joints on Span 2 was becoming more prevalent; cracking on Span 1 was now evident at both the transverse and longitudinal plywood joints, as well as at the transverse deck panel joints.

*Transverse cracking on Span 2 (no plywood) two months post construction*

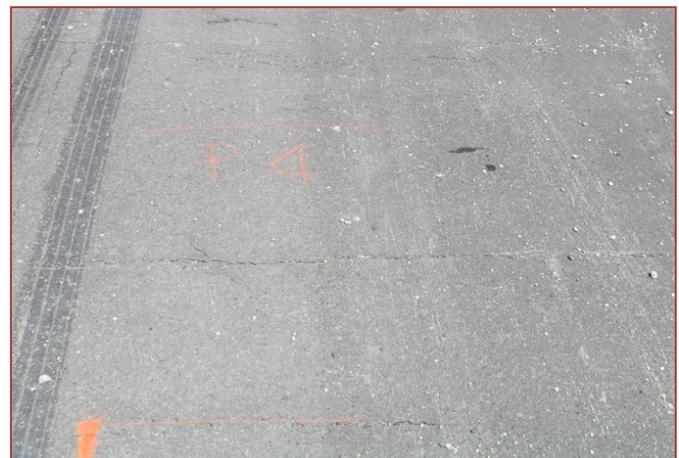
*Transverse cracking on Span 1 (with plywood) one year post construction; visible cracking evident at the transverse plywood joints as well as at the panel joints*

1. Perform follow-up field tests on the bridge to better assess and understand the performance
2. Consider reorienting the plywood to mimic what was tested on the laboratory bridge
3. If available, utilize tongue and groove treated plywood
4. Design an asphalt deck overlay mix design, and/or asphalt overlay “system,” that is optimum for this application
