CONSTRUCTION AND EVALUATION OF SUBMERGED VANES FOR STREAM CONTROL

Research Project No. HR-274

Submitted to
The Highway Division
Iowa Department of Transportation
Ames, Iowa

March 1988

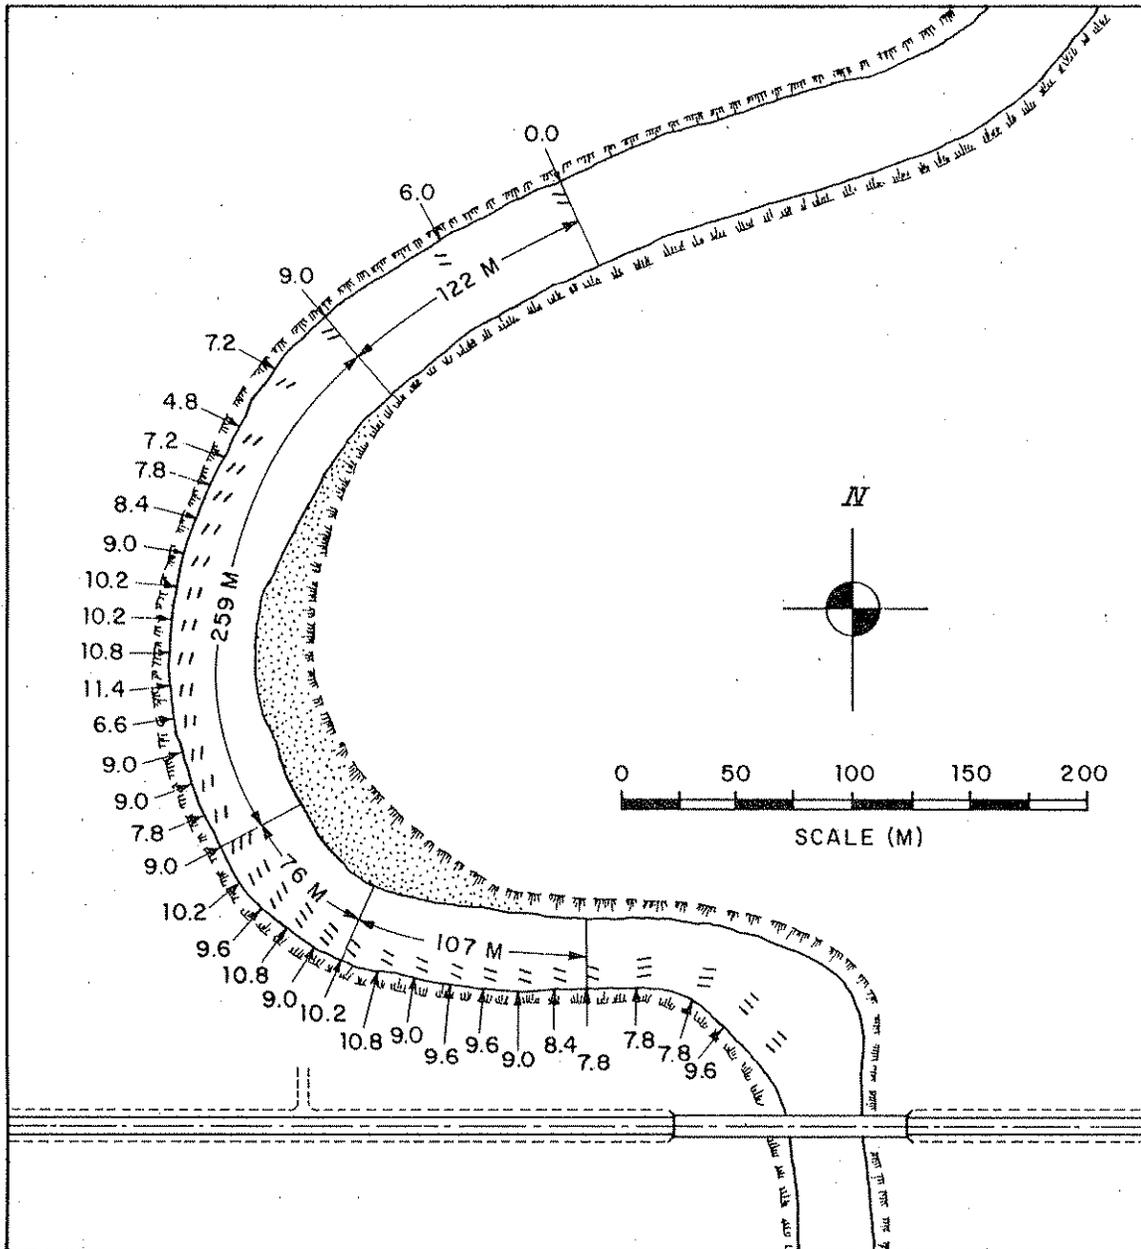
Figure 9. Vane-to-Bank Distances Measured on December 5, 1987 Aerial Photo. Discharge = $7.5 \text{ m}^3/\text{s}$.

Vane-to-bank distances were measured again on a December 5, 1987 aerial photo. The distances are shown in Figure 9. Discharge was $7.5 \text{ m}^3/\text{s}$. The average of the seven vane-to-bank distances along the rock protection is 8.7 m, while the overall average is 8.6 m, suggesting that overall the low-flow vane-to-bank distance is still about the same as in 1985 after construction. However, along a 60 m reach around the middle of the bend, a 1-2 m increase is noted.

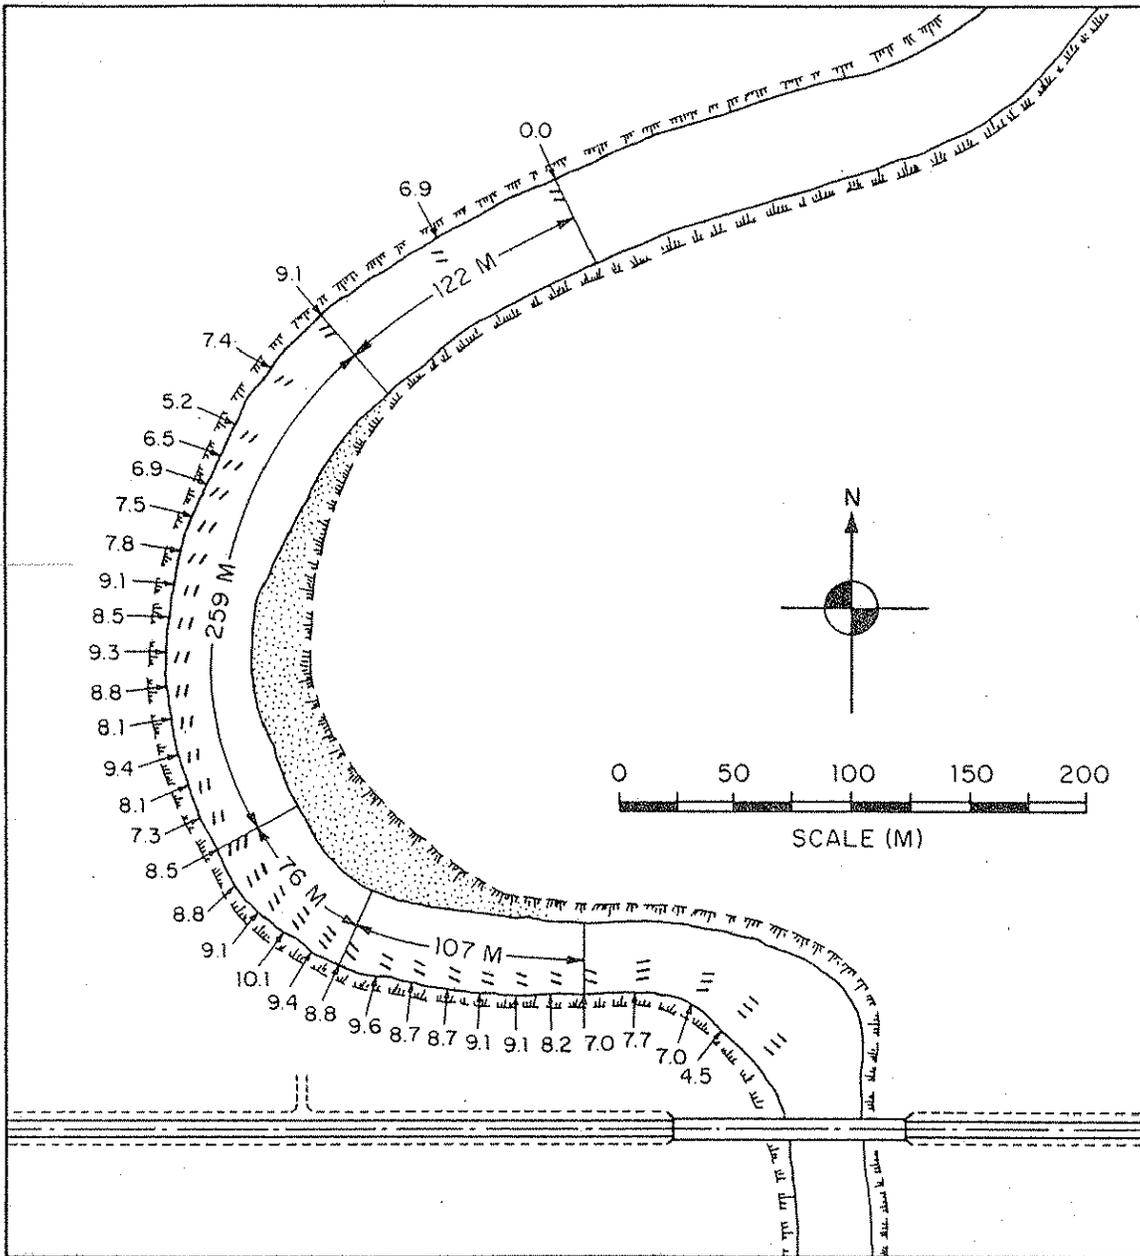
Figure 8. Vane-to-Bank Distances Measured by Iowa Department of Transportation Red Oak District Personnel on August 29, 1986. Discharge = $10.6 \text{ m}^3/\text{s}$.

On August 29, 1986, personnel from the Iowa Department of Transportation Red Oak District measured the distance from the outermost upstream pile in each vane array to the edge of the water at the bank. The distance is shown in Figure 8. The average distance was about 7.9 m, or about 1.8 m larger than the design-low flow distance. The difference between the 1986 distances and the design-low flow distance is due mainly to difference in stage. On August 29, 1986, the stage was about 0.5 m higher than the stage during the installation in August of 1985. A good reference is obtained from the data along the highway, where a rock protection is maintaining a stable bankline. The August 86 average of the seven vane-to-bank distances there is 8.4 m or 0.5 m larger than the overall average August 1986 vane-to-bank distance. This suggests that overall, the low-flow vane-to-bank distance did not increase during the one year period from August 1985 to August 1986.

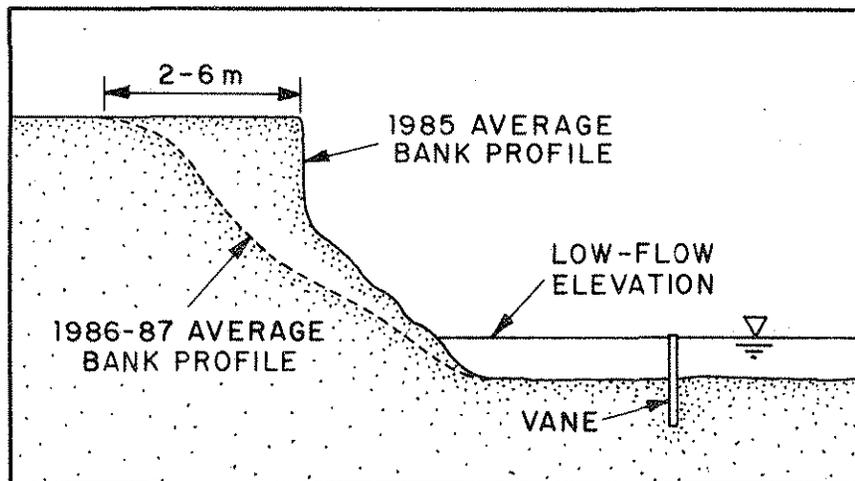
Figure 7. Schematic Comparison of Bank Profiles Before and After Installation of Vanes.

was slowed due to a group of mature trees along this part of the bank. The protrusion caused an acceleration of the near-bank flow at Section 3 resulting in an undesirable increase of near-bank depth and velocity at Section 3, as seen in Figure 5. There is some concern that this may eventually lead to the forming of a channel between the bank there and the vane system. At other sections, the slope of the bank is decreasing in a favorable manner as shown schematically in Figure 7.

No bank erosion occurred between the time of project completion and the time of the first survey. During the May 1986 high flow, the top edge of the bank receded on the average about one meter between Sections 2 and 4. Most of the erosion loss was at Section 3, where, prior to the vane installation, the bank protruded about 6 m into the channel over a length of about 30 m. These erosion losses were expected, as the pre-vane bank was too steep to be stable under undrained conditions. Because of the low percentage of sand and gravel in the bank material it may take several high flows and more erosion before the bank is cut back to a stable slope and a stable, natural toe protection is formed. The 6 m protrusion of the bank into the channel developed just prior to the vane installation when high flows caused the bank to recede about 6 m on either side of the protrusion. The erosion of the protruding bank section

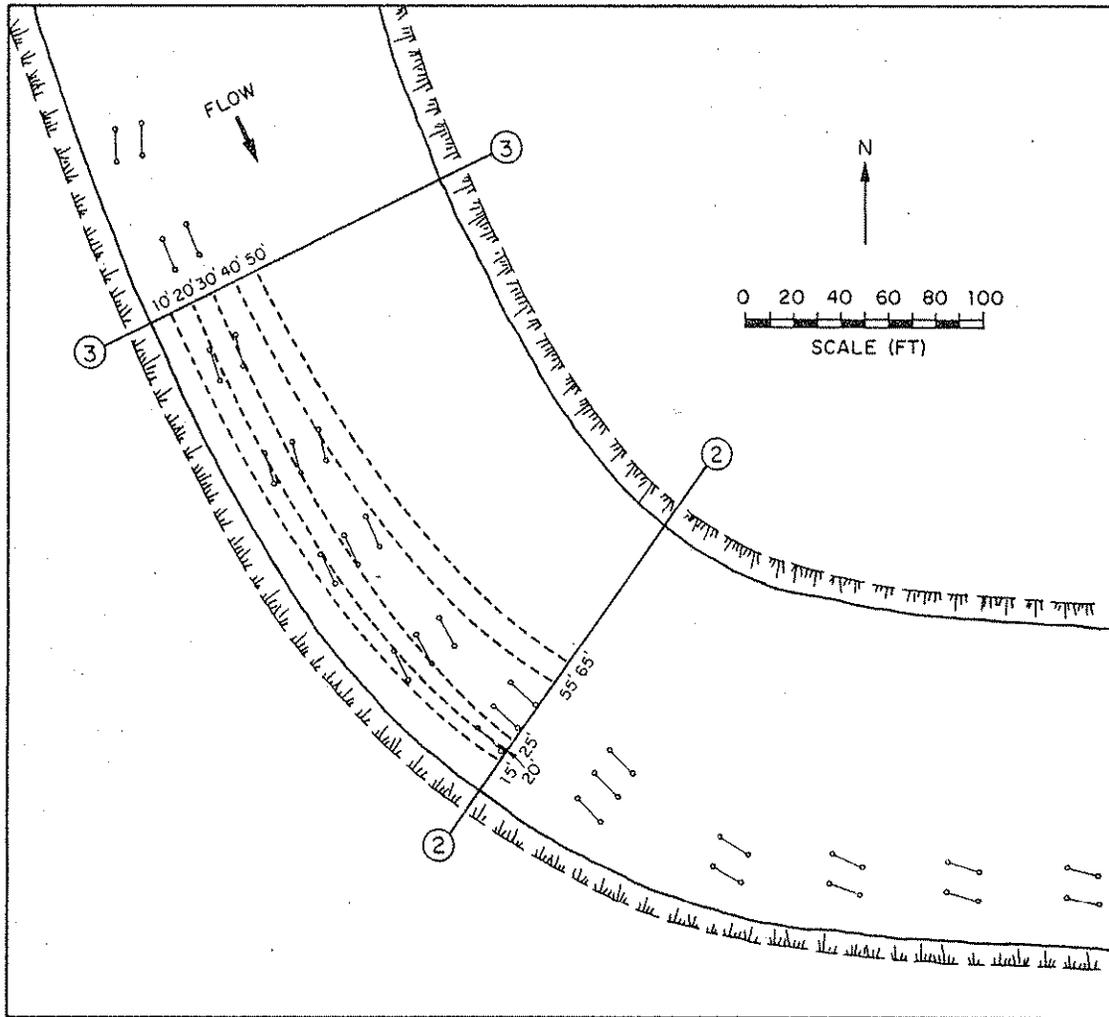
Figure 6. Average Paths of Surface Floats Measured in the May 12-13, 1986 Survey.

In order to directly test the vanes efficiency in eliminating the secondary-flow component, float studies were performed. Plastic balls were released at certain distances from the outer bank in Sections 3 and 4 and were followed photographically as they moved downstream through the bend. Their lateral position was recorded as they passed a downstream section. It was found that the floats generally moved away from the bank. Figure 6 shows results from the May 12-13 survey in which 500 floats were tracked between Sections 3 and 2. On the average, the floats followed the paths shown dotted in Figure 6, which indicates that the average deflection angle (toward the bank) was less than zero. In other words, there was no secondary-flow component. Without vanes, the deflection angle would have been greater than 10 degrees toward the bank.

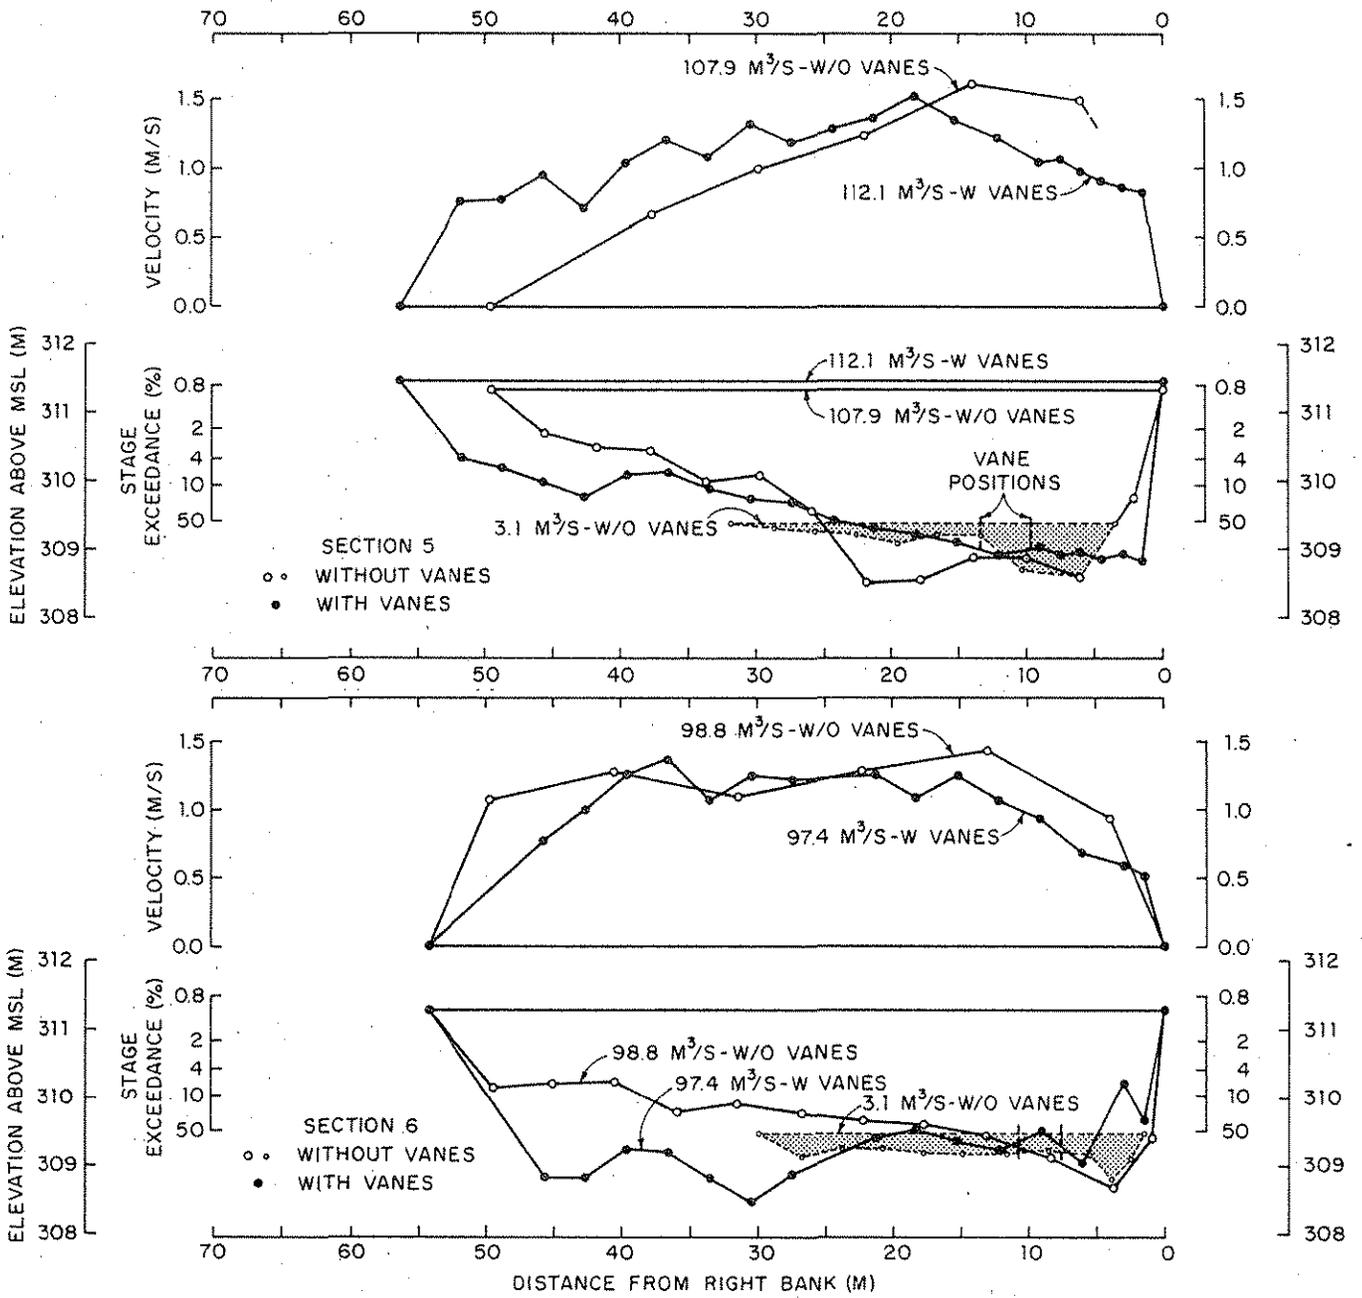
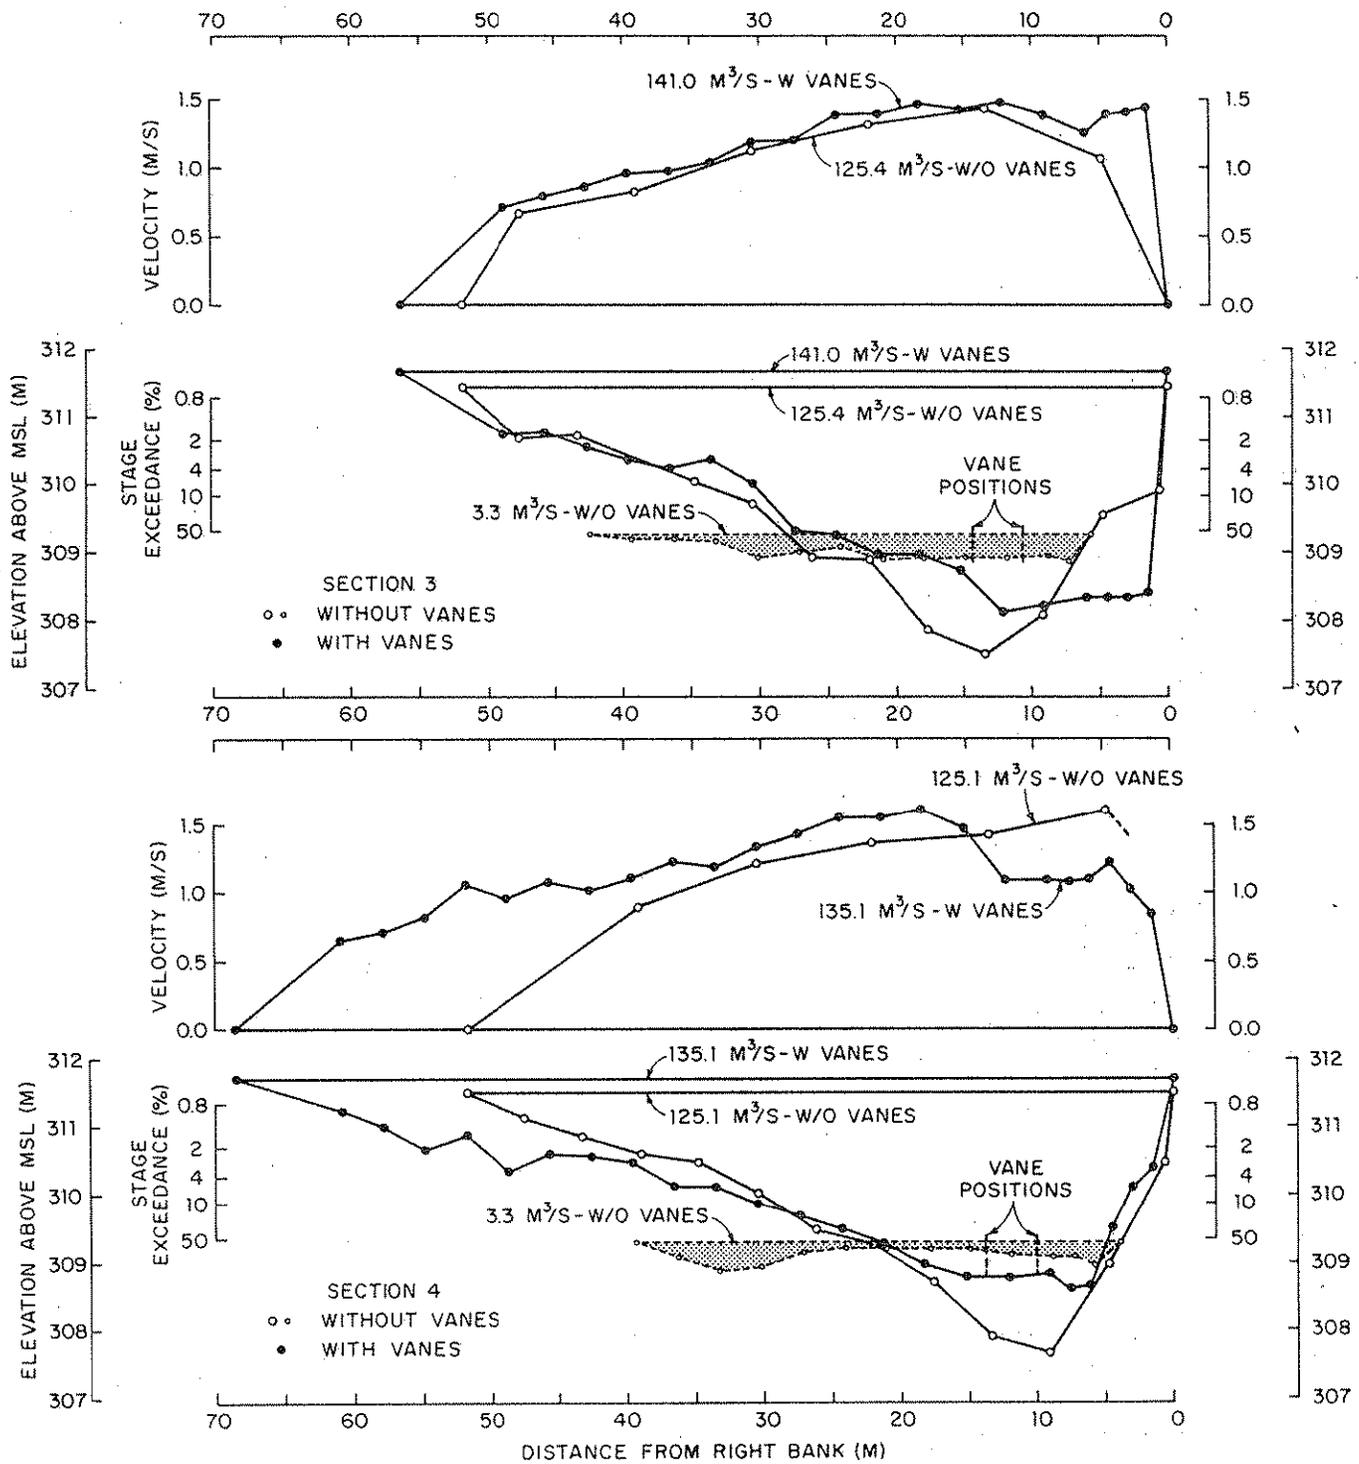
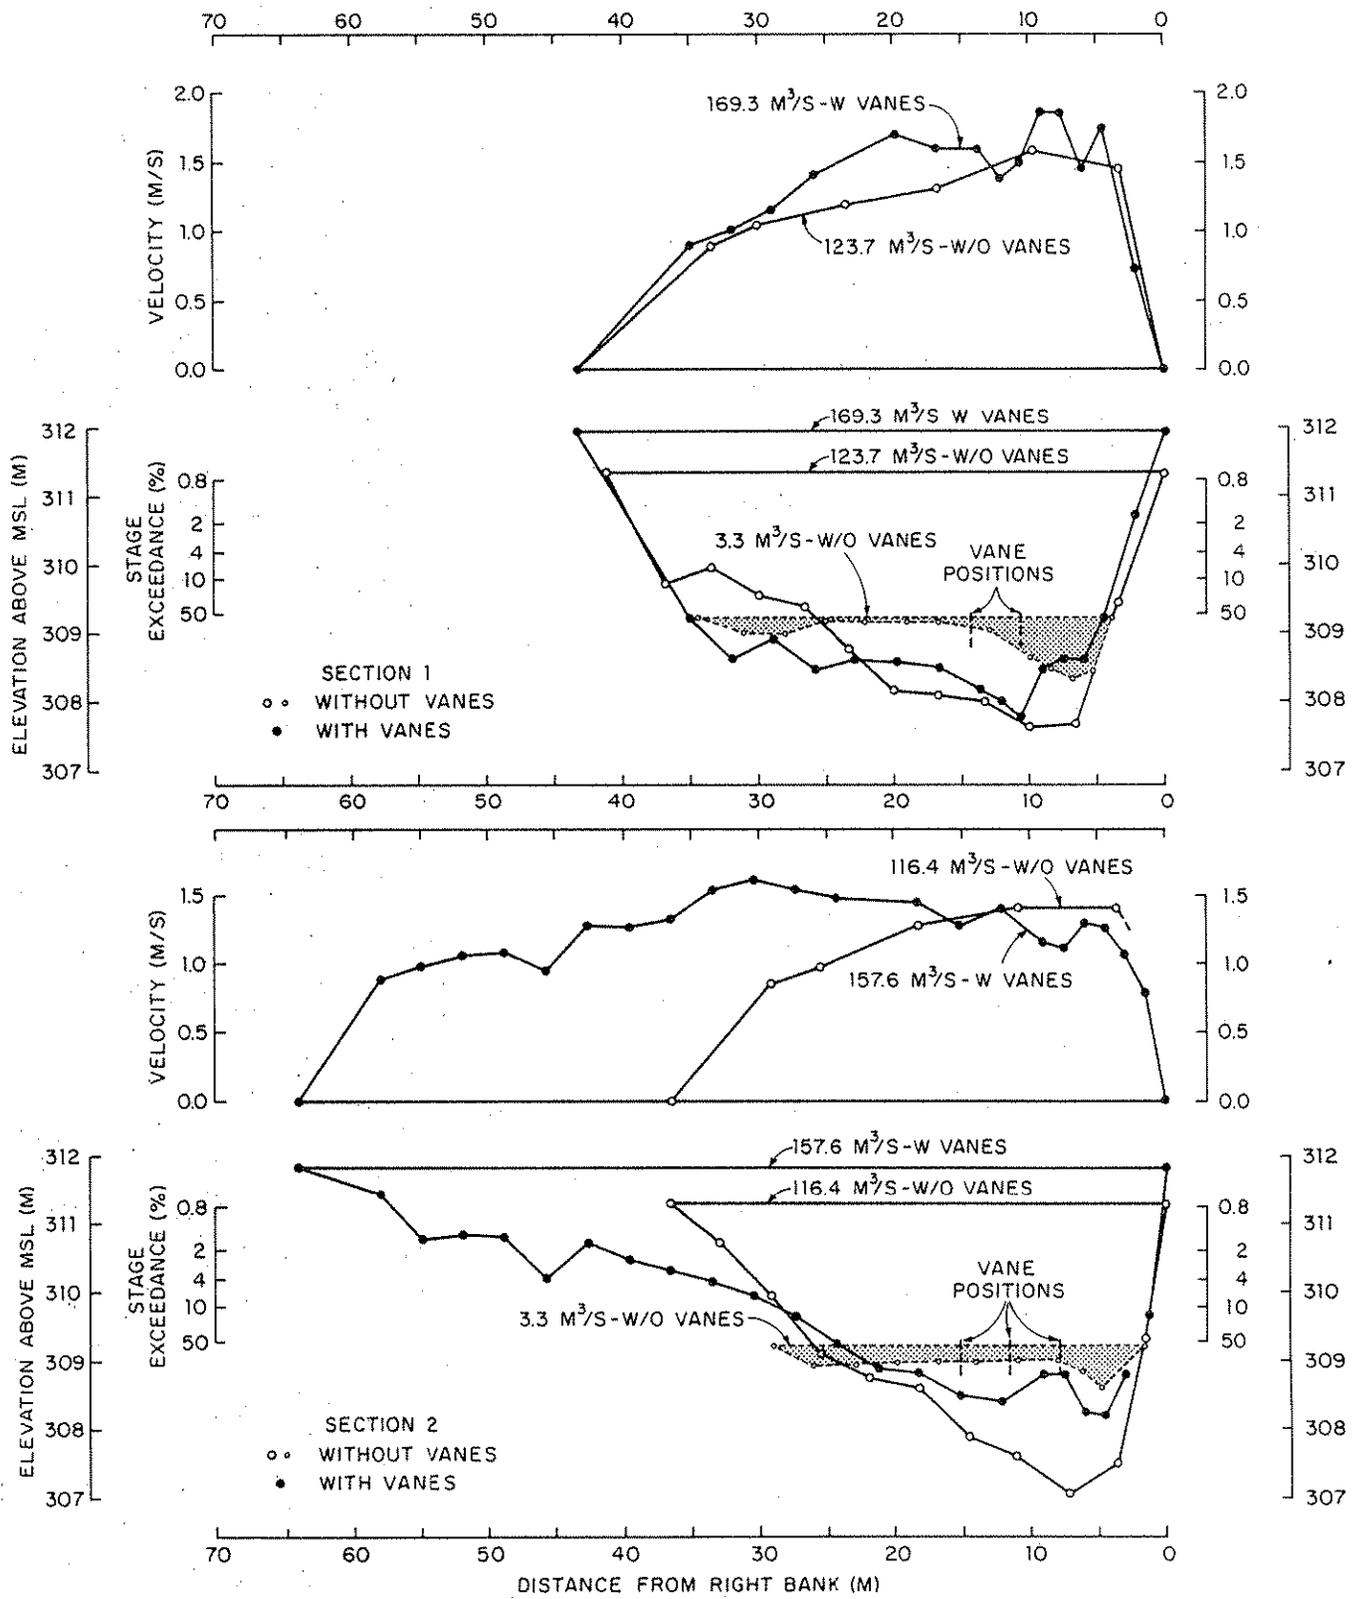
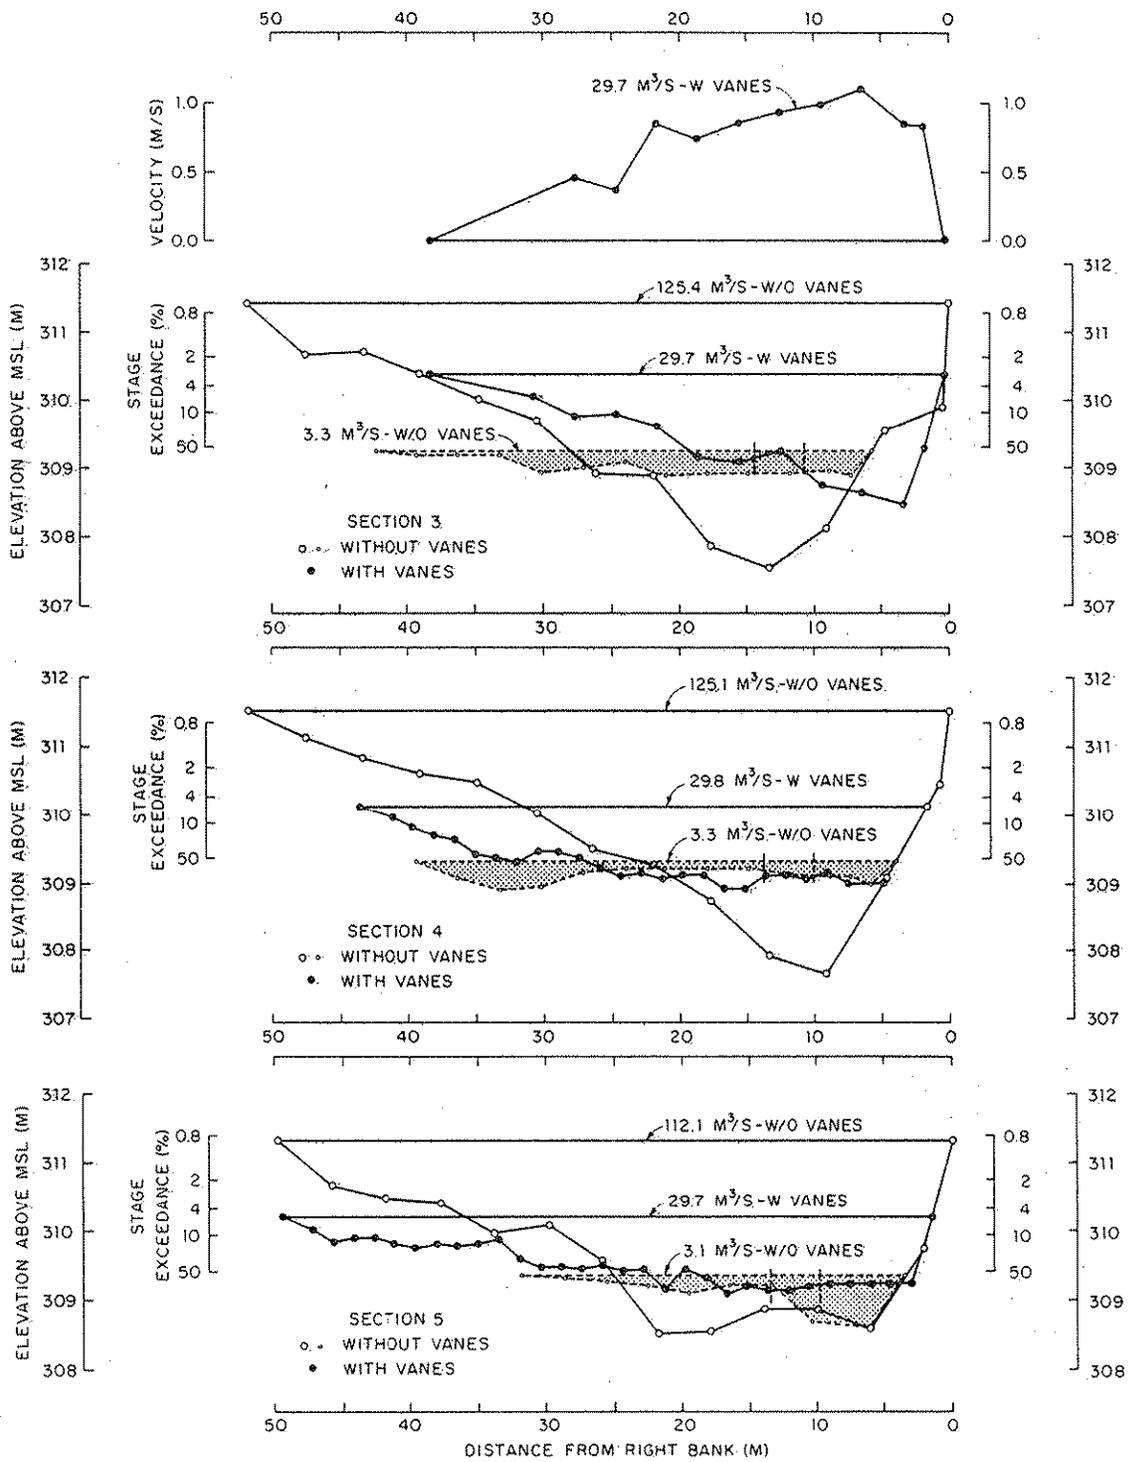
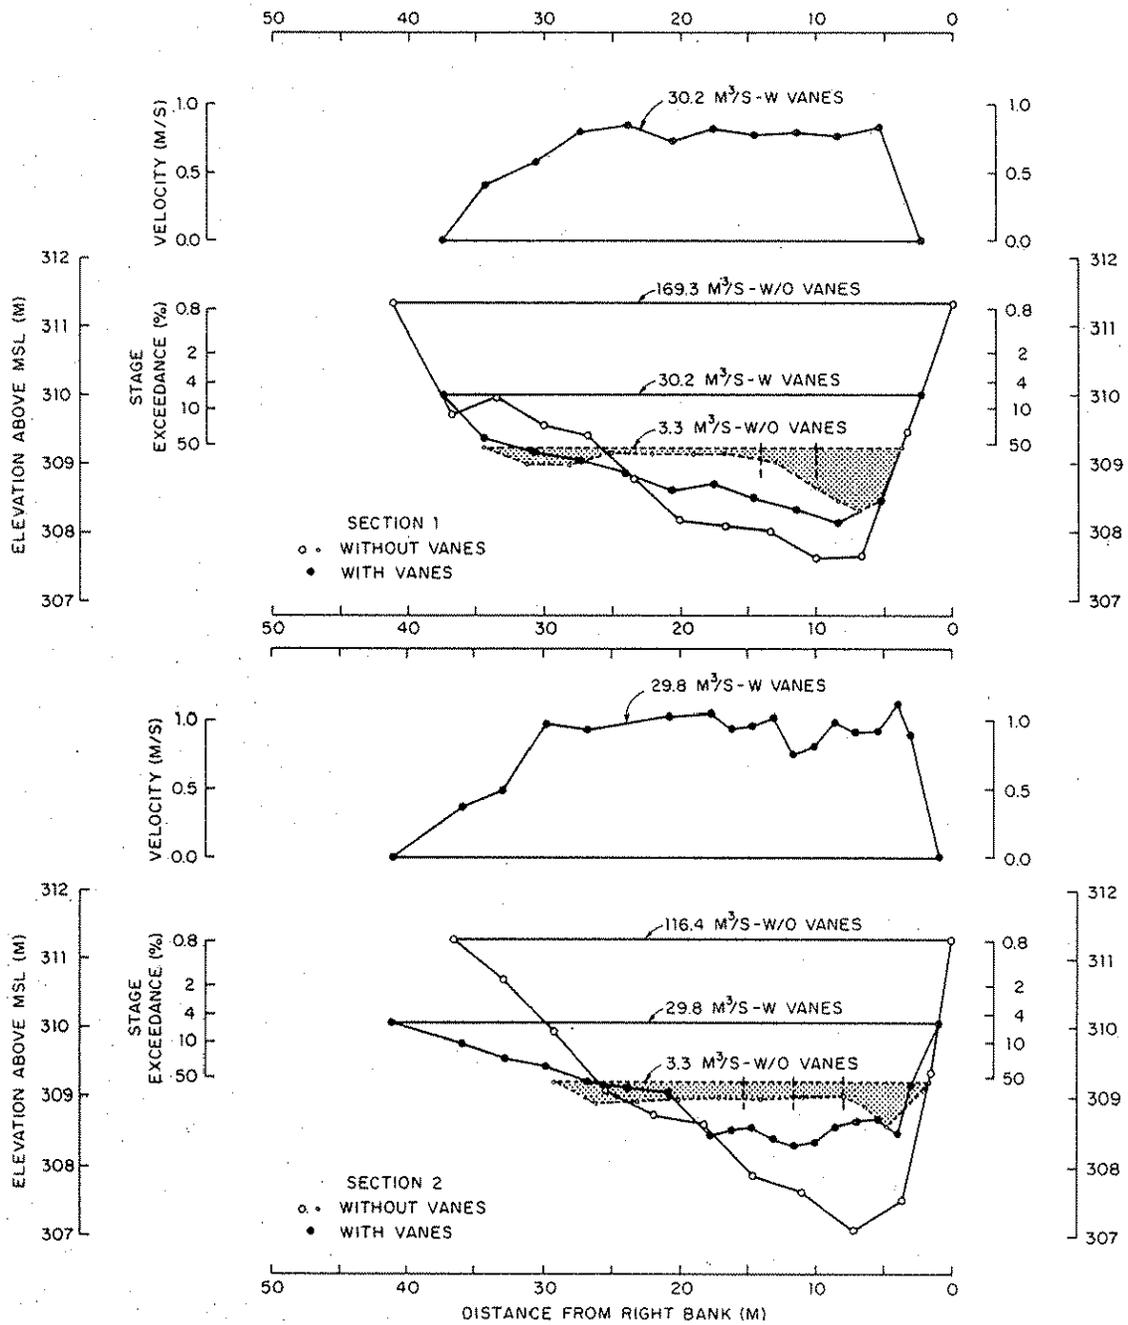
Figure 5. Sections Measured before and after Installation of Vanes.

Figure 5 shows the measured cross sections. The pre-vane cross sections are superimposed for comparison (the pre-vane low-flow cross section is shown dotted).

The vanes are seen to have produced a substantial reduction of the transverse slope of the bed. For example, at Section 2 the transverse slope of the bed with vanes was 0.062 at a near-bankfull discharge of $157.6 \text{ m}^3/\text{s}$, whereas the pre-vane transverse bed slope was more than twice as big (0.14) at a 26 percent lower discharge. Along the outer bank the vanes were generally able to maintain the bed at its low-flow elevation and prevent the near-bank scour typical of the pre-vane cross section. Instead of scouring along the outer bank, the flow at most sections widened its channel by removing sand from the inside point bar. For the same discharge there is seen to have been little difference in the average depth in the channel with and without vanes.

As seen in Figure 5, there was also a notable improvement in most of velocity distributions, which, of course, corresponds with the reduction of

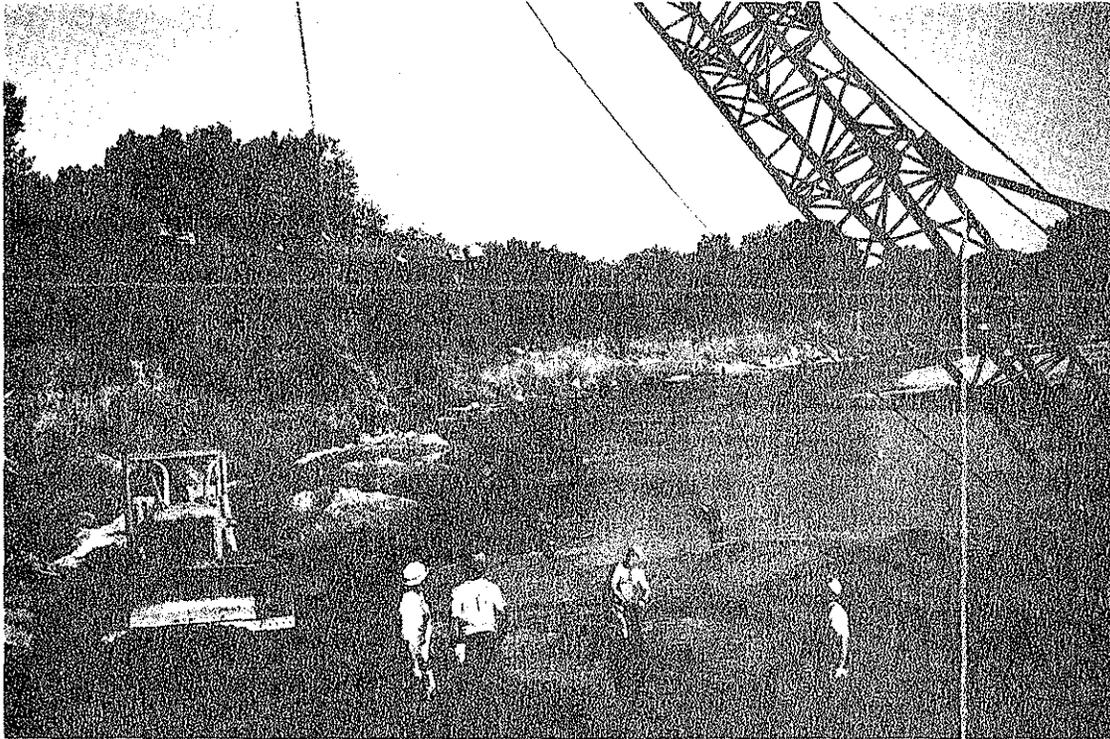
Figure 2. View from the Installation of the Vane System in the East Nishnabotna River Bend.

The vane system was installed between July 25 and September 4, 1985. [Iowa Department of Transportation Project No. FN-34-2(27)-21-69]. The day-to-day accomplishments are summarized in the attached material. Except for two days, the water depth was less than 0.5 m throughout during this period. The construction equipment (A bulldozer, a D-15 diesel hammer, and a 25 ton American 399 crane) operated from the streambed; a 6-8 m wide berm was formed along the bank, using sand from the streambed, to facilitate the maneuvering of the equipment. The piles were driven starting at the upstream end of the bend. In each array, the upstream piles were driven at the given distances from the bank line. The downstream piles in each array were driven 4.22 m from the upstream piles and 0.9 m closer to the bank, yielding an angle with the mean-flow direction of 12.2 degrees. The direction of the mean flow was determined by floating material. In each array, the pile nearest the bank was driven about 6.1 m, or twice the bankfull flow depth, from the low-flow edge of the water. After completion of the pile driving, August 21, the planks were provided with straps and lowered in place between the piles (Figure 2). The system was provided with five can buoys (float collar cans with internal balast) and marked with the "restricted area" symbol.

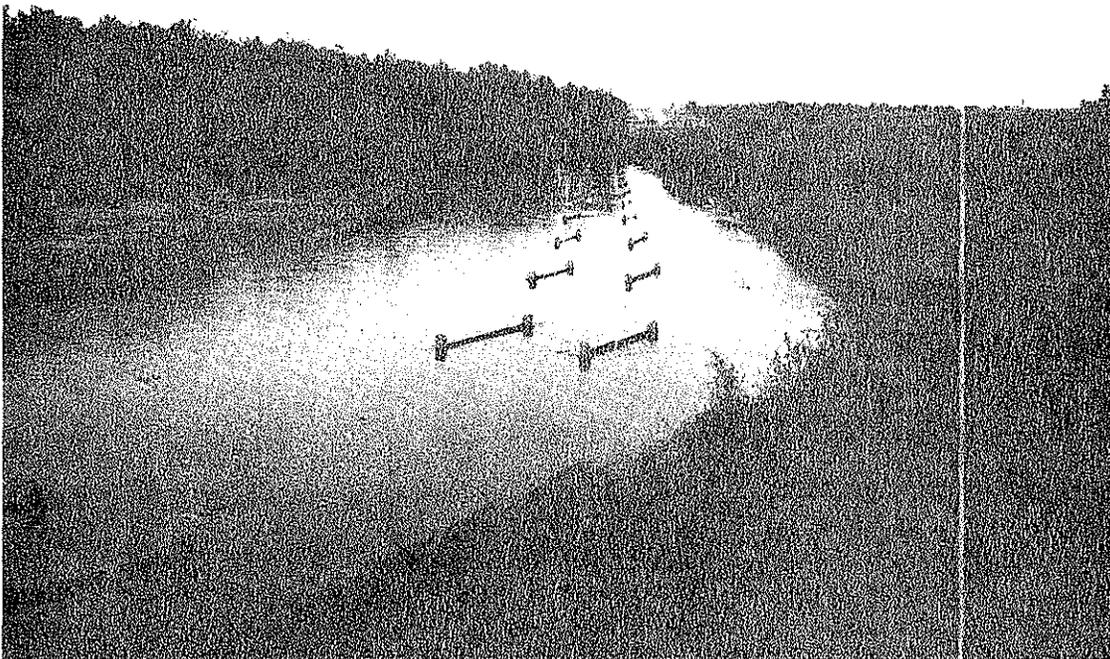
Figure 3. Downstream View of Completed System.

Figure 3 is a downstream view of the completed system at low flow (3-4 m³/s).
