# **Underseal Evaluation Project**

**Poweshiek County I-80  
near milepost 189.5, Eastbound Roadway**

**July 1985**

**UNDERSEAL EVALUATION PROJECT**

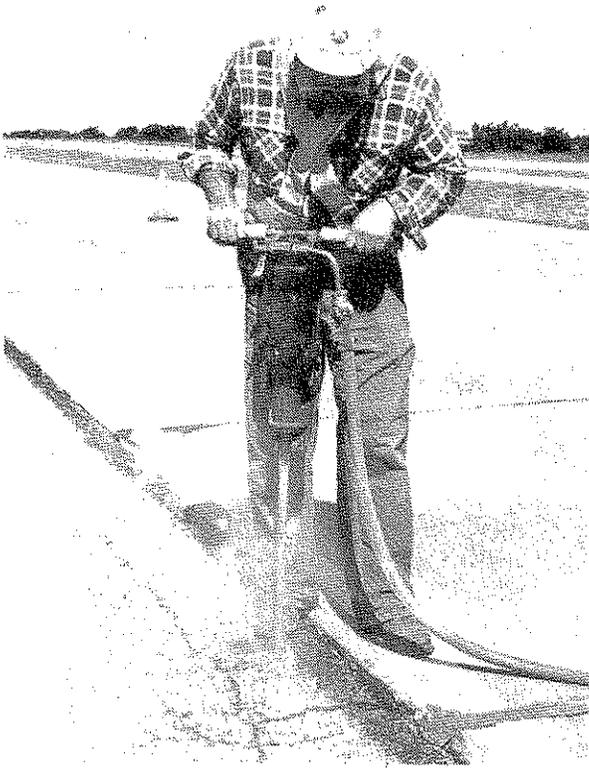
**Drilling Monitoring Holes in Shoulder  
(Pressure Relief) over the Subdrain**

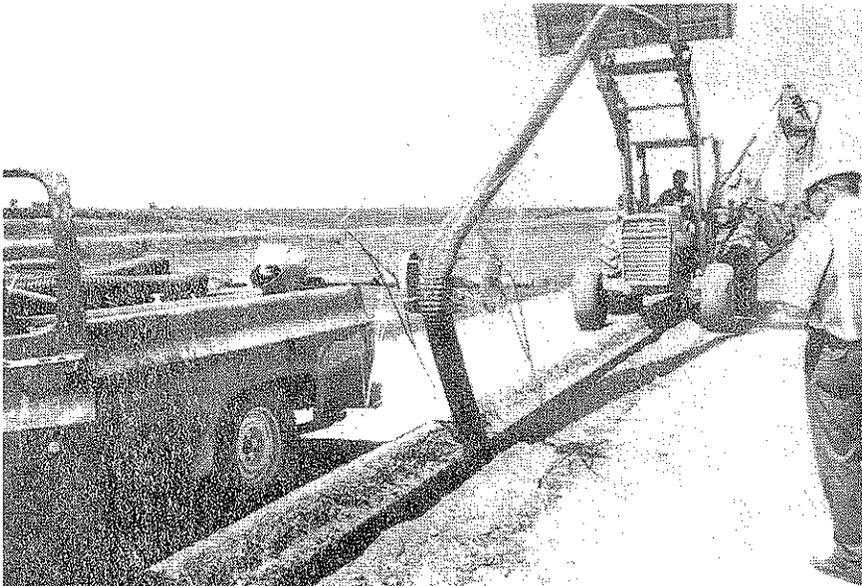
Existing 24" deep, 6" diameter slotted subdrain tubing was examined during removal to determine the effect of pavement undersealing. Removal was accomplished by cutting a 10" wide trench through the asphaltic concrete shoulder and then lifting the tubing through the surrounding aggregate backfill (see Appendix A).

**Removing Subdrain**

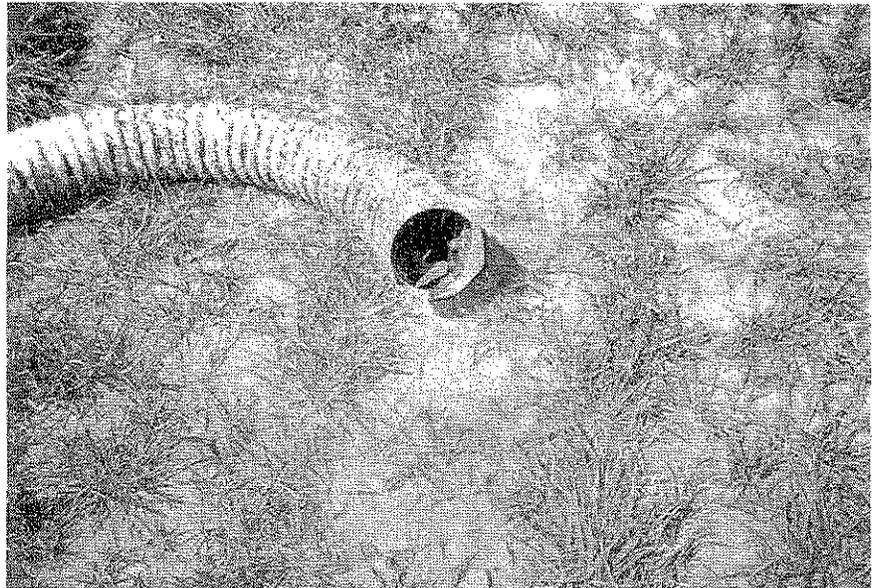
drain pipe collapsed at crack 12. Approximately 14' of pipe was encased by grout. At this location, hardened grout had entered the drain tubing and filled the corrugations in the flowline of the pipe. Some of the grout may have been removed from the tubing by flowing water while the grout was fluid. Joint 3, which contained 5 injection points, did not show any evidence of grout under the slab. The same situation was true with the approach panel of joint 11. Apparently the drainage system accepted nearly the total amount of grout placed at these locations with little harm. Heavy concentration of grout was present on the panel edge in these areas, but no grout appeared in the relief holes drilled over the subdrain. Through the entire trial section, the upper portion of the drainage trench was free of grout.

**Grout Intrusion Remaining in Subdrain Pipe**

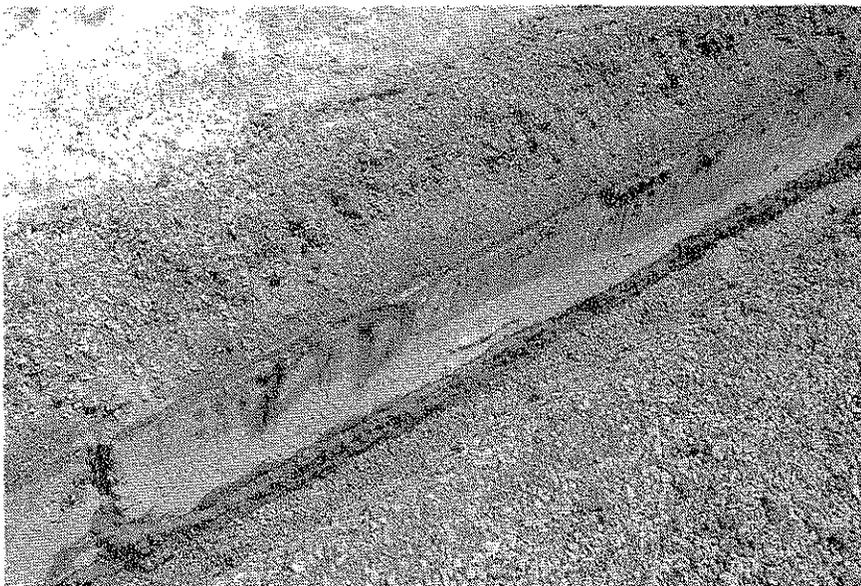
**Joint # 13. Pavement edge exposed during subdrain removal. The light area on the edge of the pavement is grout.**

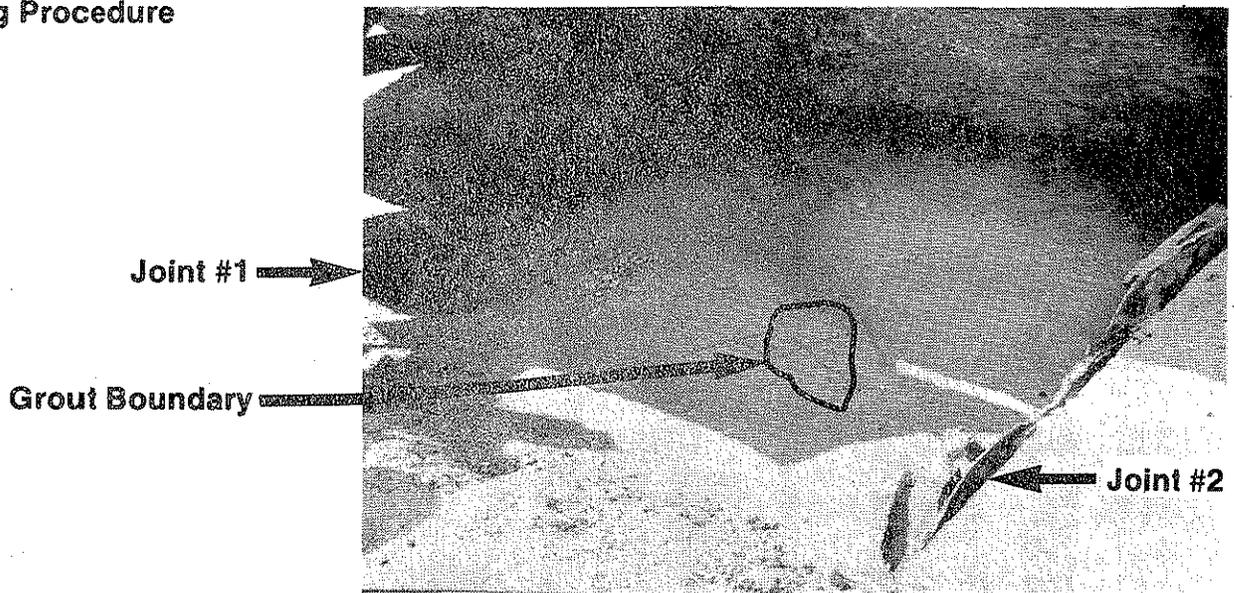
**Joint #1 and Joint #2**

Two injection points were located 3' from the outside edges of the approach panel. Grout spread consisted of a 4" to 8" diameter cone centered on each injection point. This was the first test pattern tried and demonstrates the problems associated with a "thick" grout consistency.

One injection hole was located in the approach panel, 3' from the shoulder and 1.5' from the joint. This location contained the cone effect noted at joint 1. A definite unfilled void was present near this location.

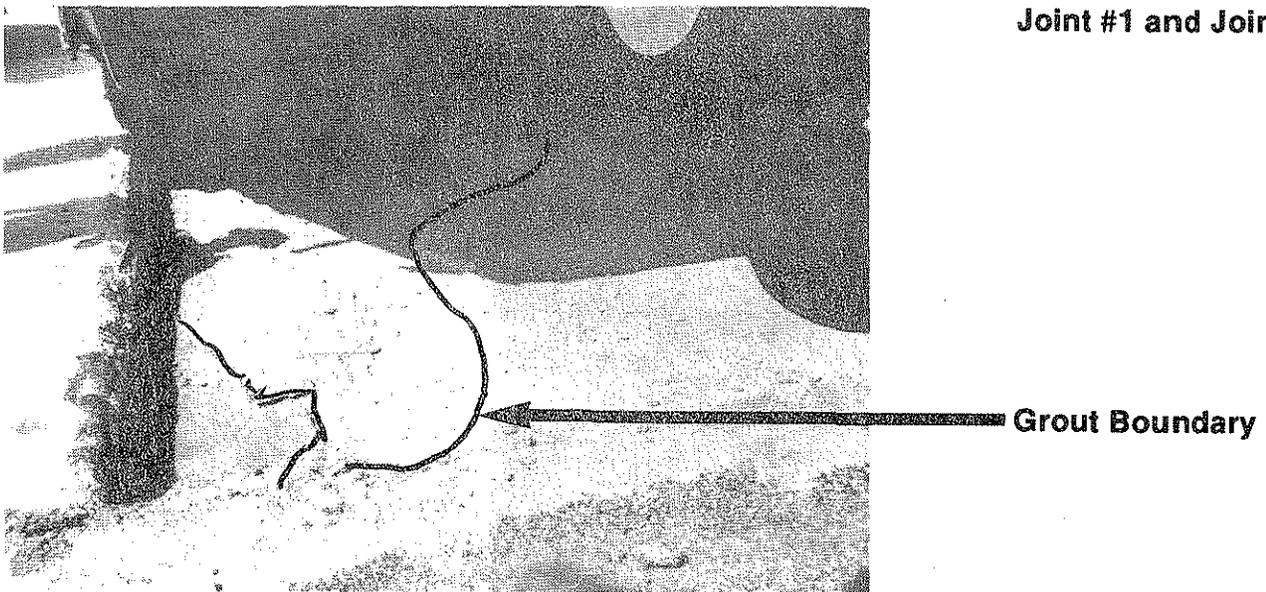
**Joint #2**

Two injection holes were located in the leave panel adjacent to a 4" foam filled pressure relief joint. Cemented base material, 5" thick, adhered to the slab adjacent to the pressure relief joint. This material tapered to an approximate 3" thickness over a 12' long area adjacent to centerline and a 3' long area 30" from the shoulder. There was no cementation in a 30" band adjacent to the shoulder. No grout projected across the pressure relief joint.

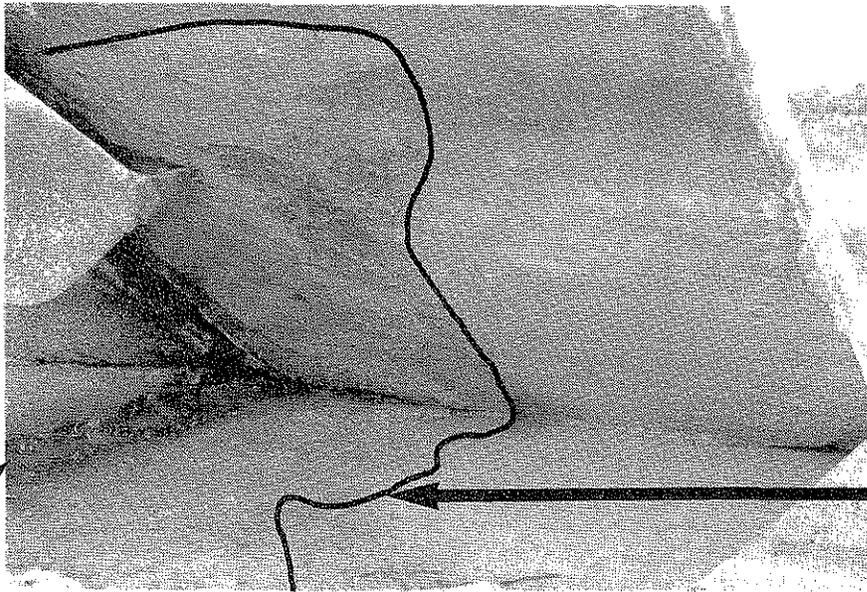
Approximately 4" of base was cemented to the leave panel, extending 5' from the joint. Grout did not migrate across the joint. There was definite evidence of "fines" removal from the interior portion of the approach panel. Considerable deterioration of the joint had occurred. Approximately 4" of dowel bar was exposed at the joint, with deterioration tapering towards the underside of the slab at an approximate 45 degree angle. The "void" left by the spalling was filled with fine rubble. Grout did not penetrate the rubble or fill the voids at the joint.

**Joint #5 Leave Panel: Grout and subbase material is adhering to underside of panel.**

**Joint.  
Note Joint  
Deterioration**

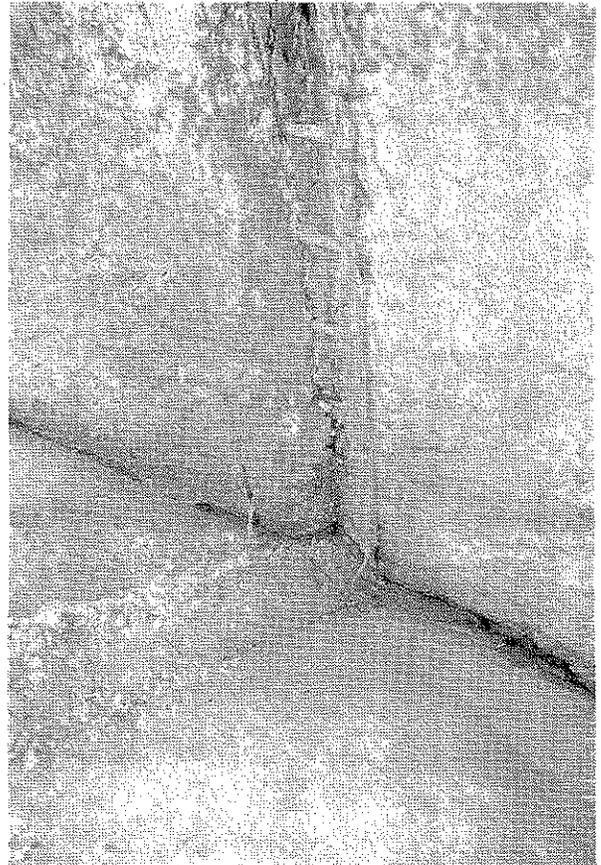
**Joint #5 Note Joint Deterioration**

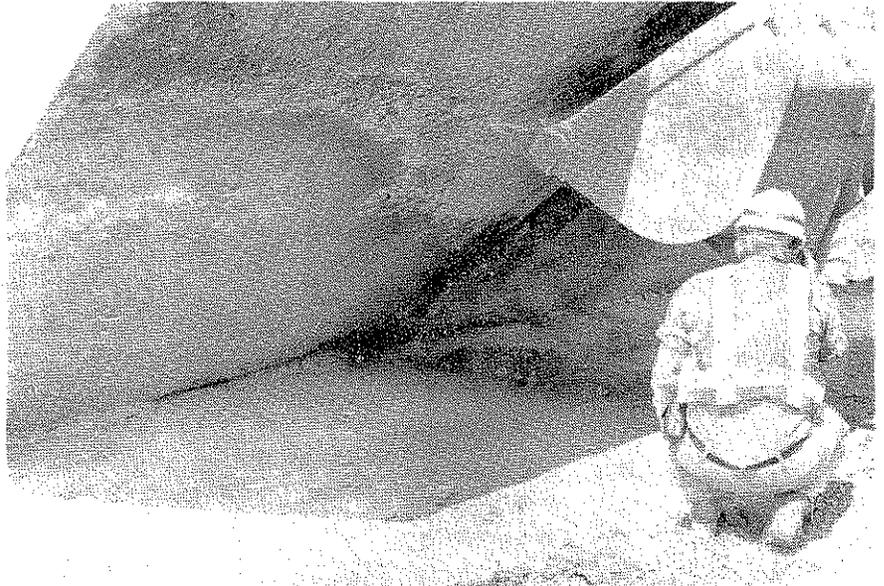
**Joint #5 Approach Panel**  
No grout distribution  
under approach panel.

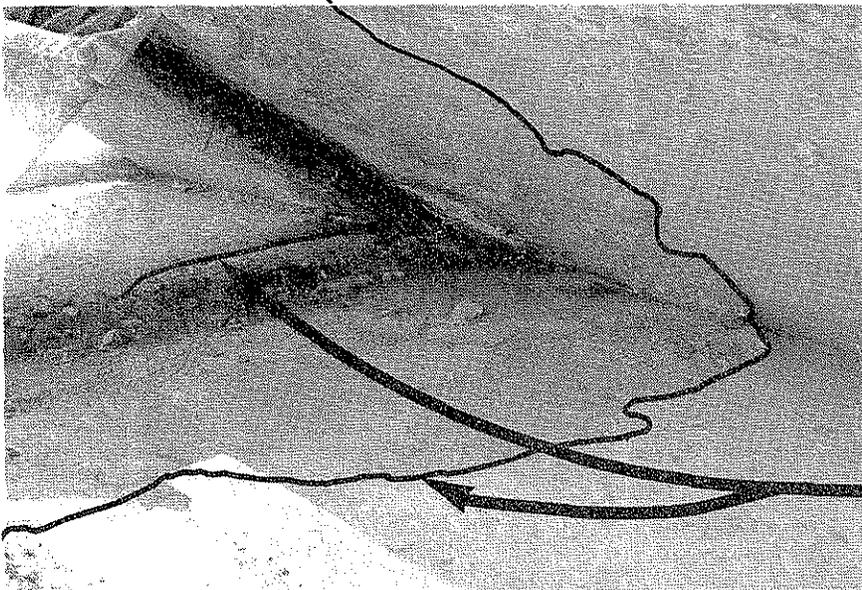
Flow characteristics were adjusted to new target values of 12 - 16 seconds at this point. Subbase was cemented to the slab, covering an area which extended for 3' under the approach panel to 7' under the leave panel. This joint also exhibited extreme deterioration, with bottom spalling extending 6" on

each side of the joint. The hole closest to centerline apparently did not penetrate the slab and all undersealing was accomplished from the hole located near the shoulder. As at all other locations, the outer 30" of the subbase appears to be choked with lime fines which the grout did not penetrate. There is evidence that grout penetrated cracks in the subgrade soil in this area.

**Joint - Note**  
Joint Deterioration

**Joint #8 Leave Panel: Note**  
Joint Deterioration. Grout and  
subbase material adhering  
to underside of panel.

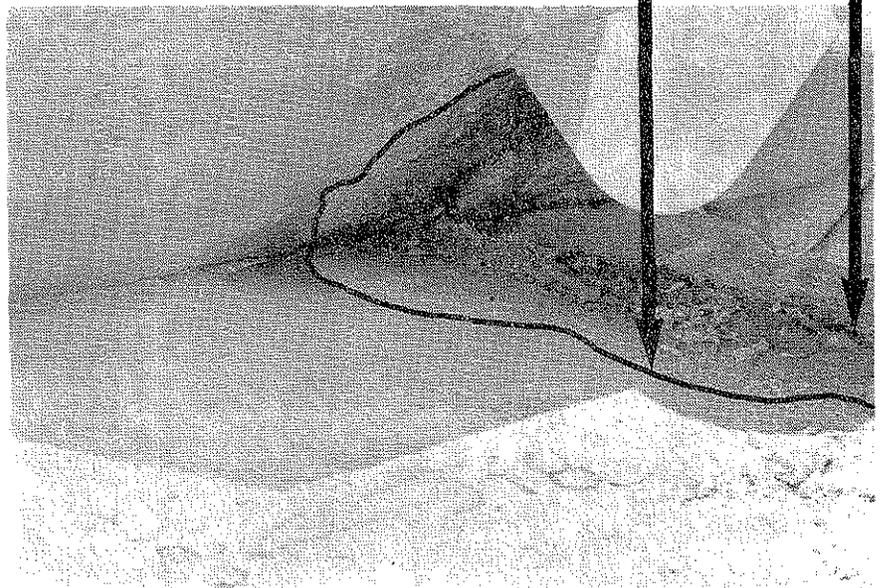
**Joint #8 Approach Panel:**  
Grout and subbase material  
adhering to underside of  
panel.

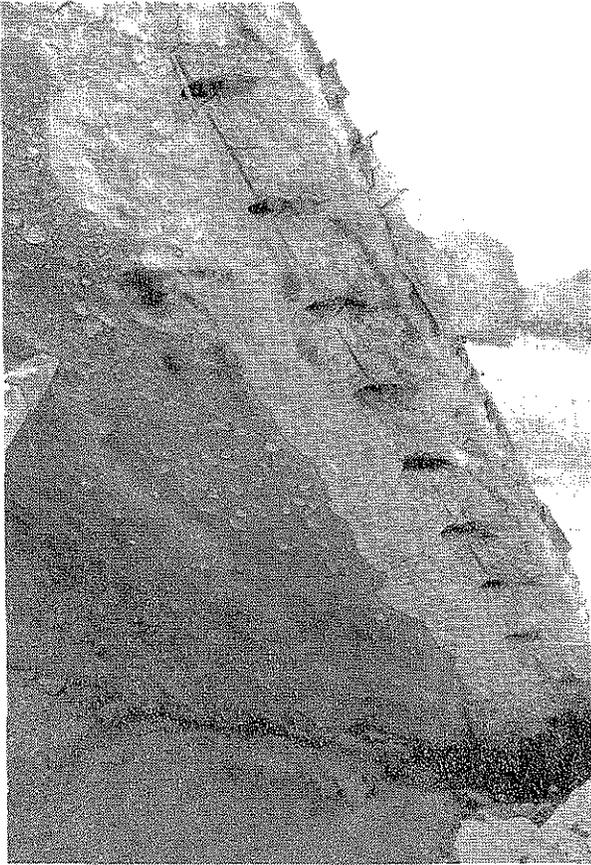
The following remarks apply to all joints except joint 2. Existing load transfer devices were at best marginally operational. At all of these joints, concrete had deteriorated at the bottom of the pavement, exposing a portion of the dowels.

**Joint #11**  
**Indicates deterioration**  
**of concrete below dowel**  
**bars.**

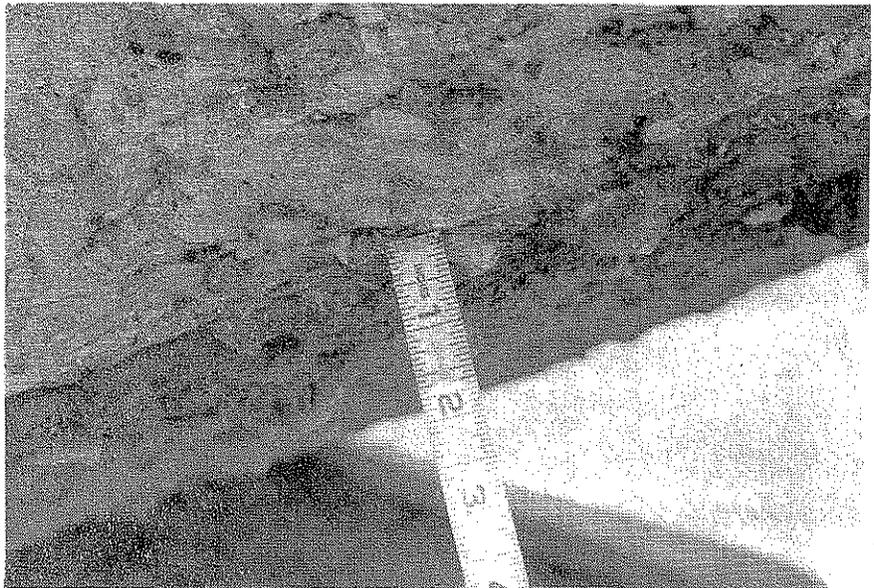
At centerline approximately 2" of subbase was cemented to the approach panel, extending for 9' from hole "0". This tapers to approximately a 5' width 24" from the shoulder. Grout was present around all of the load transfer dowels.

**Joint #11: 1/2" of grout and subbase material**  
**adhering to underside of panel.**

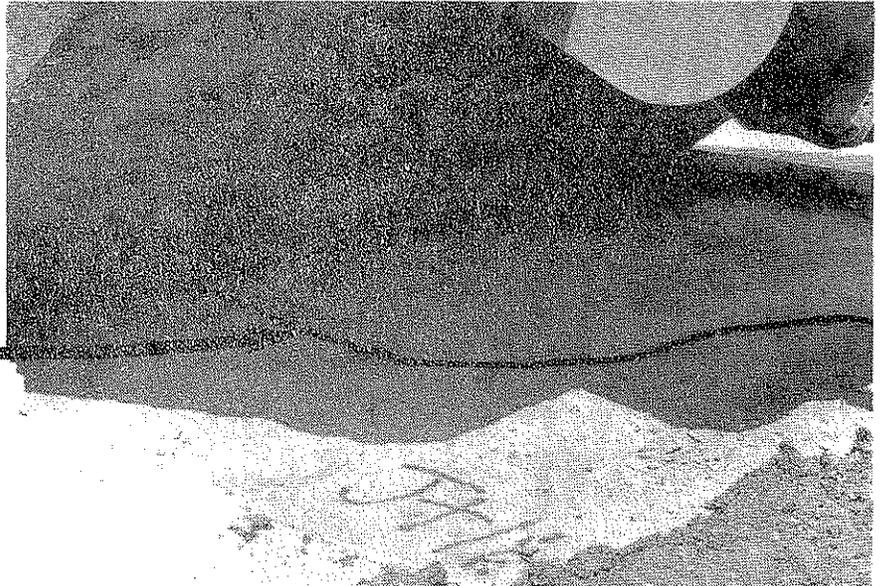
**Joint #11 Leave Panel**

The leave panel had subbase cemented to an area near the center of the panel, beginning at about 5' from the joint. Approximately 1/2" of grout was deposited immediately under the joint.

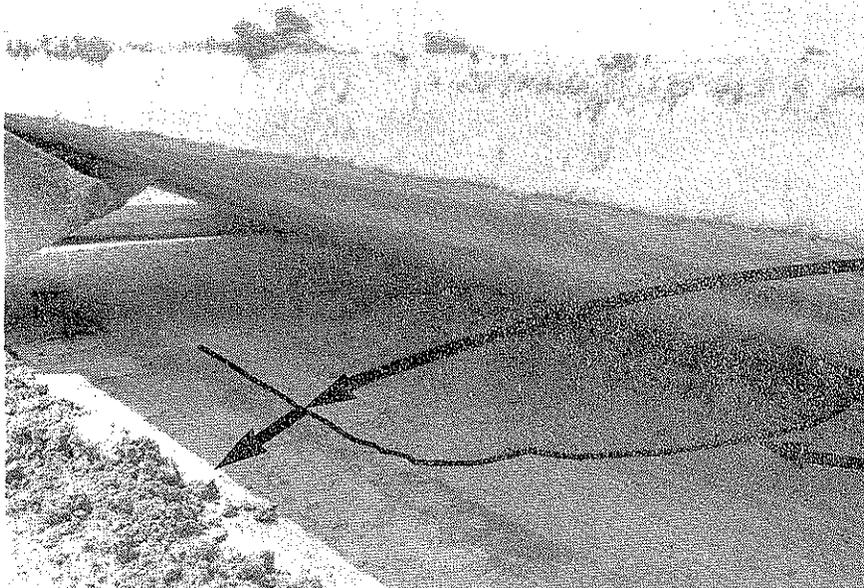
**Crack #12 Leave Panel**

The leave panel had a 3" thick layer of cemented subbase extending uniformly from the crack to approximately 6' from the crack. No cemented subbase was present throughout an 18" area adjacent to the shoulder. The three injection holes adjacent to the shoulder resulted in a 12" wide, 4" thick, "bar" of cemented subbase adhering to the slab.

No voids were noted, nor was grout deposited, in an 18"-30" band adjacent to the shoulder. The subbase throughout this band contained a noticeable accumulation of fine limestone particles. These "fines" had not contaminated the porous backfill located in the subdrain trench. This band of redeposited fines is thought to have occurred due to the dewatering effects provided by the subdrain system.

**Redeposited Fines**

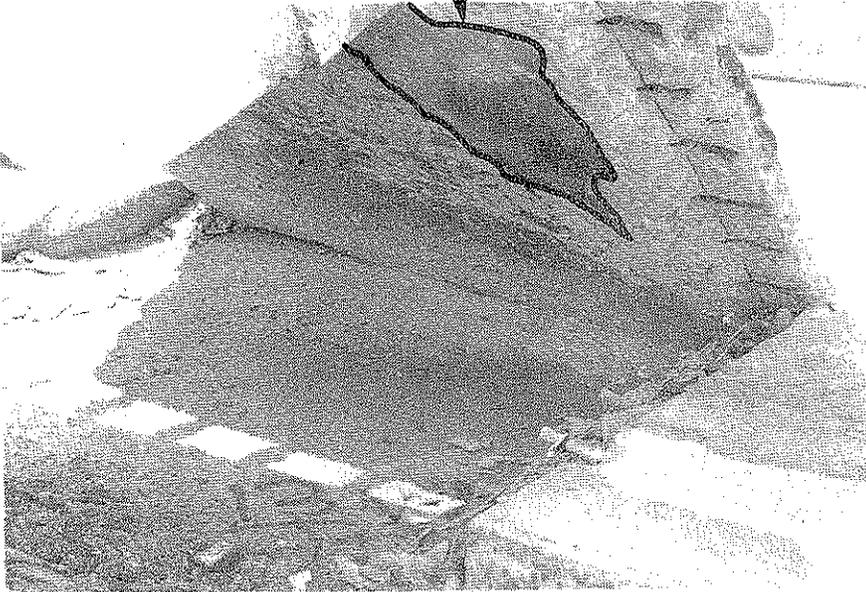
The approach panel of joint 13 had a thin grout covering on the subbase extending approximately 2' from the joint. Grout had intruded the joint and had filled the open areas around the dowel bars.

**Joint #13 Approach Panel**  
Grout and subbase material adhering to underside of panel.

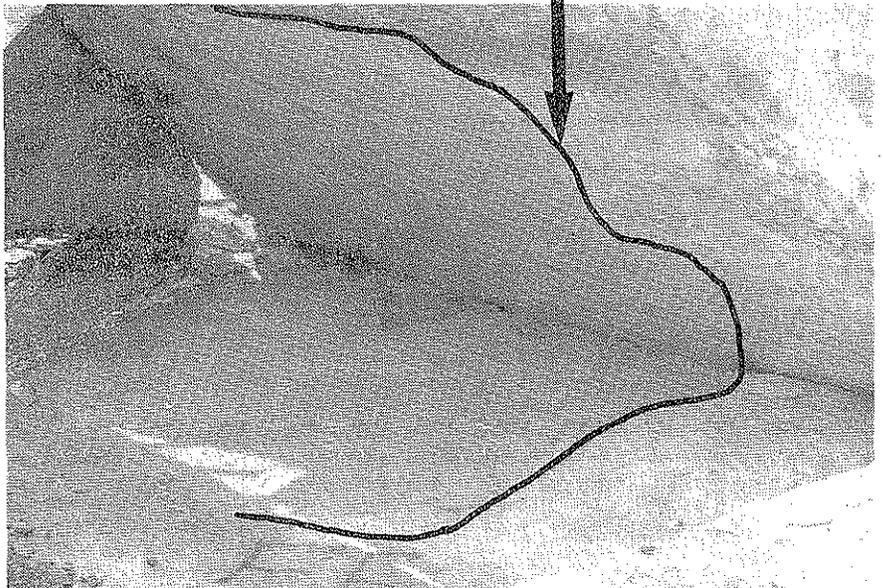
The leave panel of joint 13, extending for 18', had an approximate 2" thick, uniform layer of cemented subbase adhering to the slab. As at all other locations, the area adjacent to the shoulder did not contain grout.

**Crack #14 Leave Panel**  
Grout and subbase material adhering to underside of panel.
