BRIDGE DECK REPAIR USING EPOXY RESIN

Iowa Highway Research Board
Final Report HR-177

BRIDGE DECK REPAIR USING INJECTED EPOXY RESIN

IOWA HIGHWAY RESEARCH PROJECT HR-177

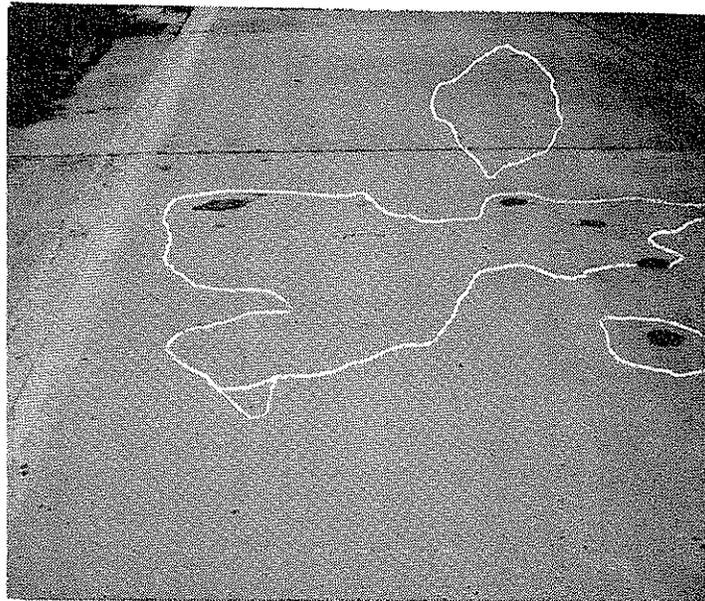
Figure 2
Delaminated Areas are Outlined

Hollow or delaminated areas were located using a chain drag and then outlined with chalk after sounding with a hammer to pinpoint the edges of the area.

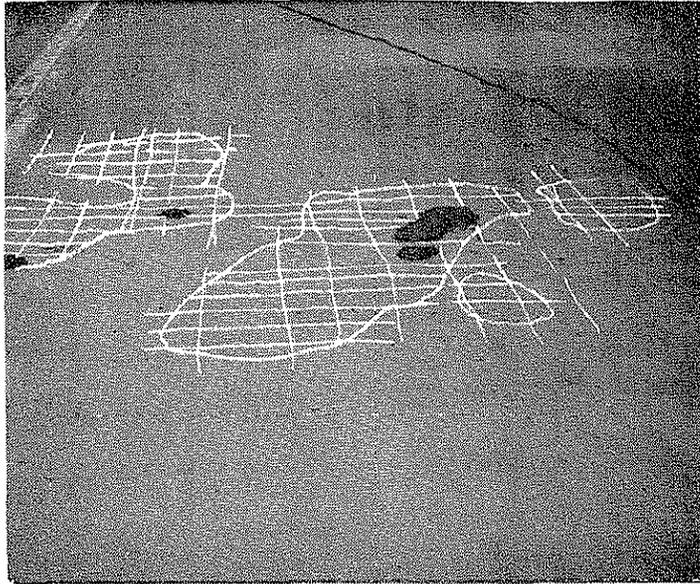
Figure 3
Location of Reinforcing Steel Marked

A pachometer was used to locate the reinforcing steel in the area so that it could be avoided to prevent damage to the drill bits when drilling the injection ports.

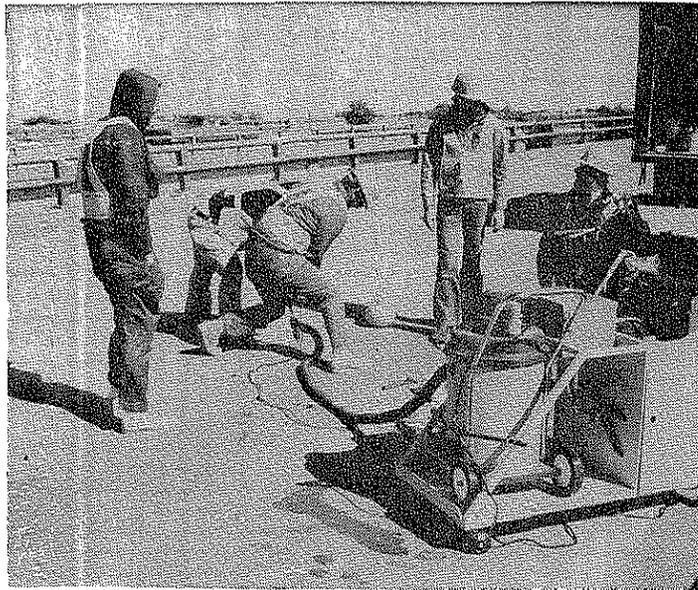
Figure 4
Drilling Injection Holes with Vacuum Attached

Holes for injection were drilled through the plane of delamination on approximately 2 ft. centers prior to commencing the repair. Sinmast injection resin was selected for this bridge in as much as the Kansas report indicated it was satisfactory for this procedure. By tapping the deck during the injection process, the flow of epoxy could be determined.

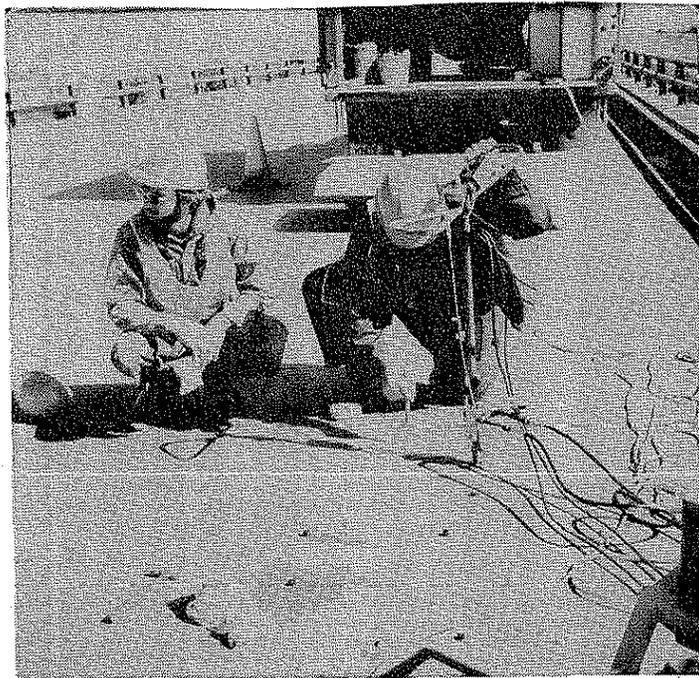
Figure 5
Injecting Epoxy and Checking Flow in Delamination
by Tapping with Small Steel Rod.

If an obstruction to the flow occurred, additional holes needed to be drilled. These additional holes must be drilled outside the area that the epoxy had penetrated. We soon learned that only a small amount of epoxy sucked
