HR-531

Condition and Performance Report

**Thin Bonded Concrete Overlay
With
Fast Track Concrete**

By
O. J. (John) Lane Jr., P.E.
Iowa Department of Transportation
Ames, Iowa
515/239-1237

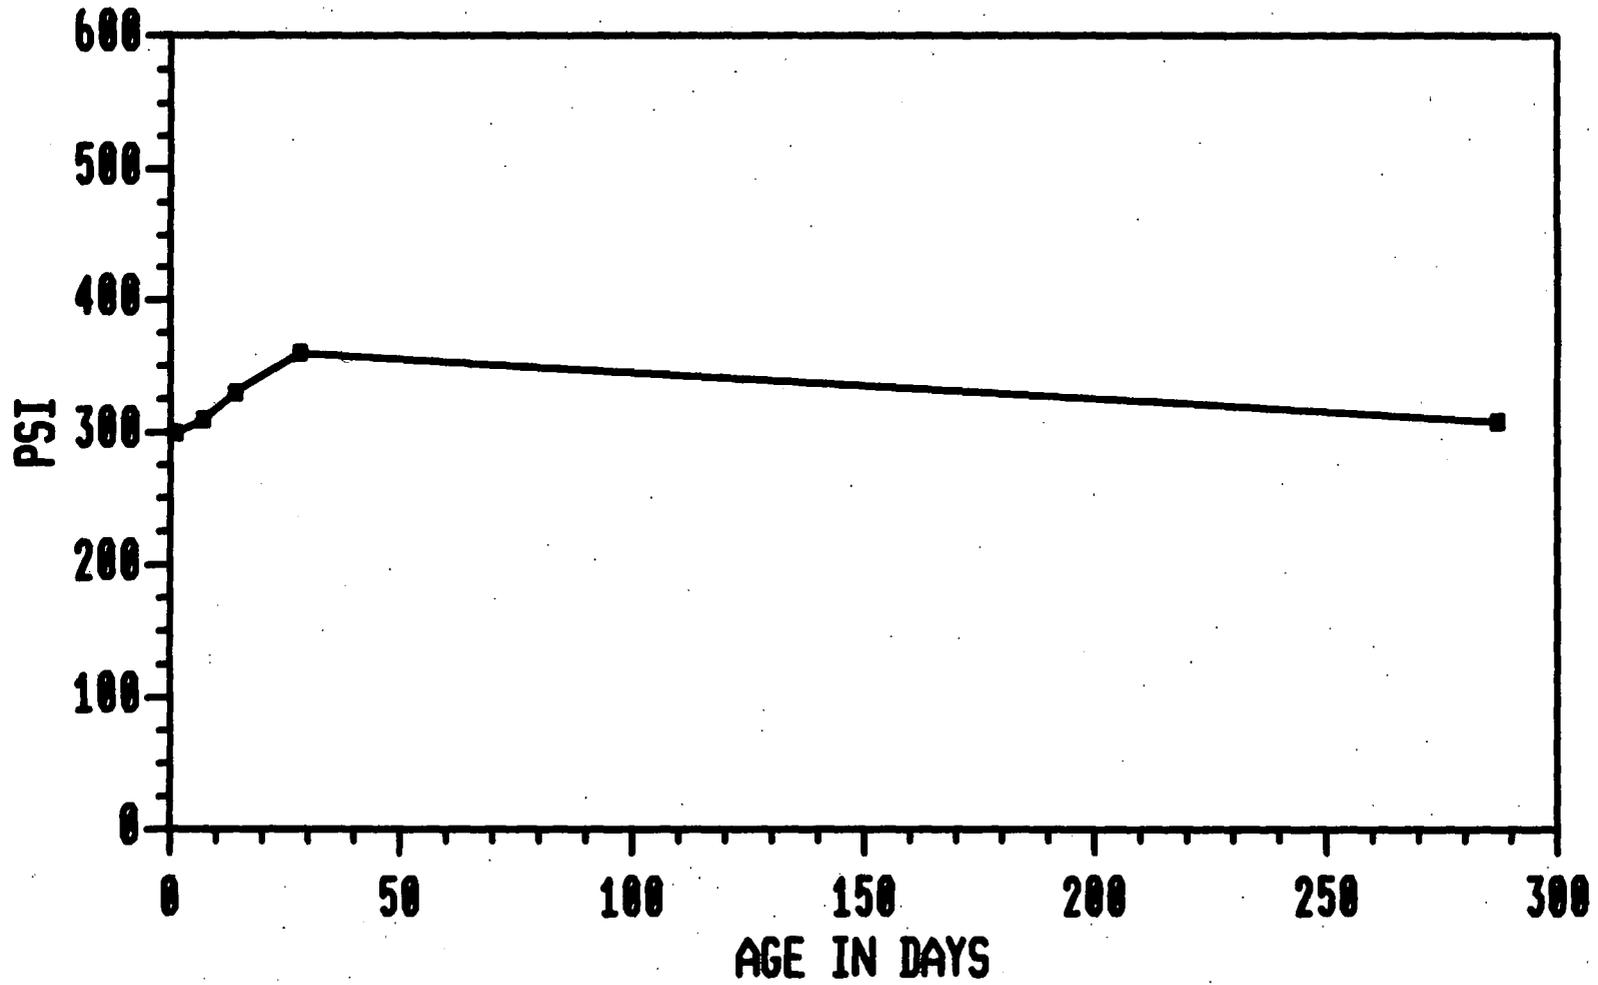
IOWA FAST TRACK CONCRETE
SHEAR STRENGTH
4" CORES

Direct shear strength at the bond line shows the bond strength on average has decreased slightly. The decrease is considered minor and not significant. The bond strength is a little lower than anticipated but is in a comfortable range and well above the minimum considered necessary to cause the old pavement and the new overlay to work together as a structural unit.

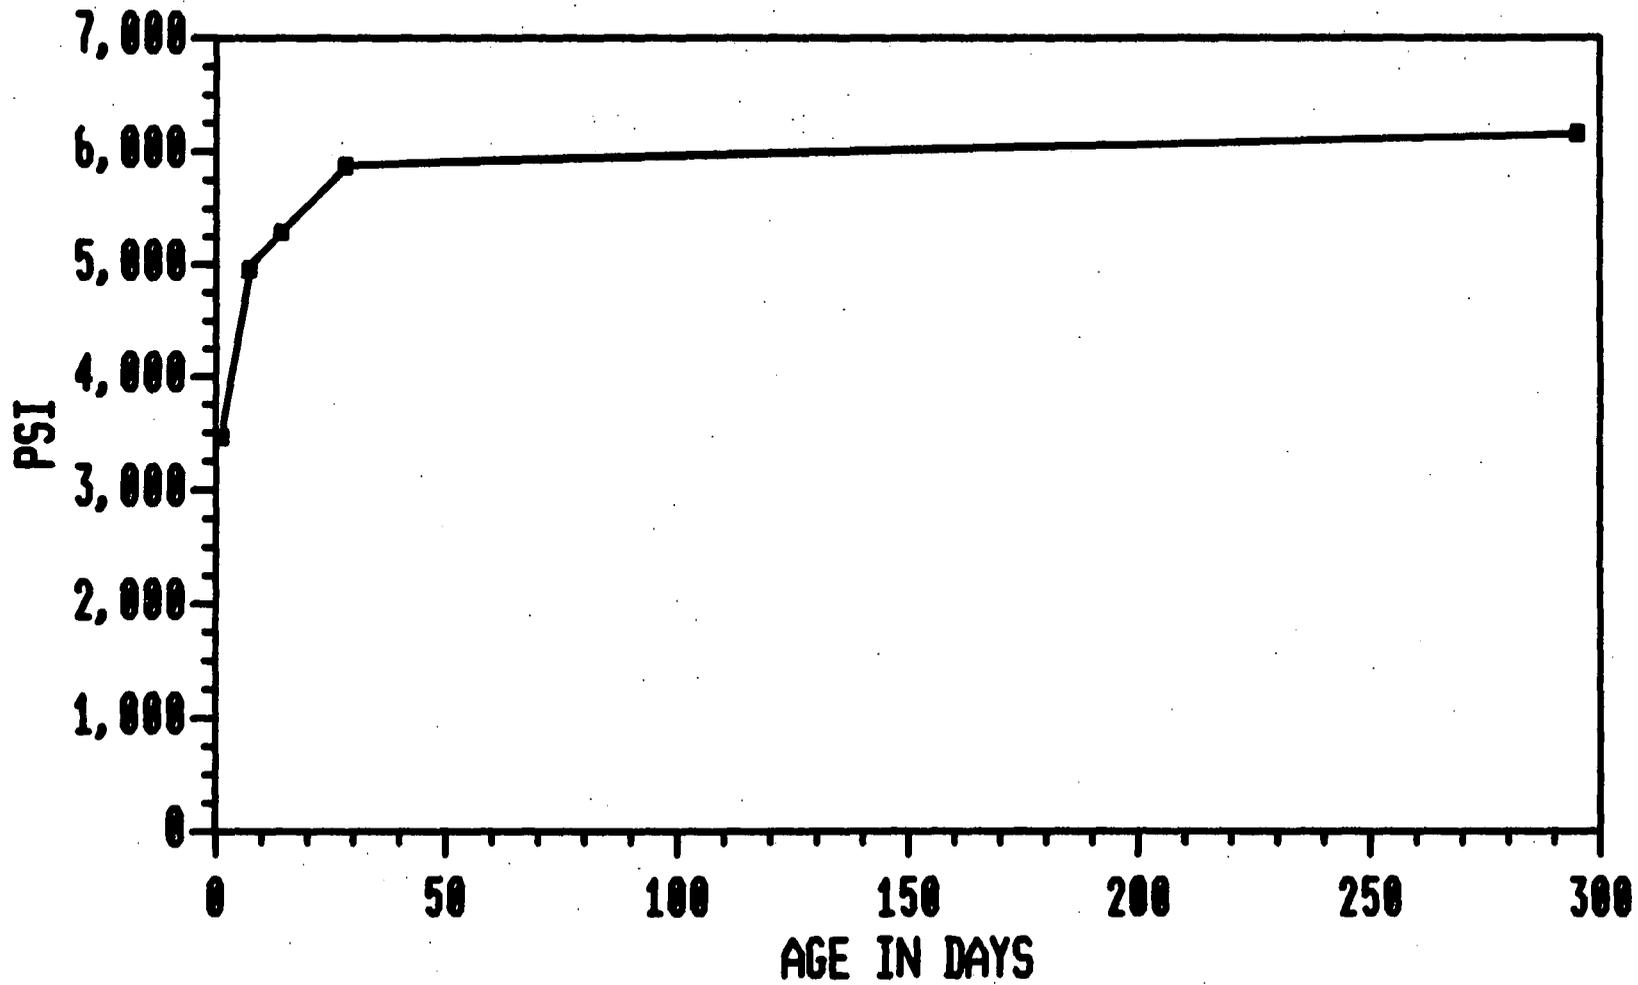
IOWA FAST TRACK CONCRETE COMPRESSIVE STRENGTH

Compressive strength of the concrete as shown by the strength of cores is very high and shows normal continued strength gain since last summer. On average the concrete containing calcium chloride is a little higher than concrete without calcium chloride.

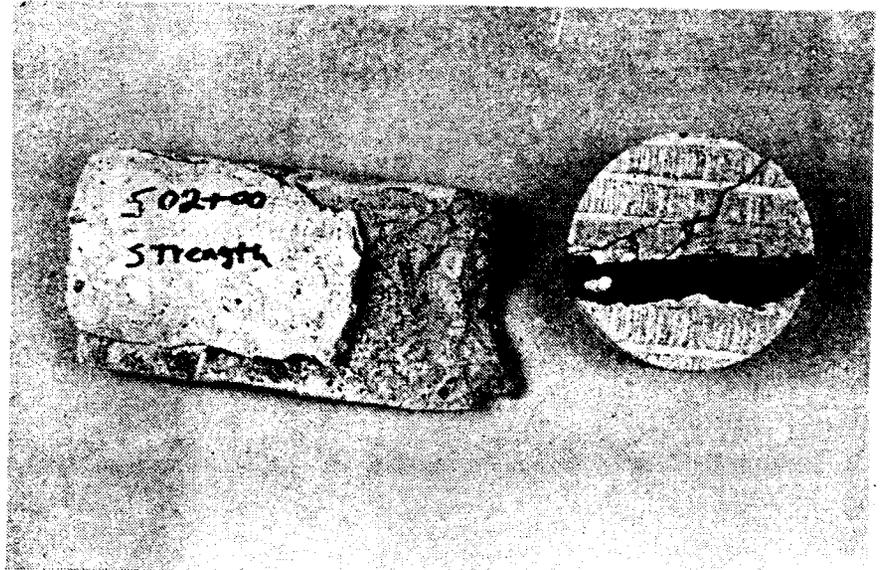
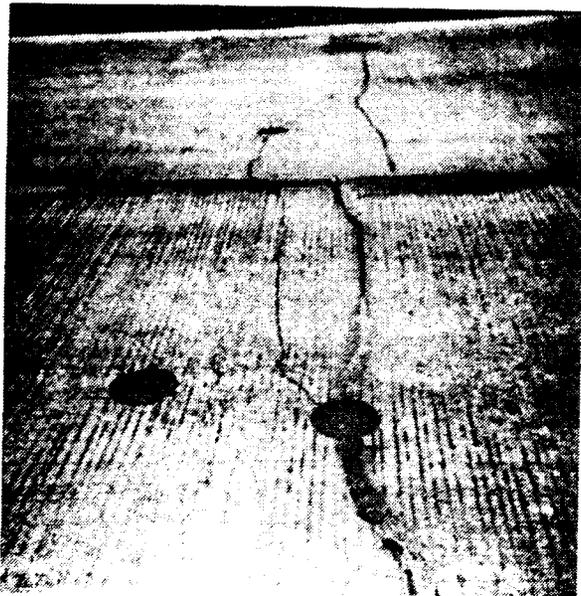
Station 502+00 A.
Crack in overlay matches
crack in old pavement.

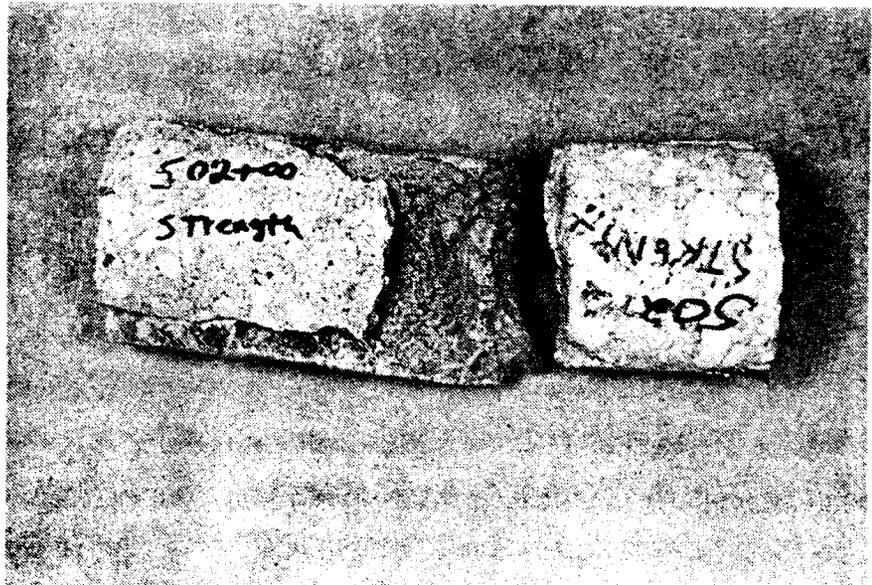
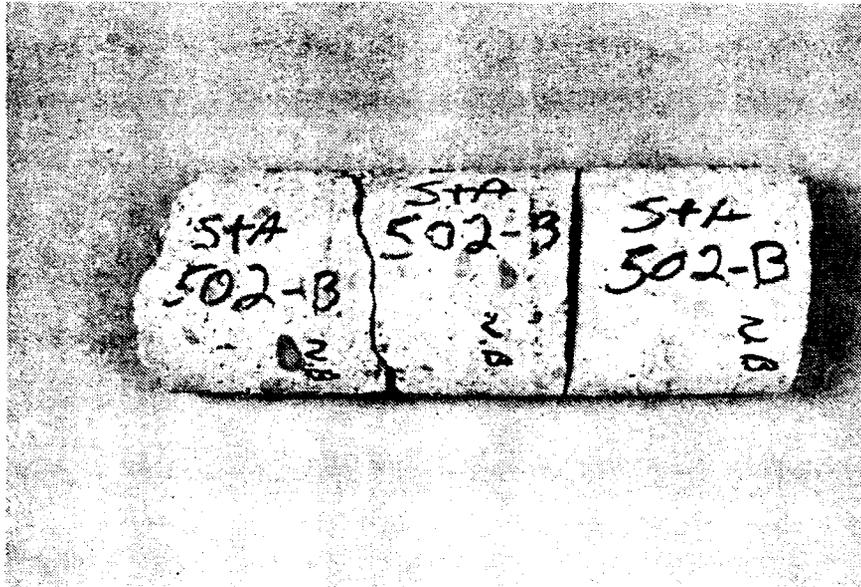
Station 502+00 B.
Crack in overlay does not match crack in old pavement.

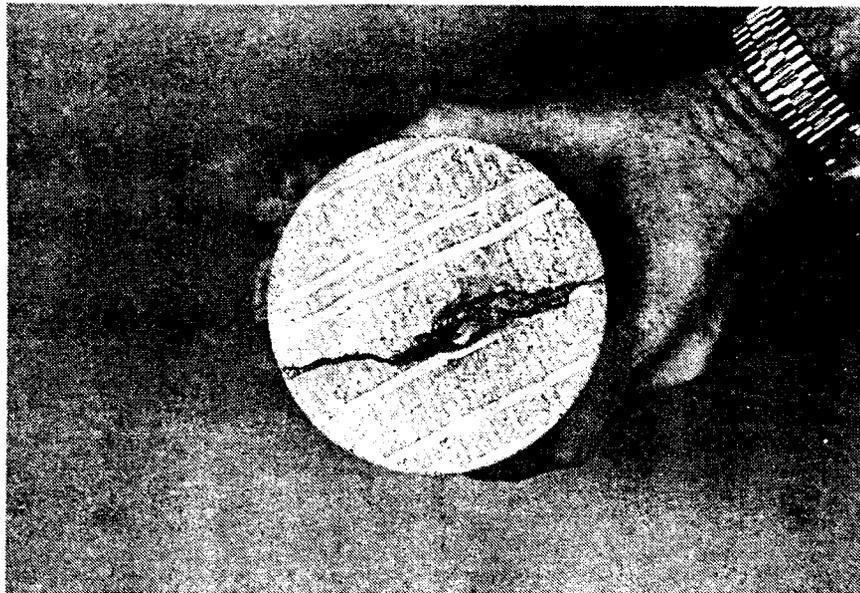
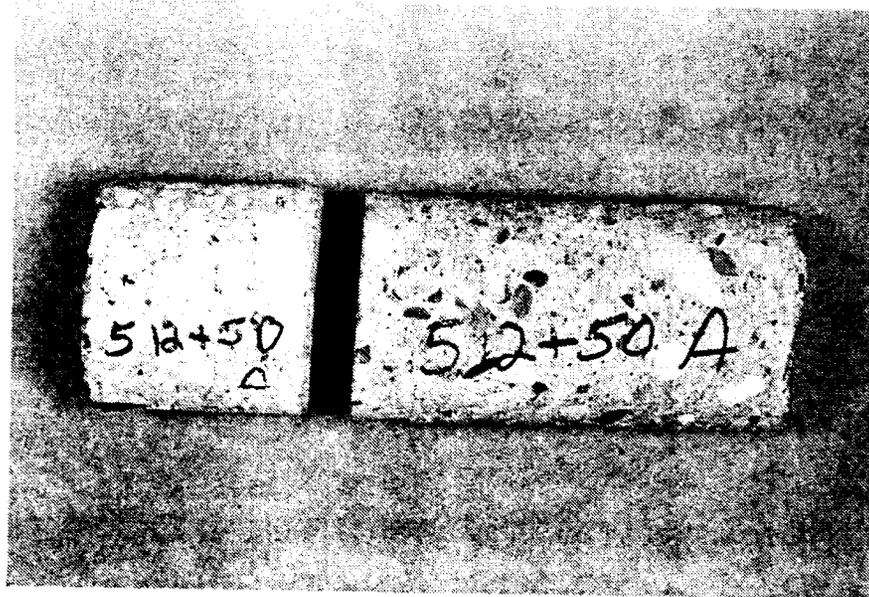
The cause of the debonding is thought to be related to the slight crack closure in the old pavement after overlay placement and during the time of maximum temperature while the insulated covers were in place. Even though crack closure was restricted by incompressibles in the crack it appears there was enough minor closure to cause a tendency for debonding. This same condition appears to have caused the minor amount of multiple transverse cracks in these same areas.

Station 512+50 A.
Crack in overlay does not match crack in old pavement.
Overlay is debonded.

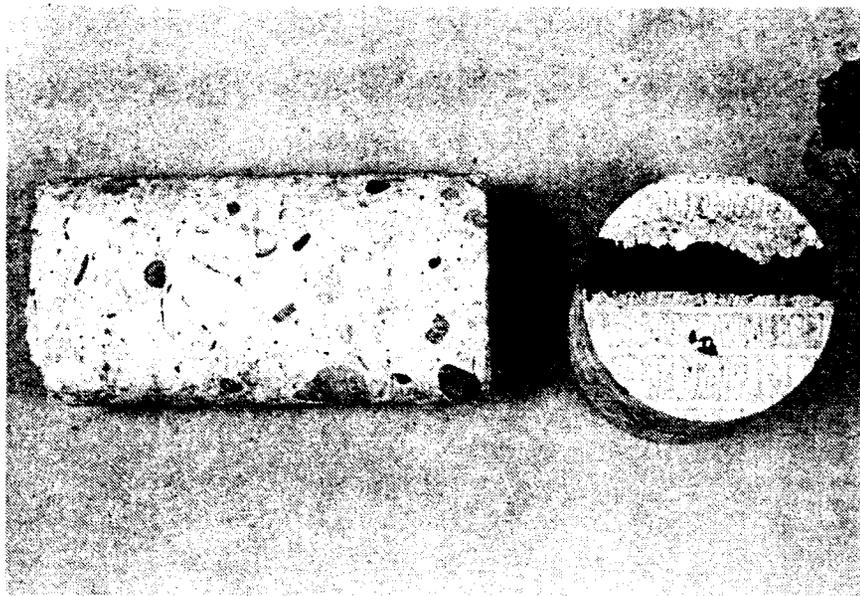
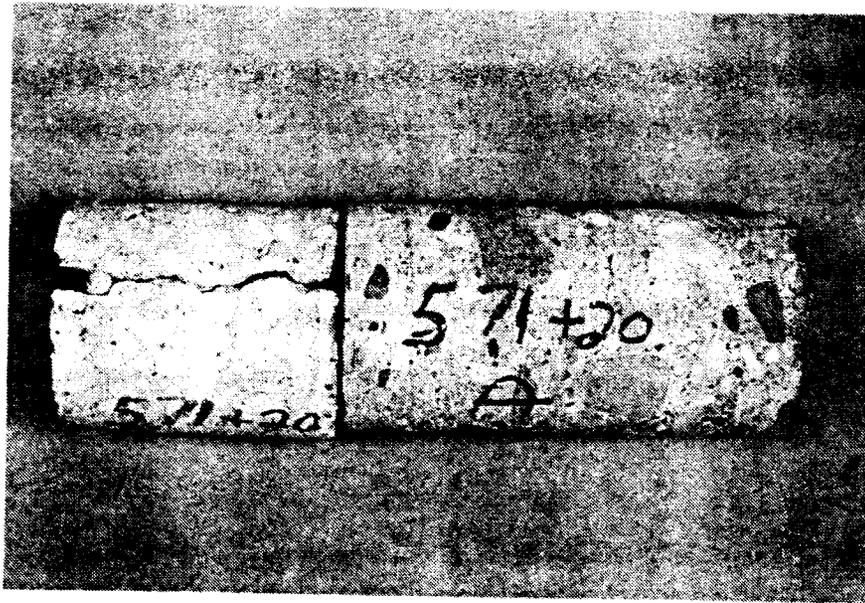
Station 571+20 A.
Crack in overlay does
not match crack in
in old pavement.

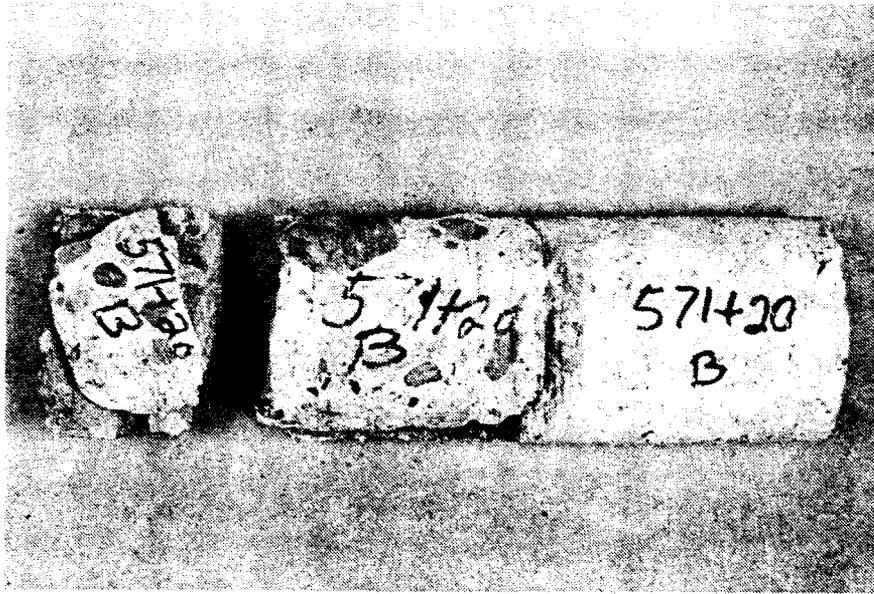
Station 571+20 B.
Crack in overlay matches crack in old pavement.

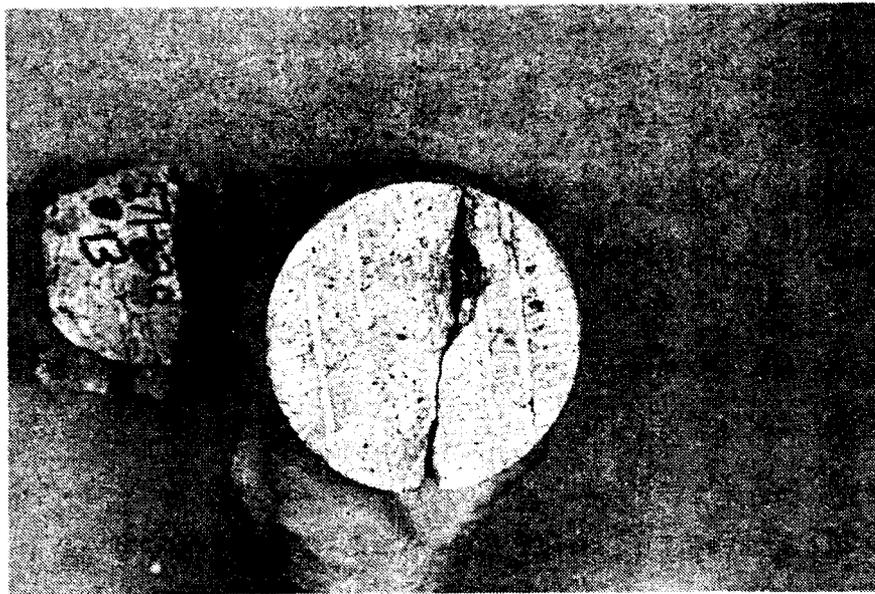
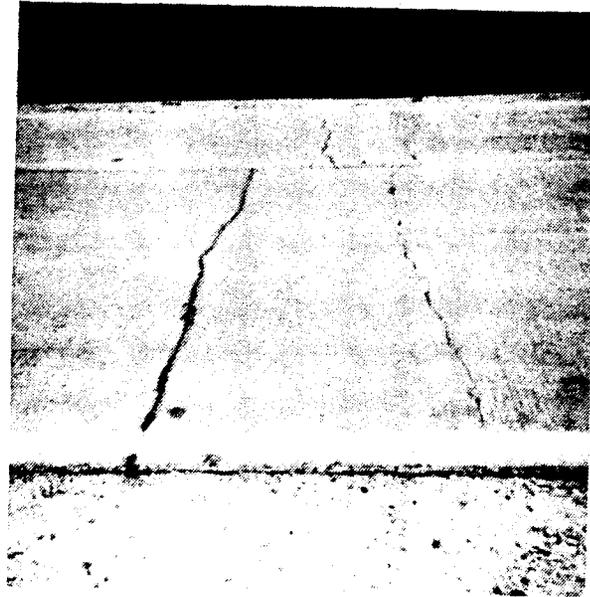
Station 592+50.

One crack in the overlay matches the crack in the old pavement.
One does not.
