**VIDEO EVALUATION  
OF  
HIGHWAY DRAINAGE SYSTEMS**

by  
**Robert F. Steffes, Vernon J. Marks  
and  
Kermit L. Dirks**

**Highway Research Advisory Board  
Research Project HR-317**

Highway Division  
Iowa Department of Transportation  
Ames, Iowa 50010

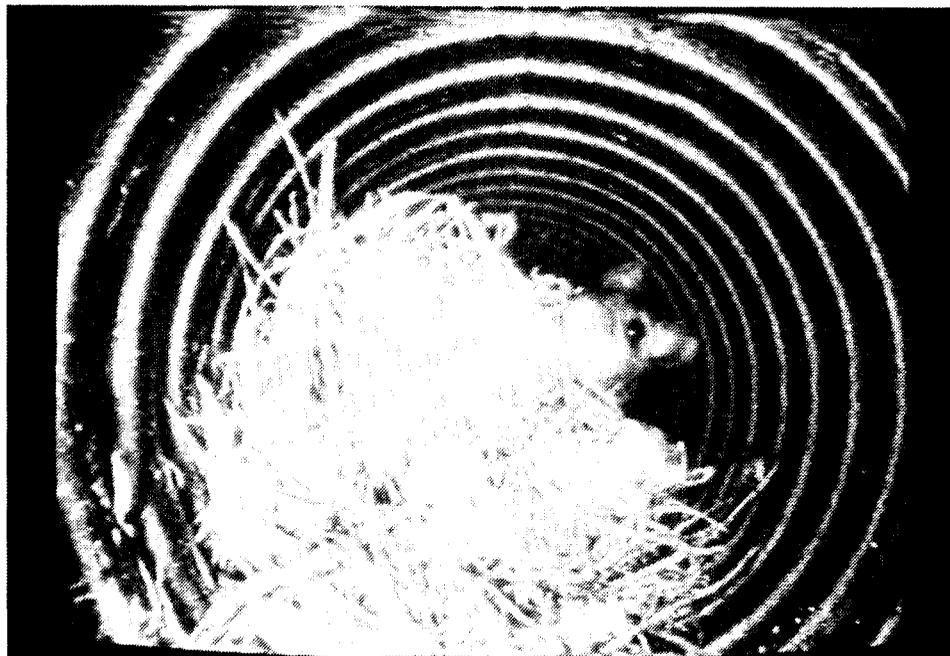
Figure 8

Drought conditions prevailed across Iowa in 1989. With little or no water flow through the 4 inch diameter edge drain pipe, the conditions were favorable for rodent nesting in the drains. The rodent guards used were a hanging finger type and they did not prevent small rodents from entering. The

video evaluations in the fall of 1989 showed rodent nests in approximately 50% of the drains inspected.

Rodent Nests in Subdrains

No rodent nests were encountered by video evaluations during the rainy spring of 1990. There was evidence of rodent nest material, i.e., grass and fur around the outlet of the drain. From these observations, it appears that water flows in the drains were sufficiently high or turbulent to flush out the rodent nests. A rodent guard made from 1/2 inch mesh is more suitable to prevent small rodents from passing.

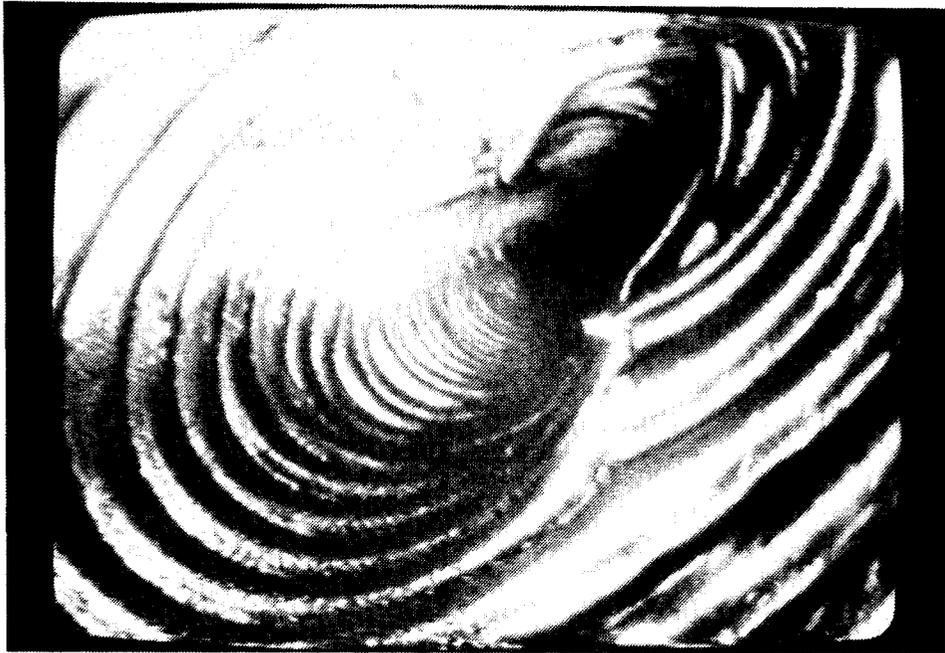
Excessive tension applied to the polyethylene corrugated pipe during installation can, in the worst case, cause it to tear and leave an opening. The opening is likely to allow backfill to enter and a cavity may develop above the opening. Pipe opening can also be caused by an oversized sharp stone, 3" diameter or larger, in the backfill which may puncture the pipe during compaction. The pipe could also be stretched which reduces its stiffness, resulting in collapse. If a drain is collapsed or plugged completely, the water flow will travel outside of the pipe through the porous backfill.

Figure 9  
Collapsed Subdrain
