LOW COST TECHNIQUES OF BASE STABILIZATION

**FINAL REPORT
IOWA HIGHWAY RESEARCH BOARD
PROJECT HR-312**

JANUARY 1994

LOW COST TECHNIQUES
OF BASE STABILIZATION
DUBUQUE COUNTY

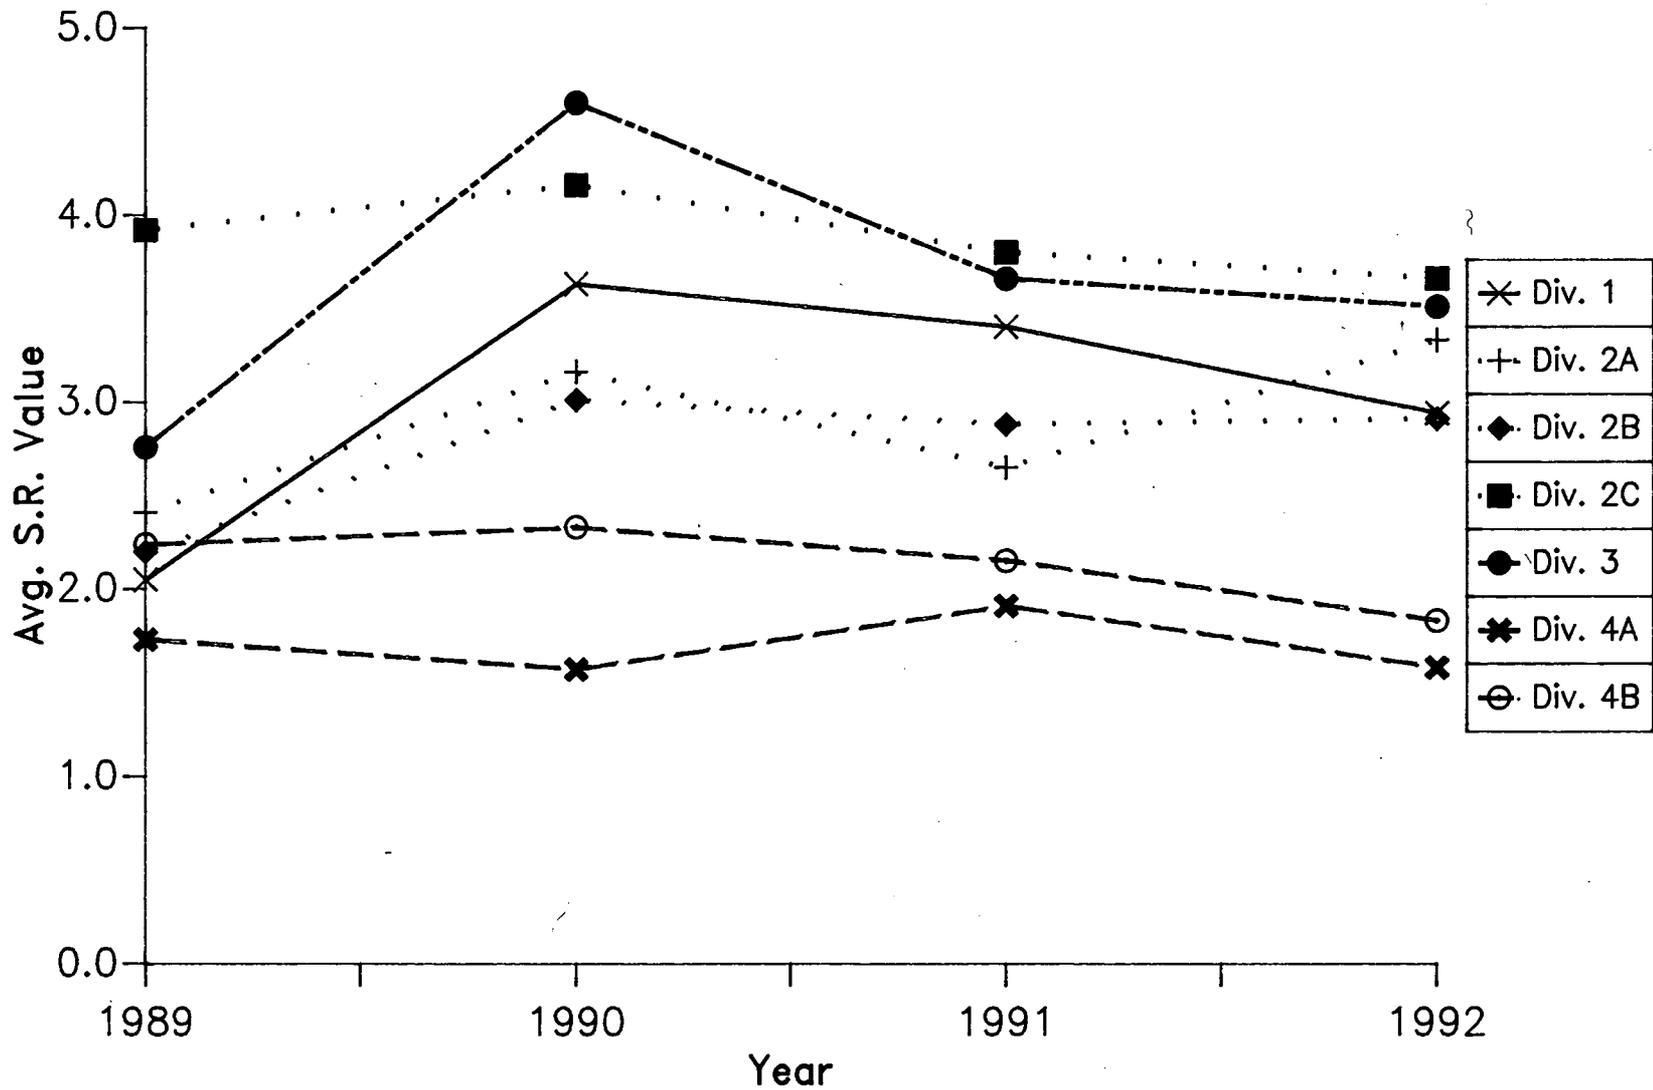
FIGURE 1

Annual Structural Rating Values Horseshoe Road, Dubuque County

The variation in the performance of the bases indicate a problem with the BIO CAT and Consolid soil stabilization techniques. The problem with the BIO CAT and Consolid system was not structural strength or the soil modulus K. The soil stabilization methods had higher values in both measurements than the emulsion or the Macadam base.

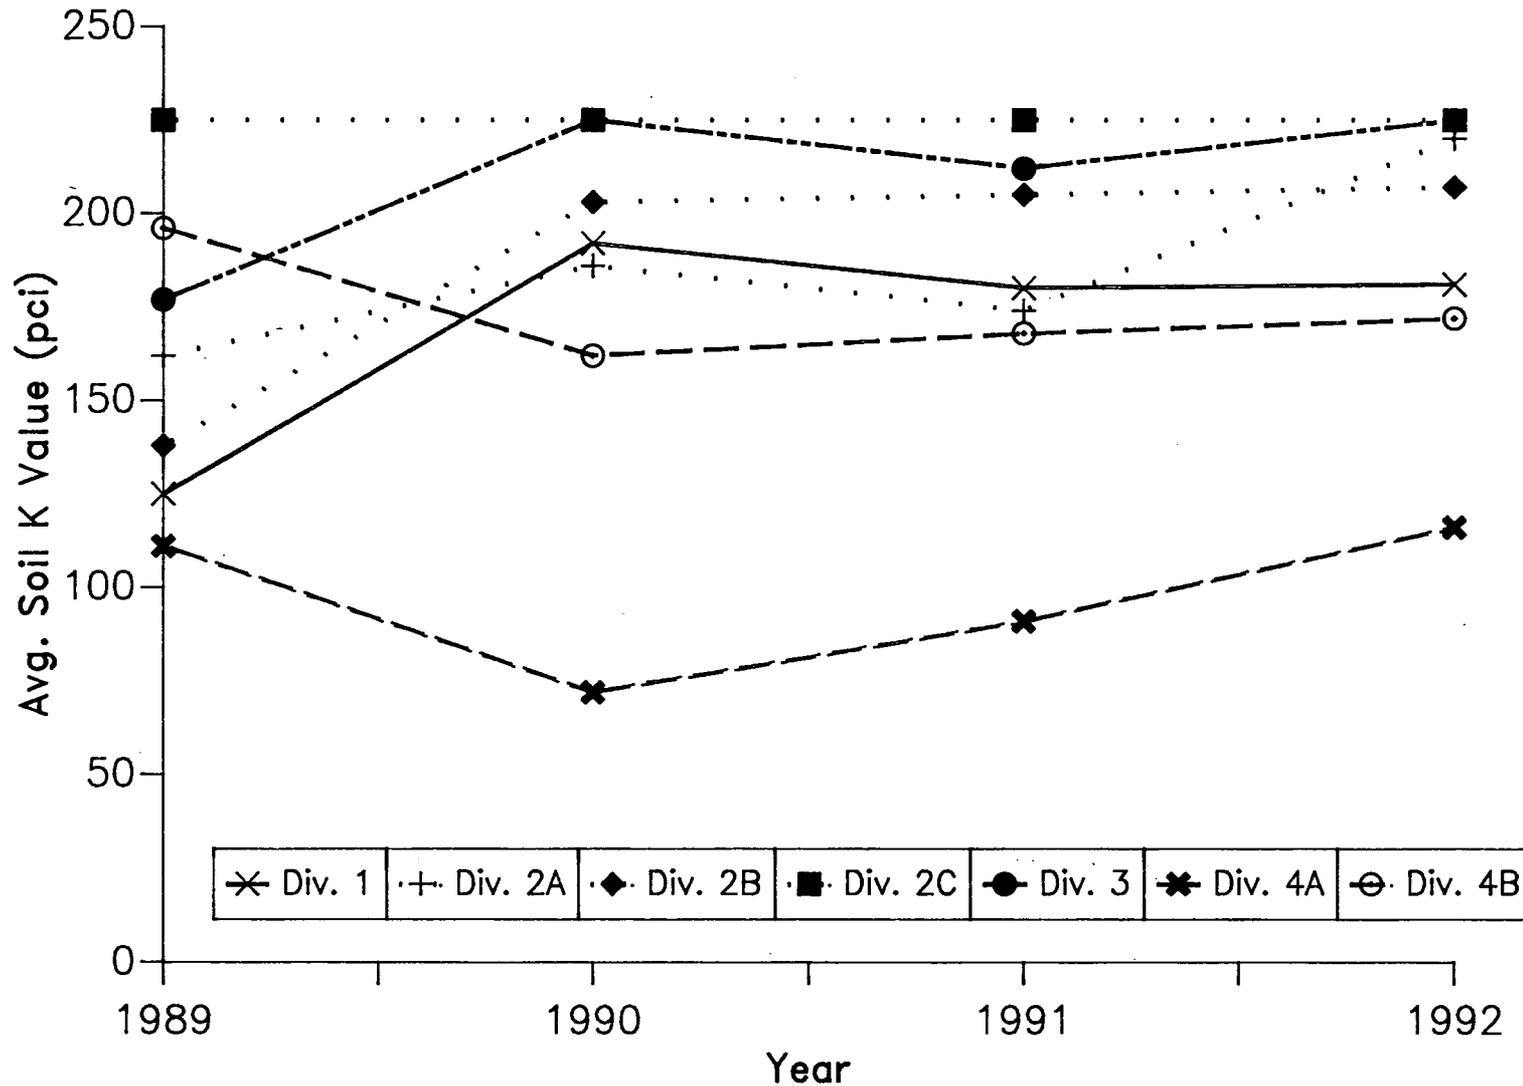
FIGURE 2

Annual Soil K Values Horseshoe Road, Dubuque County

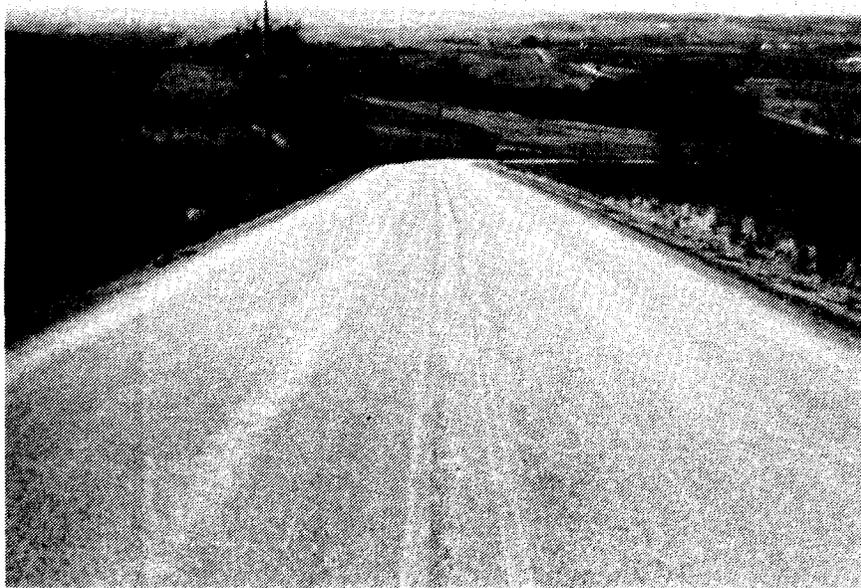
Section IV (Macadam) appeared to be in good condition for all the visual reviews. In 1991, a few places had been patched. By 1992 some minor rutting had occurred.

Photo 1 - Macadam Base Section

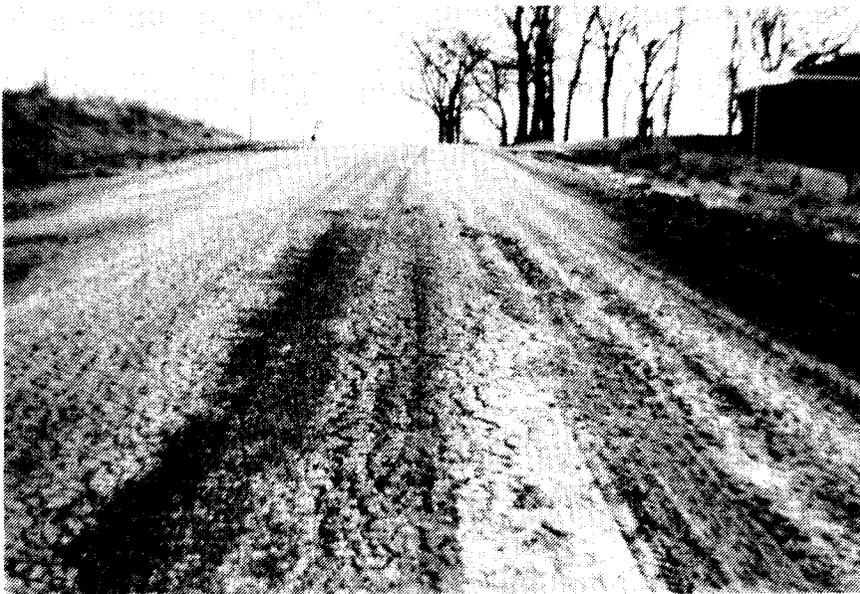
The failure of the soil stabilization techniques was primarily alligator cracking followed by rutting as the base completely

gave way to the forces of the traffic. This may have been due to freeze/thaw cycles damaging the base. The Iowa DOT evaluation MLR-87-10, "Evaluation of the Consolid System of Soil Stabilization" indicated that the method was susceptible to freeze/thaw cycles. The alligator cracking was another indicator that frost action may have caused the failure.

Photo 2 - Typical Alligator Cracking and Rutting
of Soil Stabilized Base
