# **EVALUATION OF BRISCO SCOUR MONITORS**

**FINAL REPORT FOR  
IOWA DEPARTMENT OF TRANSPORTATION  
PROJECT HR-551**

Final Report  
for  
Research Project HR-551

November 1993

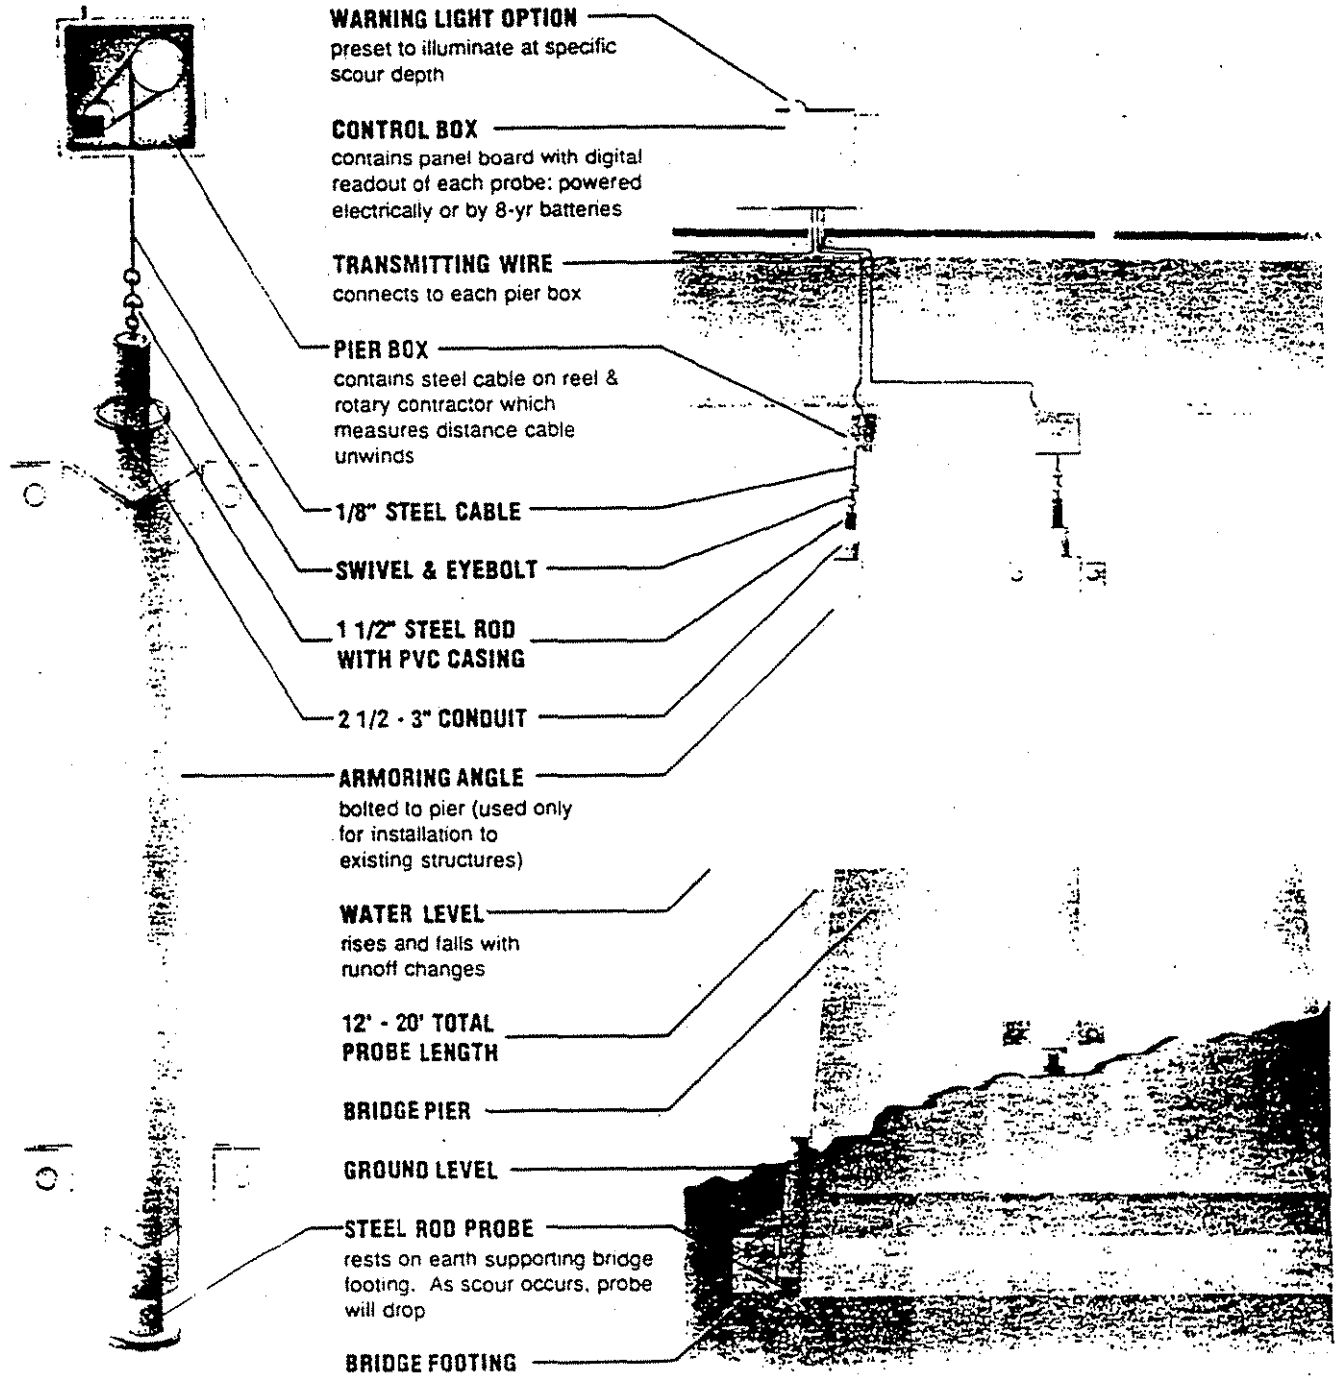
FIGURE 1  
Schematic of the Brisco Scour Monitor

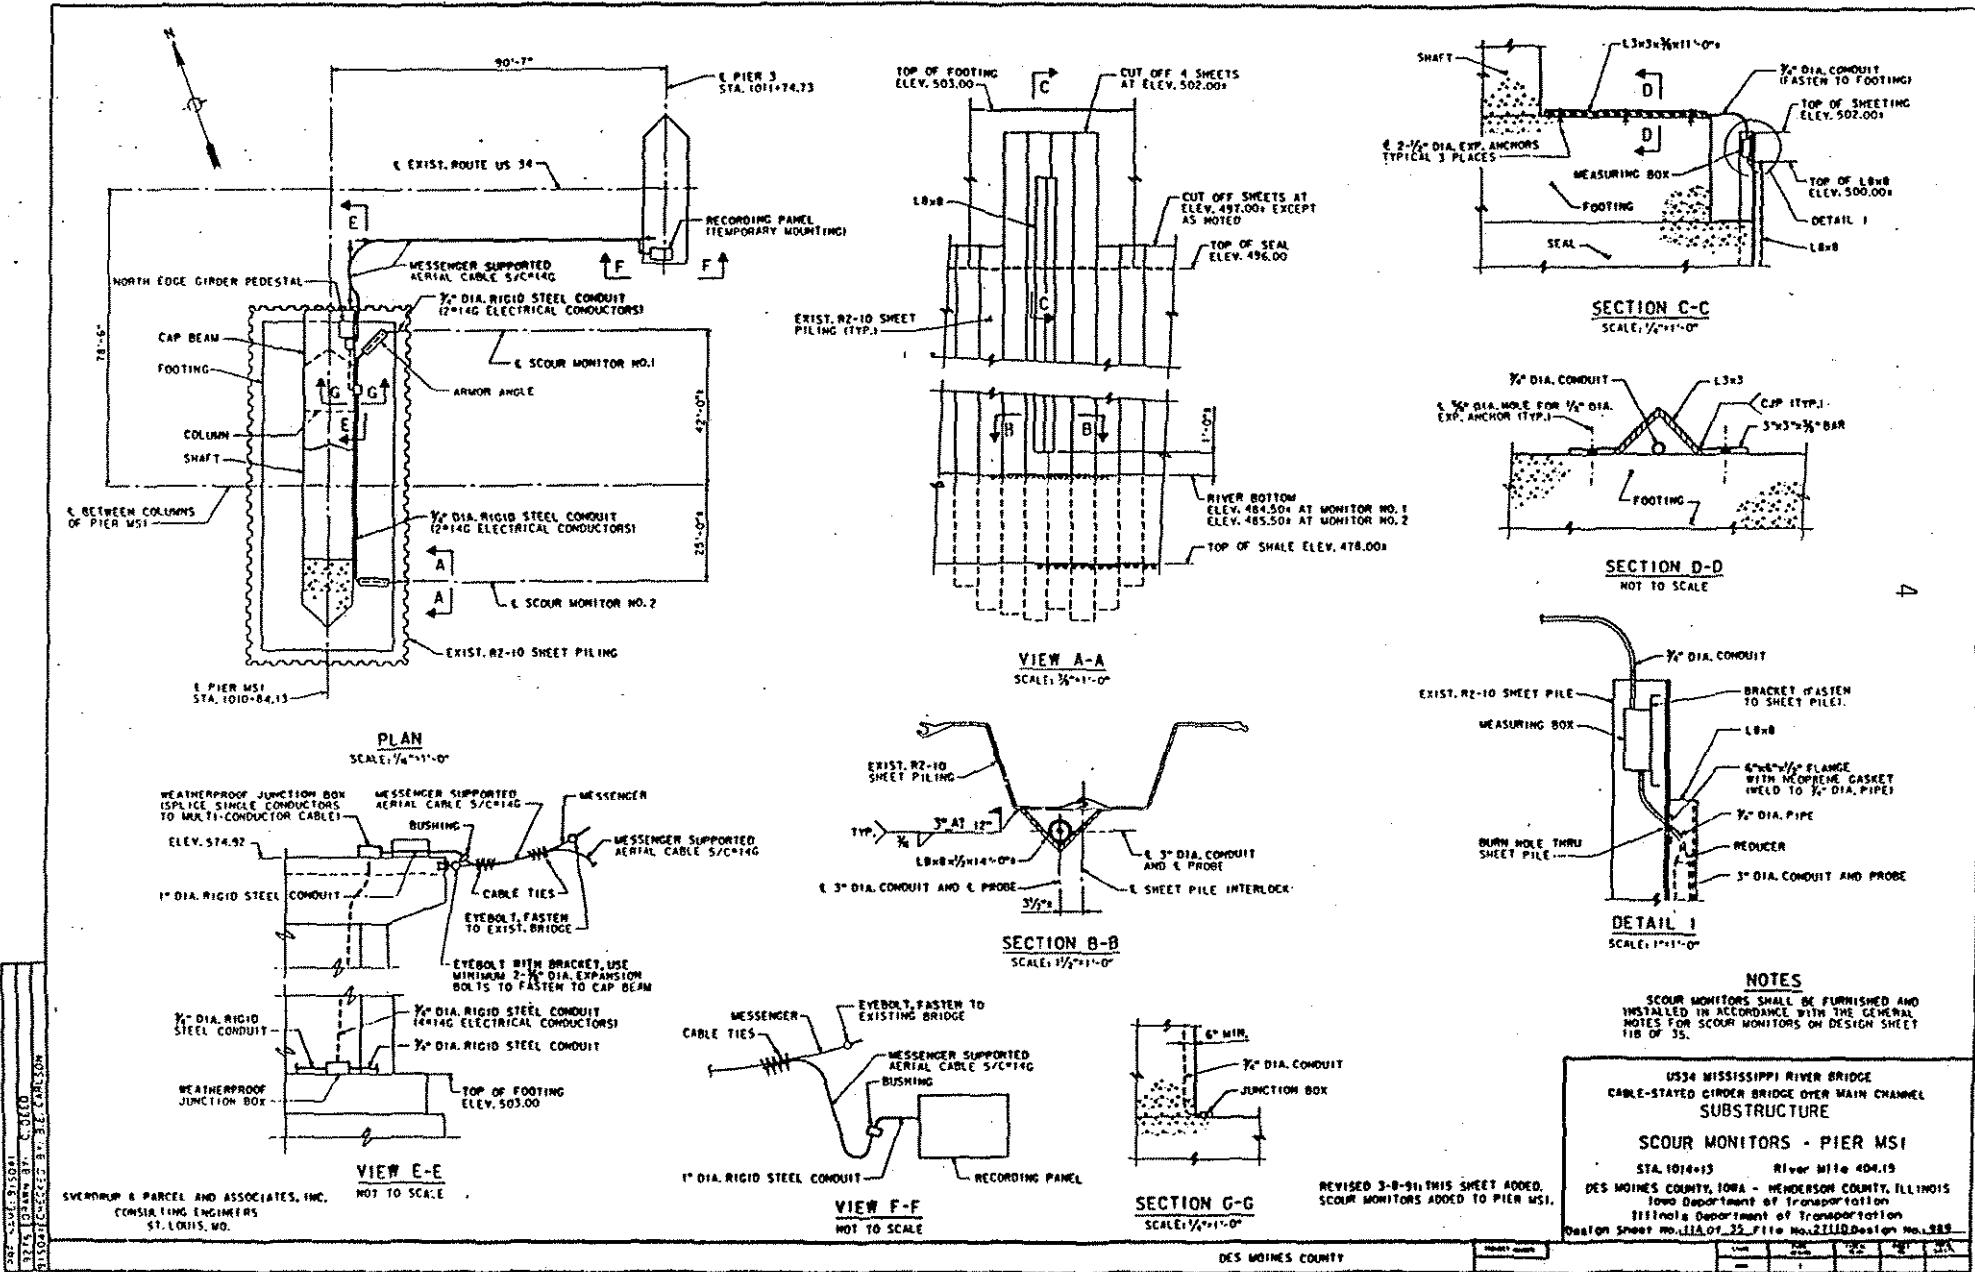
**FIGURE 2**  
Design Details for Installation  
of the Bridge Scour Monitors
