# **VIBRATION STUDY FOR CONSOLIDATION OF PORTLAND CEMENT CONCRETE**

Interim Report  
for  
Iowa DOT  
Research Project MLR-95-4

Vibration Study for  
Consolidation of  
Portland Cement Concrete

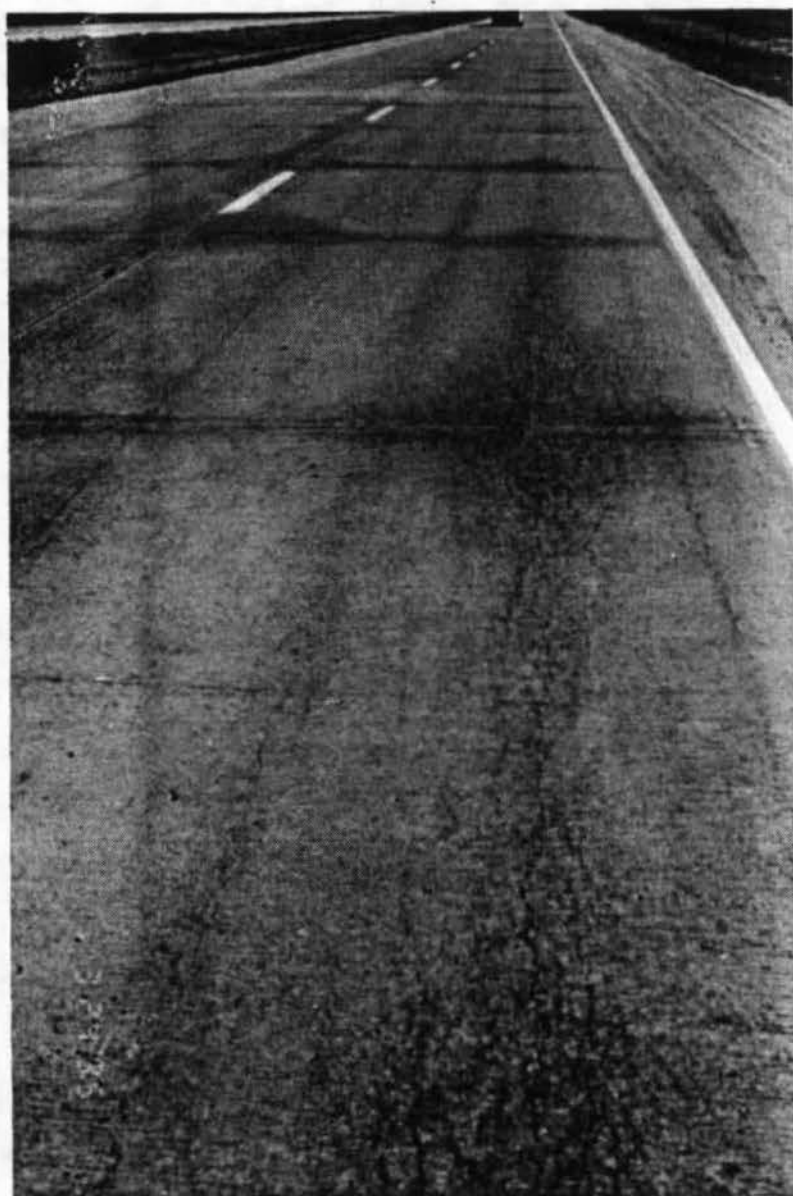
A second cracking pattern began to emerge during the following years on the US 20 project. Longitudinal cracks spaced at about 0.6 m (2 ft) began to appear in the pavement (Figure 1). The transverse distance between the cracks is very similar to the spacing of the vibrators on the paver used for the project.

FIGURE 1 Longitudinal and joint cracking on US 20 in Webster County.

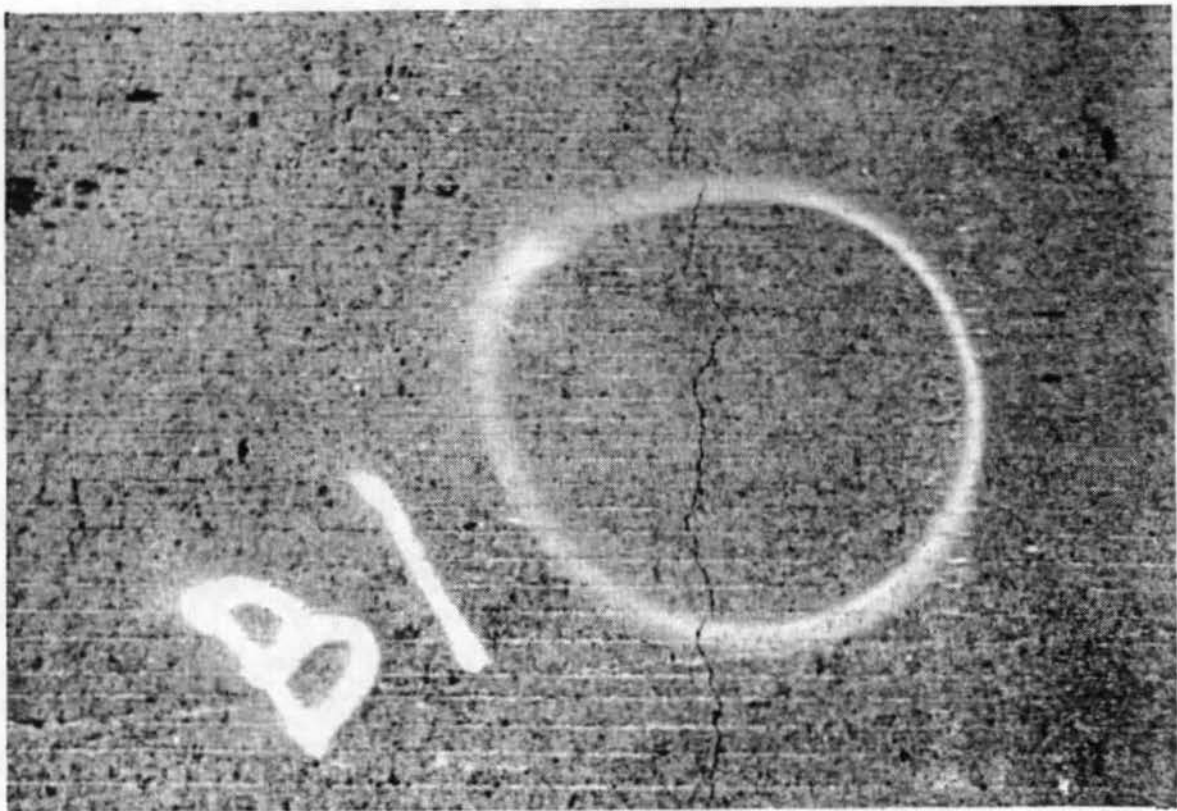
During this same time interval, a similar longitudinal cracking pattern was noticed on Interstate 80 in Dallas County (Figure 2). This roadway was also three years old when longitudinal cracking was first identified. These cracks were spaced at intervals that approximated the transverse spacing of vibrators. Cores taken from the longitudinal cracks indicated air contents of 3 percent in the top half of the core and 6 percent in the bottom half. The longitudinal cracking pattern and the reduced air content indicated the possibility of excessive vibration, since the vibrators were positioned near the top of the pavement.

FIGURE 2 Longitudinal crack on I-80 in Dallas County.

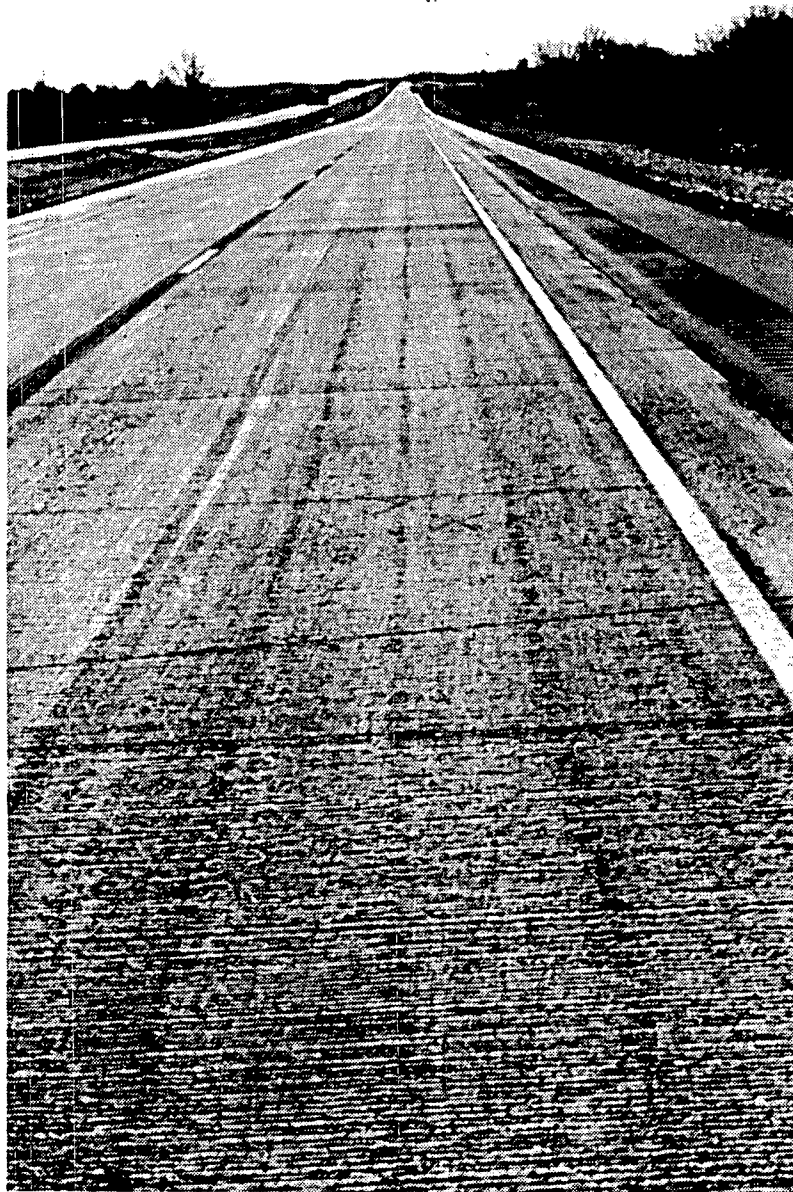
In other areas in the state of Iowa, longitudinal trails can be observed in the surface of some PCC pavement projects. These trails run parallel to each other with a spacing similar to the spacing of vibrators on pavers (Figure 3). This longitudinal disconformity of the pavement was termed

Vibrator trails are believed to be formed by the excessive vibration of concrete. The excessive vibration causes the paste content to increase in the localized area of the vibrator. This zone of increased paste allows the tines of the tining machine to penetrate deeper into the surface of the pavement, thus forming a longitudinal distortion of the pavement surface (Figure 4). Also, vibrator trails can be found below the surface when taking cores from the pavement. If the vibrator trail is slightly below the surface, it can become exposed by diamond grinding off the surface material during the removal of a bump (Figure 5,6). In this case the exposed surface has longitudinal bands where the pavement has reduced coarse aggregate due to excessive vibration.

FIGURE 3 Vibrator trail in pavement surface on US 65 in Polk County.

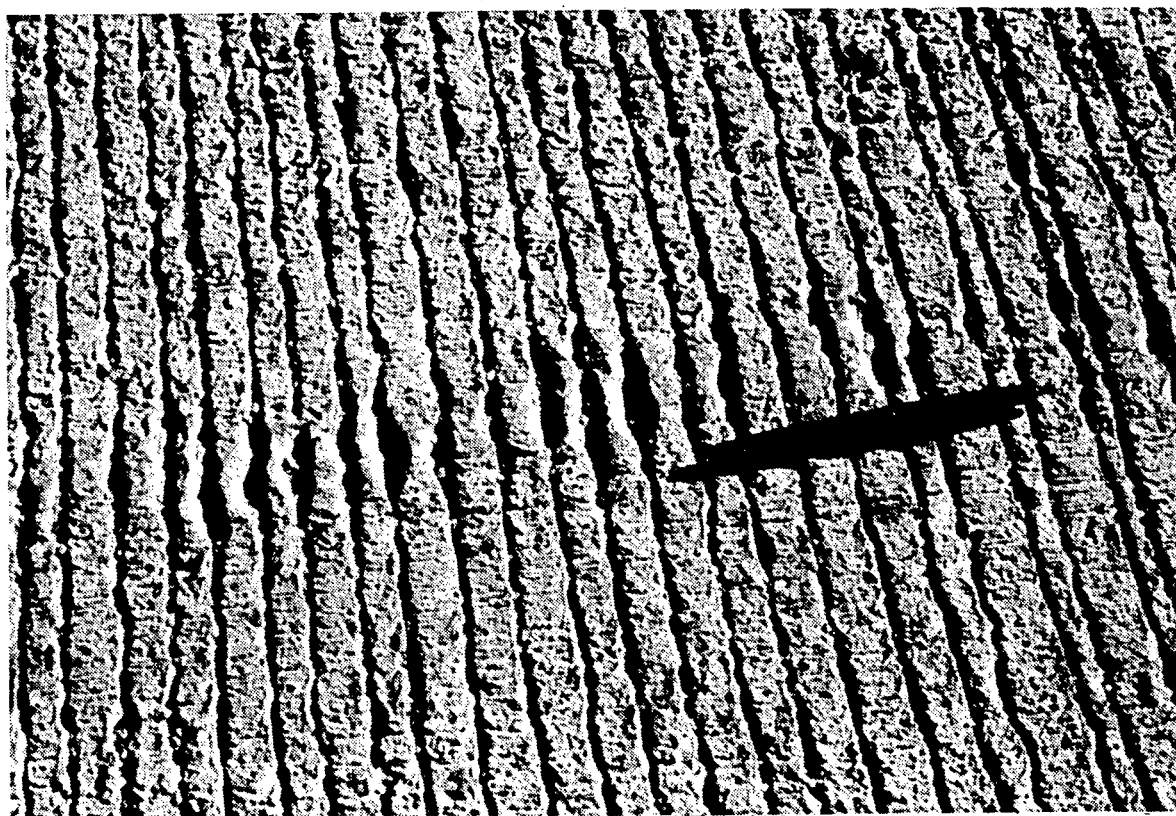
FIGURE 4 Distortion of pavement surface in a vibrator trail.

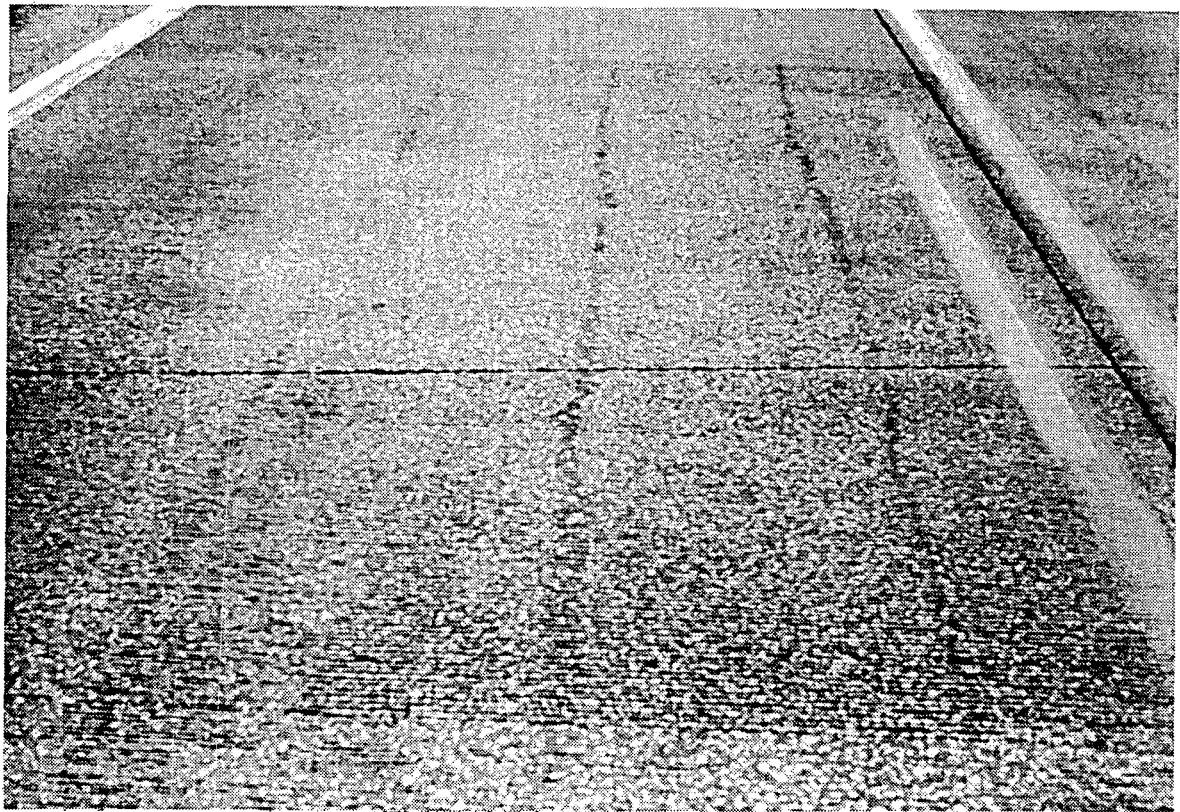
FIGURE 5 Longitudinal distortion in the surface of a diamond ground pavement.

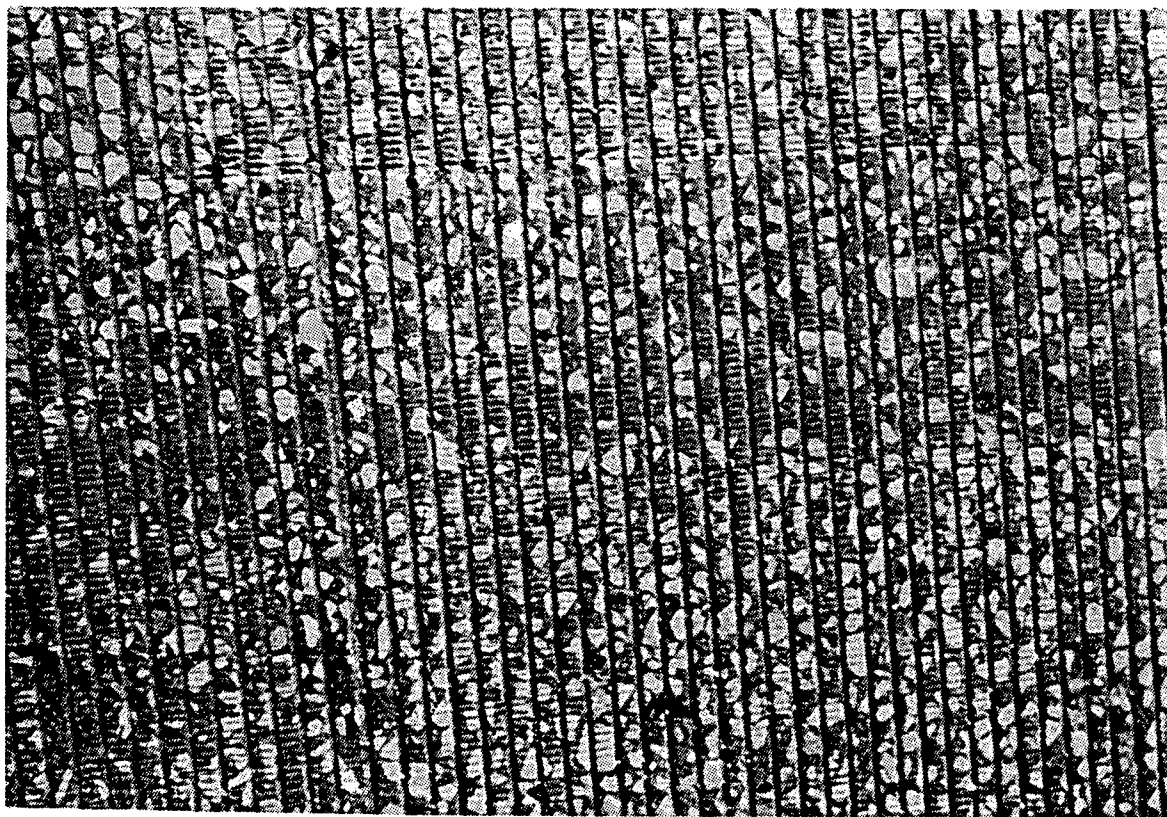
FIGURE 6 Aggregate separation in the vibrator trail in a diamond ground pavement.

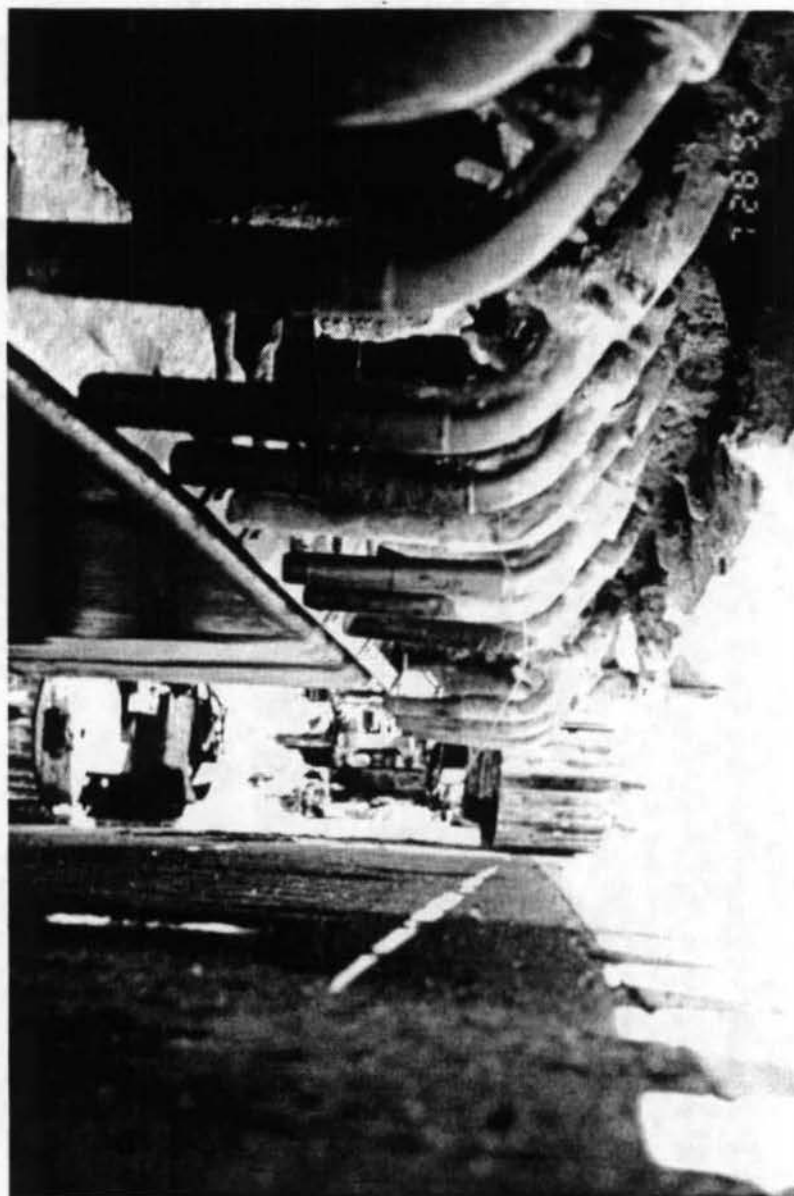
Inspection of the pavers revealed that, in most cases, the vibrators were positioned at the level of the paver's pan and in a horizontal position. However, some pavers had a large variation in the horizontal position of the vibrators. In one case the center of the vibrators ranged from 50 mm (2 in.) above the pan to 75 mm (3 in.) below the pan (Figure 8). In another case, a paver operator indicated the vibrators were at the pan level; however, evidence from cores showed the vibrators were as far as 125 mm (5 in.) below the pan. The change in position can occur from an inaccurate position indicator, sag due to oil leakage in the hydraulic system which holds the vibrators up, or loose bolts that hold an individual vibrator in position.

FIGURE 8 Variation in elevation of vibrators on a slip form paver.

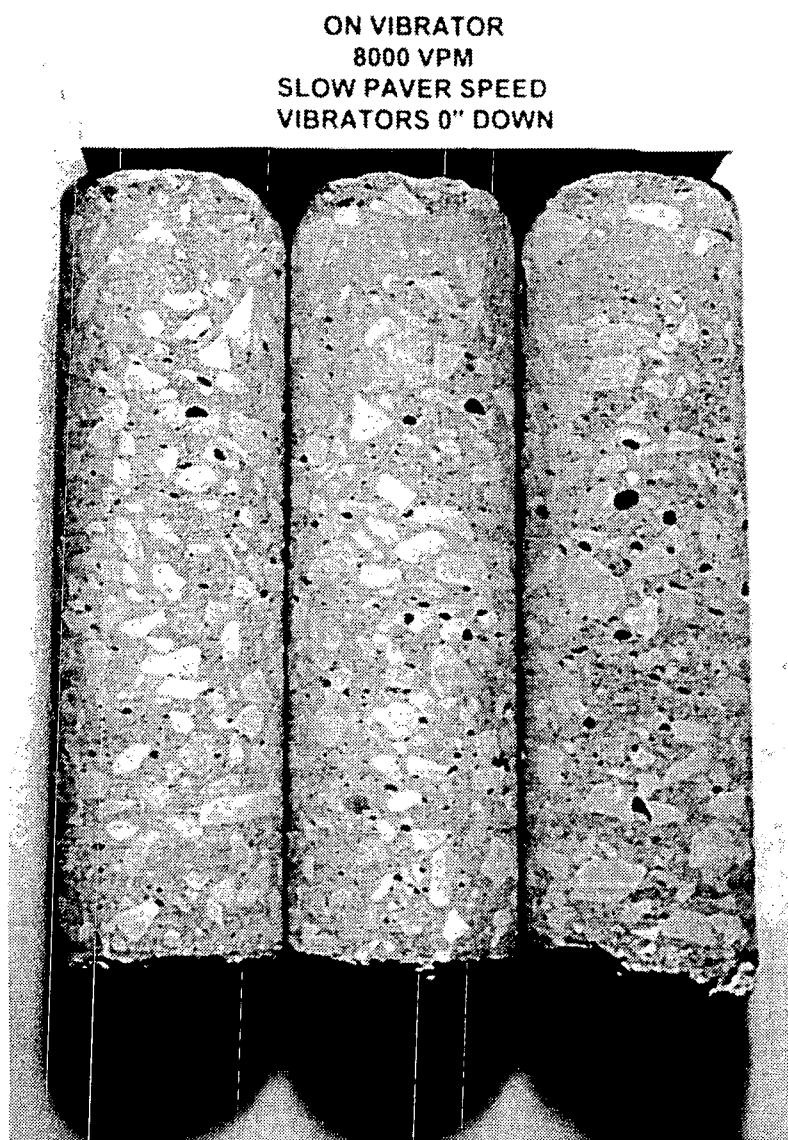
Observations from PCC cores taken on and between the vibrator trails indicate the radius of effective consolidation from the vibrator may be smaller than many claim. The cores commonly show significant entrapped air within a 100 mm (4 in.) of the vibrator location. One noticeable case of this was on project B (Figure 9). The vibrator was positioned at the top of the slab. The test variables used in this case were slow paver speed, vibrator frequency of 8000 vpm, and on the vibrator trail. This test section had the condition of maximum consolidation energy for the project. The 3 cores taken from this test section show an area of aggregate separation approximately 25 mm (1 in.) below the top of the cores. This separation is starting to show the formation of a vibrator trail. However, this consolidation effort still is leaving entrapped air only 100 mm (4 in.) from the area of segregated concrete. Similarly, on project C where a vibrator was running at 12000 vpm entrapped air is located within 100 mm (4 in.) of areas of excessive vibration (Figure 10). In this case the vibrator was 125 mm (5 in.) below the pavement surface. A vibrator trail can be clearly seen passing through the core, yet entrapped air can be found in the bottom third of the cores taken in this vibrator trail.

FIGURE 9 Cores from project B showing aggregate separation near their top.

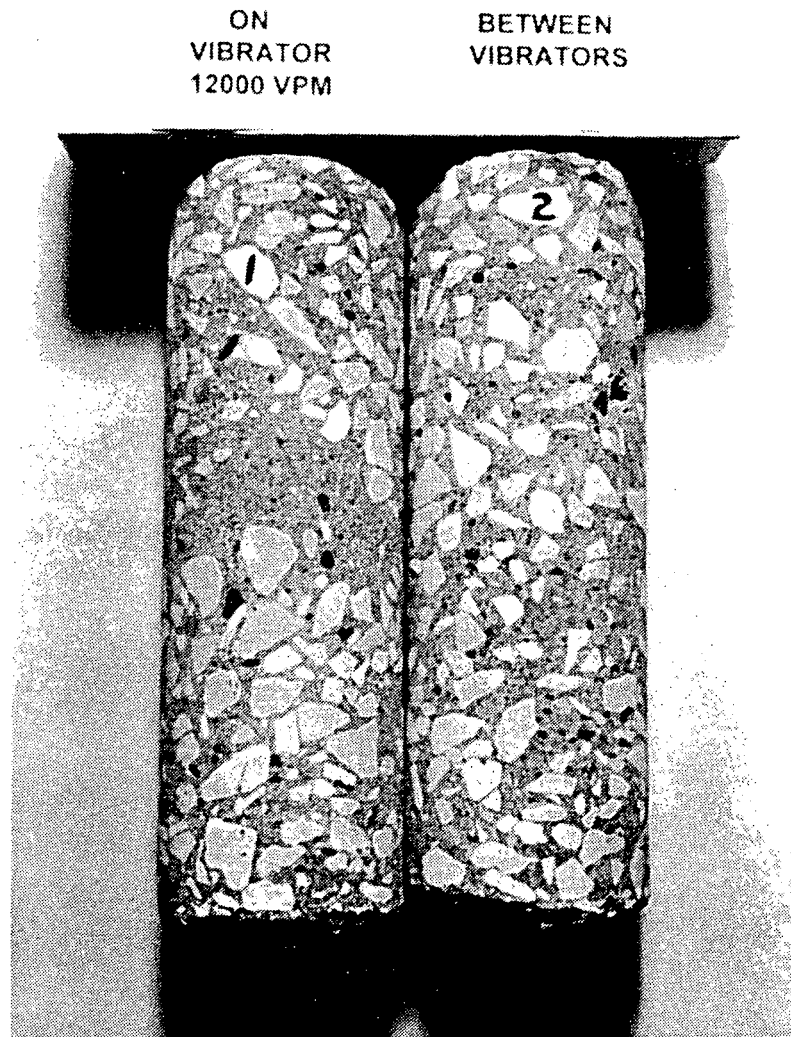
The vibrator found to be operating at 12000 vpm on project C caused significant air loss in the concrete. From the cores, the location of the vibrator was estimated to be 125 mm (5 in.) below the surface of the pavement. Hard air tests indicate air contents of less than 2 percent for the middle portion of these cores (Figure 12). This indicates a severe case of over vibration. The bottom third of the cores had an average air content of 6 percent. Also, cores were taken midway between the vibrator operating at 12000 vpm and the vibrator positioned next to it, a distance of 215 mm (8.5 in.) transversely. These cores had air contents very similar to those taken at 5000 vpm and between the vibrators. The combination of the air content difference between the bottom and the middle of the core and the difference in air content from on to between the vibrators indicates that the vibrators' energy is concentrated in the few inches immediately

FIGURE 10 Cores from project C revealing aggregate segregation in a vibrator trail.
