# **Evaluation of Long-Term Field Performance of Cold In-Place Recycled Roads:**

## **Field Distress Survey**

**Final Report  
May 2007**

**Sponsored by**  
the Iowa Highway Research Board  
(IHRB Project TR-502)  
and  
the Iowa Department of Transportation  
(CTRE Project 03-160)

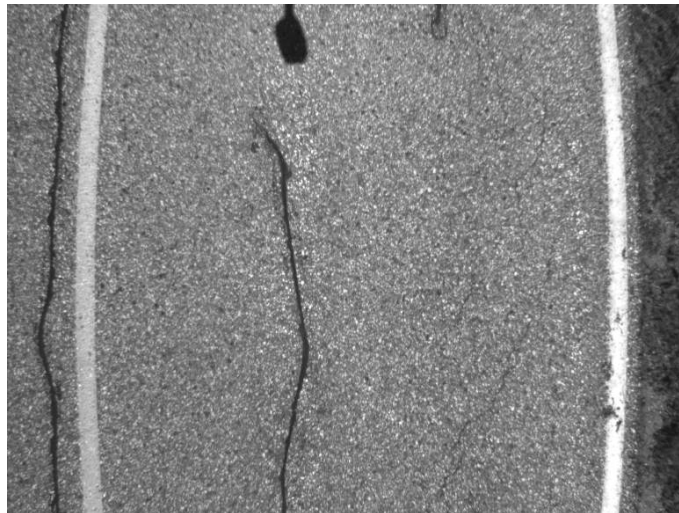
On June 23, 2004, at 16 years since construction, another distress survey was conducted using an AICS and a rutting device and the survey results are summarized in Table A.1.4. As shown in Table A.1.4, the most dominant type of distress was alligator cracking with an average area of 240 ft<sup>2</sup> per 100 ft. station. A rutting area is computed as 140 ft<sup>2</sup> per 100 ft. station. The test section exhibited a PSI value of 59, a PCI value of 54 resulting in an average value of 57. Figure A.1.4 shows a sample digital image of sealed longitudinal cracks acquired using the AICS.

**Figure A.1.4 Longitudinal Cracks in 198th Street test section, Boone County**

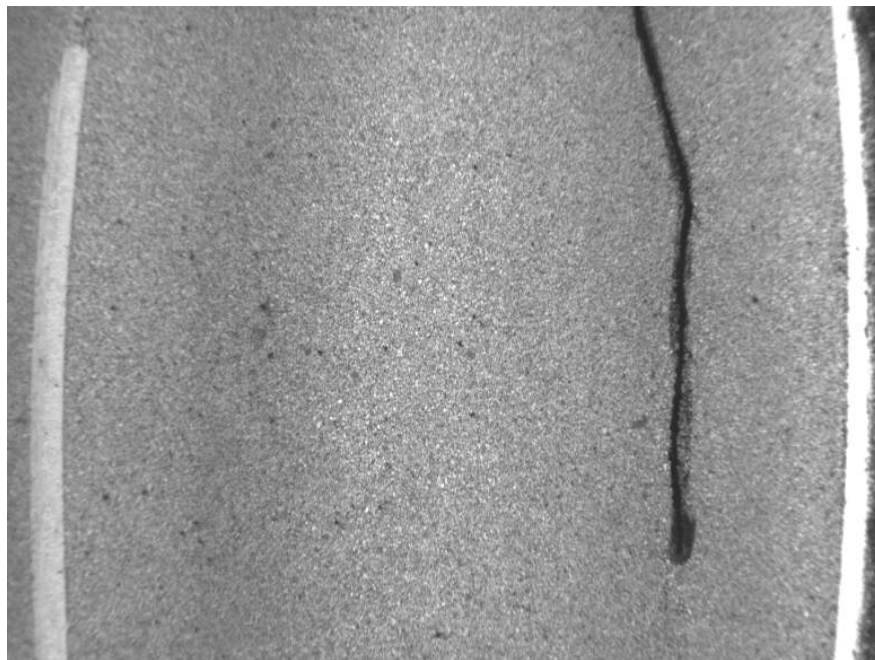
**Figure A.2.4. Longitudinal crack of E 52 test section, Boone County**

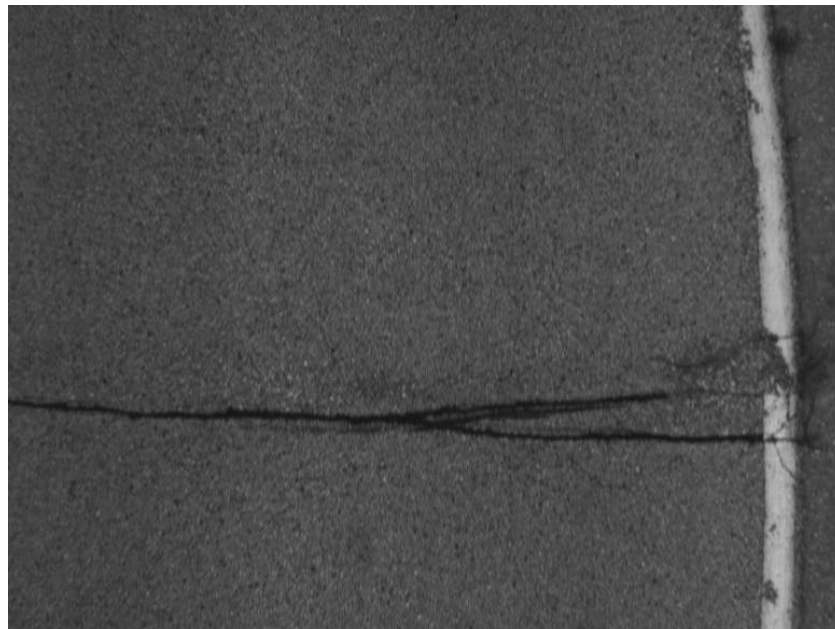
**Figure A.3.4 Transverse crack in T 16 test section, Butler County**

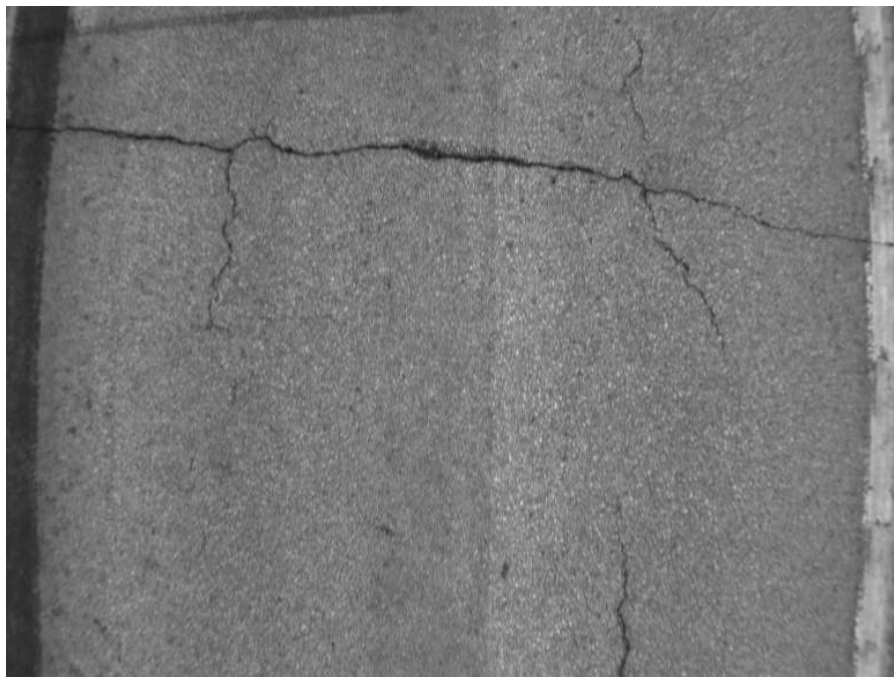
**Figure A.4.4. Longitudinal and transverse cracks in IA 175 test section, Calhoun County**

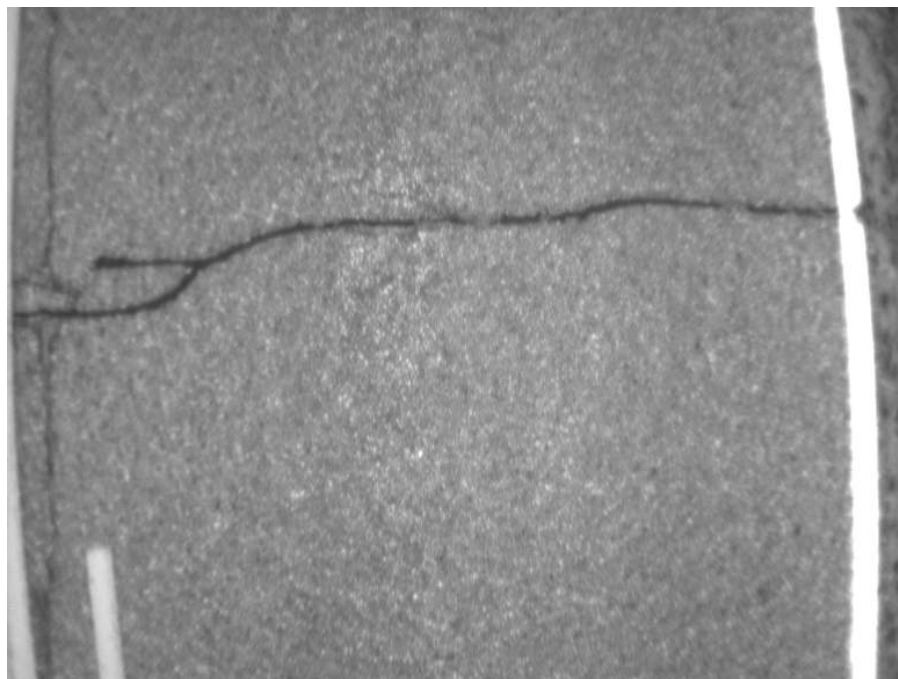
**Figure A.5.4. Transverse Crack in B 43 test section, Cerro Gordo County**

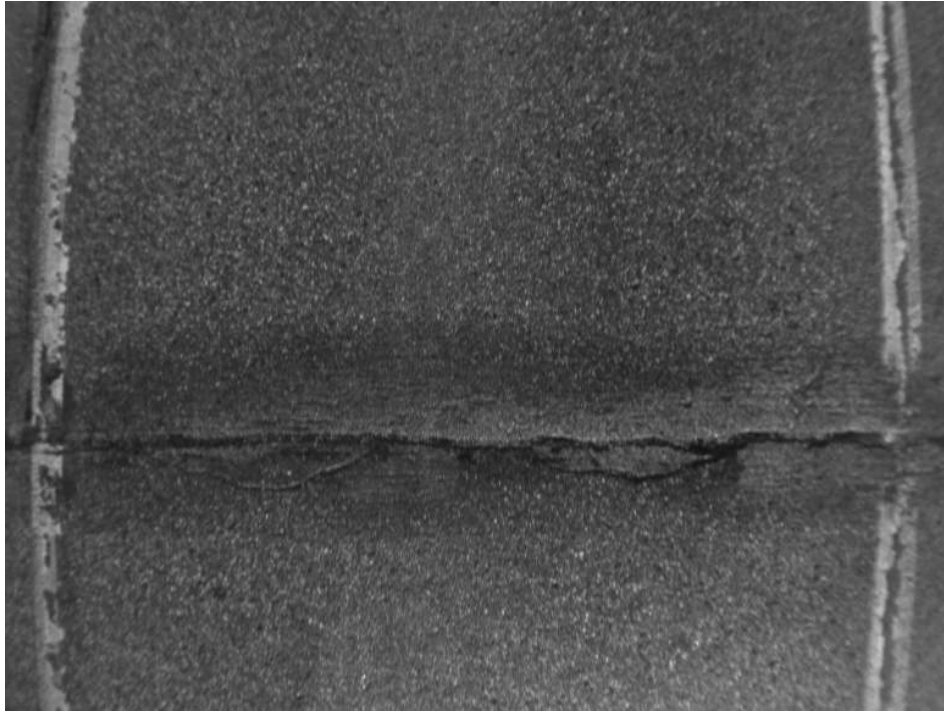
**Figure A.6.3 Transverse crack in South Shore Line test section, Cerro Gordo County**

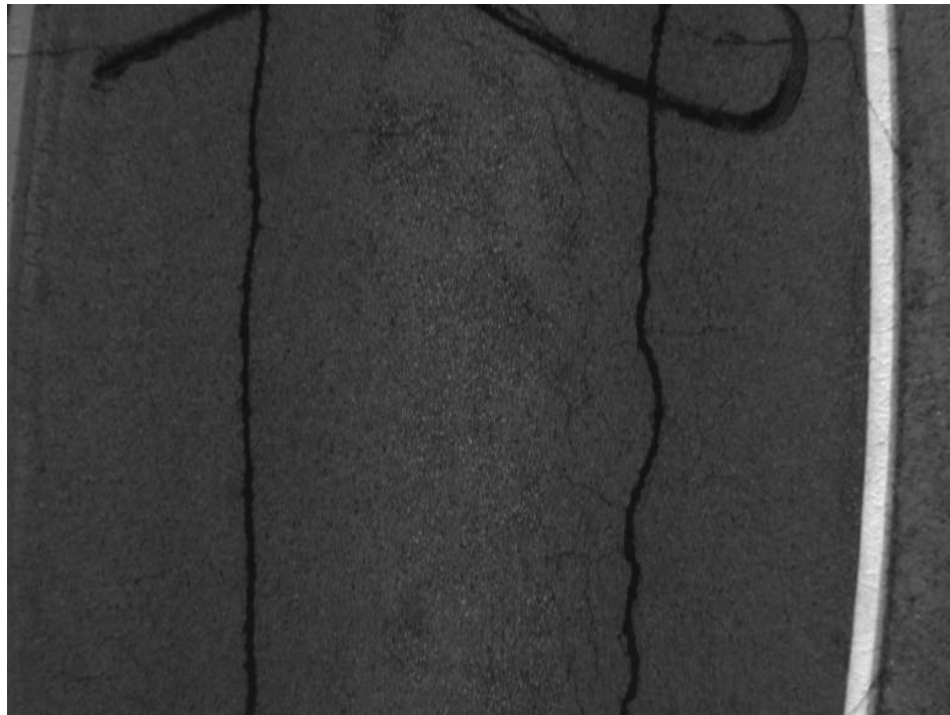
**Figure A.7.4. Longitudinal cracks in E 50 test section, Clinton County**

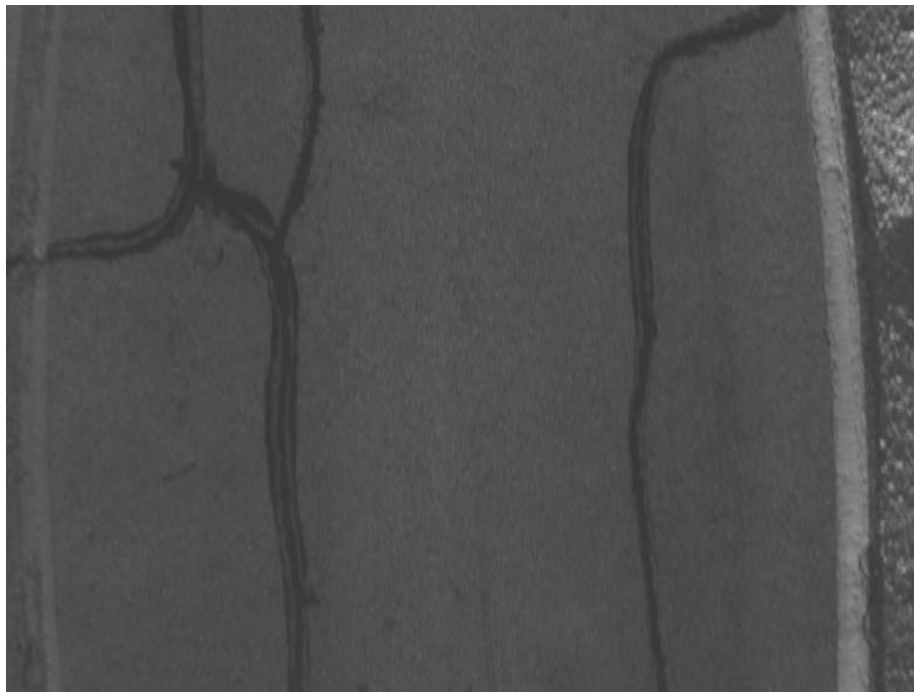
**Figure A.8.4 Longitudinal Cracks in Z 30 test section, Clinton County**

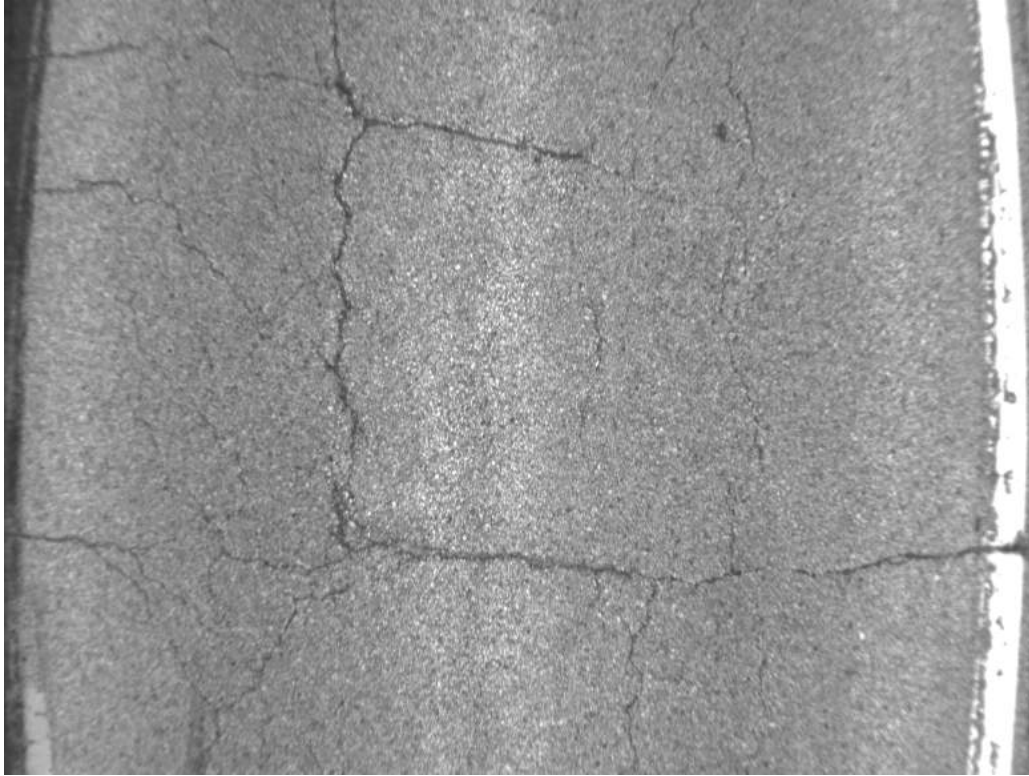
**Figure A.9.3 Alligator crack in IA 144 test section, Greene County**

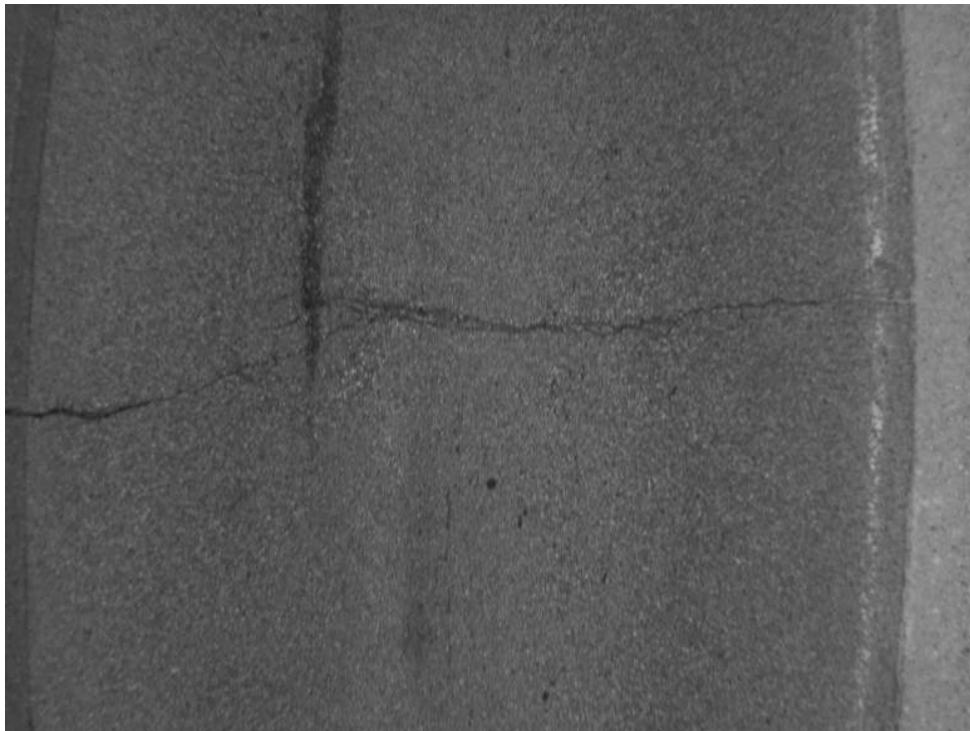
**Figure A.10.4. Transverse crack in IA 4 test section, Guthrie County**

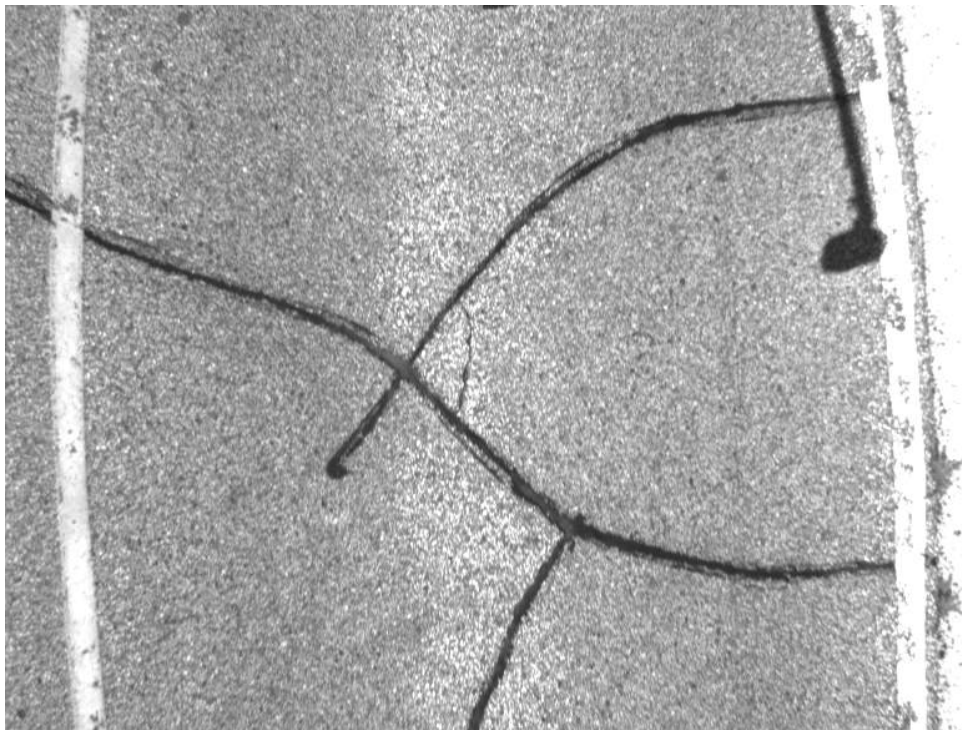
**Figure A.11.3. Transverse Cracks in D 35 test section, Hardin County**

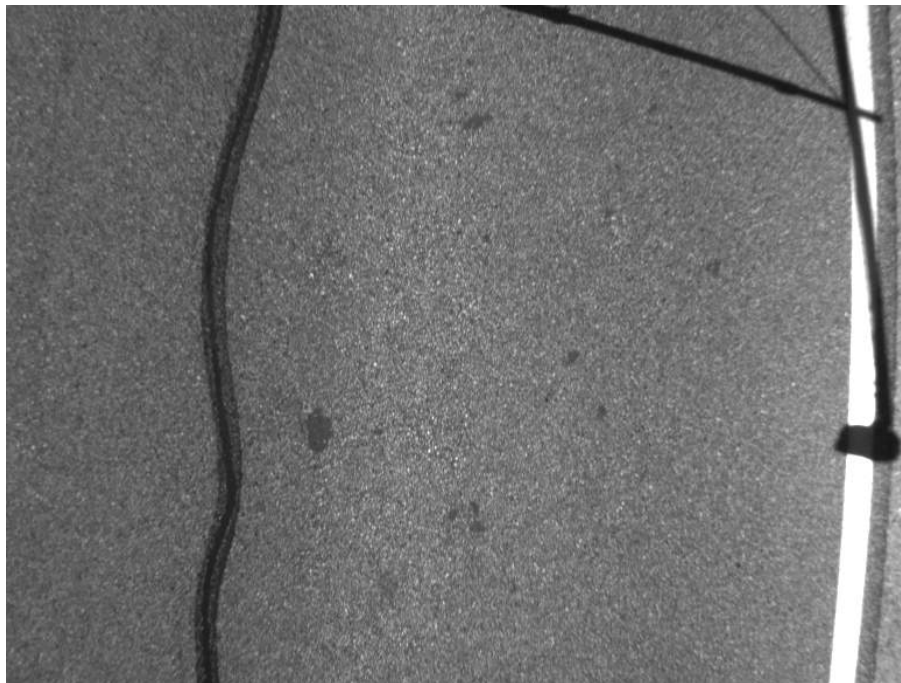
**Figure A.12.4. Longitudinal crack in F 70 test section, Muscatine County**

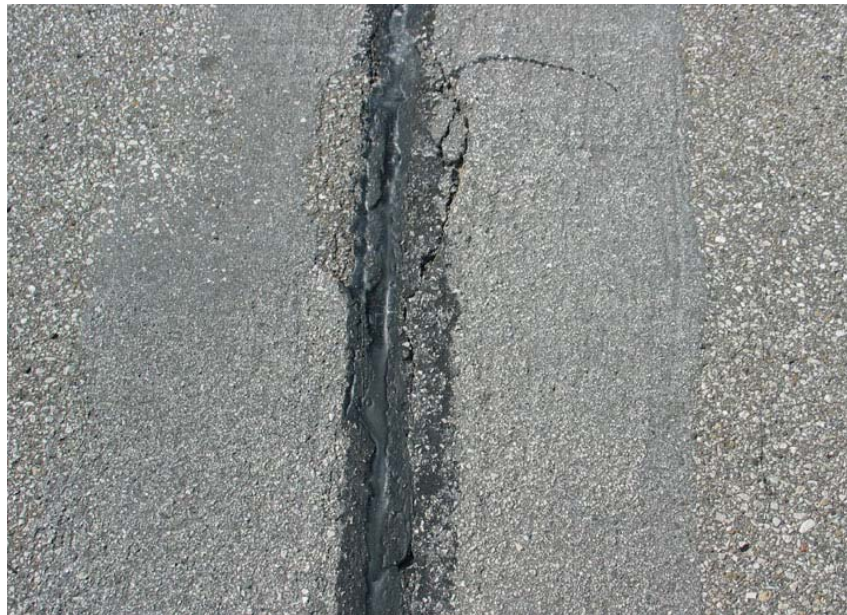
**Figure A.13.4. Patching and sealed crack in G 28 test section, Muscatine County**

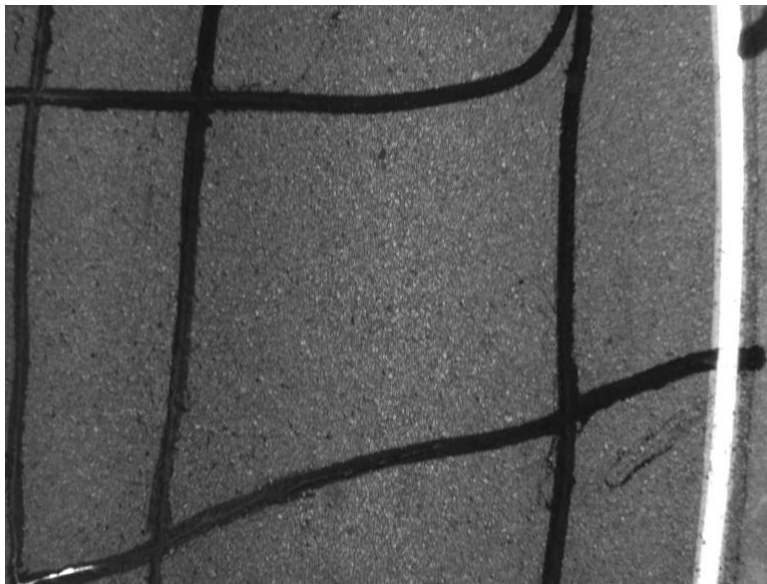
**Figure A.14.4. Block Crack in Y 14 test section, Muscatine County**

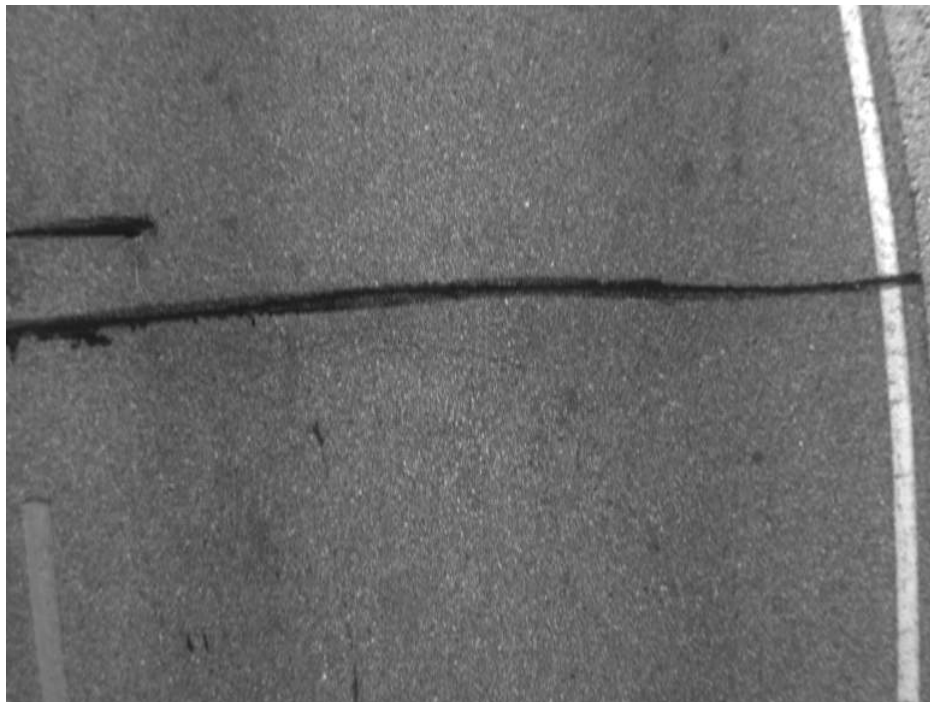
**Figure A.15.4. Transverse crack in E 66 test section, Tama County**

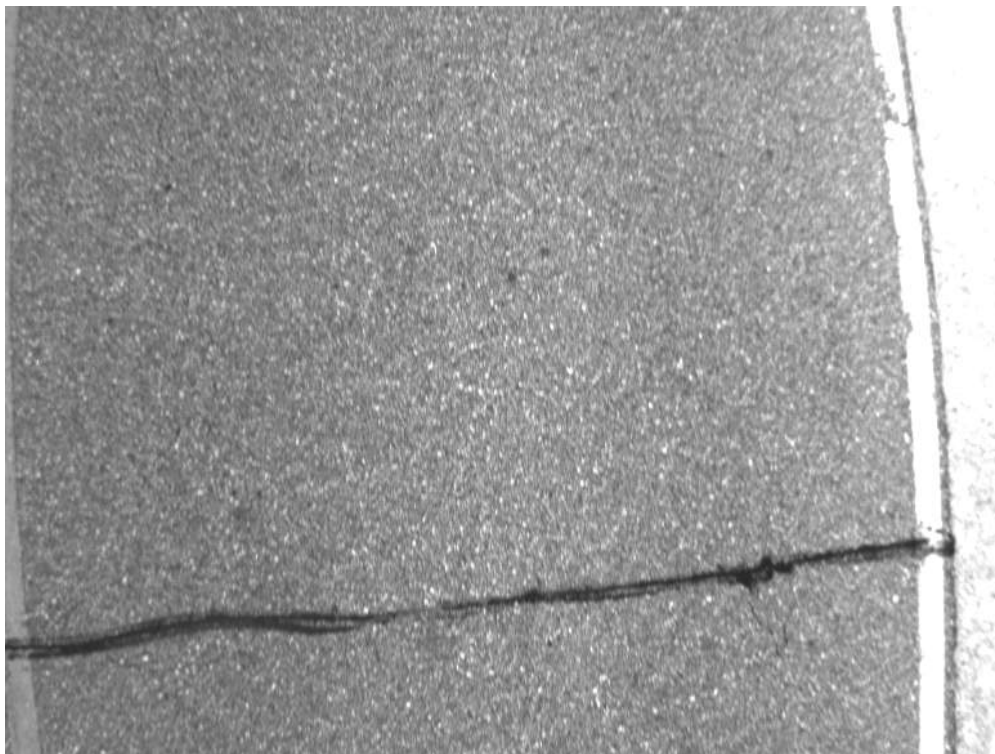
**Figure A.16.4. Transverse crack in V 18 test section, Tama County**

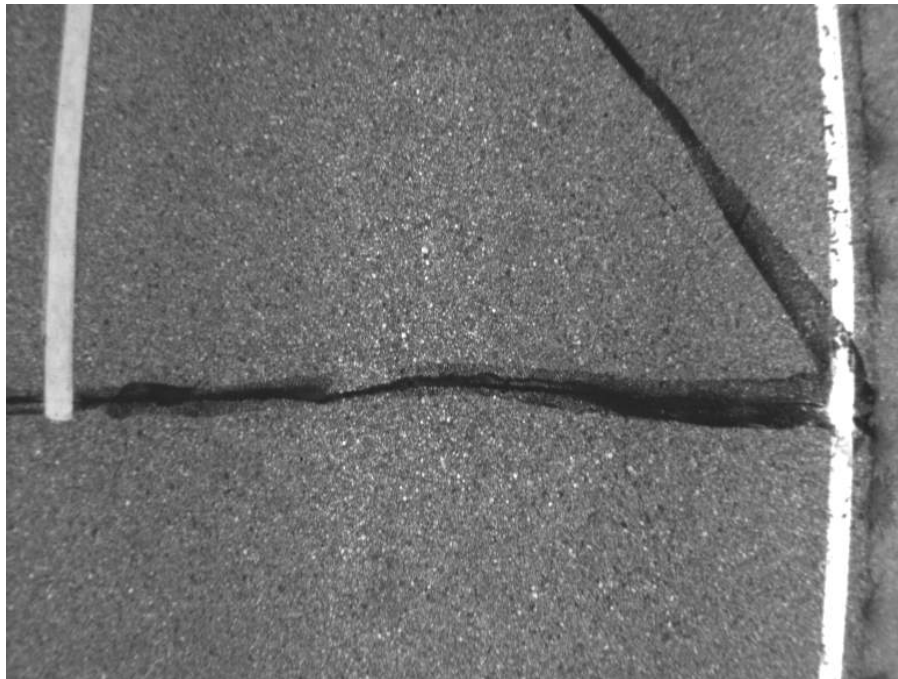
**Figure A.17.4. Transverse crack in R 34 test section, Winnebago County**

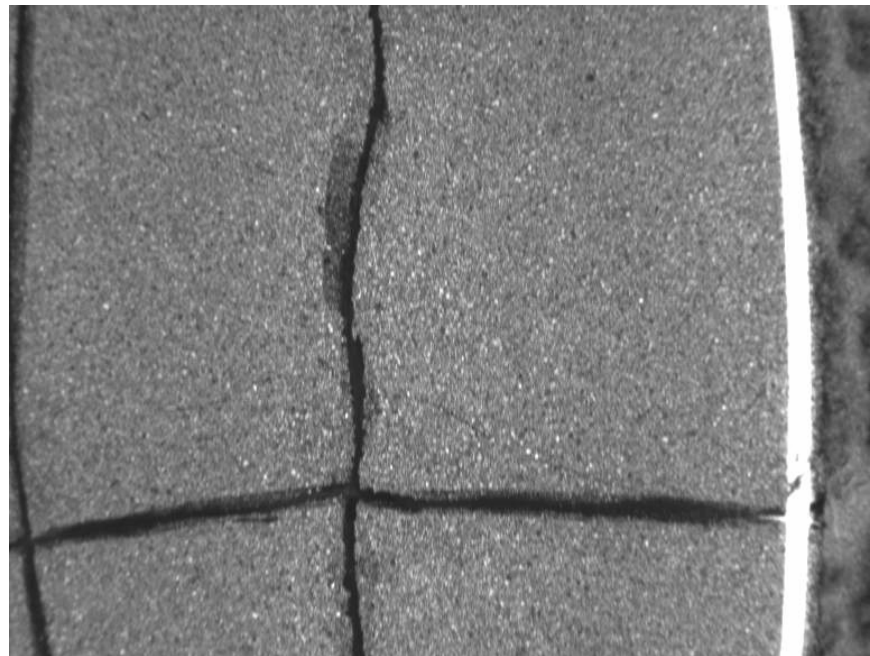
**Figure A.18.4. Longitudinal and transverse cracks in R 60 test section, Winnebago County**

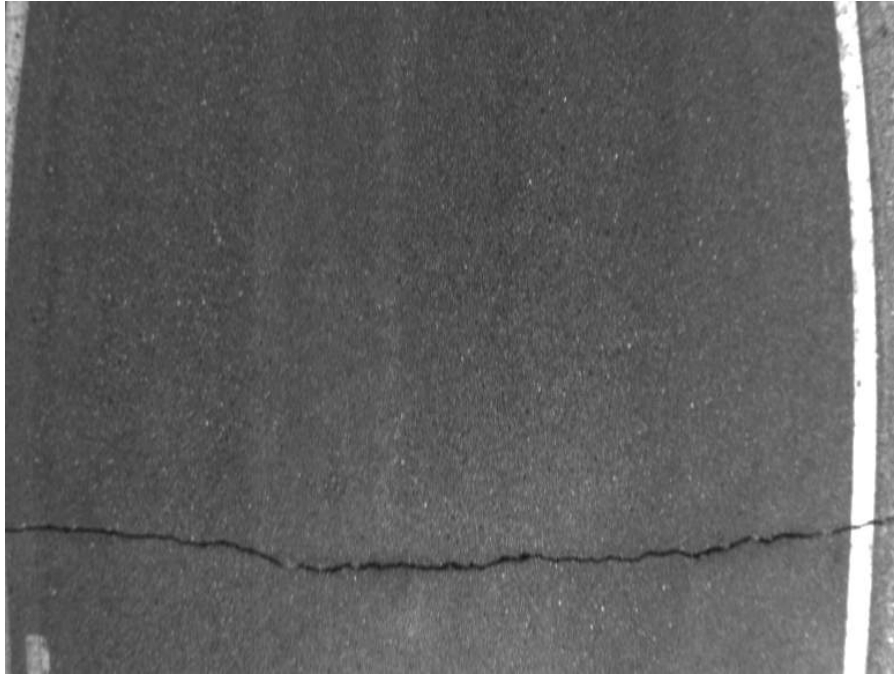
**Figure A.21.4. Transverse crack in North of Breda test section, Carroll County**

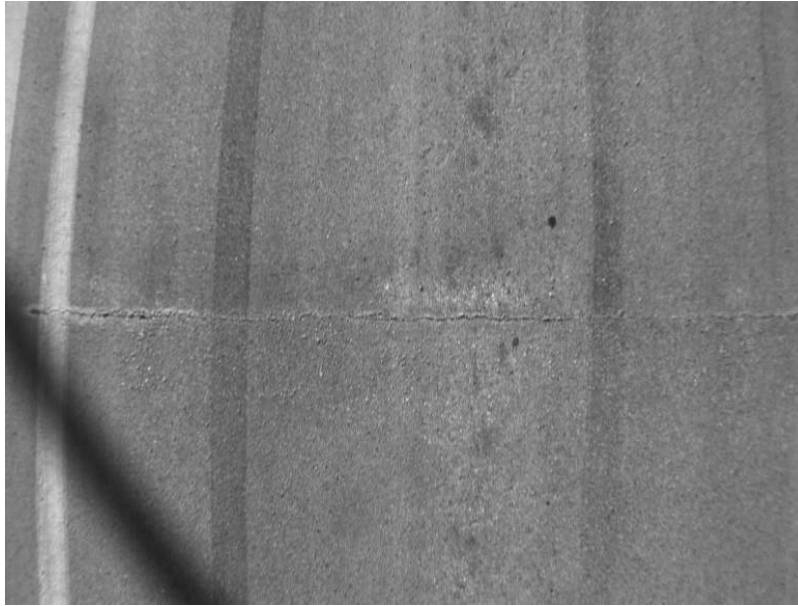
**Figure A.23.4 Transverse Crack in IA 44 test section, Harrison County**

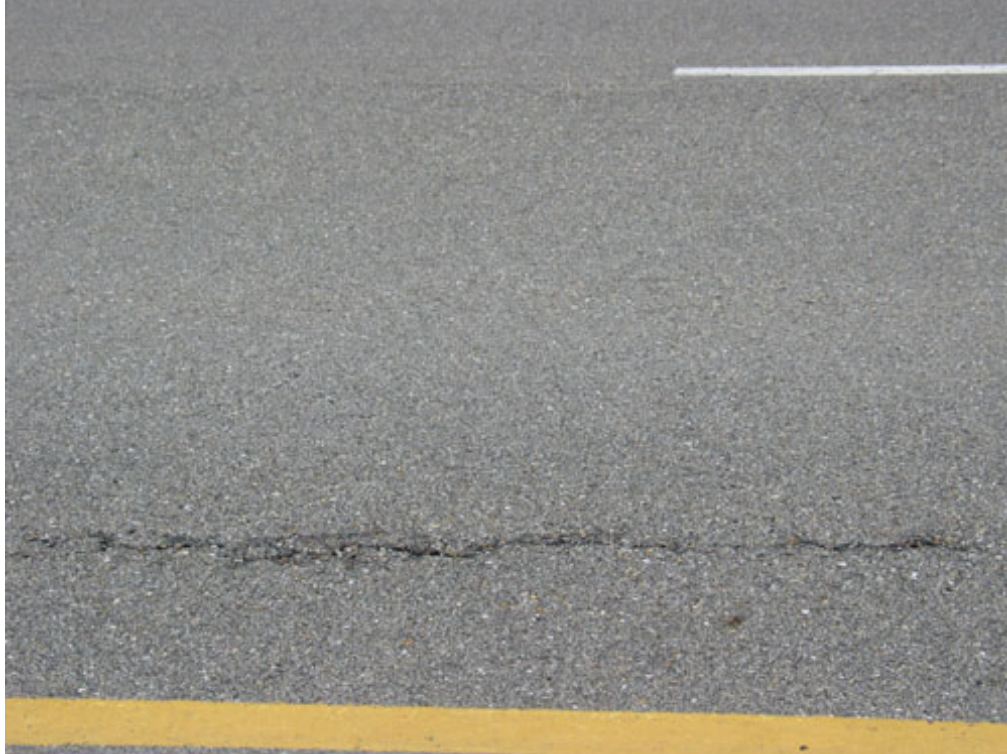
**Figure A.25.3. Longitudinal crack in US 20 test section, Delaware County**

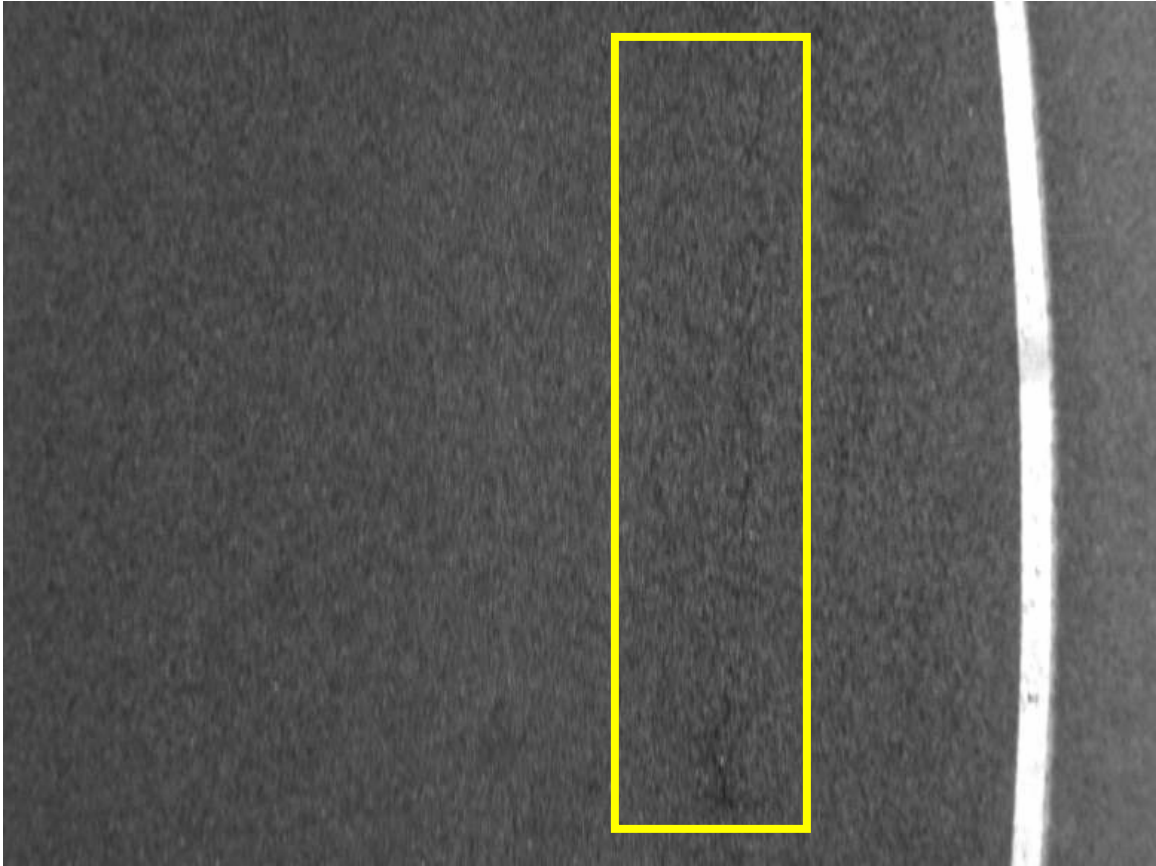
**Figure A.26.4. Alligator crack in US 61 test section, Jackson County**
