**USE OF
LONGITUDINAL SUBDRAINS
IN THE
3R PROGRAM**

**FINAL REPORT
Project HR-509**

**Highway Division
December 1981**

VERNON J. MARKS
RESEARCH ENGINEER
515/239-1447

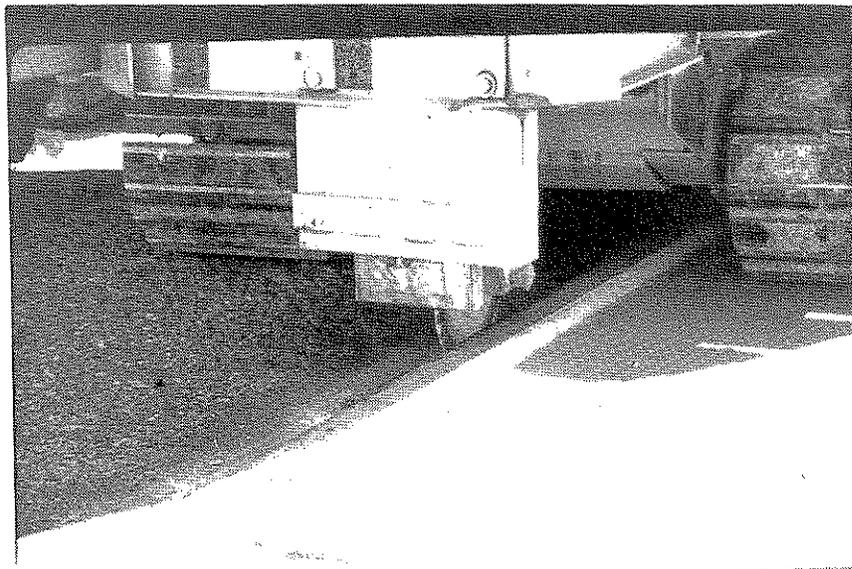
Figure 2: Disc Cutter Wheel to Aid in Alignment

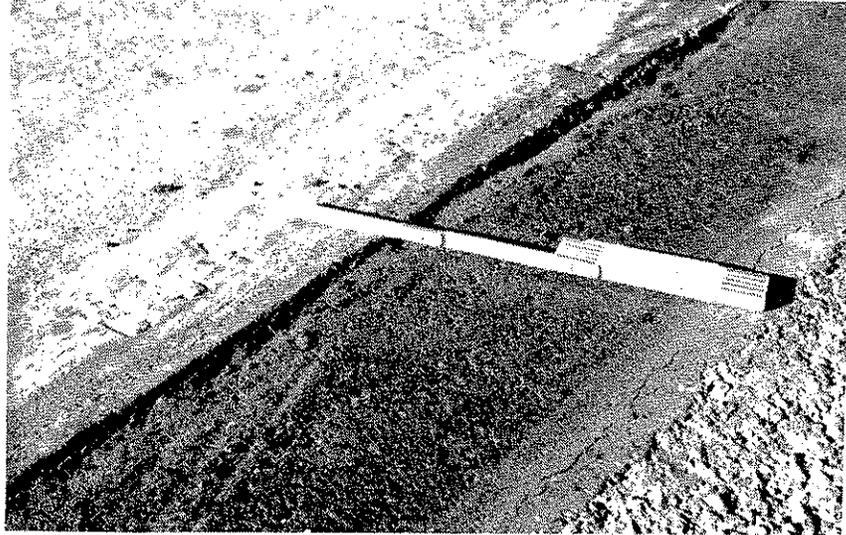
Figure 8: Finished Trench Prior to Cover Aggregate Placement

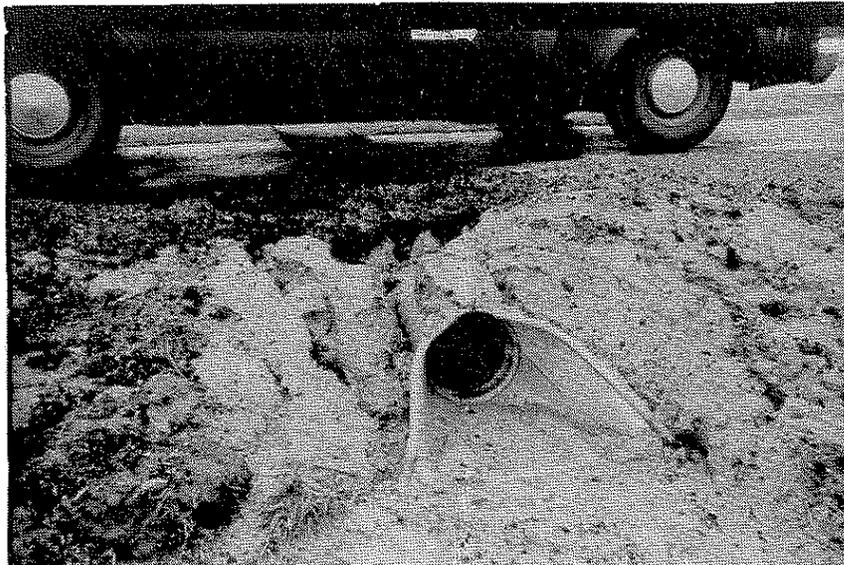
Construction was not completed during 1978. Another problem was recognized in the early spring of 1979. The RF-22 outlets froze shut during the winter period. Early spring flow from the subdrains eroded the earth fill around the RF-22 outlet (Figure 11). This problem was solved by carrying the porous backfill the total length of the RF-22 outlet.

Figure 11: Erosion Around the RF-22 Outlet

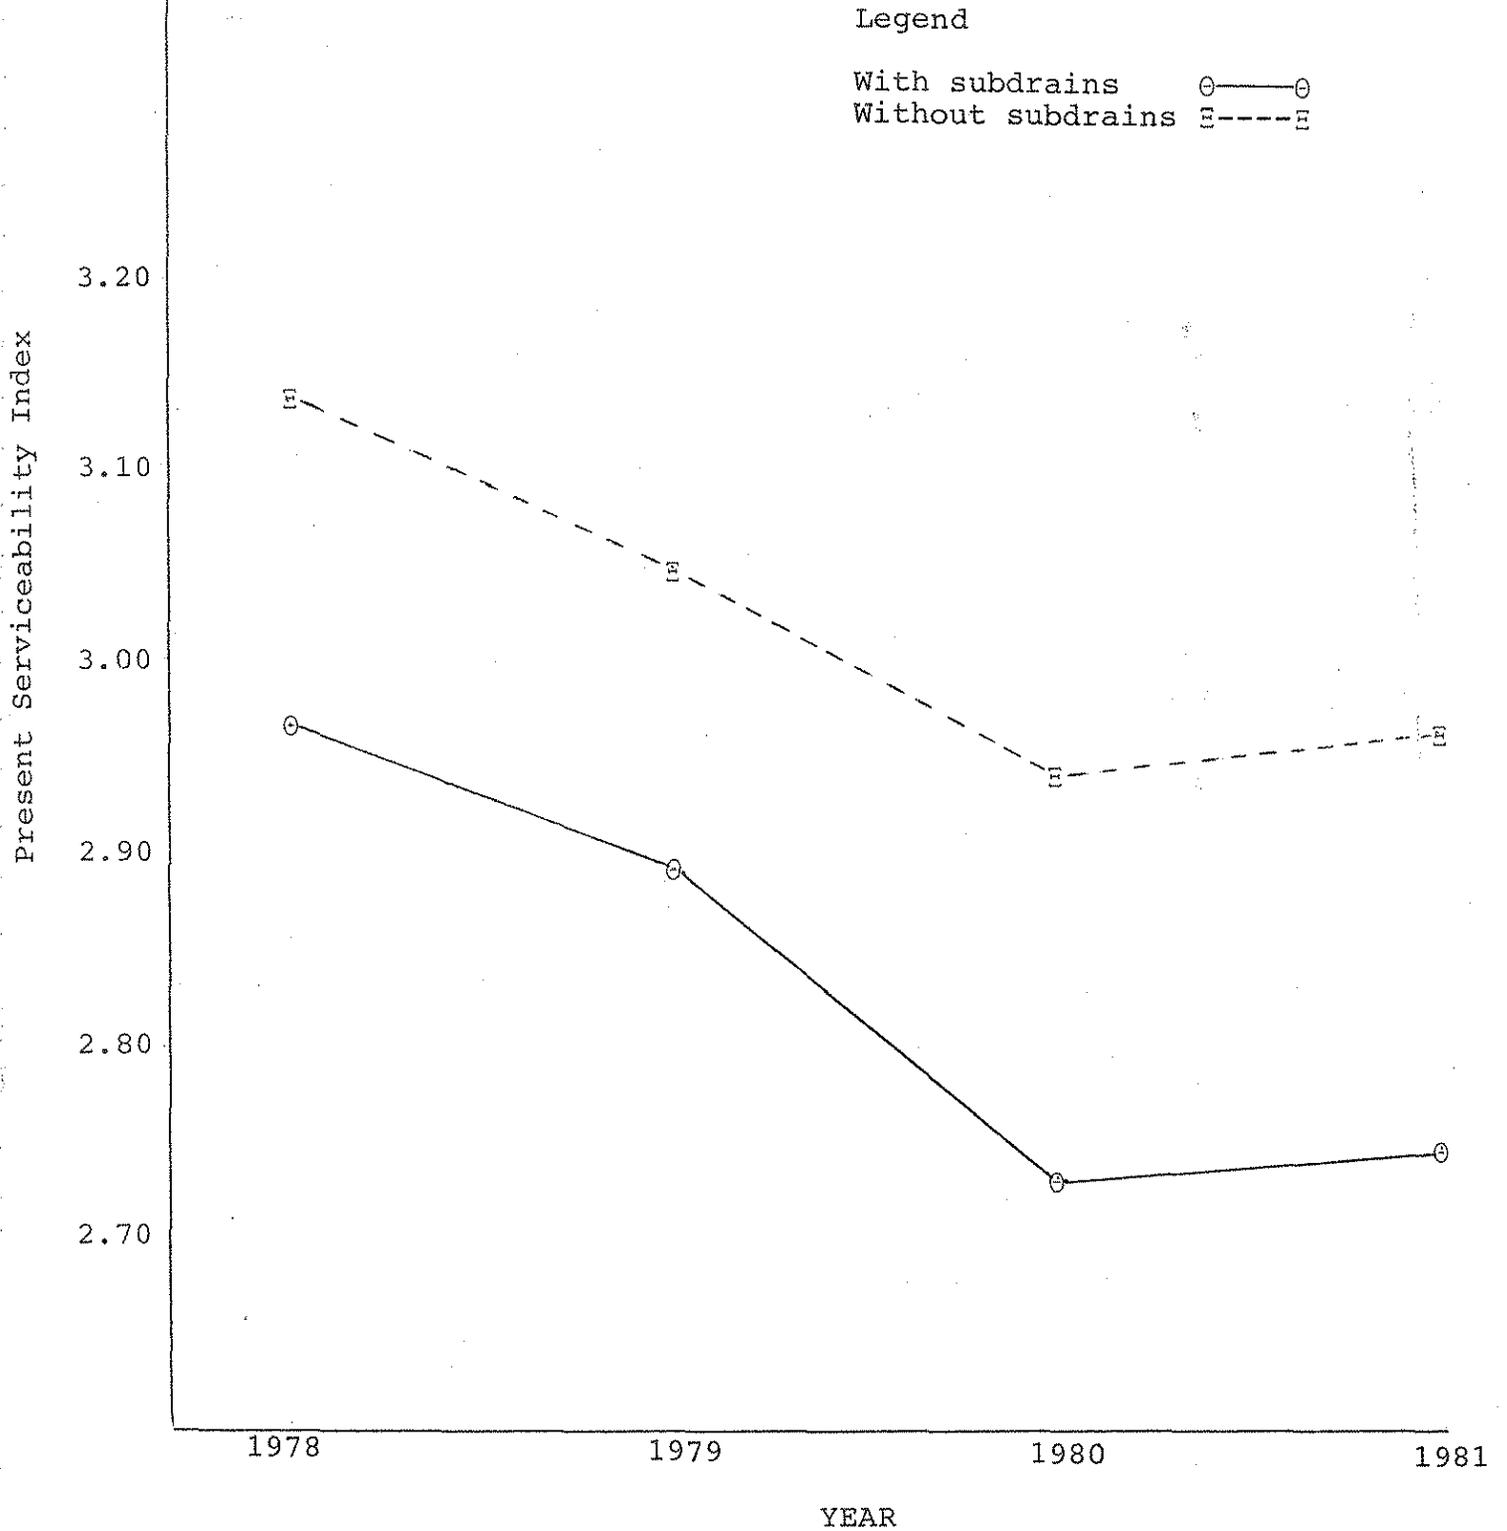
Figure 12 PAVEMENT DETERIORATION

The graphical plot of PSI in figure 12 indicates no significant change in the rate of pavement deterioration when compared to an adjacent section of pavement without longitudinal subdrain installation.

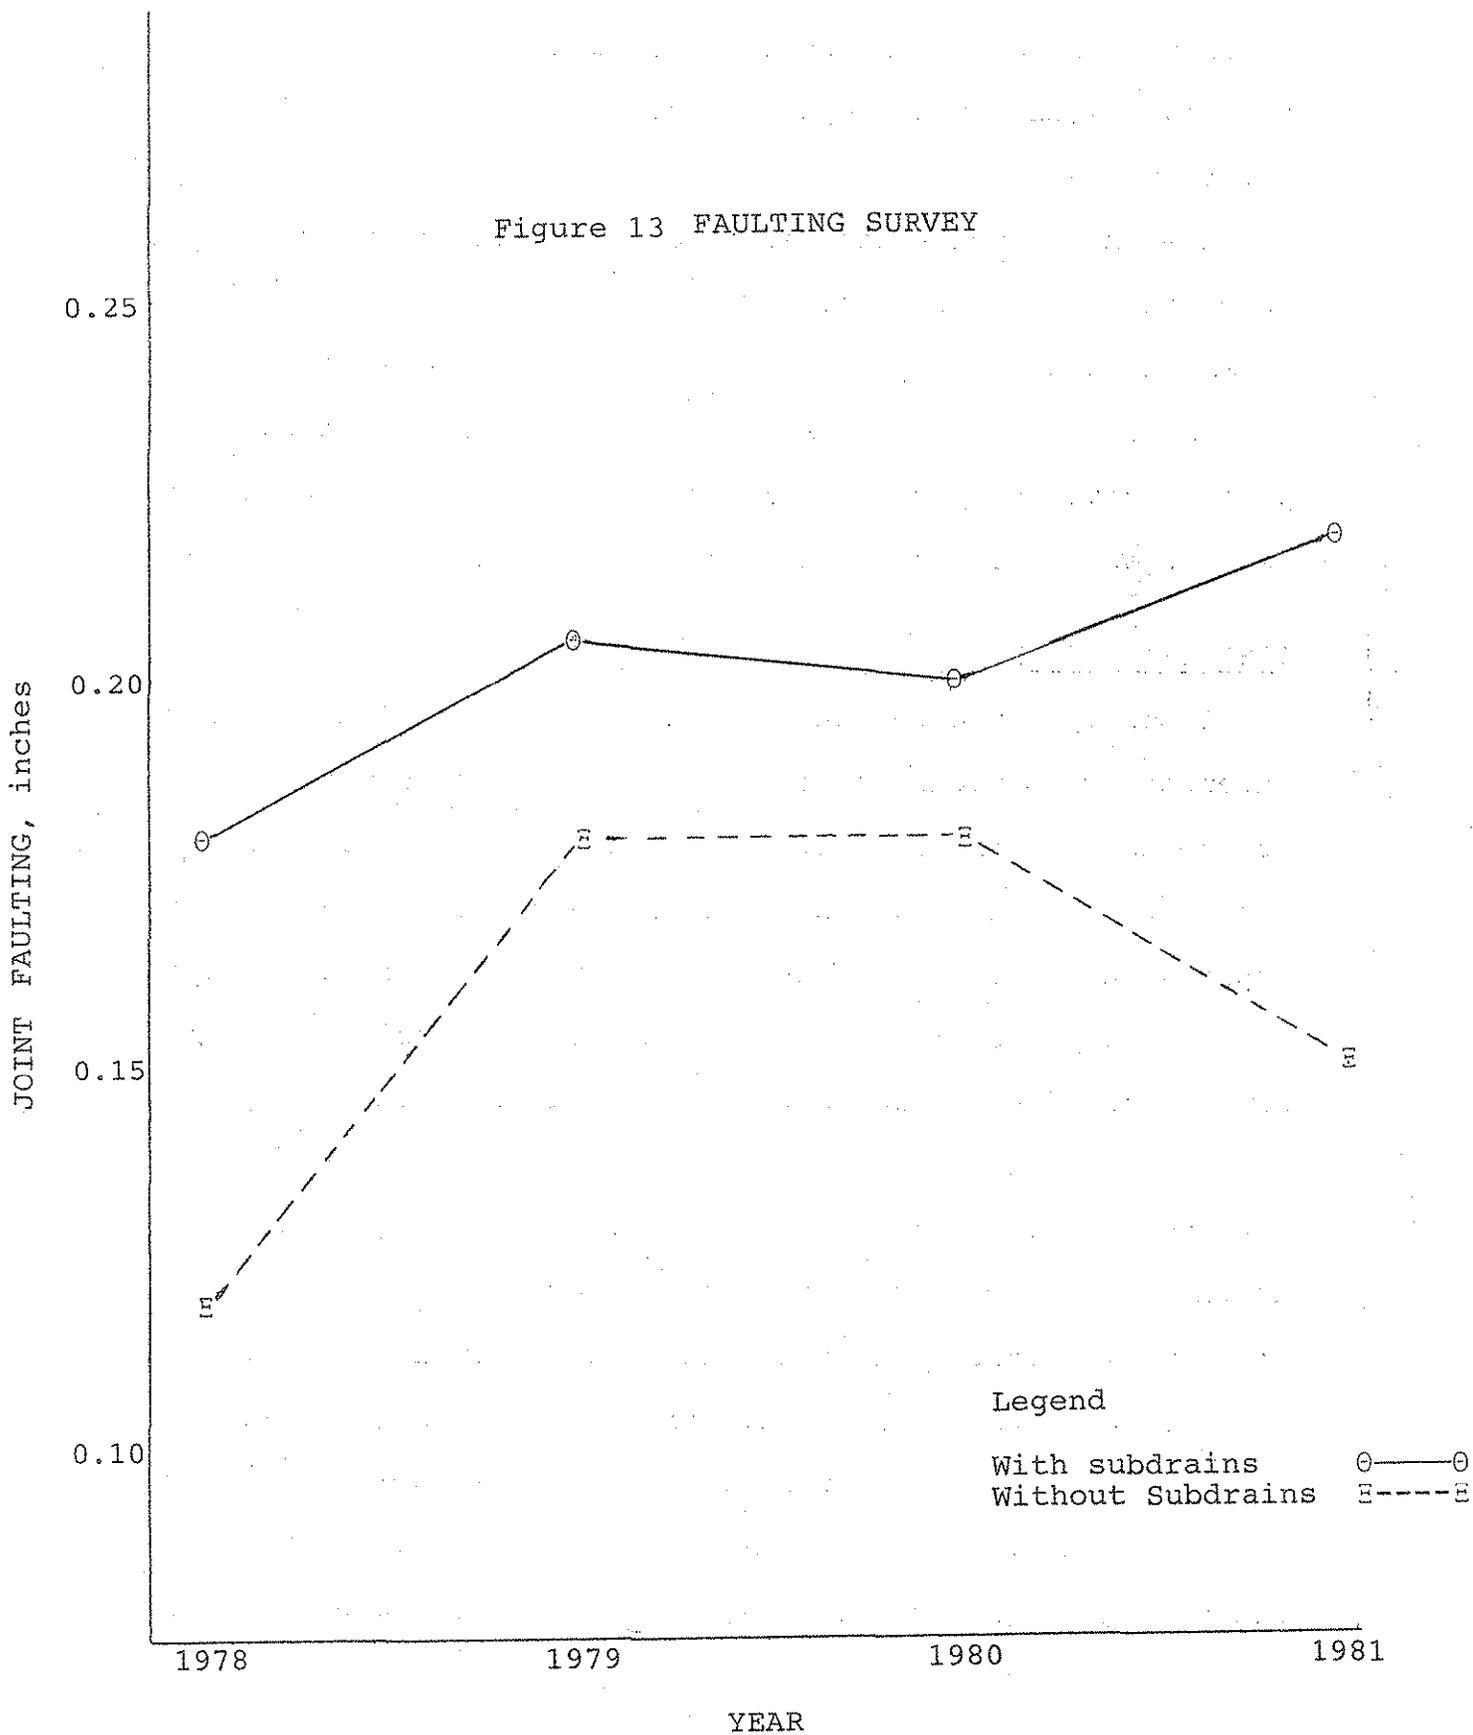
Figure 13 FAULTING SURVEY

Again, a graphical plot (Figure 13) does not indicate significant difference between the pavement within the subdrain project and the adjacent pavement without subdrains. The data seem to be quite variable which could be due to weather or temperature variations.
