Pilot Construction Project for Granular Shoulder Stabilization

Final Report
September 2013

Sponsored by
Iowa Highway Research Board
(IHRB Project TR-634)
Iowa Department of Transportation
(InTrans Project 11-405)

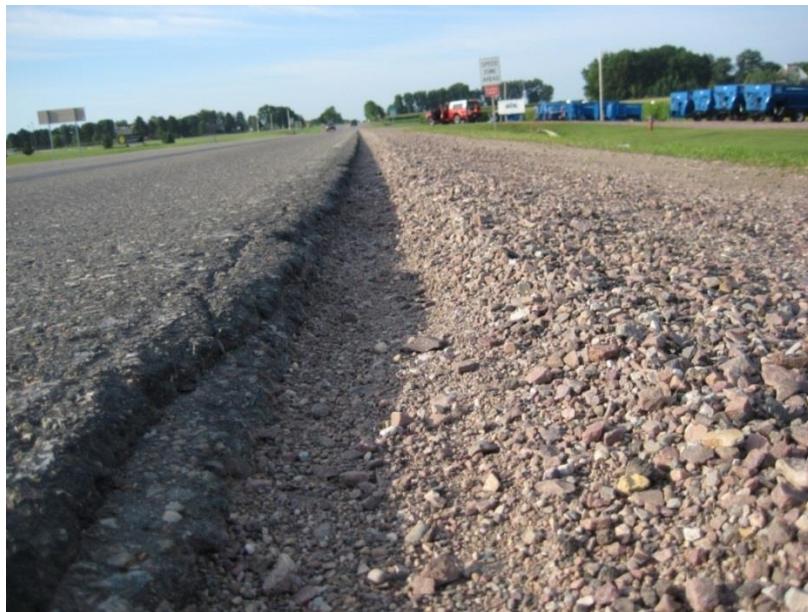
Edge rutting on granular shoulders, as shown in Figure 1, is a serious traffic safety issue because it can cause vehicles to run off the road, which can lead to loss of control and even loss of life (Jahren et al. 2011). Edge rutting is caused by three factors: wind and air currents, vehicle off-tracking, and drainage.

Figure 1. Edge rutting on granular shoulder (Jahren et al. 2011)

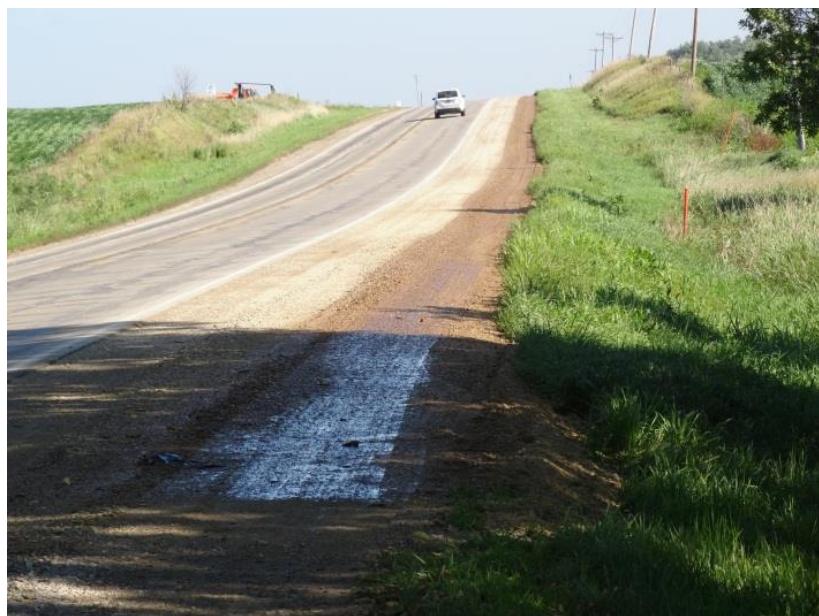
Usually, the width of sprayed soapstock was 4 ft, which required two nozzles working simultaneously. North of Leland, soapstock was applied at full width going up to the hill, because gullies caused by water erosion tended to developed near the grass line (they had been filled in with new compacted aggregate before soapstock application commenced). The result of this application is shown in Figure 9.

Figure 9. Soapstock applied on the shoulder of US 69 up the hill near Leland, Iowa

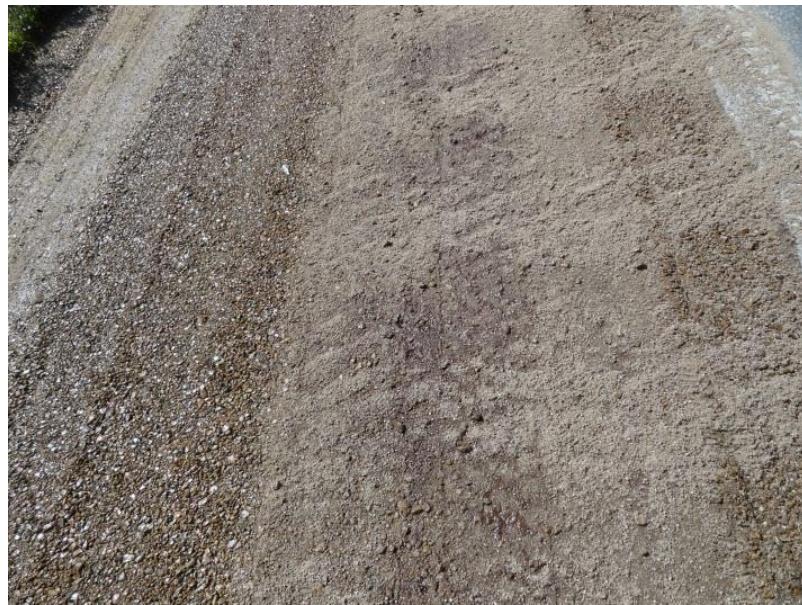
In one place, recycled asphalt paving material was newly spread on the shoulder. After the soapstock and sand was applied to it, the mixed material looked much like dense-graded aggregate, with a noticeably greater amount of fine particles (Figure 11).

Figure 11. Soapstock and sand applied to recycled asphalt paving materials

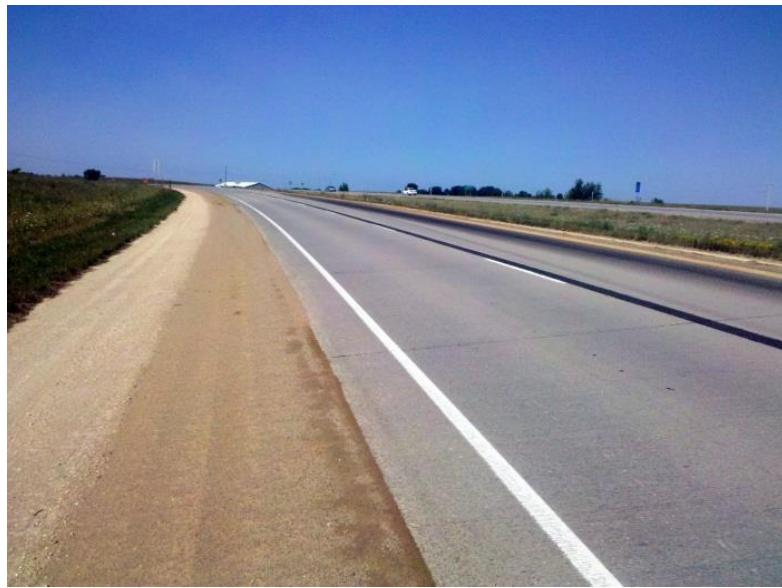
Section 2.02 was located on curves of US 63 near Denver. This highway is a four-lane divided highway with a traffic level (6,000 ADT) heavier than the targeted study level. Soapstock was applied on both outside and inside shoulders and adjacent to both SB and NB lanes. The result of one section of the treated shoulder is shown in Figure 13.

Figure 13. Soapstock and sand applied on the shoulder of US 63 near Denver, Iowa

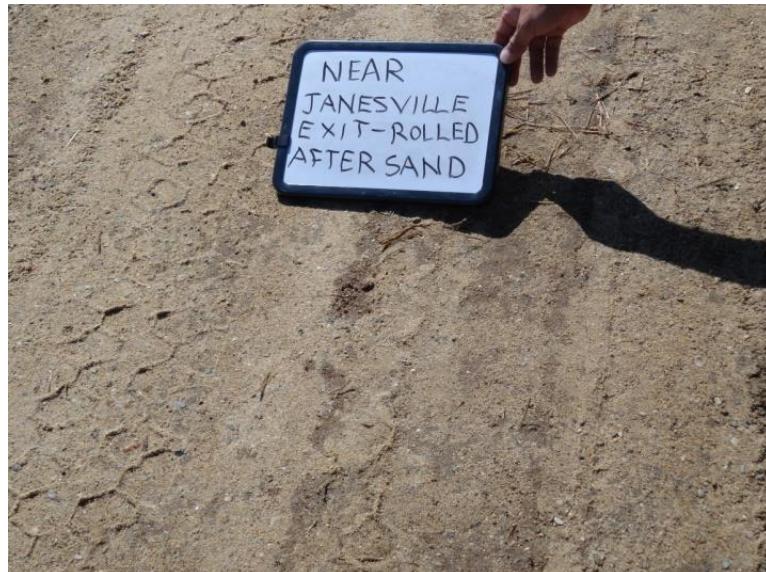
In the same location, Section 2.02, one action observed by researchers might be meaningful for a successful application. This was near the Janesville exit on US 63 near Denver, and the treated surface was rolled after the sand application. The result of this is shown in Figure 14.

Figure 14. Surface rolled after sand application for the shoulder of US 63 near Denver, Iowa

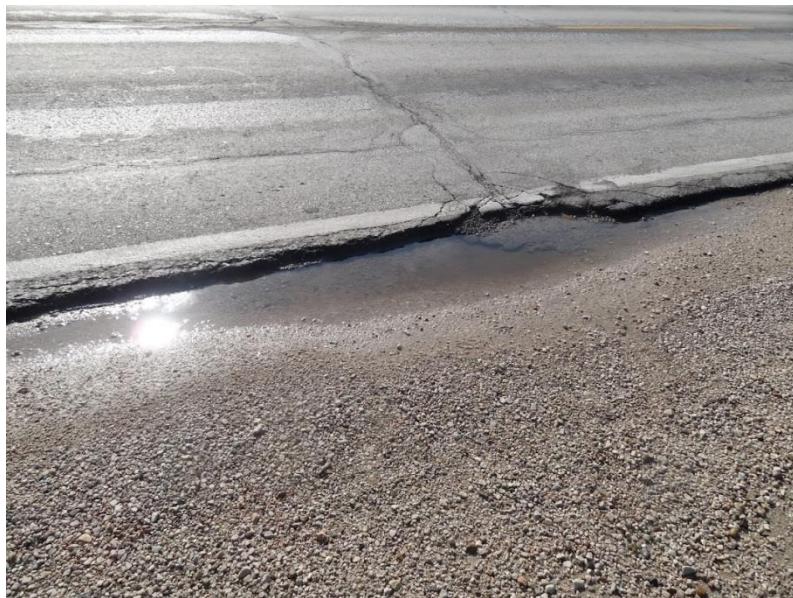
The possible reason for this failure might be water erosion. There is an uphill grade adjacent to this location, which results in water runoff that erodes the edge drop off area.

Figure 22. Edge rut developed south of Algona, Iowa

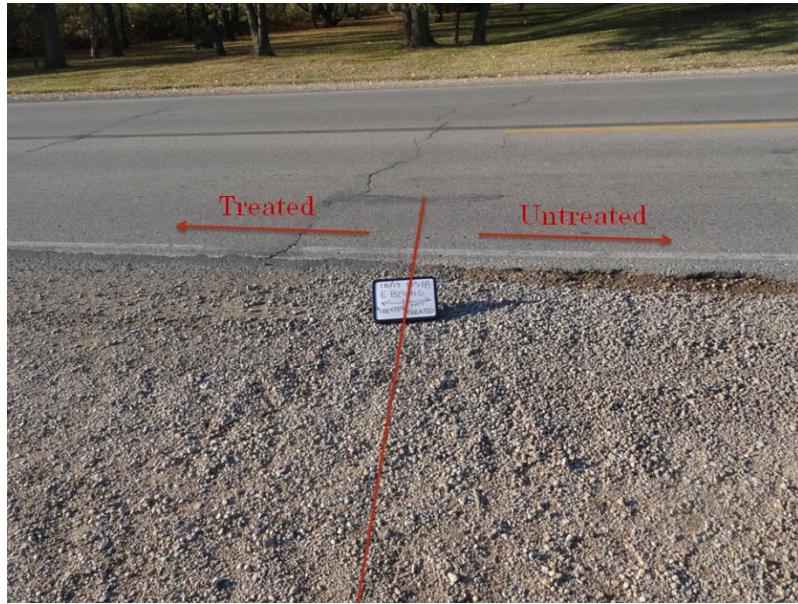
Figure 23 shows an example of a comparison of an untreated shoulder edge and the untreated one.

Figure 23. Results compared for treated and untreated shoulder edge

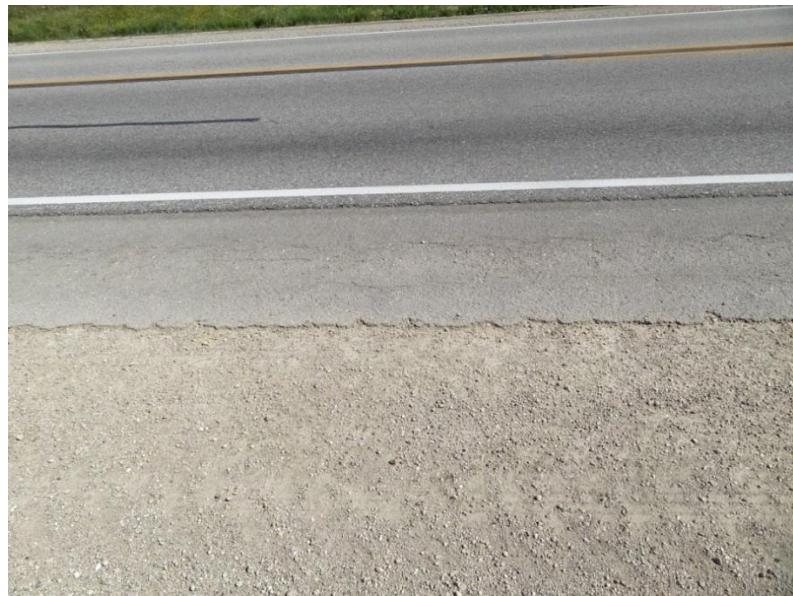
Figure 24 provides an example of good shoulder performance for this area. This shows a shoulder section of IA 3 on adjacent to the EB lanes just east of Waverly, where a thick layer of soapstock remained firmly on the shoulder. Another example is shown in Figure 25. This shoulder section was on US 63 near Denver, where soapstock had penetrated into the shoulder and could not be seen easily.

Figure 24. Eastbound shoulder of IA 3 east of Waverly, Iowa

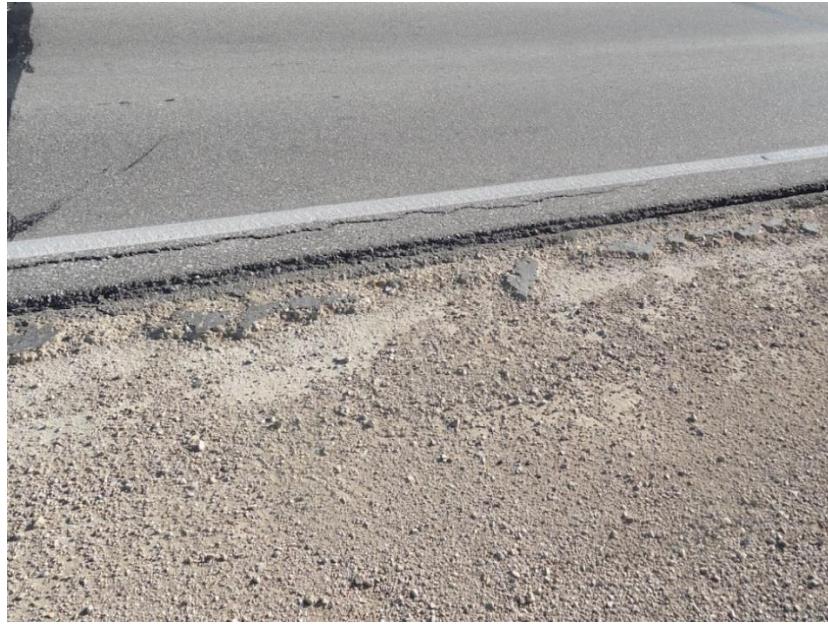
Figure 26 shows one example of an undesired situation where most soapstock was abraded away by traffic, although neither edge ruts or potholes developed. This was part of the shoulder of IA 3 EB east of Allison. However, an edge drop-off did exist because there was not enough shoulder aggregate in this area to maintain the designed cross slope and fill flush to the pavement edge.

Figure 26. Soapstock missing east of Allison, Iowa

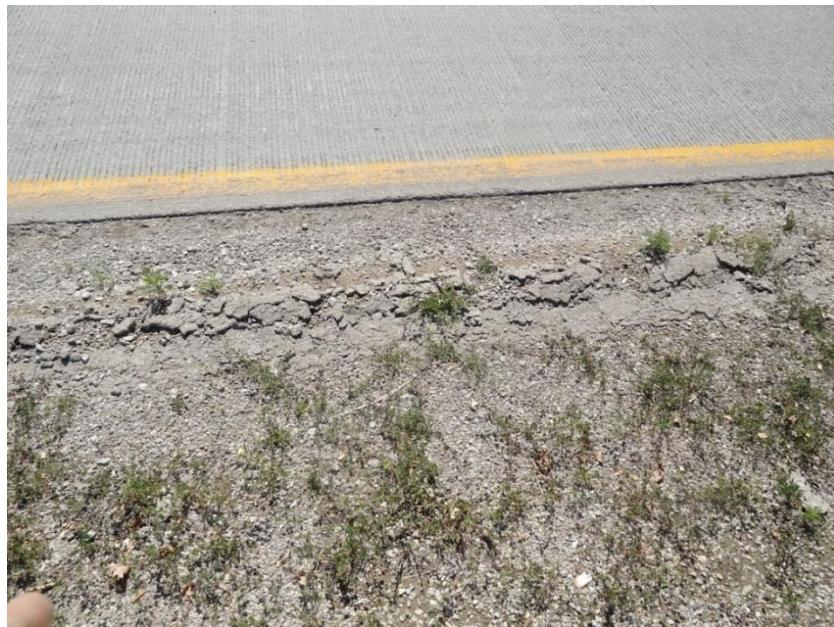
Figure 27 shows another undesired situation where the soapstock was not remaining on the inside shoulder of US 63 NB near Denver. Part of the shoulder materials had been displaced by traffic. Researchers observed that the inside shoulder material was less stable in comparison to the outside shoulder material and was easily prone to displacement.

Figure 27. Northbound inside shoulder of US 63 near Denver, Iowa

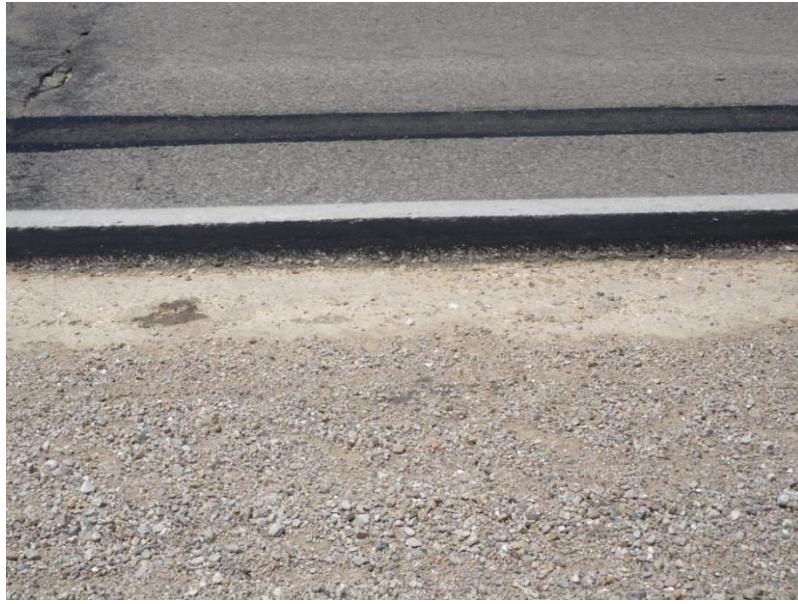
Figure 28 shows one shoulder section of US 18 EB east of West Union. Although the shoulder had been regraded, the hard surface resulting from the soapstock could still be observed. Another example is shown in Figure 29. The shoulder was also along US 18, west of Clermont, where the whole section was regraded with new gravel.

Figure 28. Shoulder of US 18 eastbound east of West Union, Iowa
