U.S. Department
of Transportation
**Federal Highway
Administration**

Video Inspection of Highway Edgedrain Systems

April 1998

FHWA-SA-98-044

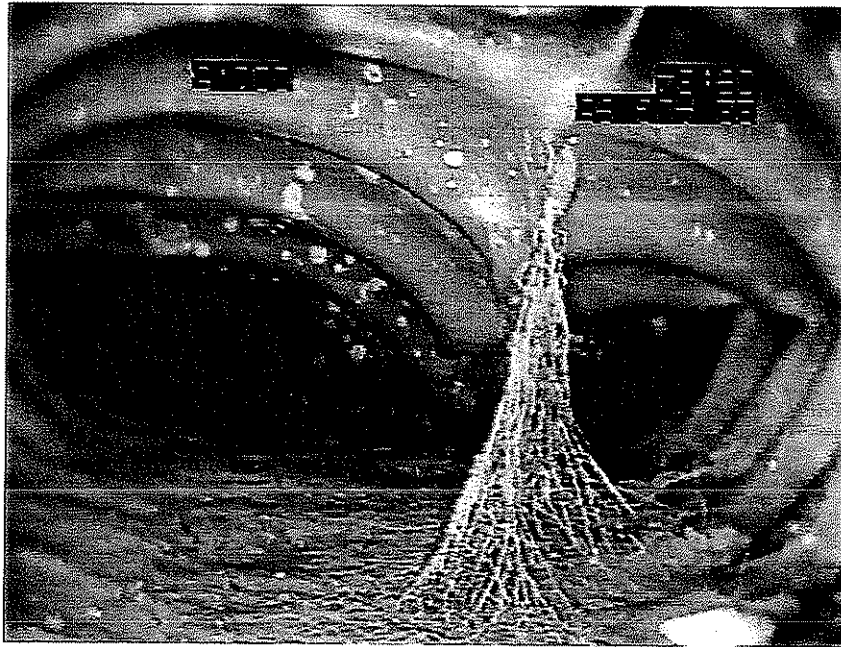
Of the 287 lateral/mainline edgedrain systems attempted, over 100 demonstrations were terminated due to defects with the laterals. Fifty-two (18%) had crushing in the lateral. Another 50 (17%) of the lateral systems were silted-in, limiting the investigations on these systems (Figure 8 and 9). In addition, 36 (13%) were composed of geocomposite sock, panel drain, drop tees, drop inlets, or no mainline systems at all (Figure 10).

Figure 8. Silted and Crushed Lateral, Just Inside the Lateral Outlet (1.5 Feet).

(Note: The Image is Upside Down)

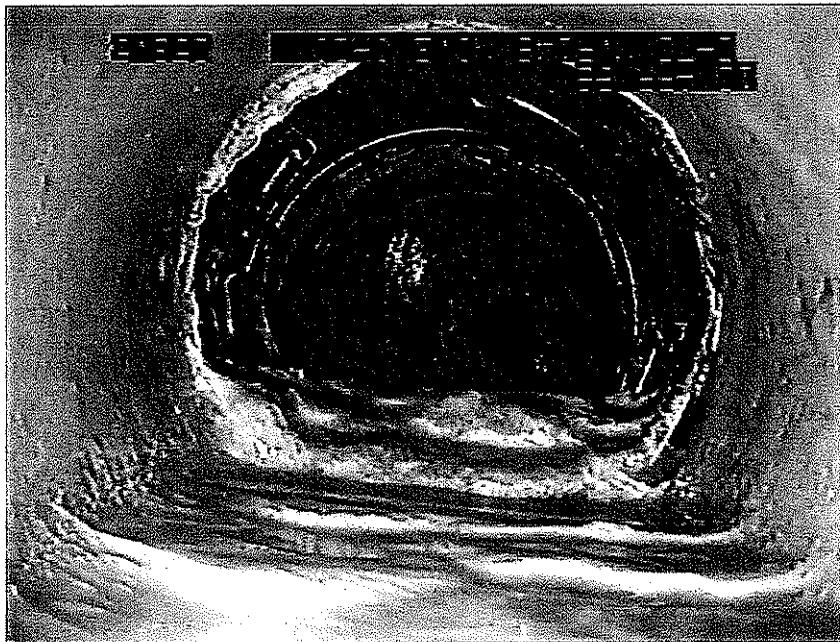
HEAVY SILTED AREA AT LATERAL/MAINLINE JCT.

Figure 9. Heavy Silt Flow at Lateral/Mainline Junction.

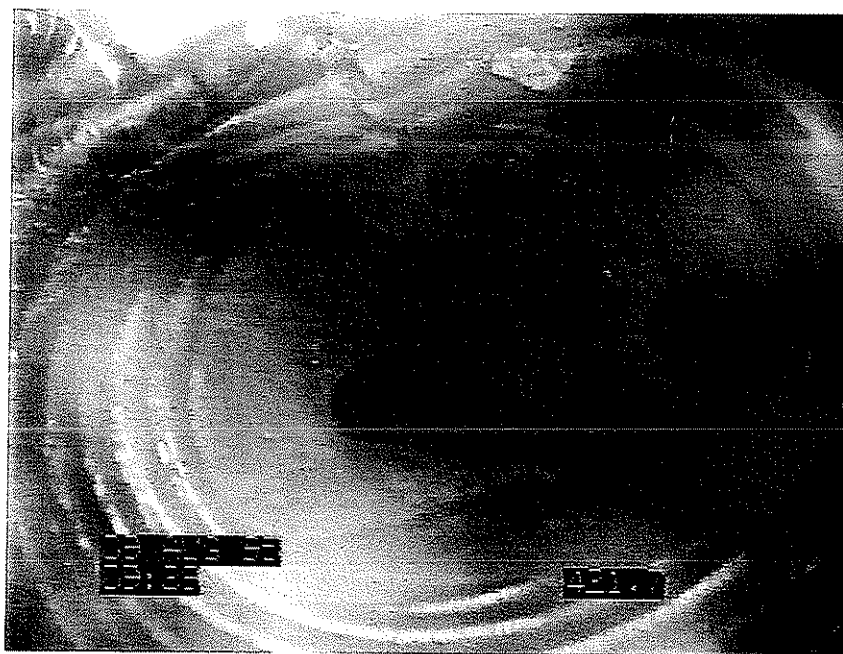
Figure 14. Inferior Construction Materials (A Brick End Cap)

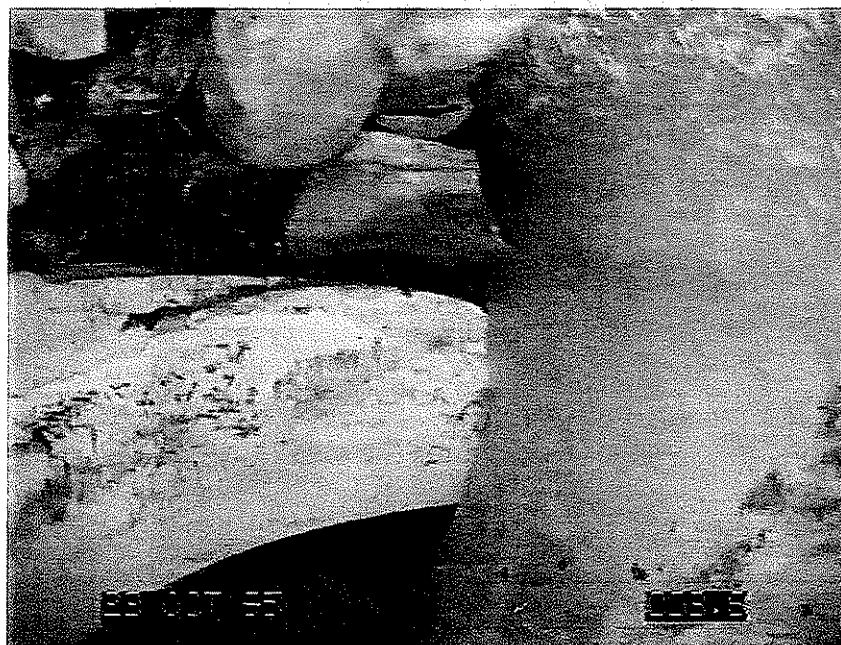
Figure 15. Materials/Obstructions Introduced During Construction. Note: PVC

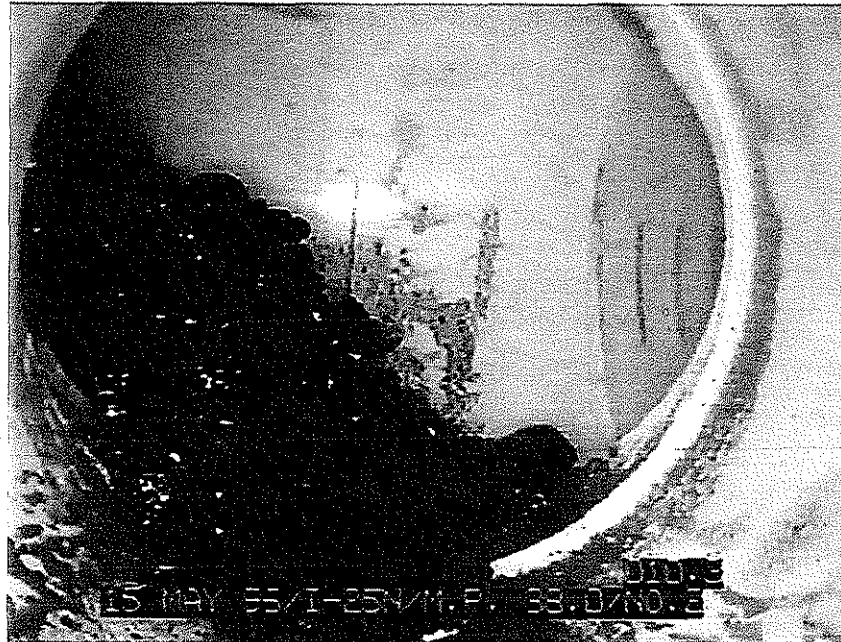
Figure 16. Asphalt-Stabilized Base in Edgedrain.

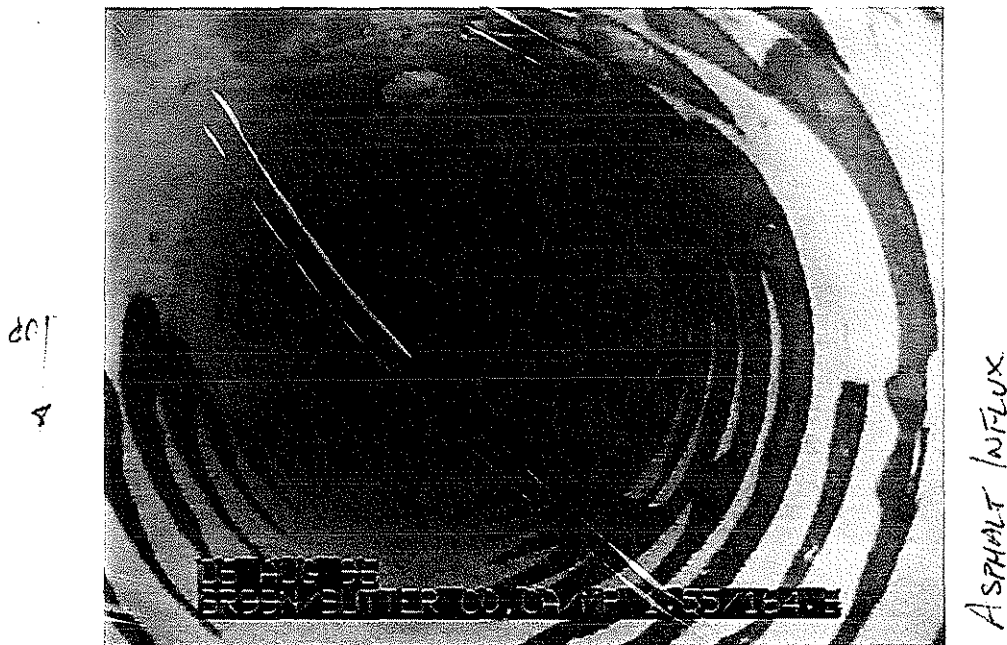
Figure 17. Asphalt Base Permeating Slots in Drain.

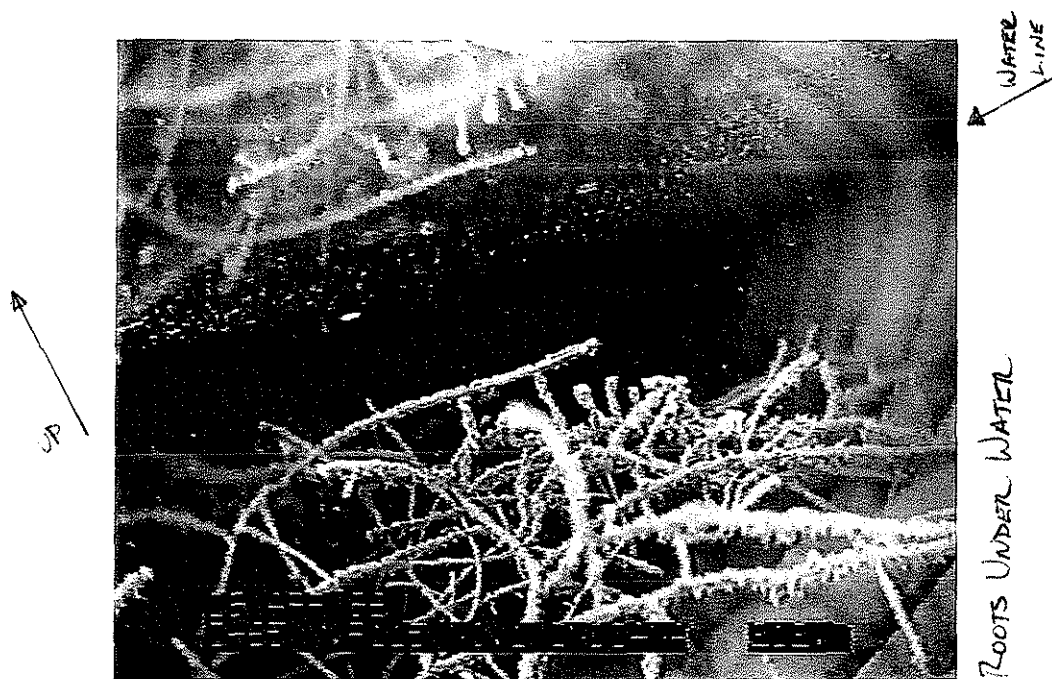
Similarly, if the pipe is not placed to an uniform grade, sags will develop which can lead to other concerns. These sags will collect water which fosters weed growth (Figure 18) and a habitat for all sorts of creatures, such as turtles, snakes, crawfish and frogs (Figure 19). If rodent screens are not

Figure 18. Root Growth Underwater.

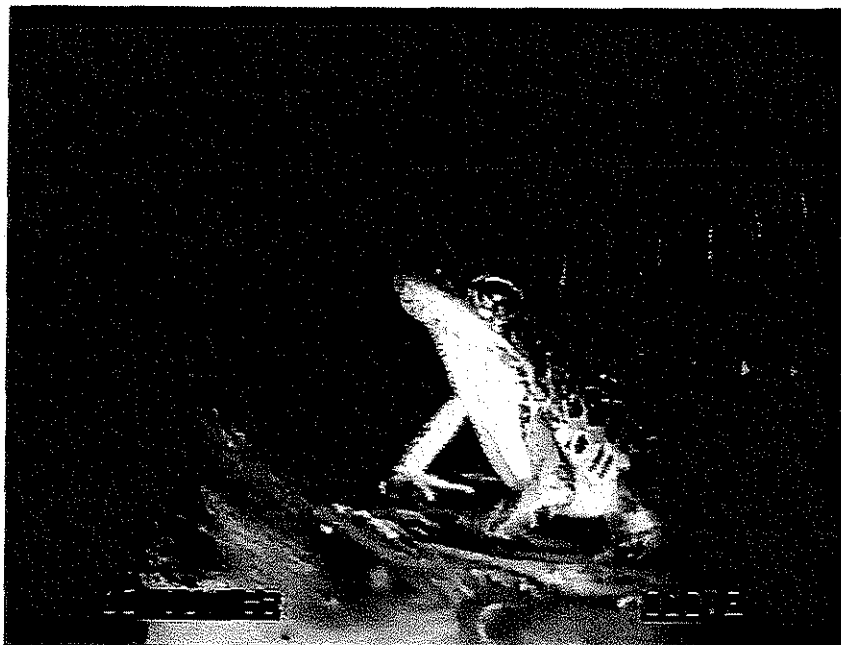
Figure 19. Sags With Standing Water Provide a Desirable Environment for Unwanted Inhabitants.

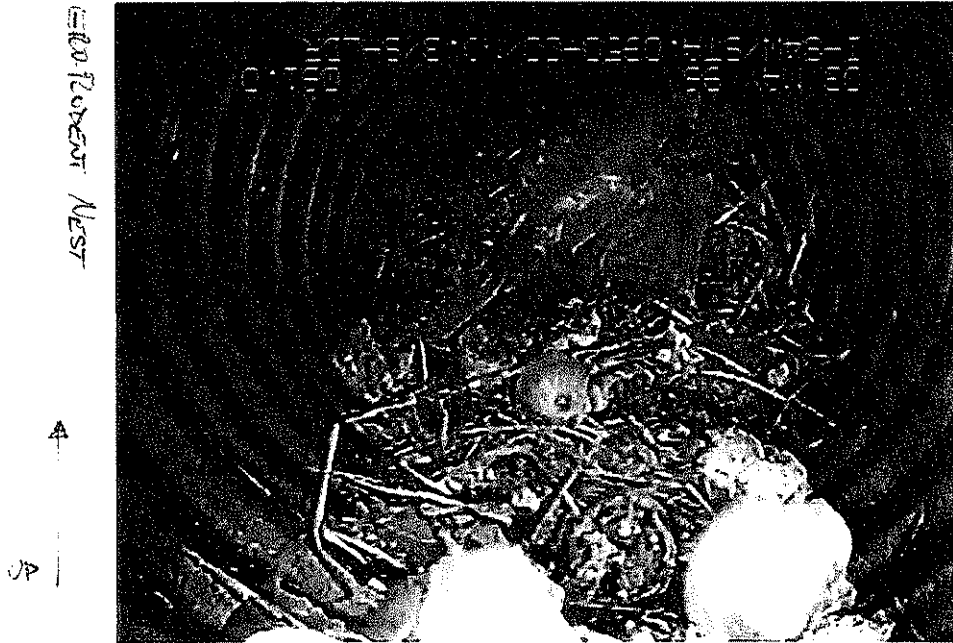
Figure 20. Rodent's Nests Found Blocking the Mainline at 61.0 Feet.

incorporated in these systems, this can lead to other obvious unwanted inhabitants (Figures 20 and 21). These and other revealed problems highlight the need for video inspections of highway edgedrain systems as a quality assurance tool for both rehabilitation and new projects. Detailed observations are included in Appendix A.

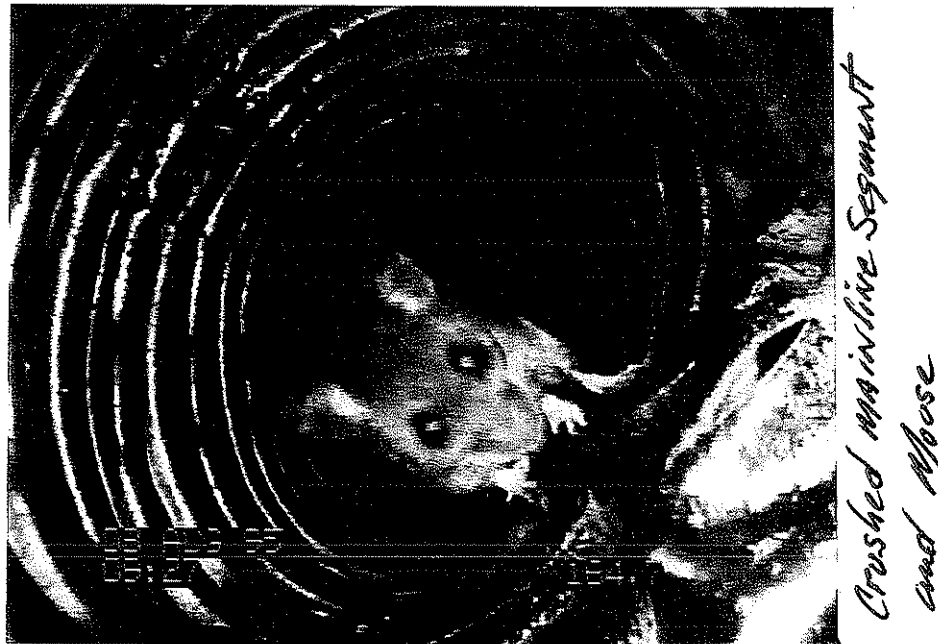
Figure 21. Mouse in Mainline.
