**Final Report
Iowa Highway Research Board
Project HR-360**

**Field Evaluation of Engineering Fabrics
for Asphalt Concrete Resurfacing - Audubon County**

**Ed Engle
Secondary Road Research Coordinator
515-239-1382
Office of Materials
Project Development Division
Iowa Department of Transportation
Ames, Iowa 50010**

April 2001

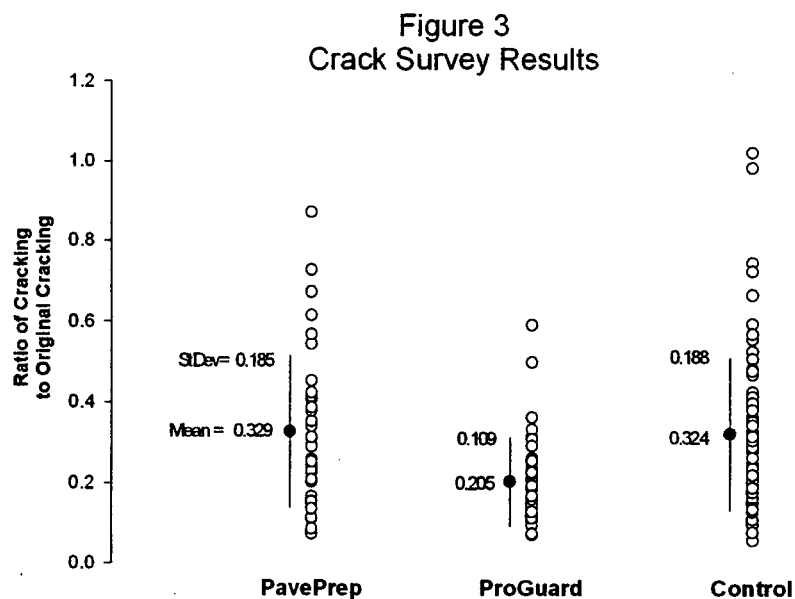
Figure 3 graphs the data from a pooled comparison between the two fabrics and control, showing mean and distribution data. Each data point is a ratio for one location of the amount of cracking after five years to the amount of cracking before the overlay. These data indicate a statistically significant difference (at a five percent level) in the average for the ProGuard compared to control.

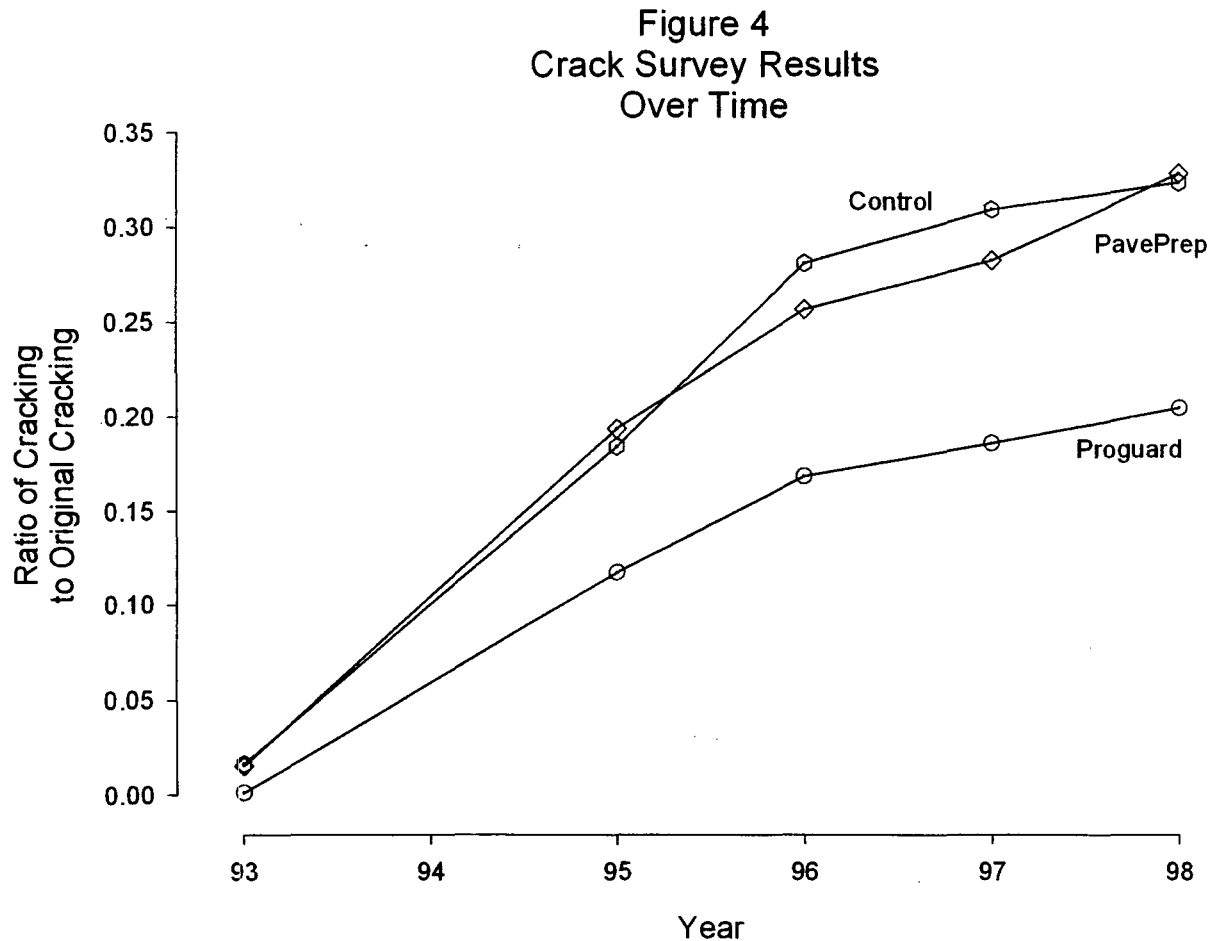
Figure 4 shows the crack data over time for each year after paving. Each point on this graph is the mean of all the data for that section, in that year. As a point of reference, note that the data from Figure 3 is contained in the final three data points of this graph. The slopes of the lines in this graph indicate that the ProGuard treated sections developed cracks more slowly during the first three years compared to the PavePrep and control sections. During the last two years of study, the rates of crack formation appear similar across all three sections.

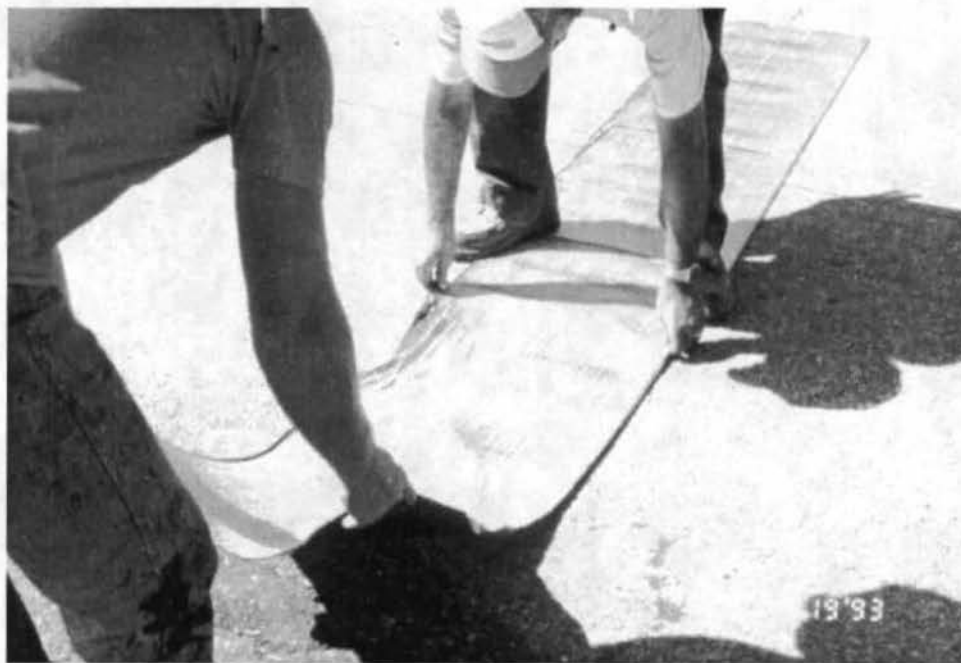
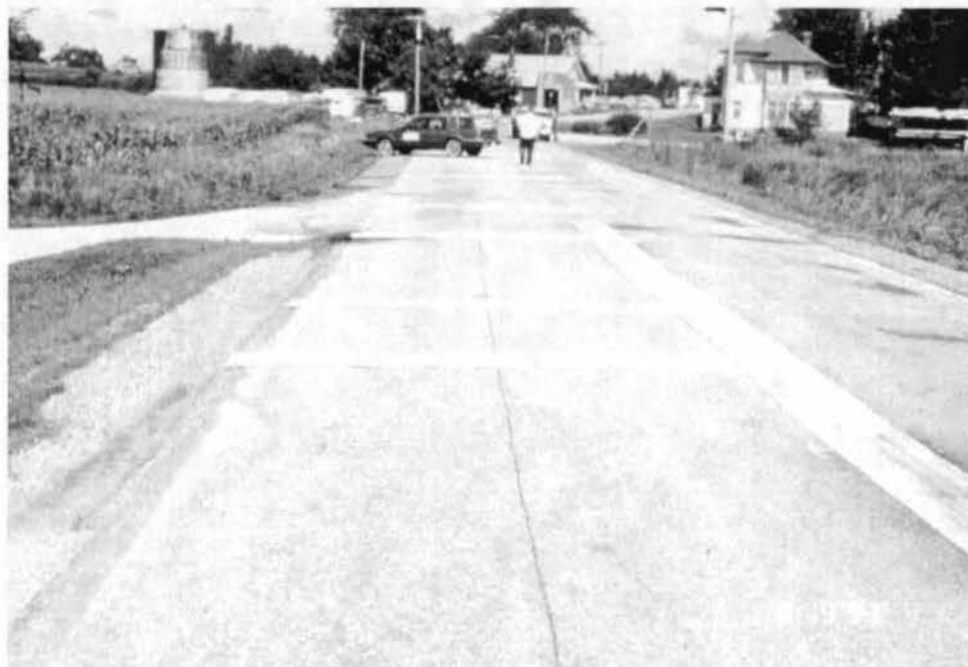
These photographs show the placement of PavePrep fabrics. Note that this fabric is self-adhesive so there is no tack coat underneath.

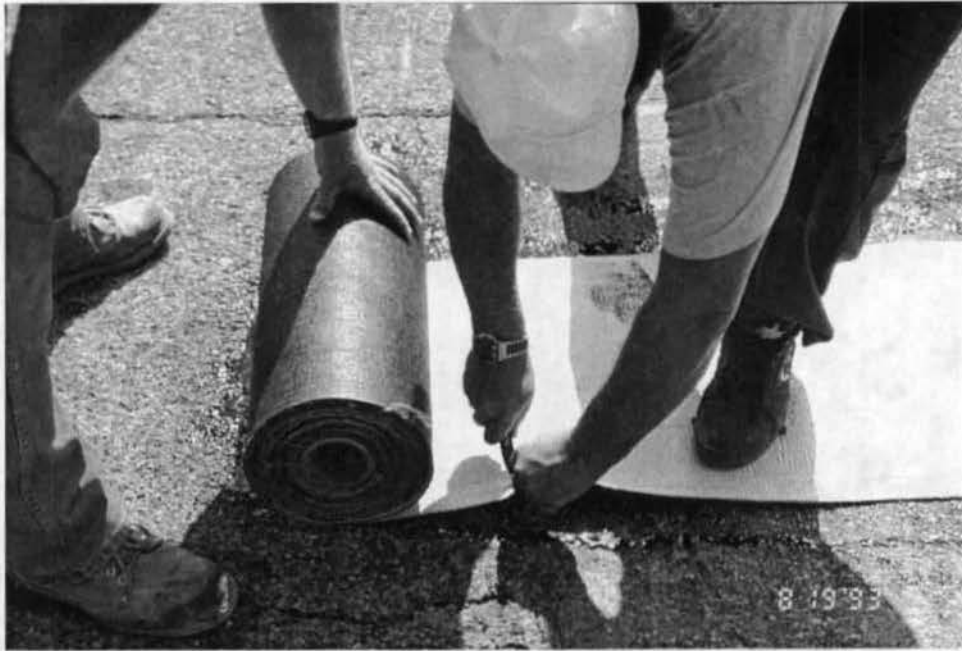
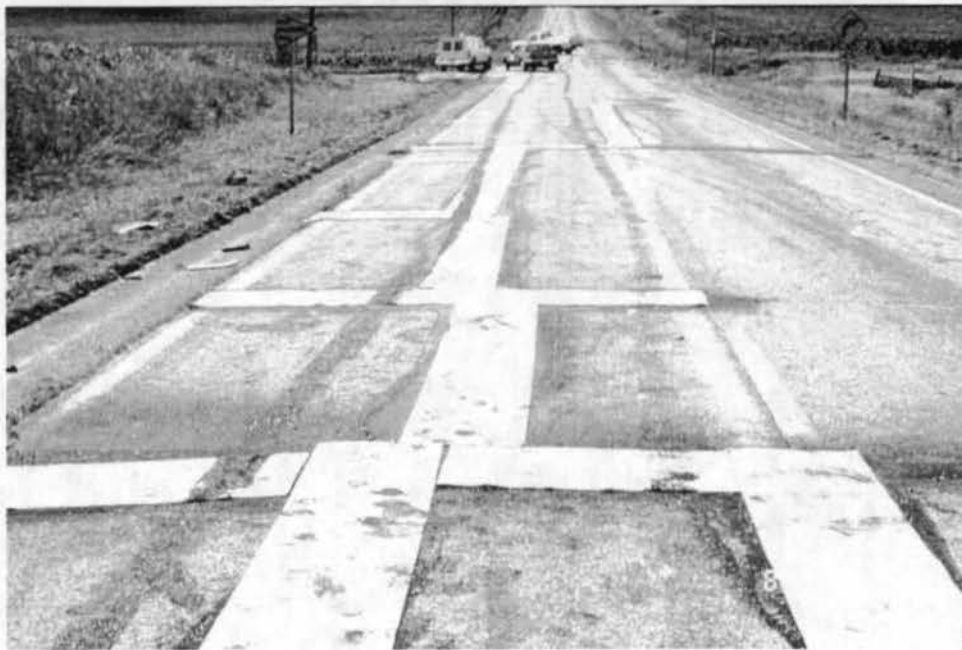
Placement of ProGuard fabric prior to spreading sand on exposed tack coat.

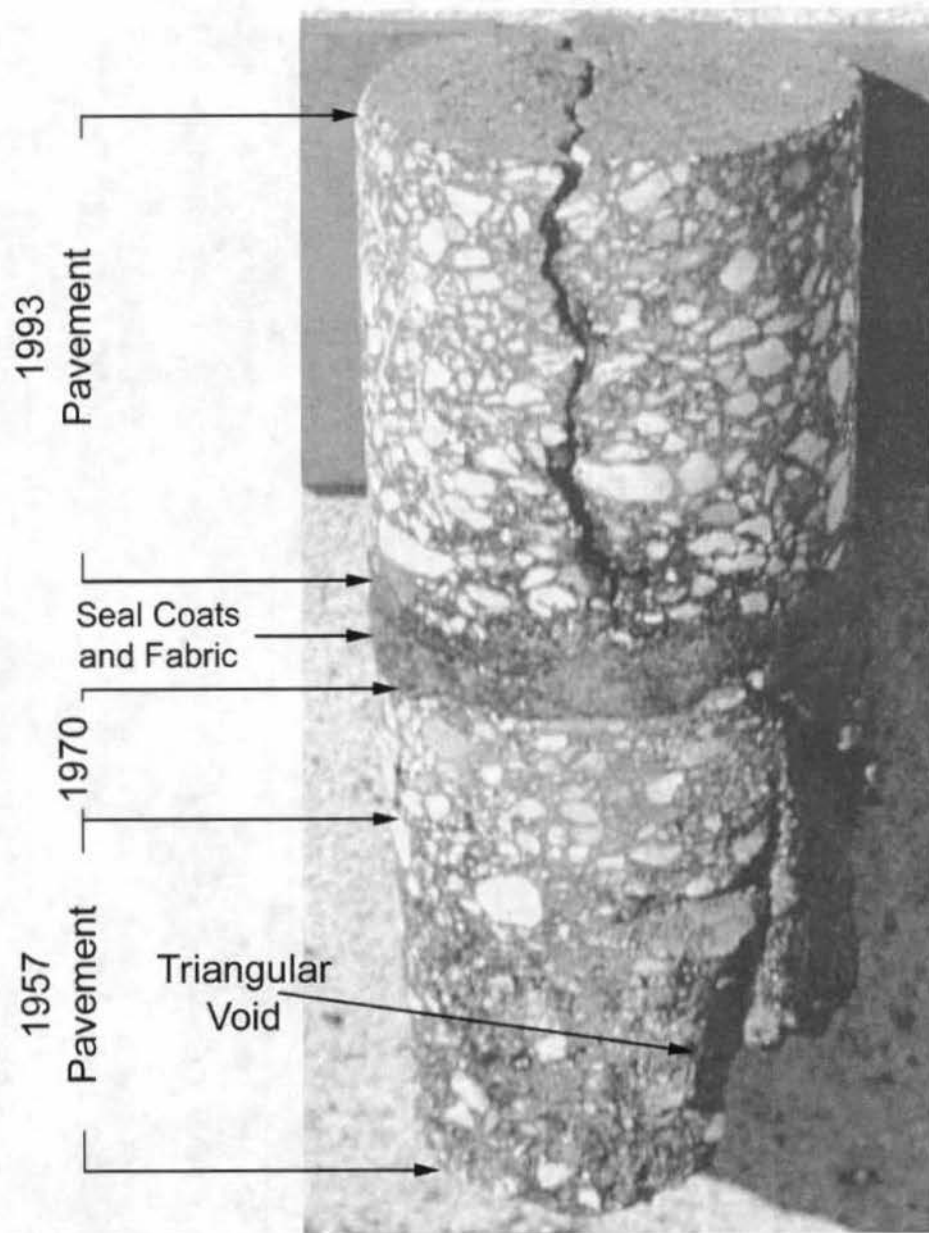
This is an average core showing all of the history of the pavements on this road. The bottom section is the lean mix with lots of fines. Notice the amount of material that has been lost due to raveling leaving a void. Above that is a section from the 1970 overlay which is also showing some loss of material. There follows a thinner section which is a combination of seal coat, tack coats and fabric. At the top is the three inch overlay from this research project.

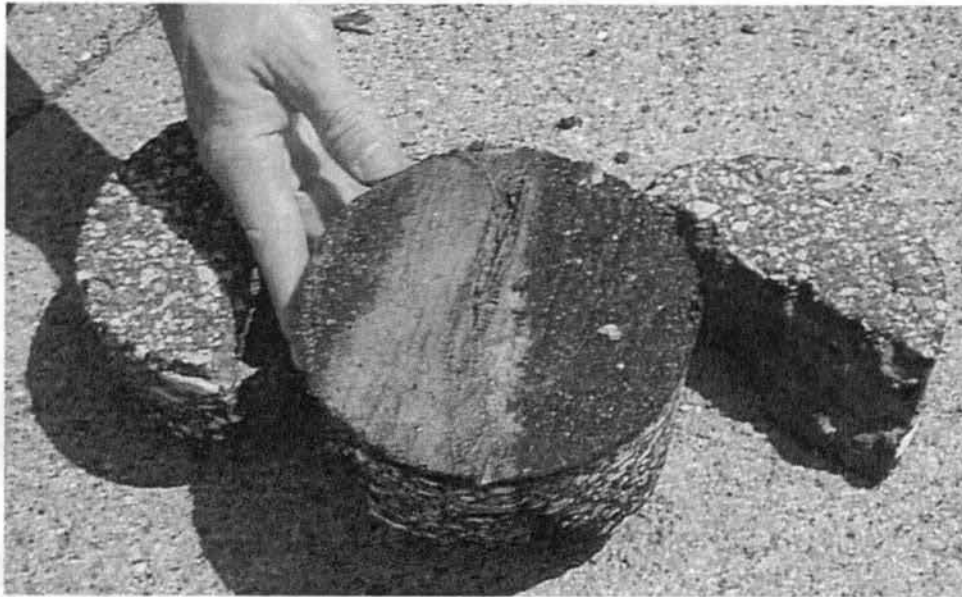
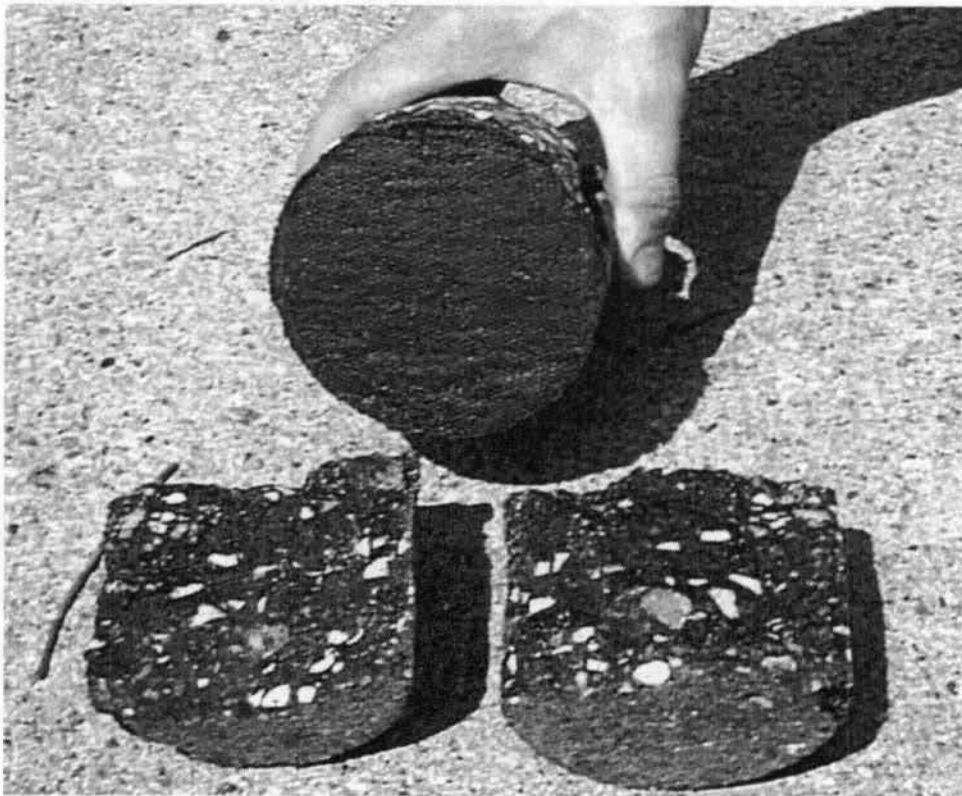
These photographs are representative of the condition of the fabric from most of the cores removed from this project. Note that there was very little bond between the top two pieces and the remainder of the core. The lighter area on the top photograph is water staining. Also the fabric is in an oval shape with the long axis perpendicular to the crack and accordian-like wrinkles parallel to the crack (mostly visible in the top photograph). Most of the samples had limited distress in the top layer of fabric and were completely separated in the bottom layer and mastic layers.
