# LOW PROFILE MARKER FOR WET/NIGHT VISIBILITY

HR - 1005 Final Report

HIGHWAY DIVISION  
April 1977

John H. Moody

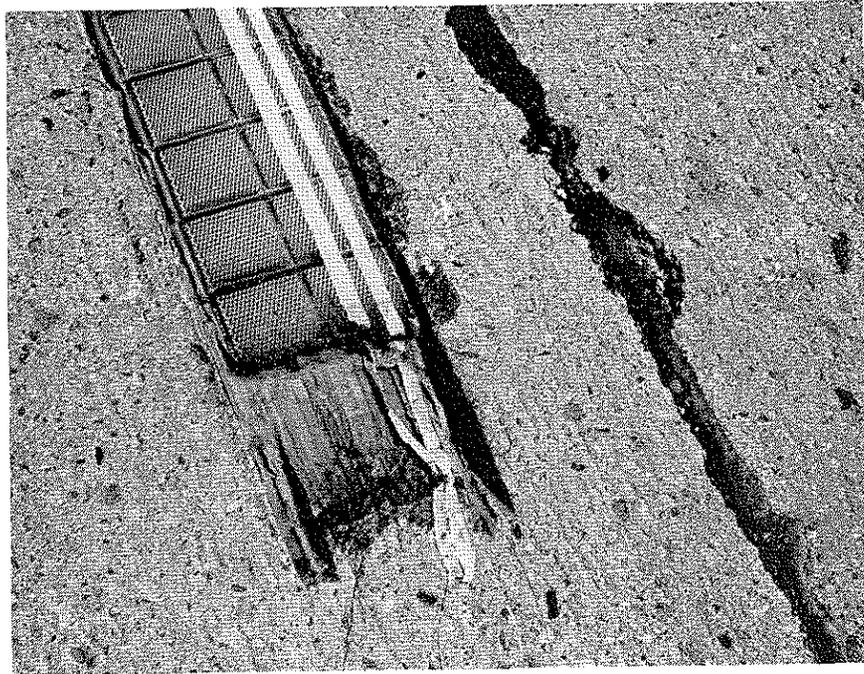
Figure 2A. Illustrates reflector unit installed using Polymeric Systems - Adhesive Sealant

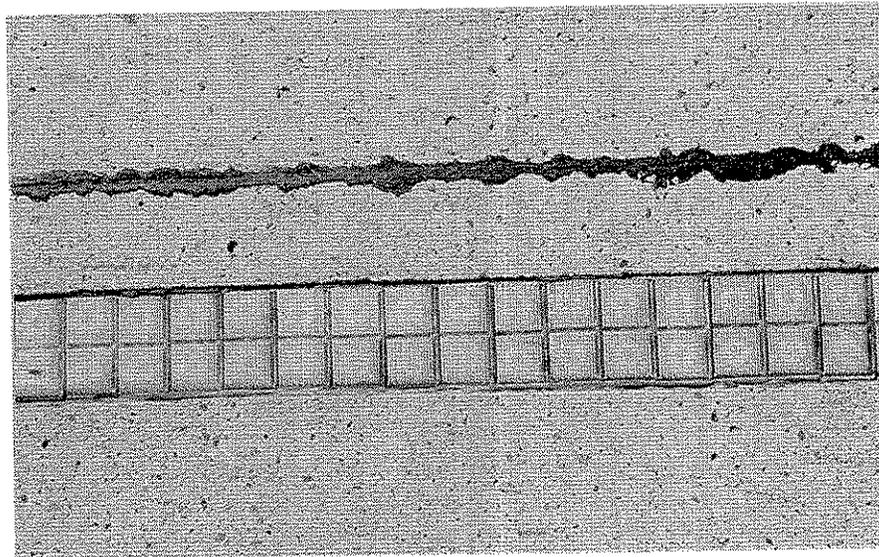
Figure 7. A reflector unit in "excellent" condition

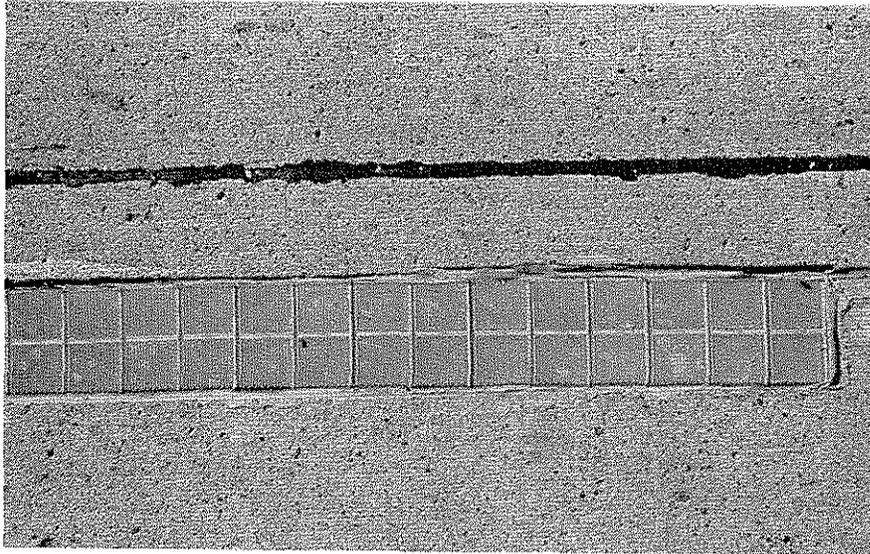
Figure 8. A reflector unit in "good" condition

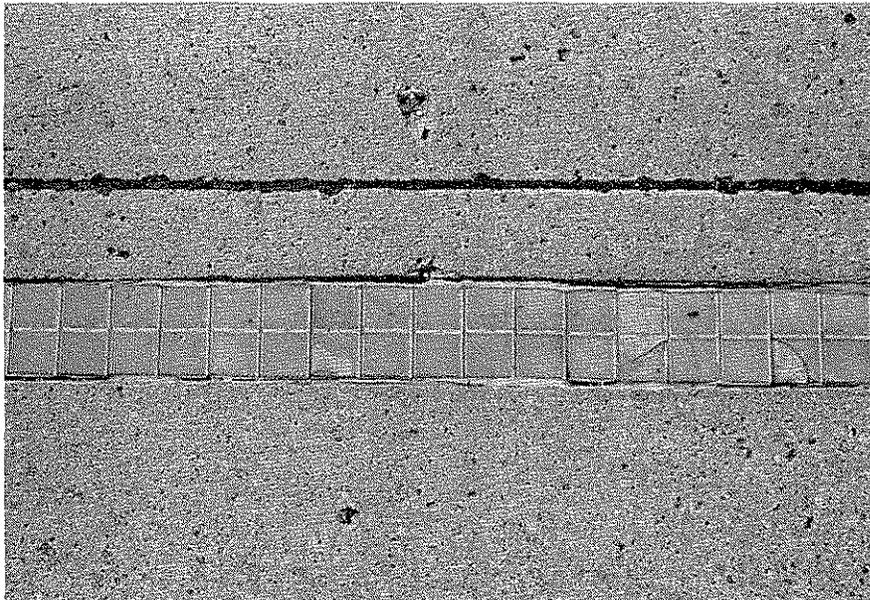
Figure 9. A reflector unit in "fair" condition

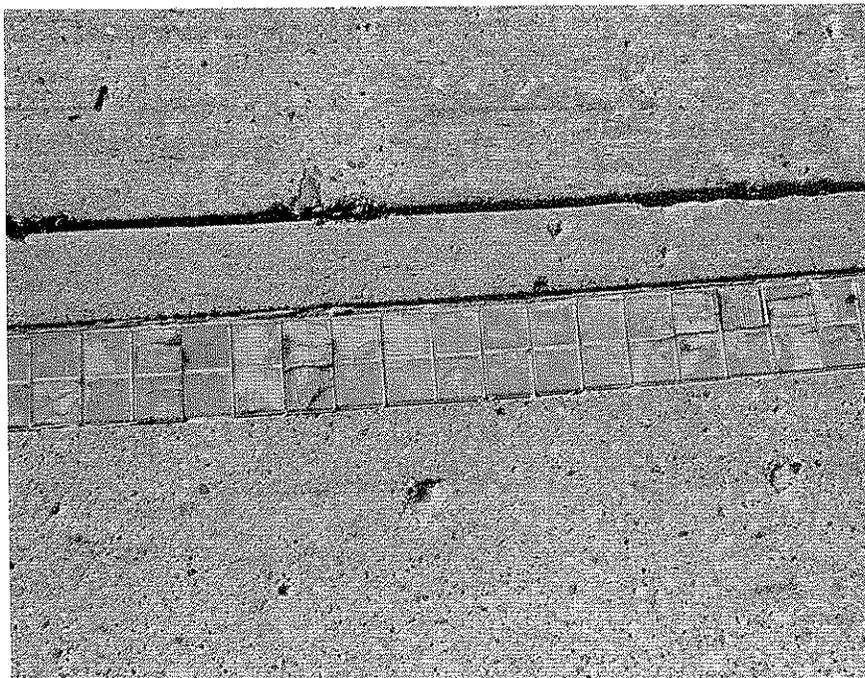
Figure 10. A reflector unit in "poor" condition

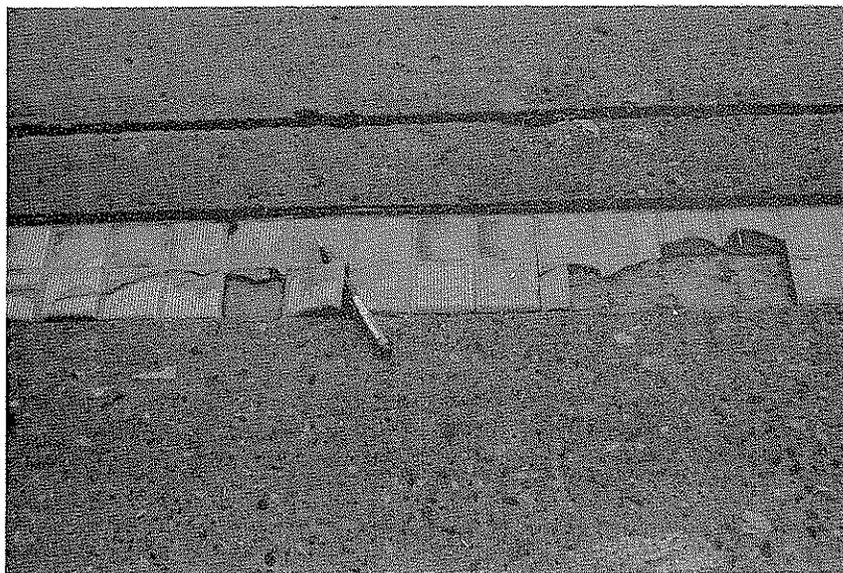
It appears that the aluminum-backed reflector units are less durable than those with lucite backing. There is more breakage among the aluminum-backed units and some units showed a separation of the aluminum coating from the acrylic material.

Some reflectors appeared to have been punctured by a small stone or piece of aggregate forced through the surface by a vehicle tire. Some of this damage may have been caused by studded tires. Again, breakage due to traffic appeared to be greater among the aluminum-backed units.

Some of the loosening of reflector elements may have been a result of epoxy failure. However, with the exception of the first day's installation, where workmanship may have been a factor, it is believed that most failures were due to a separation of the aluminum coating from the acrylic material. Although the type of epoxy used may have caused the loosening, only one (1) epoxy was applied to the aluminized markers and therefore any conclusions would be only speculative. If some of the breakage experience was due to shock, the use of a more resilient material such as the Polymeric Systems Adhesive - Sealant may well be an improvement. For the most part, it appears that the epoxy used was quite effective, however.

To the date of the final inspection (9-8-76) there were no complete physical losses of markers. However, the condition of some markers was extensively deteriorated as illustrated by Figure 11.

Figure 11. Badly deteriorated units
