**PRESSURE RELIEF AND
OTHER JOINT REHABILITATION TECHNIQUES**

FINAL REPORT

February, 1987

14. Sponsoring Agency Code	
15. Supplementary Notes FHWA Contracting Officer's Technical Representative: Peter Kopac, HNR-20					
16. Abstract A study of four major concrete pavement joint rehabilitation techniques has been conducted, including: pressure relief joints, full-depth repairs, partial-depth repairs and joint resealing. The products of this research include the following for each technique: a summary of published research, detailed documentation of the design and performance of the 36 projects, conclusions and recommendations of the state highway engineers panel, "Design and Construction Guidelines" and "Guide Specifications." The latter two products are prepared for use by state highway agencies. The results of this study are based upon a review of literature, extensive field surveys and analysis of 36 rehabilitation projects, and the experience of an expert panel of state highway engineers.

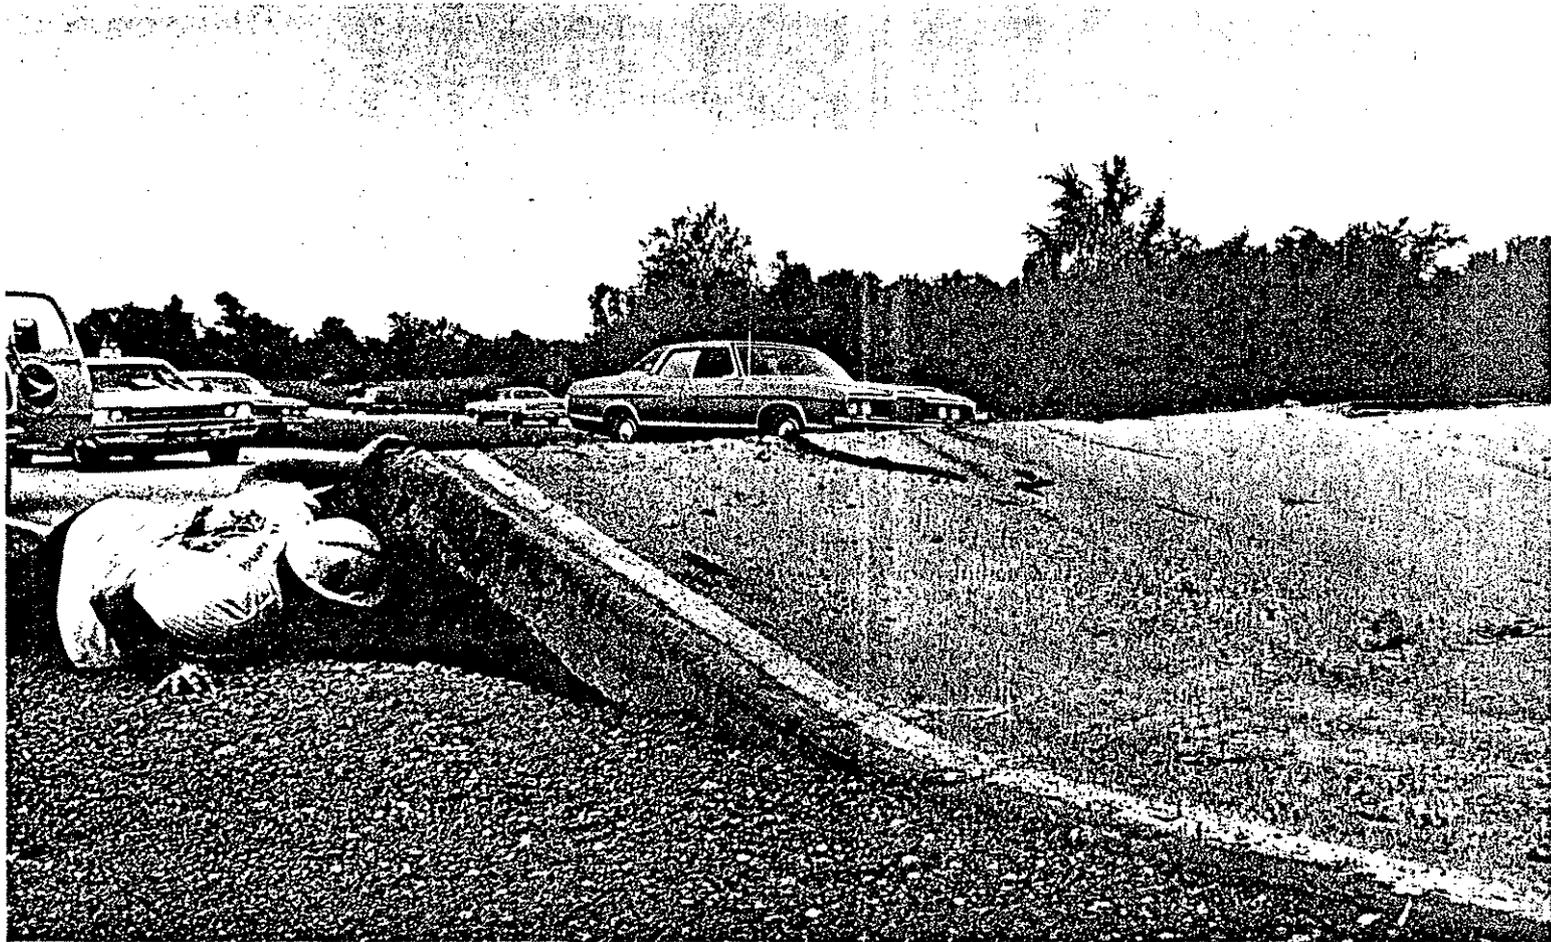
Figure 1. Blowup on Ohio 21, Summit County, 1975.
(Photograph, Akron Beacon Journal)

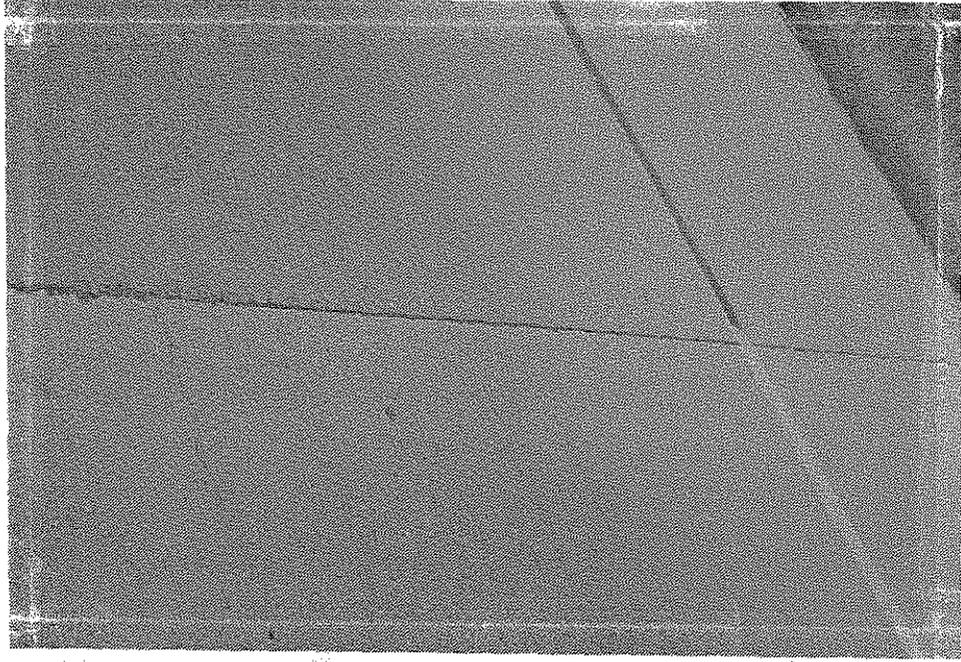
Figure 4. Photo of Spalls Caused by Differential Vertical Movement.

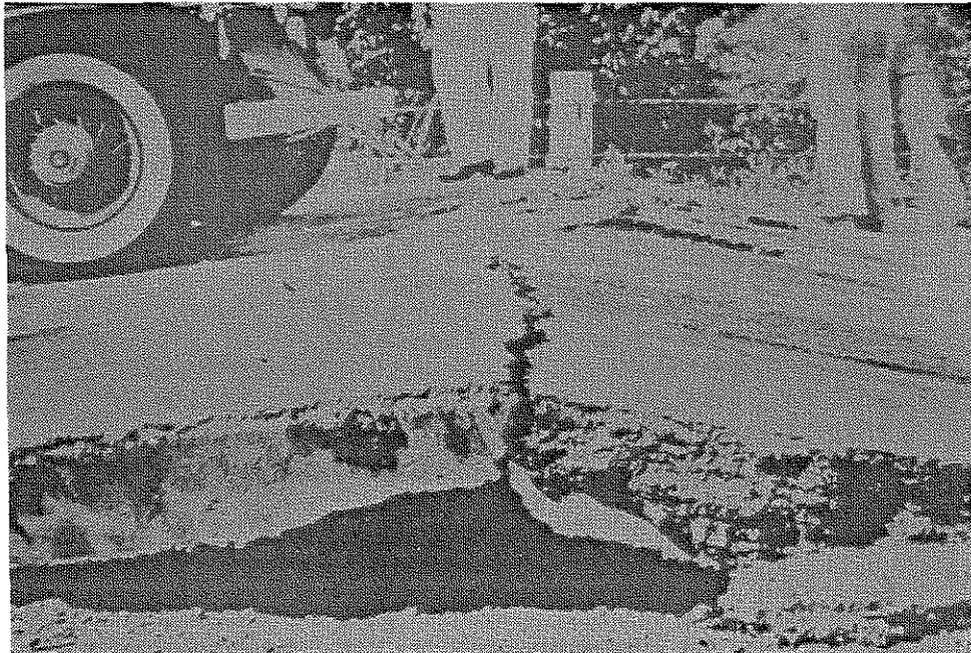
Figure 5. Photo of Blowup (Localized Vertical Movement).

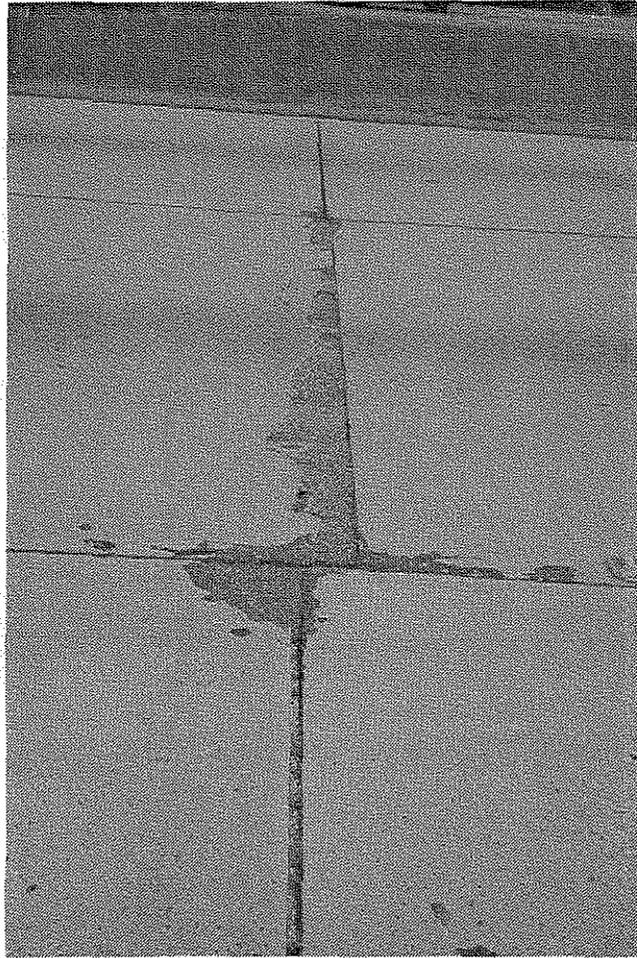
Pressure damage may continue after relief joints have been installed. The New York DOT has documented projects where the longitudinal joint ties have sheared as the traffic lanes moved independently (see Figure 7).

Figure 7. Photo of Traffic Lane Movement After Placement of Relief Joints.

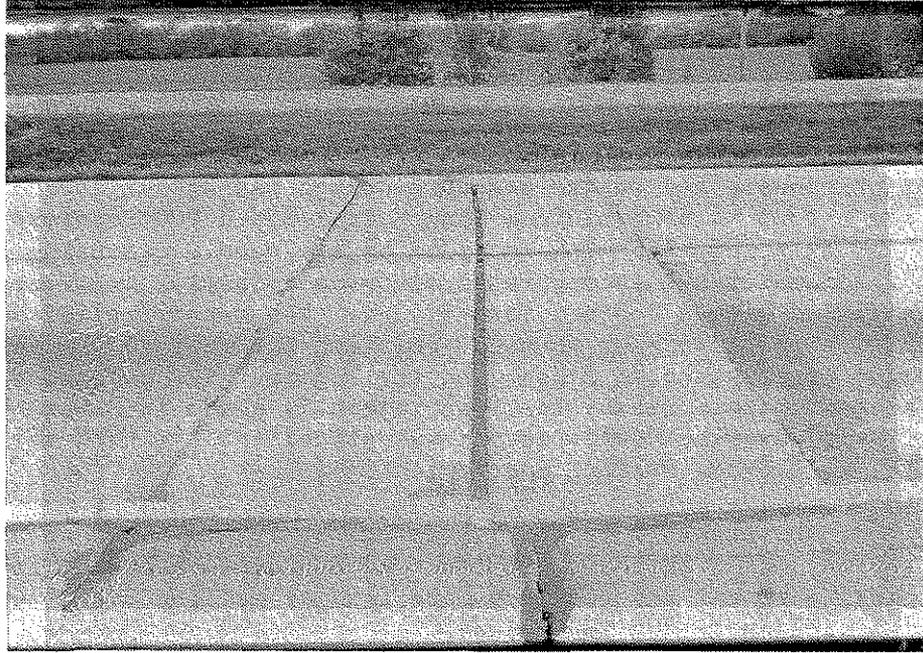
Figure 28. Photo of Pressure Relief Joint Constructed on IL055252 (Sample Unit 1, Station 4+50).

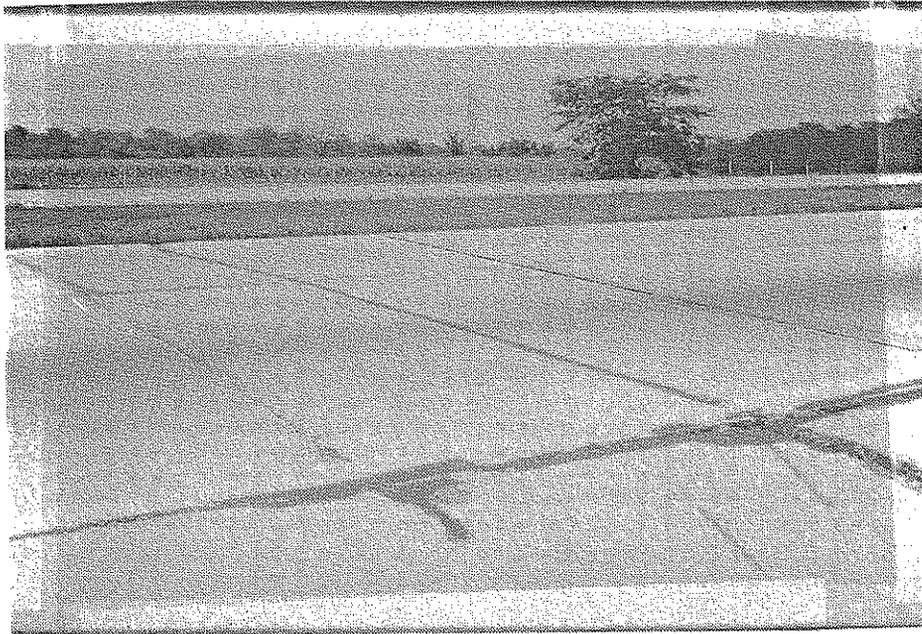
Figure 29. Photo of Pressure Relief Joint Constructed on
IL055252 (Sample Unit 2, Station 2+00).

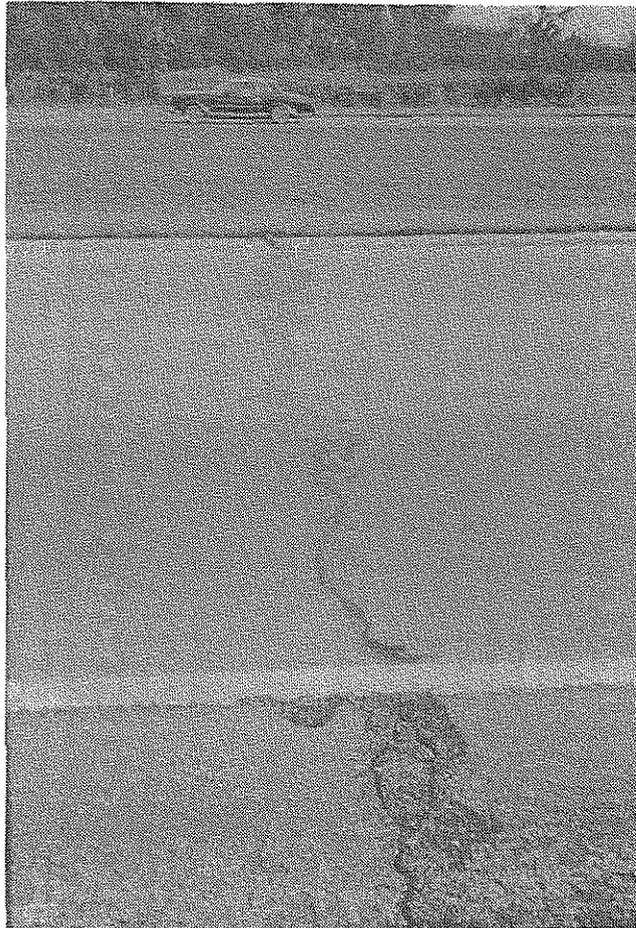
Figure 31. Photo of Sealed Crack Over Pressure Relief Joint on OH070066.

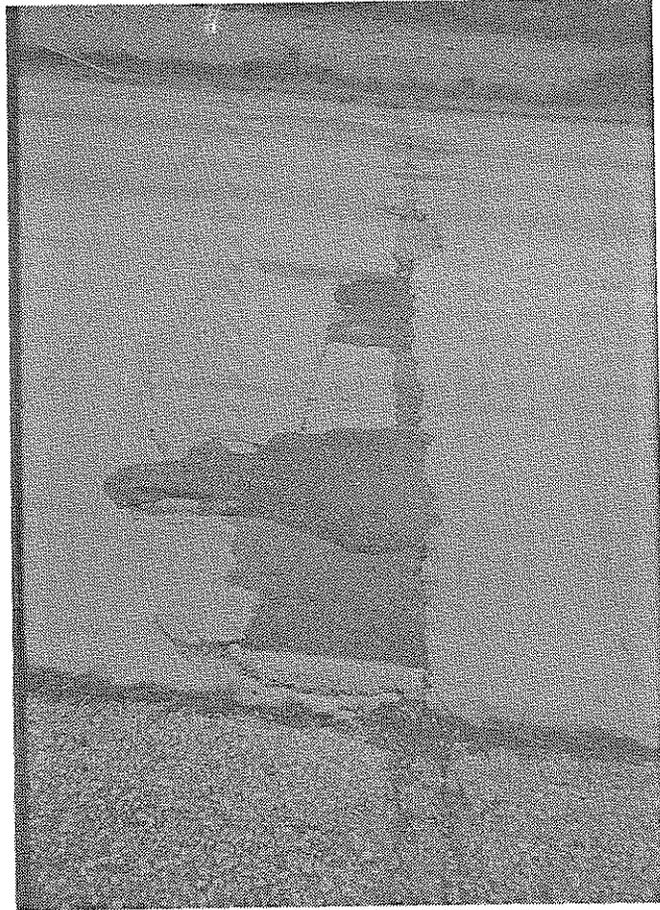
Figure 33. Photo of Pressure Relief Joint on OH270029
(Same Relief Joint as in Figure 32).

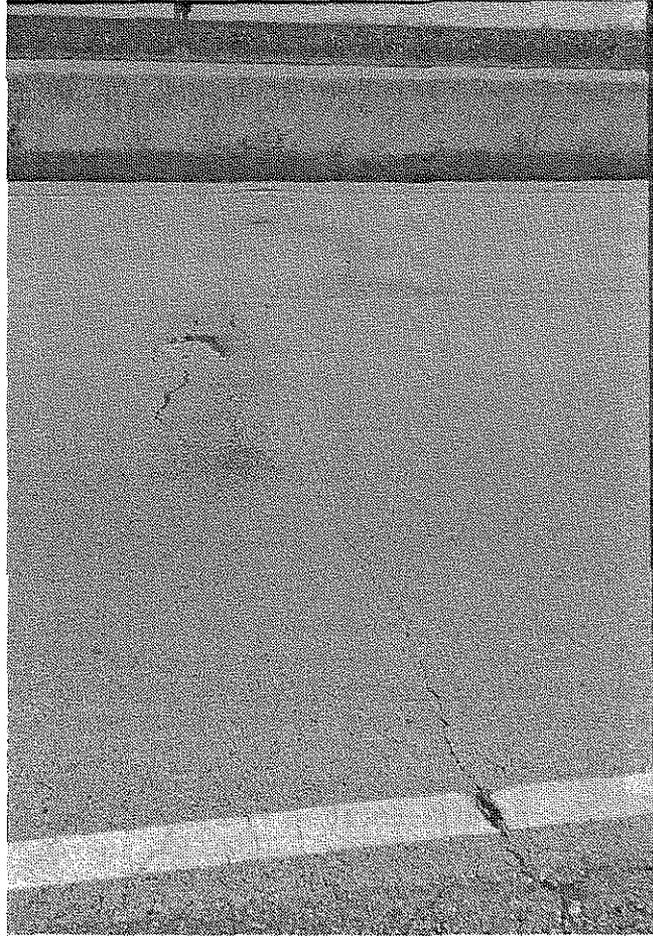
The pressure relief joints placed on this project are inappropriate because there are no signs that pressure buildup problems existed. Furthermore, the interruption of the continuous reinforcement can be

Figure 36. Photo of AC Overlay Above Pressure Relief Joint in Sample Unit 1 (Station 1+84) of IL072067.

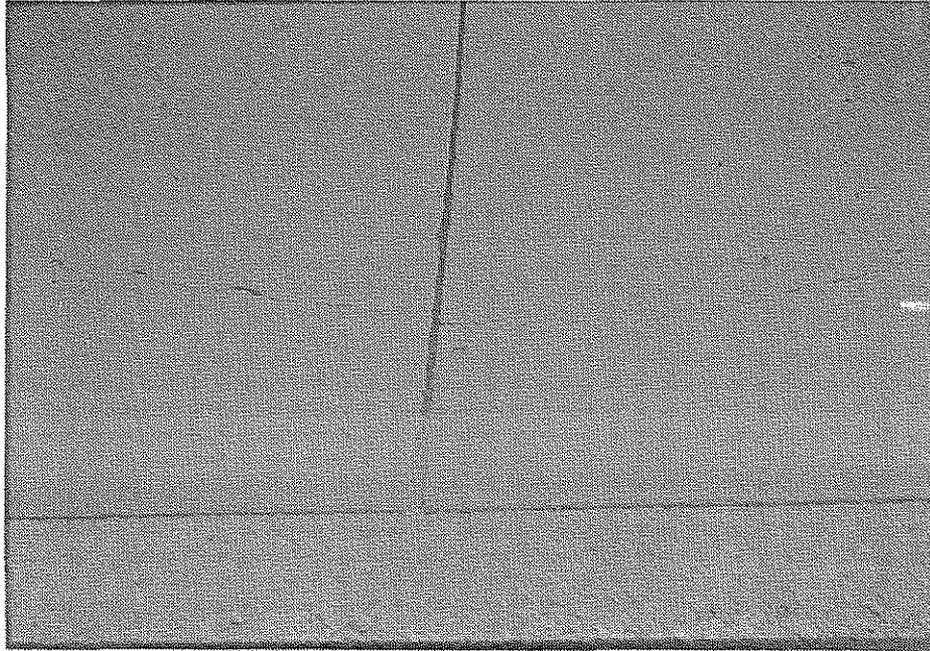
The pressure relief joints installed in 1980 were inappropriate for this project. They were placed to relieve pressure and prevent blowups and other pressure-related damage. However, since no pressure damage had previously occurred and the pavement has short joint spacing, it is doubtful that there was a potential for pressure damage existed. It is unclear whether compressive stresses were building (e.g., did the observed longitudinal compression cracks form before or after 1980?) and, if so, whether the installation of pressure relief joints was the best approach to address the problem.

Figure 38. Photo of Regular Contraction Joint with Longitudinal Compression Cracks on IA030156.

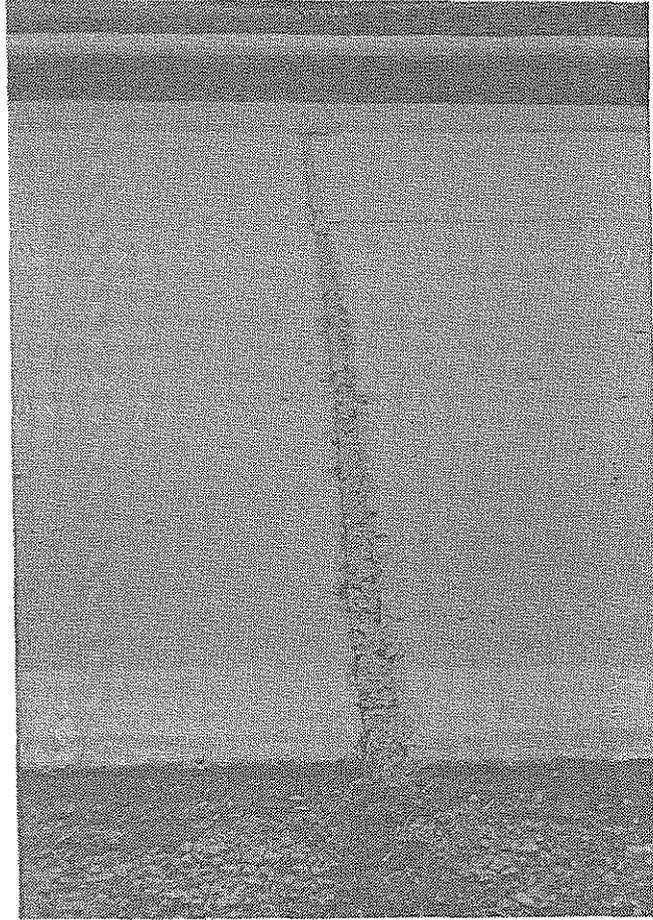
The pressure relief joints (excluding those located near bridges) have closed to an average width of 0.84 in [21 mm] and have faulted an average of 0.23 in [5.7 mm]. The filler is frequently absent and the joints are full of incompressibles (see Figures 41 and 42). Several of the relief

Figure 41. Photo of Pressure Relief Joint
Filled with Incompressibles on IA035086.

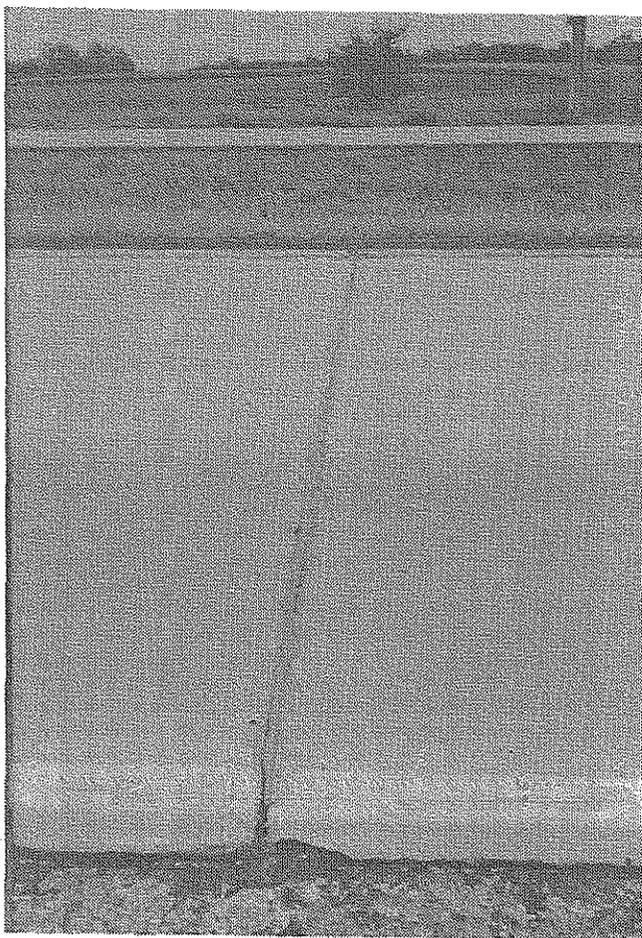
Figure 42. Photo of Pressure Relief Joint with Filler Intact on IA035086.

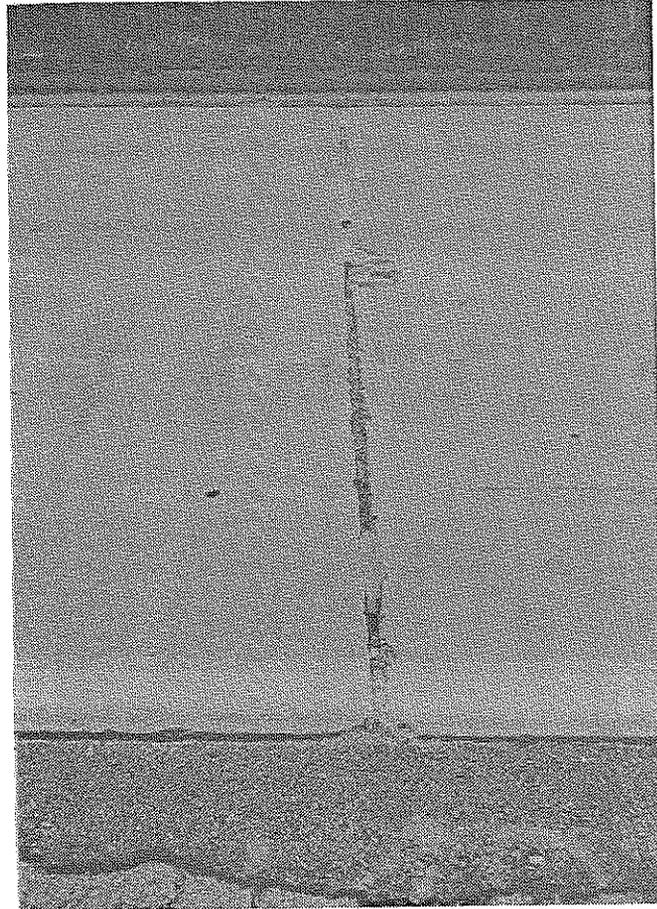
Figure 43. Photo of Pressure Joint on IL055102
with Medium- to High-Severity Spalling.

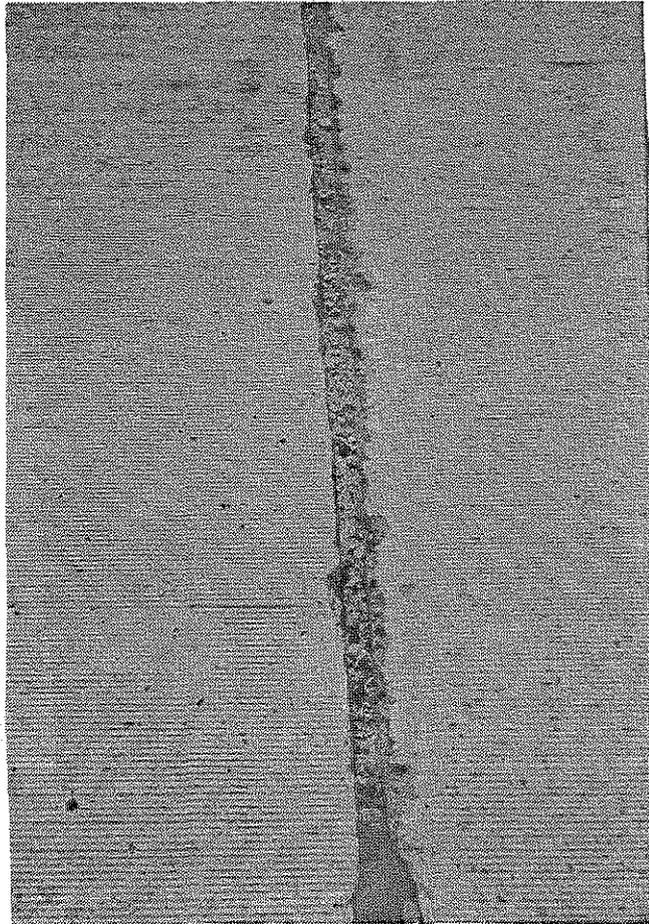
Figure 44. Photo of Pressure Relief Joint Filled with Incompressibles on IL055102.

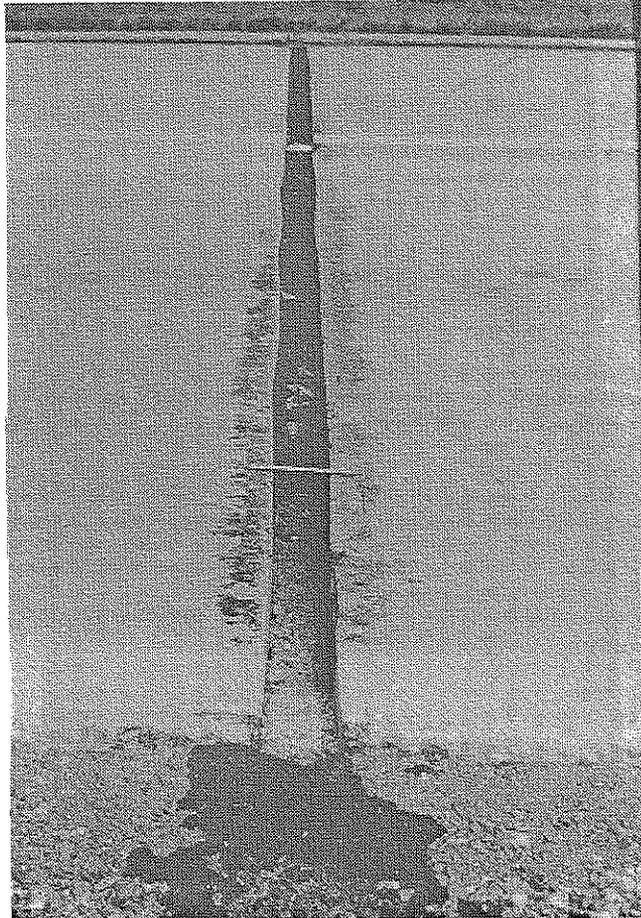
Figure 46. Photo of Pressure Relief Joint Filled with AC in Sample Unit 2 (Station 7+30) of IL080105.

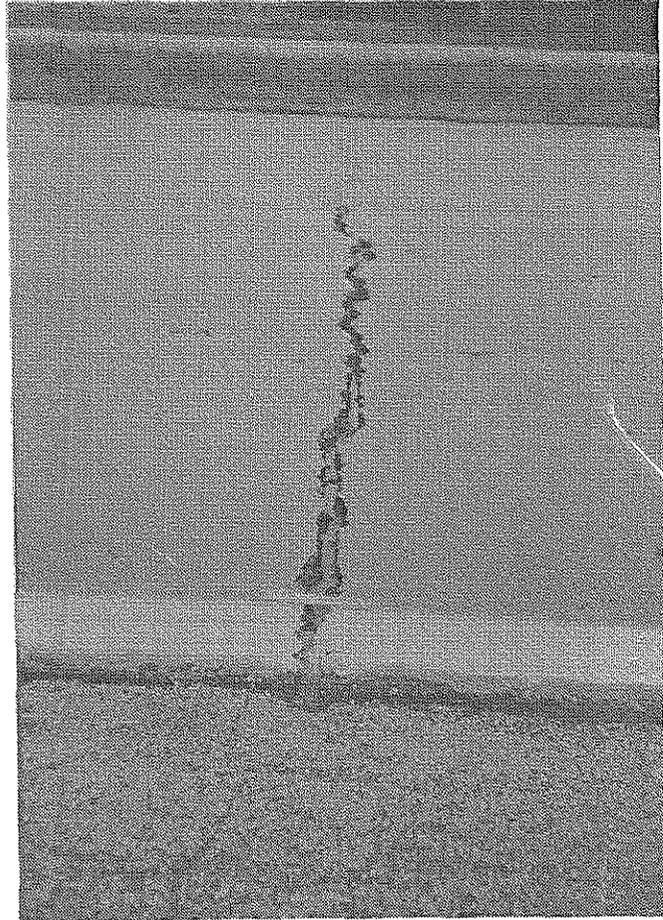
Figure 49. Photo of High-Severity Crack in Sample Unit 3
(Station 9+60) on MI127.

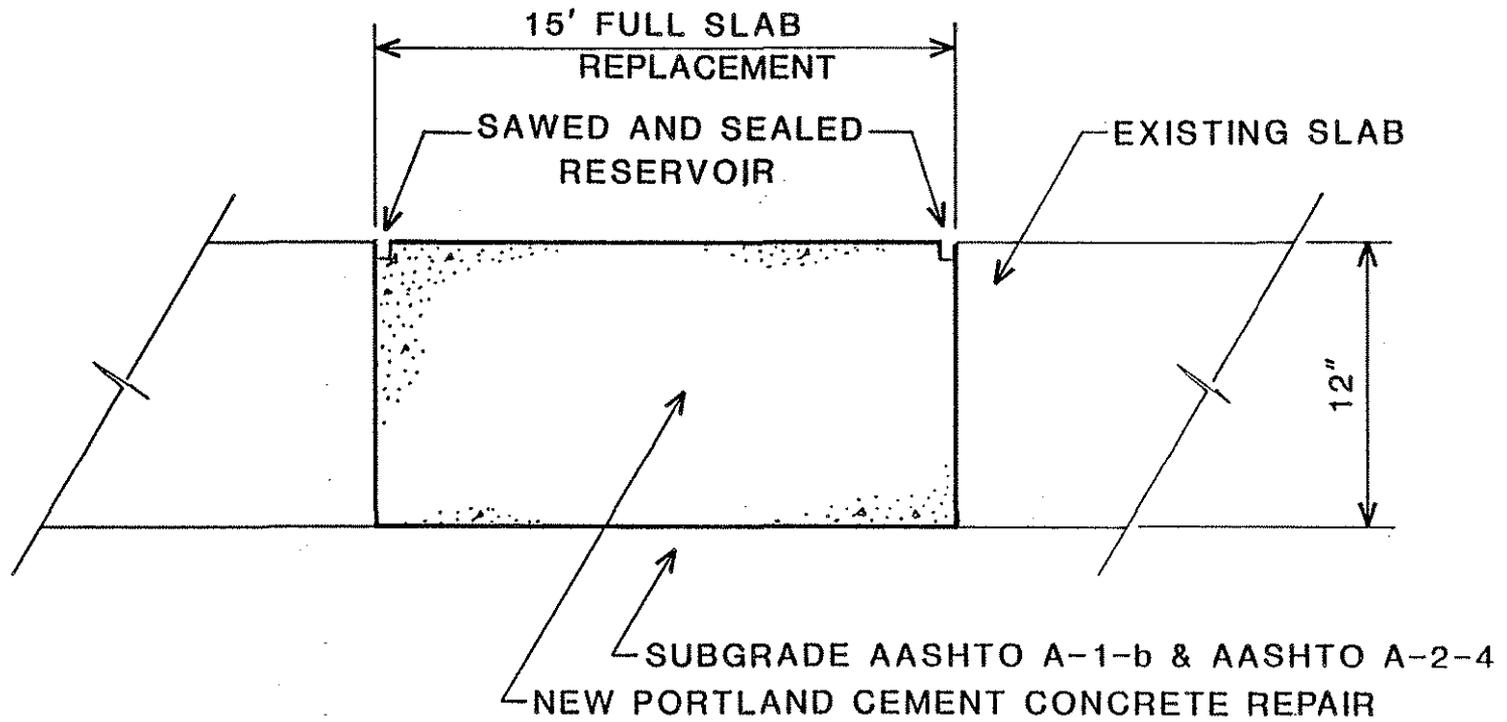
The full-depth repairs placed in 1982 have successfully addressed the joint spalling and faulting of the original pavement. They are performing well and show no signs of distress. Since only two repairs were evaluated, it is difficult to assess the effectiveness of this repair technique. Based on their condition, it would appear that they have been successful. However, there presently exists a large number of cracked slabs. It is possible that not enough full-depth repairs were placed in 1982.

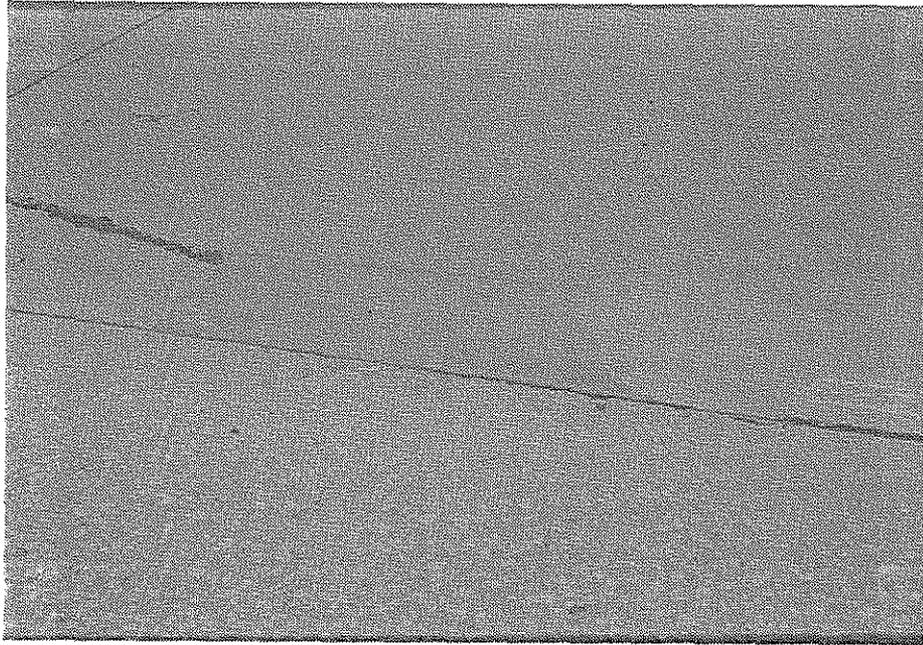
Figure 96. Photo of Partial-Depth Repair at Working Crack on NE080404.

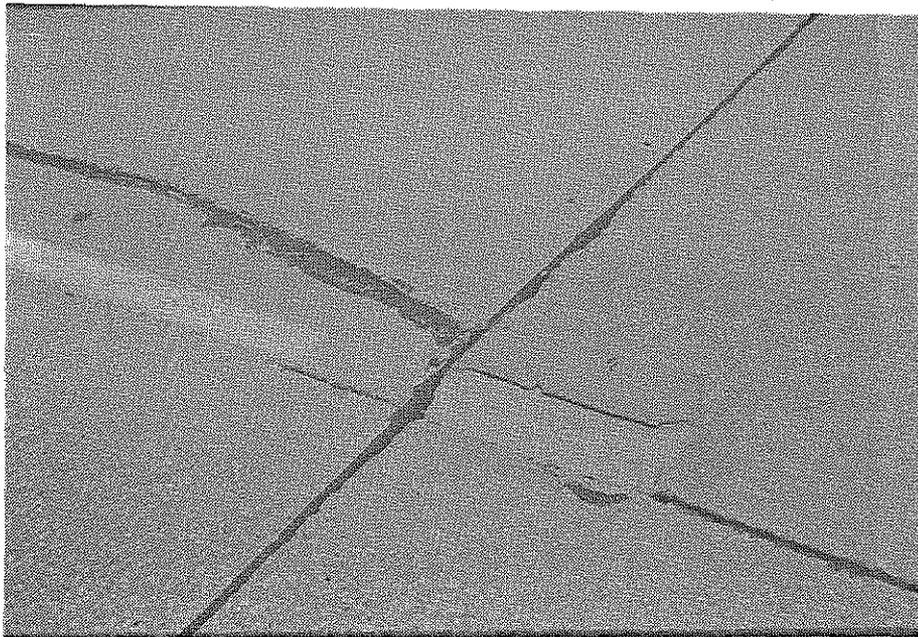
Figure 97. Photo of Material Loss of Partial-Depth Repair on NE080404.
