FIELD INSTRUMENTATION, TESTING, AND LONG-TERM MONITORING OF HIGH-MAST LIGHTING TOWERS IN THE STATE OF IOWA

FINAL REPORT

November 13 2006

Iowa Department of Transportation
Office of Bridges and Structures
800 Lincoln Way
Ames, IA 50010

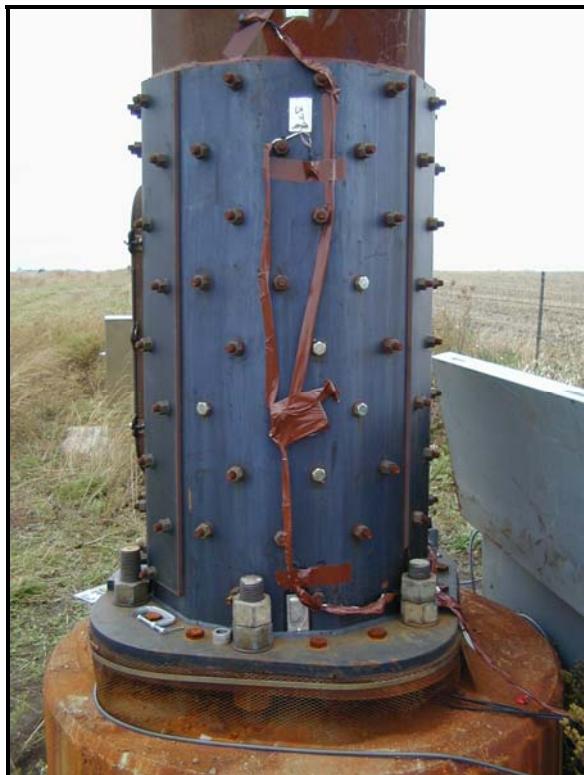
The second tower had been retrofitted with a steel reinforcing jacket at the base as seen in Figure 1.1. The retrofit was designed by Wiss, Janney, Elstner, and Associates. Strain gages were installed on both the reinforcing jacket and on the original tower just above the jacket. This tower is termed the “*Retrofit tower*.”

Figure 1.1 – Jacket retrofit designed by Wiss, Janney, Elstner, and Associates and installed in Clear Lake, Iowa

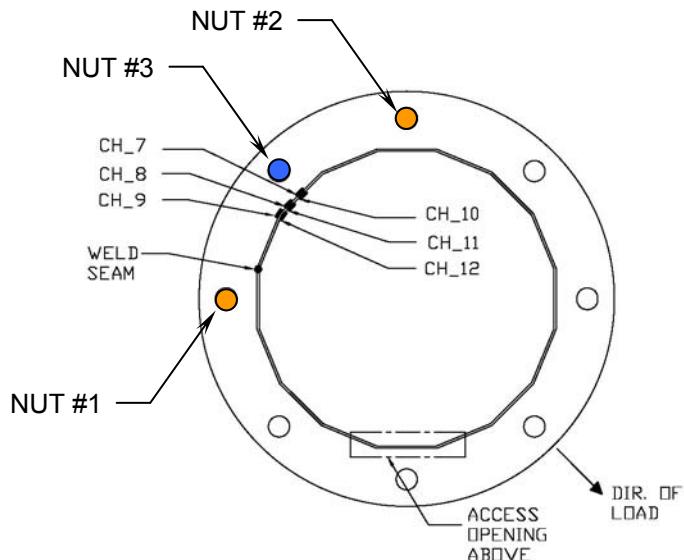
Presented in Figure 3.6 is a plan view of the tower base indicating the locations of the loosened nuts (nut #1 and nut #2). Note that the two nuts are located on either side of the strain gages at the base.

During the second test, the leveling nut directly adjacent to the strain gages (nut #3) was lowered approximately 1/16" and the top nut was tightened down to simulate the effect of improper leveling of the leveling (support) nuts prior to tightening the top nuts.

Figure 3.6 – As-built tower at Sioux City - location of loosened bolts

Table 3.4 contains the maximum static stresses measured during the tests where nuts were loosened. It can be seen that the stresses at 5'-9" above the base (CH_5 and CH_6) are generally unaffected by the loosening. However, at the base weldment (CH_7, 8, 9, 11, and 12), the stresses increase with increasing number of nuts loose. It is also interesting to note that at 3" above the base (CH_1 and CH_2), the stress increase is higher on the tension side (CH_1, where the nuts are loose) than the compression side (CH_2, where the nuts are fully tight), where there is minimal effect on the stress.

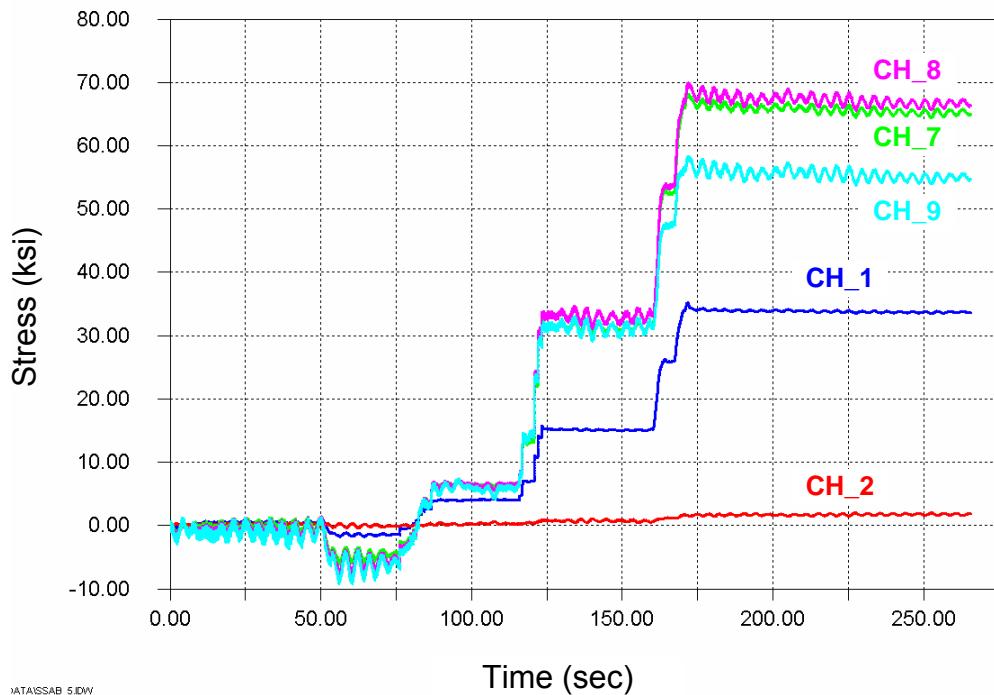
Strain gages CH_7, CH_8, and CH_9 are located at the weld toe below CH_1 (see Figure 2.9.) It can be seen that at the weld toe, very high stresses (70 ksi) are induced into the tube wall by tightening down the anchor nut. It is likely that the material locally yielded.

Figure 3.7 – Localized stress changes due to poor installation techniques
(As-built tower at Sioux City)

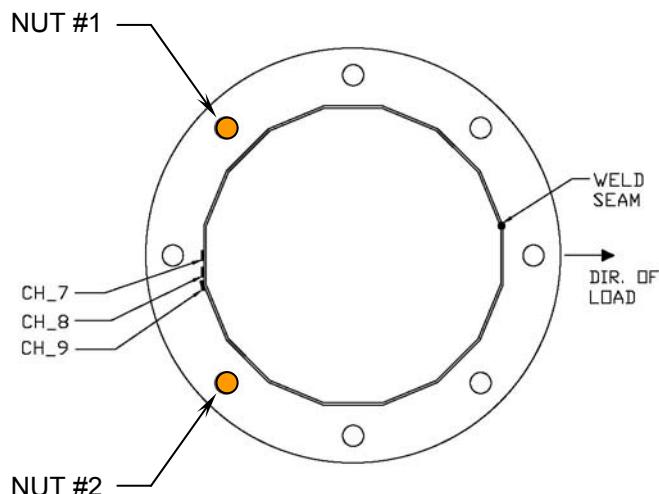
At the Retrofit tower, one test was performed to evaluate the effect of loose anchor nuts. During this test, load was first applied to the tower and held. Then a nut was loosened while the load was held. Subsequently, a second nut was loosened. Finally the tower was unloaded. The load applied to the tower remained approximately constant during the entire test. Presented in Figure 3.8 is a plan view of the tower base indicating the locations of the loosened nuts (nut #1 and nut #2). Note that the two nuts are on either side of the strain gages at the base.

Figure 3.8 – Retrofit tower - location of loosened bolts

Table 3.5 contains the maximum static stresses measured during the test where nuts were loosened. Note that stresses are presented for three cases, namely with no nuts loosened, one nut loosened, and two nuts loosened. As with the As-built tower, it can be seen that the stresses at 5'-9" above the base (CH_5 and CH_6) are generally unaffected by the loosening. However, at the base weld (CH_7, 8, and 9), there are significant stress increases with increasing number of nuts loose. For example, the stress at strain gage CH_9 is 6.53 ksi with all nuts fully tightened, but rises to 8.14 ksi (one nut loose) and 14.92 ksi (two nuts loose). Again, the stresses 3" above the base on the tension side (CH_1) increase with increasing number of loose nuts while on the compression side (CH_2), the stress increase is minimal. Overall, the stresses are lower in the Retrofit tower than in the As-built tower as expected.

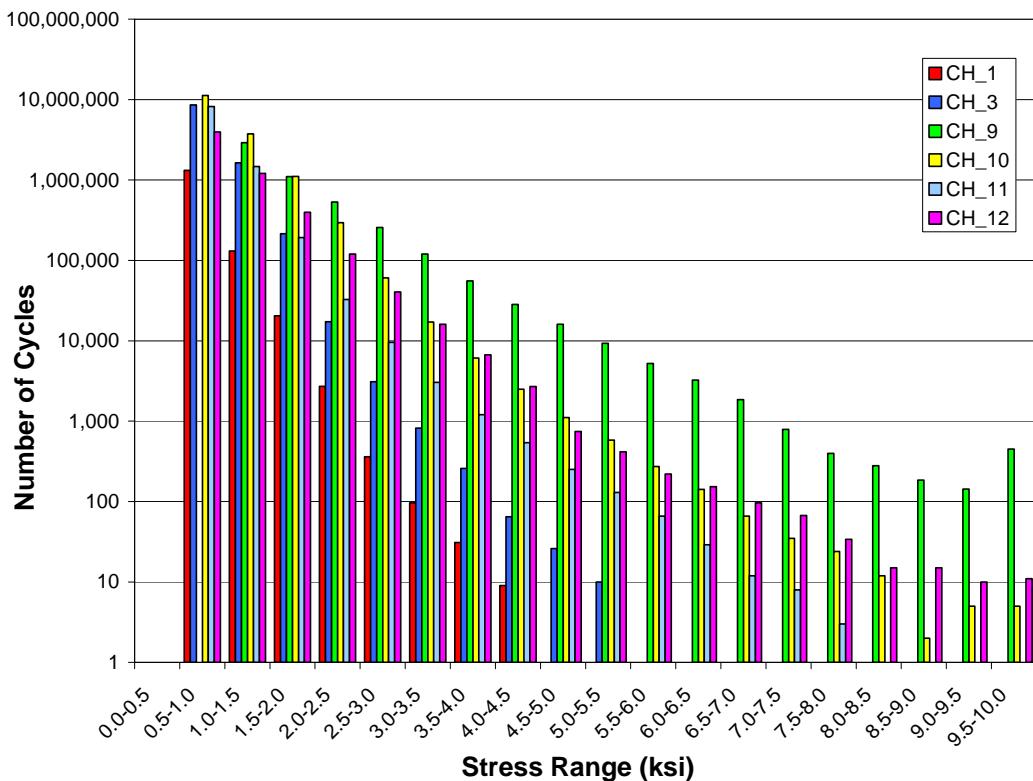
The groove-welded connection at the base of the tower (strain gages CH_1 and CH_3) is considered at category E' per AASHTO [2], with a CAFL of 2.6 ksi, due to the fact that the backing bar is not welded to the base plate by a full penetration weld. (*It is noted that although some penetration exists, the shop drawings [13] indicate that the backup ring is called out as being attached with a fillet weld and not a CJP to the base plate (detail 2 shows a 6.3 mm fillet weld). A similar detail was also observed in the investigation into cracks found at a high-mast lighting tower in Iowa examined by Dr. John Fisher [14]. In the examination by Fisher, cracks initially occurred at the weld toe on the pole wall and then initiated in the backing bar ring.*)

It is noted that in the previous report prepared by the late Robert Dexter indicated that this detail was an E detail, and not E', since it was groove welded. However, as indicated above, AASHTO presently refers to this detail as an E'. It is not entirely clear why this was classified as an E detail in the earlier report and is believed to be a mistake. However, Dr. Dexter was recognized as an expert in fatigue and detail classification and he may have felt that the classification of this detail as E' was too harsh. Regardless of the reason, it is certain that there is limited full-scale test data to support the classification of this detail as E or E' and that other factors, such as base plate thickness etc. are now recognized to play a substantial role in actual fatigue resistance of the detail and not just the type of weld used. Two research projects currently underway at the time of this report (October 2006) at the University of Texas and another at Lehigh University (NCHRP 10-70) will be conducting full-scale testing of these types of connections and will address this issue further and result in sufficient data to accurately establish the fatigue resistance of this type of connection. It is anticipated that the research may reveal that the actual fatigue resistance of base plate connections with thinner base plates (say less than 2 inch) will be less than Category E'.

However, it must be noted that the category designation of E' is based on very limited laboratory testing and most likely is unconservative due to the relatively thin tube wall and baseplate. Laboratory testing as part of upcoming NCHRP and pooled fund research projects is planned to improve the existing fatigue knowledgebase on these details.

Figure 4.1 – Stress-range histograms for strain gages located on the As-built tower

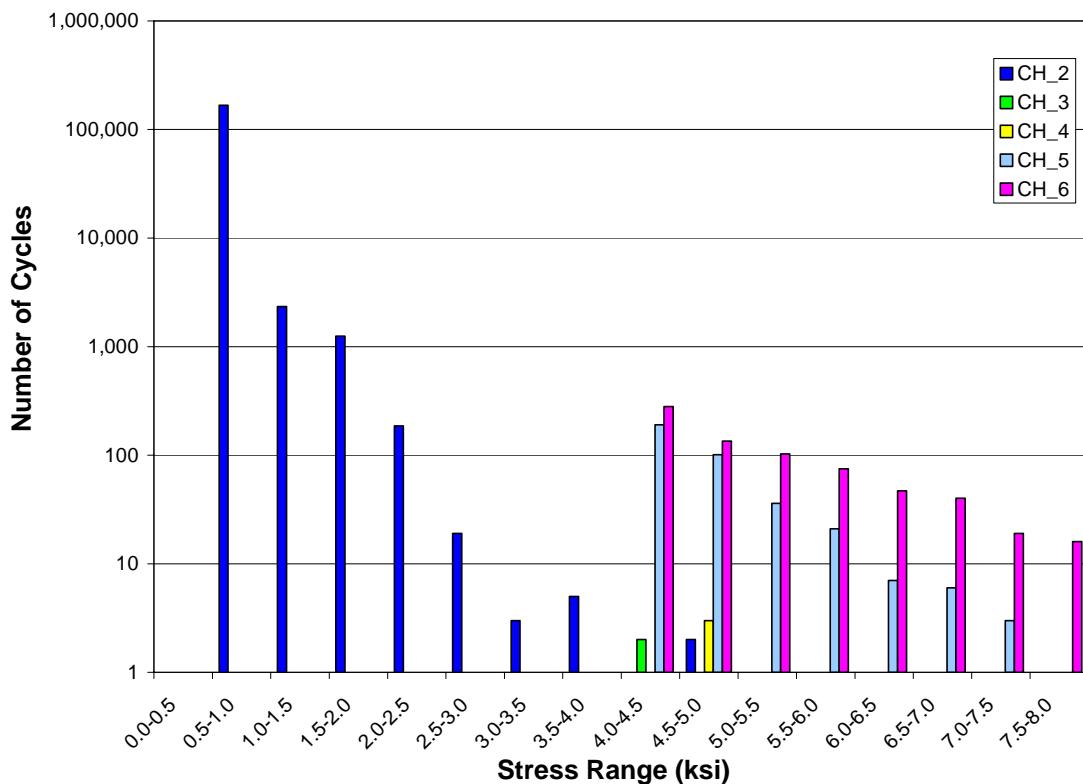
As a result, all stress cycles less than 2.5 ksi were removed from the spectrum. It can be seen from Table 4.4 that the CAFL was never exceeded and therefore infinite fatigue life can be expected on the jacket itself.

Figure 4.5 – Stress-range histograms for strain gages located on the Retrofit tower

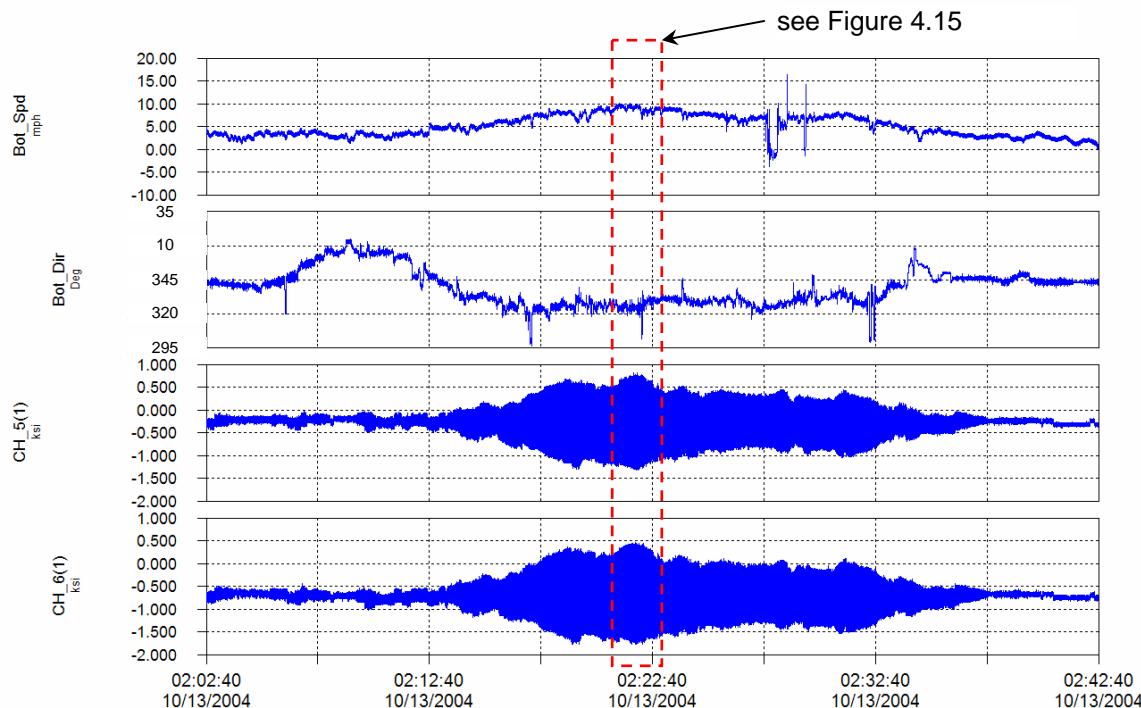
In this section the wind phenomena of vortex shedding will be examined. Good examples of vortex shedding were recorded at the Retrofit tower. Such an example is presented in Figure 4.14. Shown in the Figure is a segment of time equal to 40 minutes recorded on October 13, 2004. Four data traces are shown in the Figure, namely wind speed at the 33 foot elevation, wind direction (corrected to represent compass directions), strain gage CH_5, and strain gage CH_6. These strain gages are located on opposite sides of the tower on the tower just above the retrofit jacket. A zoomed-in segment of data indicated by the dashed box, is shown in Figure 4.15.

Figure 4.14 – Example of vortex shedding occurring in the second vibration mode (frequency = 1.32 Hz) showing response of strain gages CH_5 and CH_6

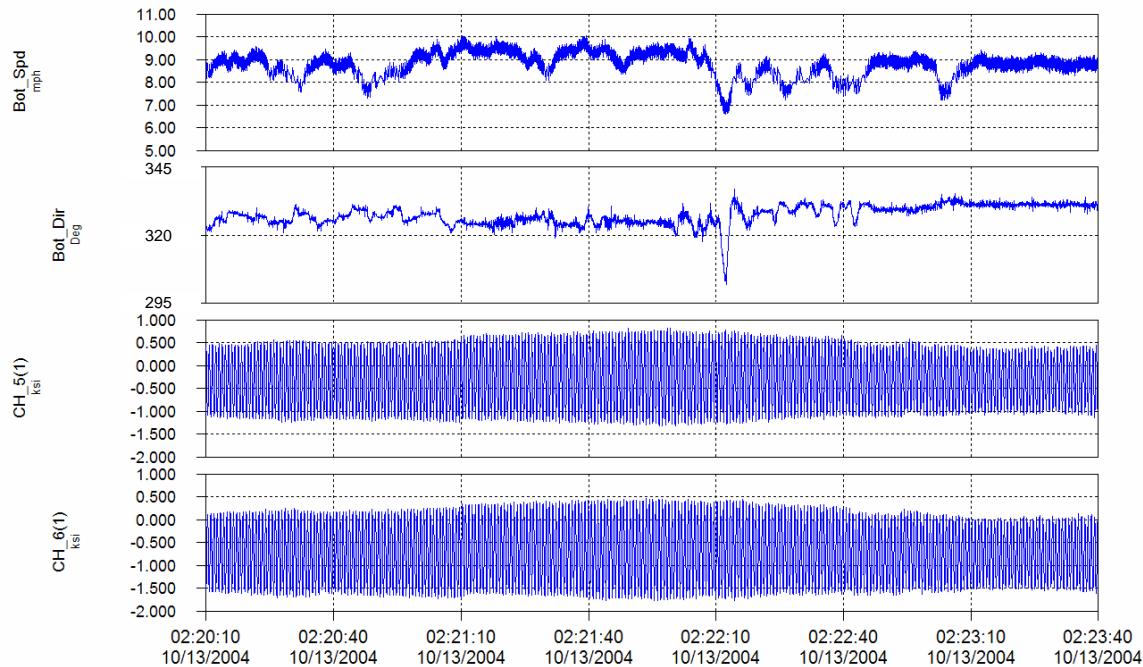
Though this stress is not excessively high, there are approximately 1300 stress cycles caused by this single event. It has been found that the 2nd mode vortex shedding is most common at these towers, but that the measured stress range is low. However, due

to the fact that the groove-welded connection at the base has poor fatigue resistance (the CAFL may be less than 2.6 ksi for E'), vortex shedding has the potential to cause a large number of damage-causing cycles.

Figure 4.15 – Detail plot of vortex shedding occurring in the second vibration mode (frequency = 1.32 Hz) showing response of strain gages CH_5 and CH_6
