# Road Safety Audit for the US 61/ Harrison Street and West Locust Street Intersection in Davenport- Scott County, Iowa

**Final Report**  
**October 2008**

**Sponsored by**  
the Iowa Department of Transportation

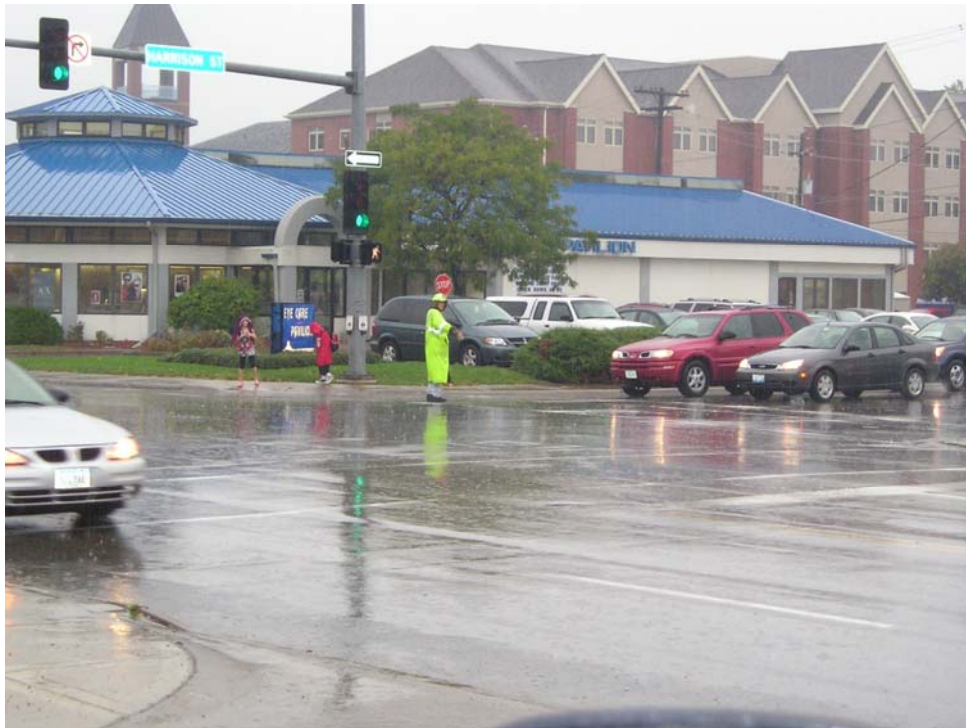
The Davenport Police Department has established a crossing guard training program for school pedestrian crossings. One of these crossings is located at the audit intersection. Shirley Hicks and Robin Nelson, who work in that department, described the details of the program. Crossing guards are trained and compensated by the police department and are made up mostly of retired persons. According to Hicks and Nelson, these guards are very conscientious and do a good job protecting the children. They are furnished with highly visible apparel for various weather conditions and are compensated for their work. A crossing guard committee has been formed that meets about five times annually to discuss the problems and concerns of the guards. Some of the recent comments include concerns for sidewalk conditions approaching this intersection and the need for right turn on red restrictions during school children commute times at one corner of the intersection. A need to repaint the crossing's pavement markings was also noted. These issues will be examined in this report during the field reviews later.

**Figure A.1. Crossing guard with school children**

At the next scheduled crossing guard meeting, consider discussing MUTCD Part 7 guidance and recommendations, especially regarding STOP paddle requirements and apparel, and consider discussing the crossing habits of junior high students.

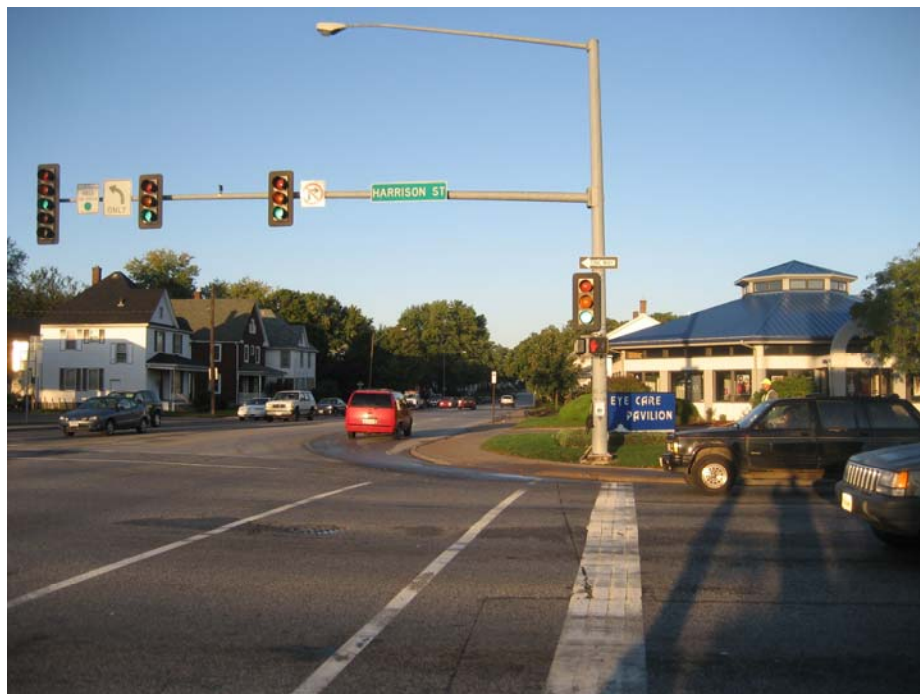
**Figure A.2. Pedestrian crossing pavement markings**

Replace existing pedestrian crossing markings, using milled-in installation to prolong service life. Additionally, install a “No Right Turn When Pedestrians Are Present” sign or similar restrictive signing for southbound Harrison Street to westbound Locust Street traffic. Consider installing count-down signals for pedestrian use.

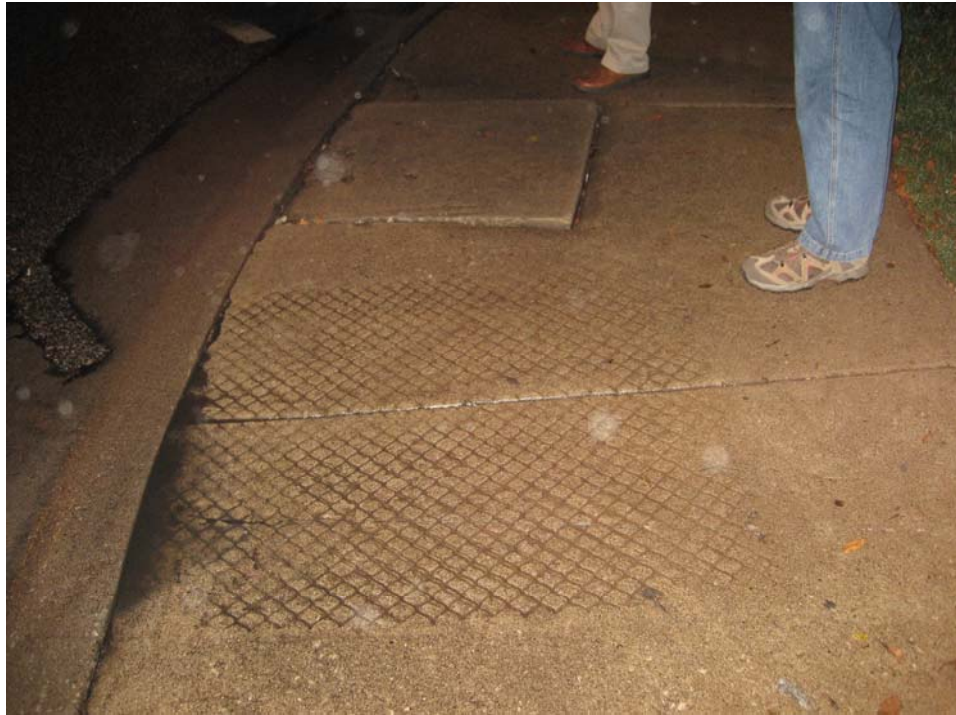
**Figure A.3. Pedestrian ramp**

Review the condition of disabled pedestrian ramps and repair or replace as needed.

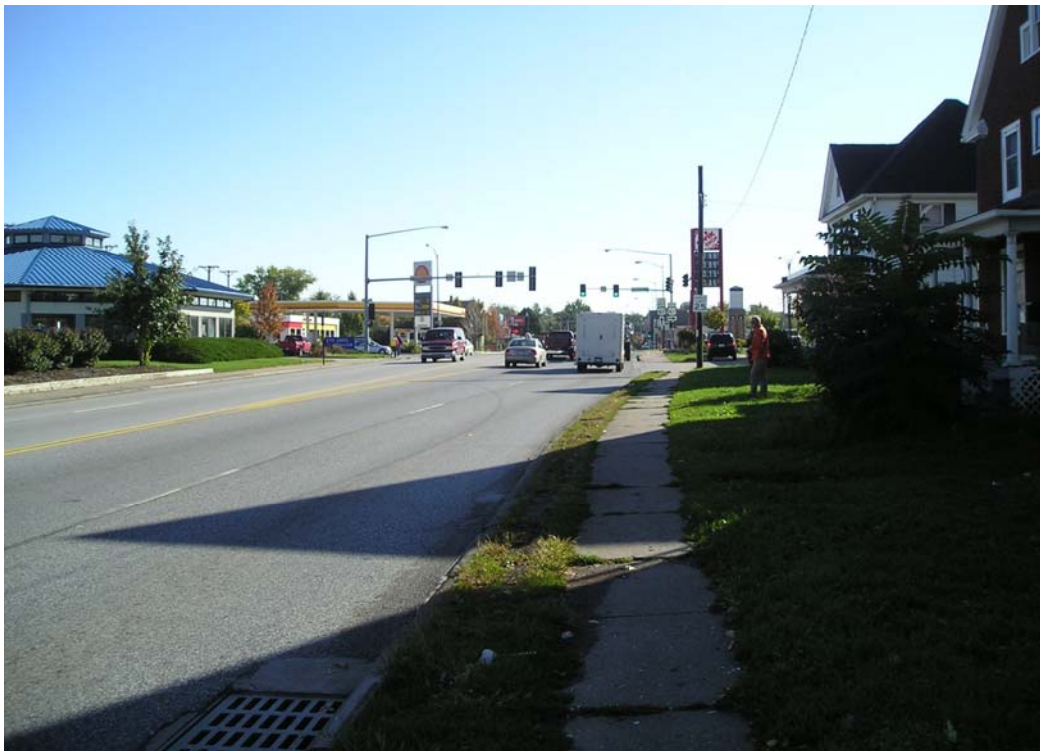
**Figure A.4. Eastbound Locust Street**

If a sufficient area can be found, consider placing a radar speed trailer on eastbound Locust Street to alert drivers and monitor the speeds of approaching traffic west of the intersection.

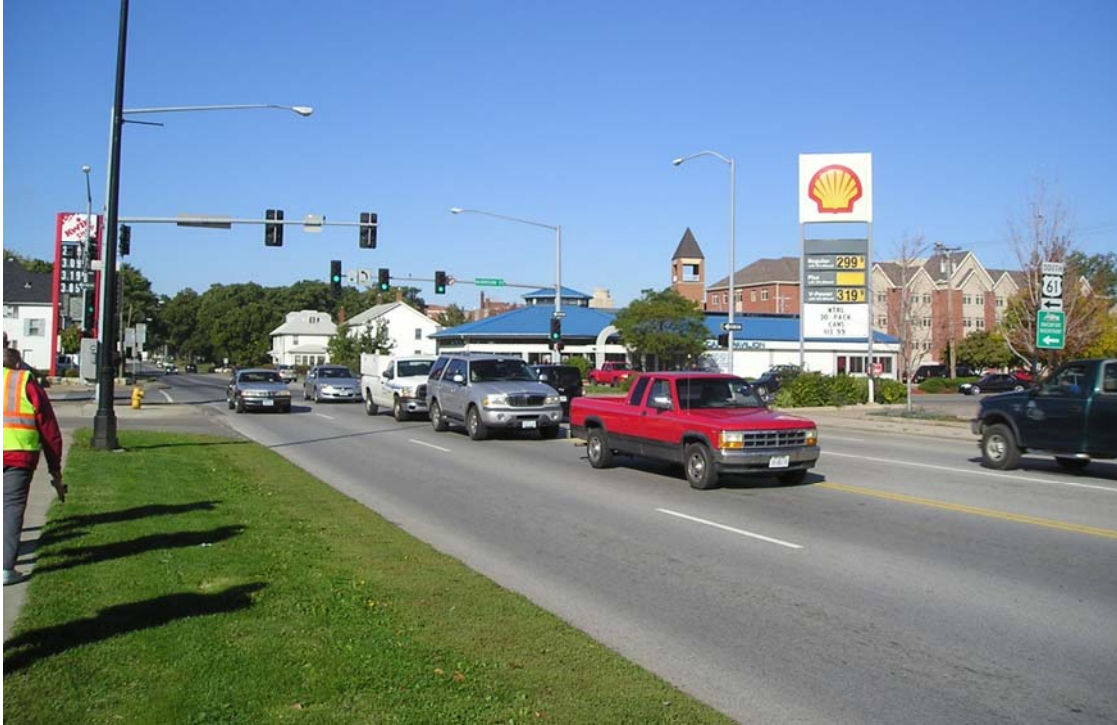
**Figure A.5. Left turning traffic on eastbound Locust Street**

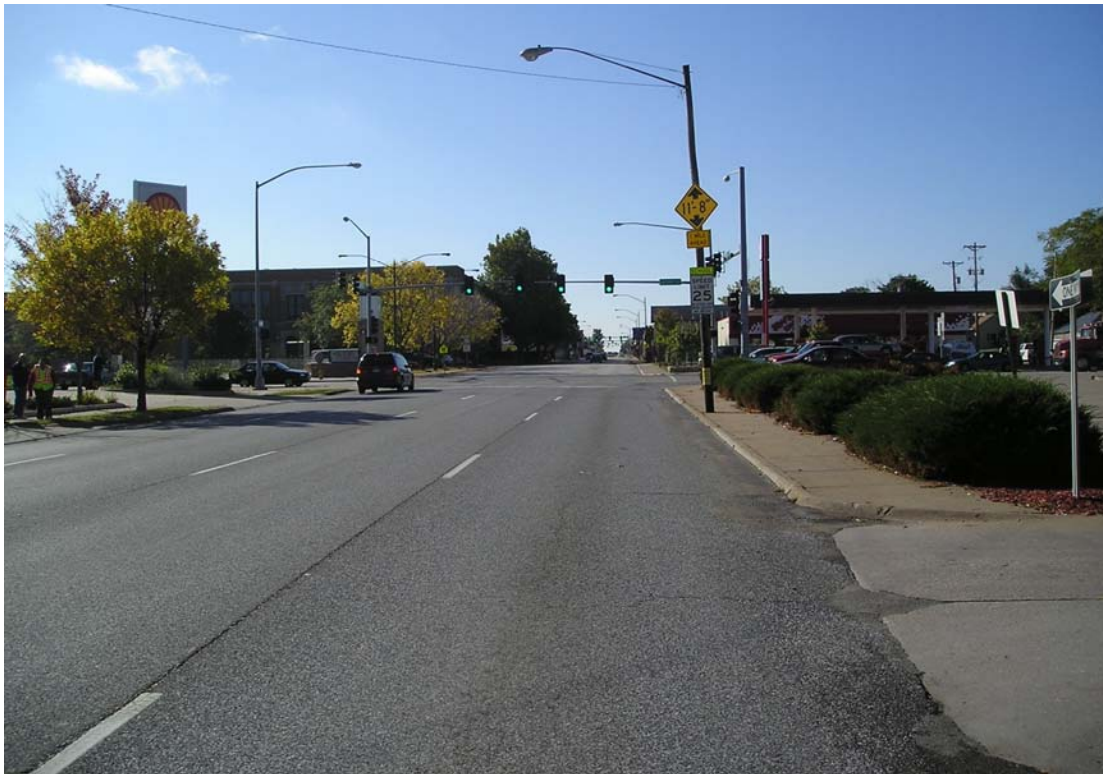
**Figure A.6. Southbound Harrison Street**

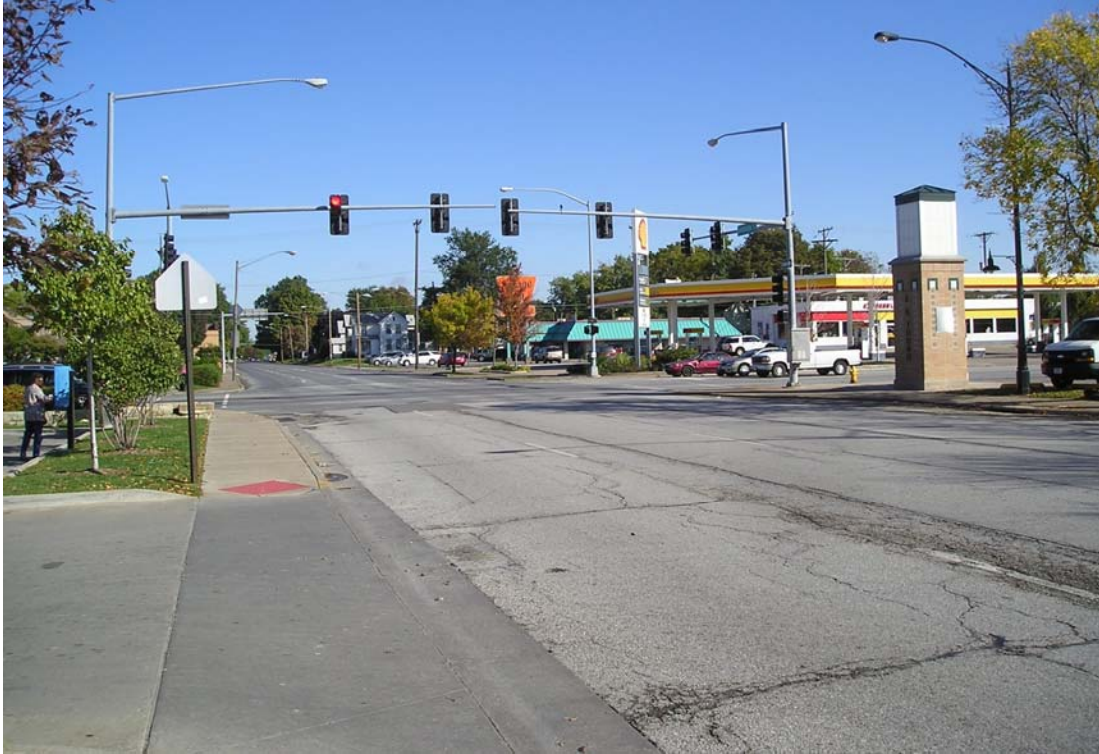
The southbound traffic signal assembly features a “tattle-tail signal” facing south to advise law enforcement officers if a signal violation has occurred. This can be effective, but it is less efficient than automated enforcement because it requires the presence of an officer to observe violations and issue citations.

**Figure A.7. Tattle-tail signal for southbound Harrison Street traffic**

When the city's automated enforcement program is recommenced, consider relocating cameras to this intersection to address red light running. Meanwhile, continue using the "tattle-tail" signal on southbound Harrison Street to mitigate signal violations for that movement.

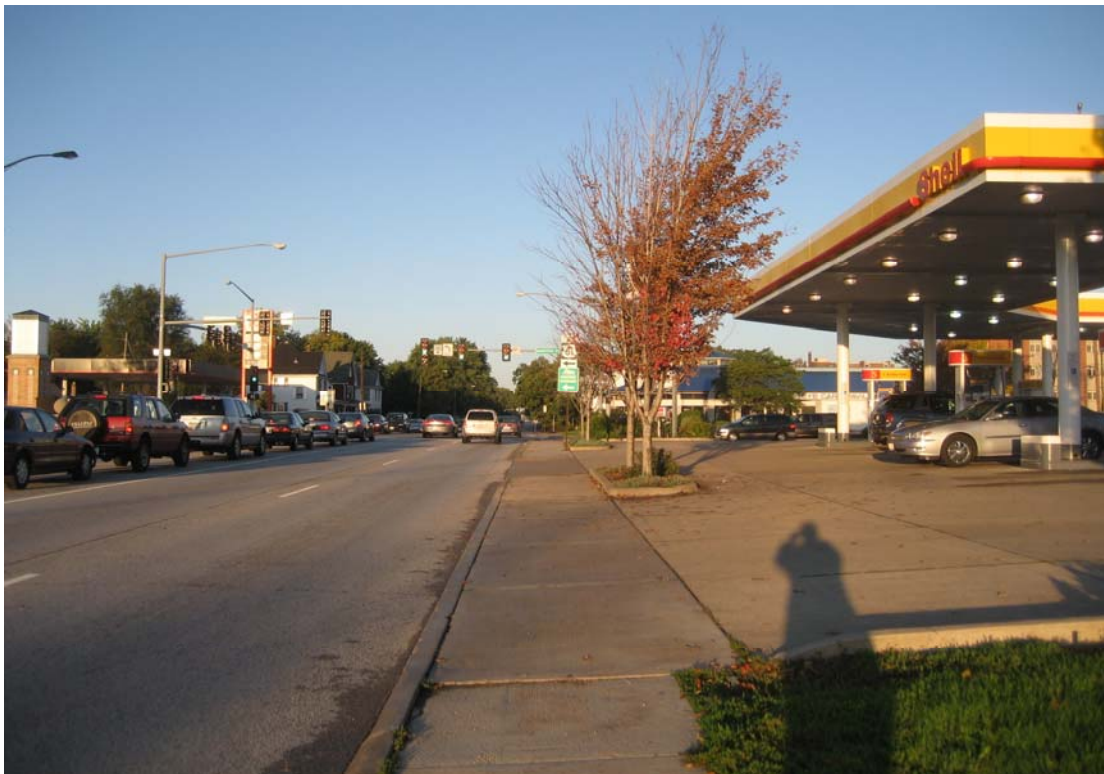
Some visibility restrictions from parked vehicles, vegetation, and a business sign were noted in the northwest corner of the intersection, but all sight restrictions were off the public right-of-way. In addition, it was noted that the visibility of the right-hand signs and signals was hampered by trees and other vegetation along westbound Locust Street approaching the intersection.

**Figure A.8. Westbound Locust Street**

Consider visiting with service station owners and other advocates about the sight restrictions caused by trees and vegetation along westbound Locust Street approaching the intersection. If possible, negotiate removal and/or trimming to improve sign and signal visibility.
