TRAFFIC SIGNAL INVENTORY PROJECT

FINAL REPORT

Sponsored by the Iowa Department of Transportation
CTRE Management Project 00-67

JUNE 2001

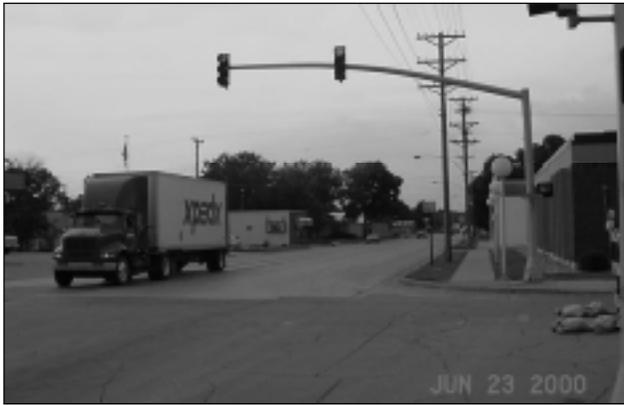
Figure 1 South Leg of Intersection 01

MUTCD: Neither of the traffic signals have backplates on any of their signal heads (see Figure 1). This is especially critical on the overhead mast arms signals on the state highway (which is an east-west street). There were no timing sheets in the cabinets.

Standard Practice: The Superior Street approaches have signal indications on the mast arms only. There are no pole-mounted signals for these approaches (see Figure 1). The Prospect Street approaches have only pole-mounted signals (no mast arms).

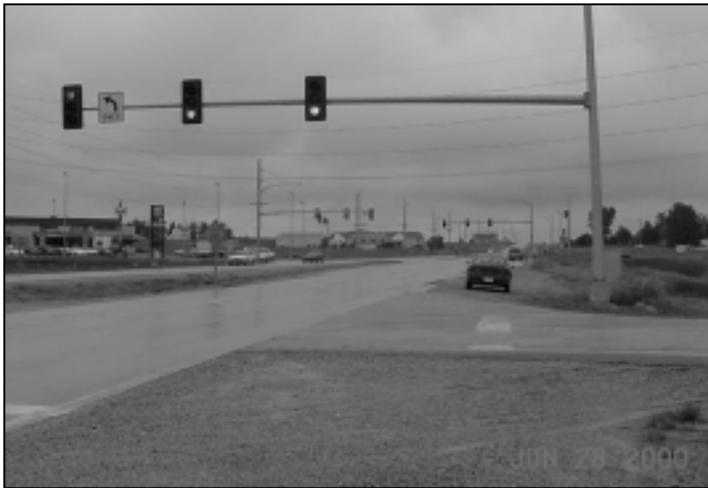
Figure 2 North Leg of Intersection 04

Standard Practice: There were not redundant left-turn signal heads for the protected left-turn phase. All signal heads are mast-arm mounted (see Figure 2).

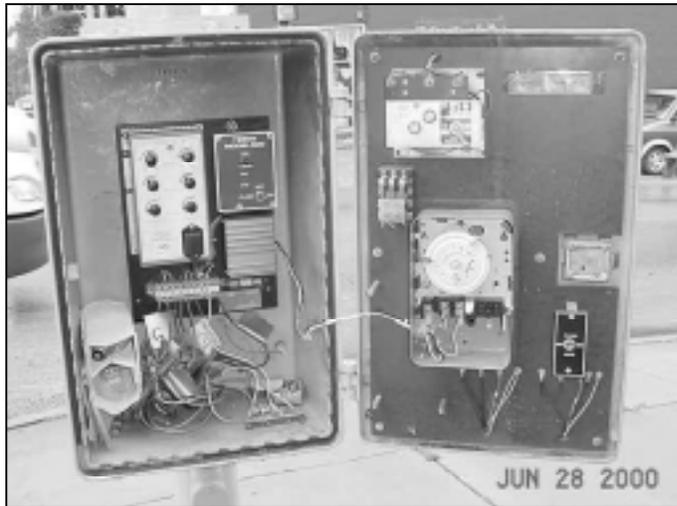
Figure 3 Controller Cabinet for Intersection 05

Operations: The controller is fairly obsolete (see Figure 3). The city may want to look at upgrading the equipment and possibly making the intersection semi- or fully actuated. In the meantime, the cycle length of 80 seconds may be able to be shortened without causing any delay at the intersection.

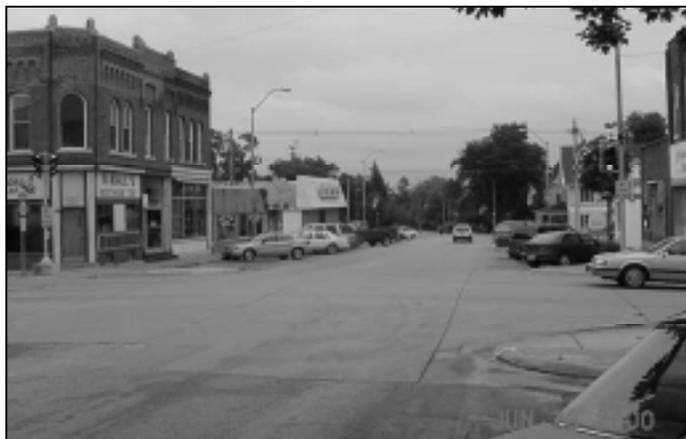
Figure 4 East Leg of Intersection 05

Standard Practice: All four approaches have only pole-mounted signals (no mast arms). As shown in Figure 4, the target values of the signals may not be optimal due to other visual clutter in the driver's field of view.

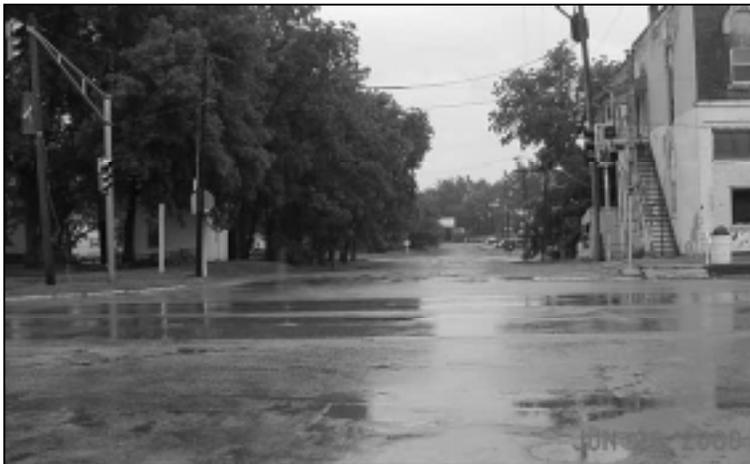
Figure 5 West Leg of Intersection 06

signal. Highway traffic has a constant green indication and side street traffic has a flashing red indication until a pedestrian button is actuated (see Figure 5). During the pedestrian movement, both highway and side street traffic face a solid red indication. The signal is controlled by an electro-mechanical controller. The dial rests at a “home” position until a pedestrian button is actuated.

MUTCD: The traffic signal does not have backplates on any of the signal heads. Nor was there a timing sheet in the cabinet. In all likelihood, the signal does not meet warrants for a pedestrian crossing. As the signal currently operates, it is not in compliance with the MUTCD.

Standard Practice: The operation at this intersection is highly unusual. The Iowa DOT should look closely at either changing the operation of the signal or removing it completely.

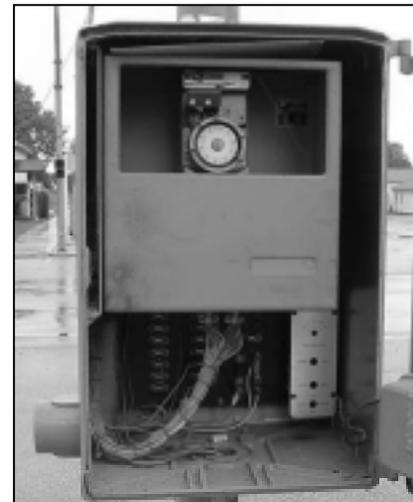
Figure 6 Controller Cabinet at Intersection 06

Operations: The controller is fairly obsolete (see Figure 6). If the signal is in fact warranted, the City may want to look at upgrading the equipment and possibly making the intersection semi- or fully actuated with three-section vehicular indications on all four approaches. For an unfamiliar driver, approaching the signal on the side street may cause some confusion.

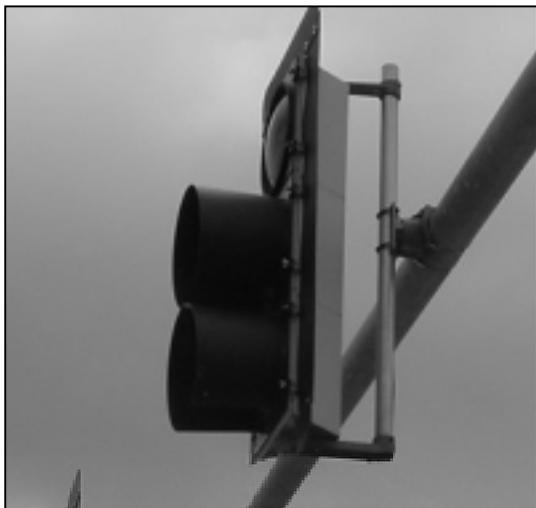
MUTCD: There was at least one vehicle indication visor missing at each of the three signals (see Figure 7) and there were numerous overhead backplates that were damaged and in need of replacement. The red clearance intervals were too short at all three intersections. The pedestrian clearance interval was too short at the East Jefferson intersection. None of the traffic signals have indications for pedestrians on all legs of the intersection.

Figure 7 Missing Visor on Mast-arm Signal at Intersection 10

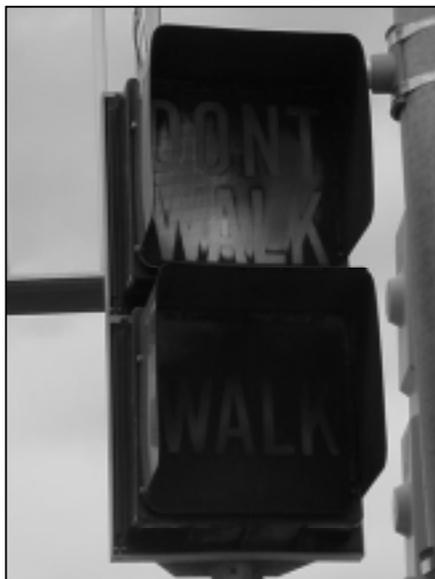
Operations: At least one “Don’t Walk” lens needs to be replaced at each of the three signals (see Figure 8). The signals do not appear to be operating in a coordinated fashion despite their close proximity to each other. The left-turn phases at the Jefferson and Franklin intersections may be unwarranted. The intersection design is fairly unusual. The west legs of both the Jefferson and Franklin intersections have angle parking in the middle of the street.

Figure 8 Don't Walk Lens at Intersection 10

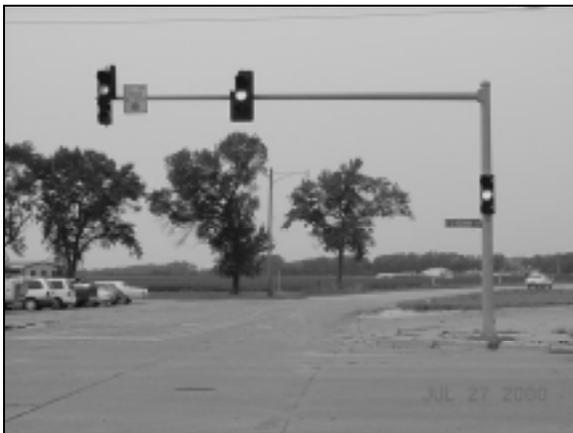
Operations: Numerous backplates at the Sheridan intersection were in need of replacement (see Figure 9). There were also many dim lights at both the Sheridan and commercial driveway intersections. All three cabinets were very dirty and needed their filters replaced (see Figure 10). Timing sheets either did not exist or were not current at all three locations. The left-turn phase at Sheridan may not be warranted.

Figure 9 Damaged Backplates at Intersection 14

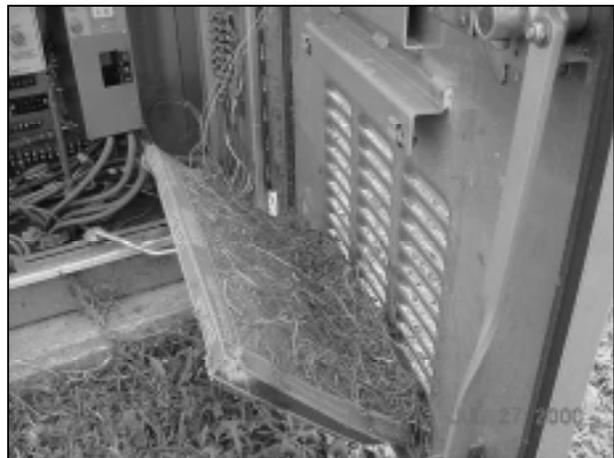
Figure 10 Dirty Filter at Intersection 14

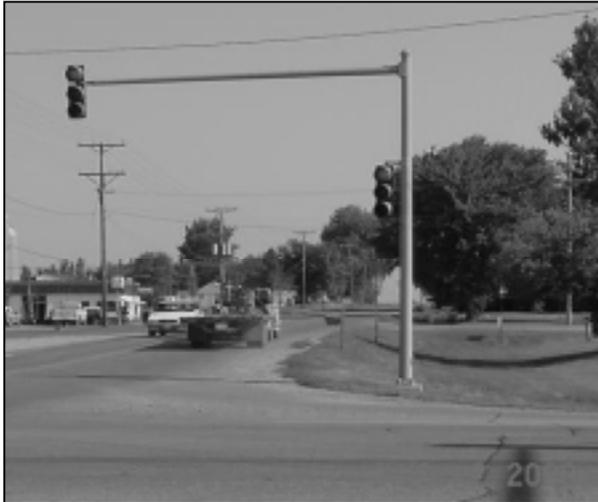
Figure 11 Missing Backplates at Intersection 17

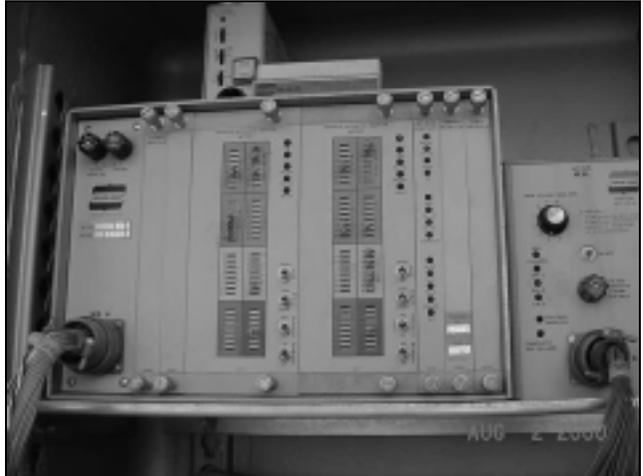
Figure 12 Controller for Intersection 17

Operations: There was no timing sheet in the cabinet. The controller is very outdated (see Figure 12). Recommend upgrading to a more state of the art controller.

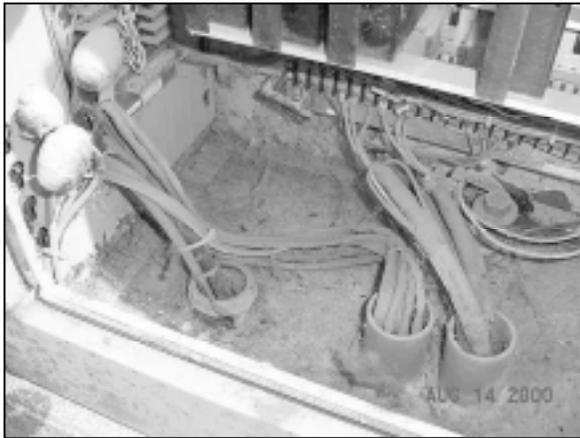
Figure 13 Dirty Cabinet at Intersection 20

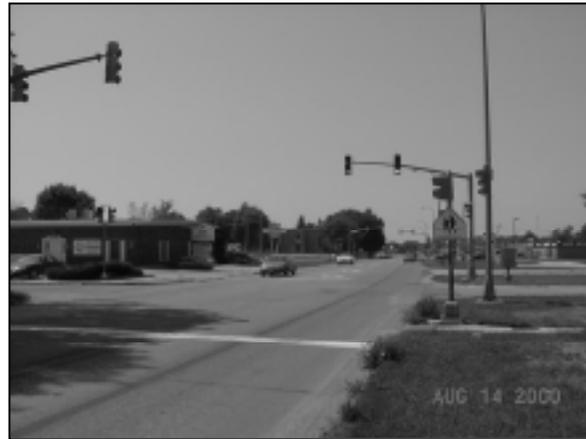
The separate left-turn phases may be unwarranted at Lakeside Drive and Lake Avenue. Crosswalks, especially those with a marked school crosswalk sign, need to be repainted at most of the intersections (see Figure 14). The phasing designations were not standard NEMA phasing.

Figure 14 Missing Crosswalks at Intersection 26

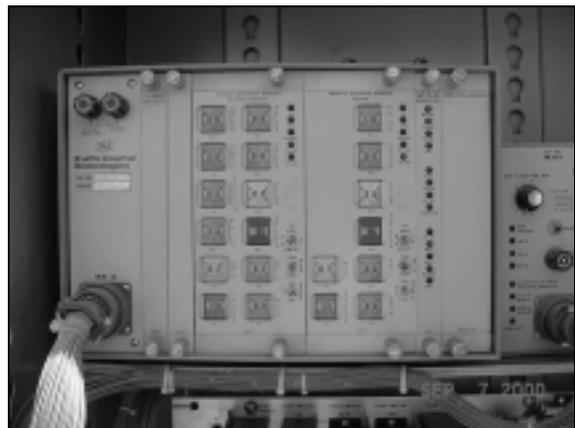
Figure 16 Controller at Intersection 33

None of the intersections had current timing sheets in the cabinet. Most cabinets were in need of cleaning. The controller at the commercial driveway is out of date and needs to be replaced (see Figure 16).
