PROTECTION OF STRUCTURAL CONCRETE SUBSTRUCTURES

IOWA HIGHWAY RESEARCH BOARD

PROJECT HR-220

CONSTRUCTION REPORT

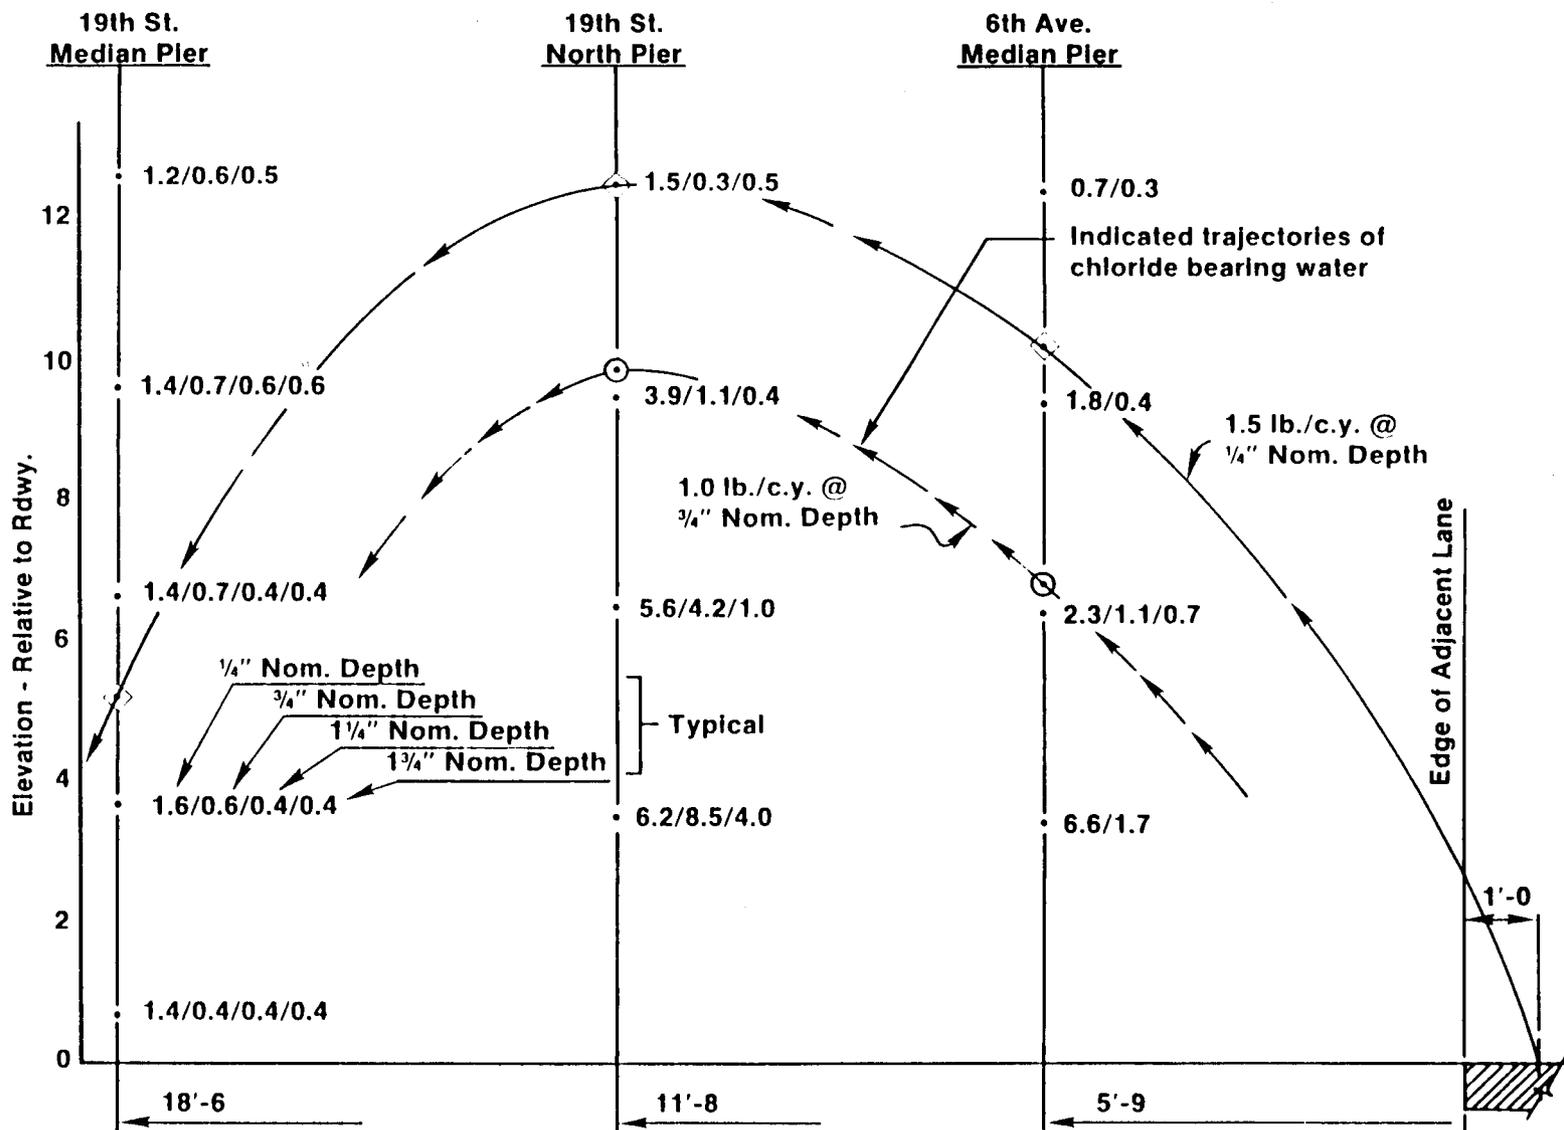
**FIGURE 1 - CHLORIDE CONTENTS
I-235 PIER COLUMNS**

From the tests of core samples taken in the I-235 corridor, there is an indication that chloride intrusion, adequate to provide an electrolyte, is not likely beyond a zone which extends to a height of approximately twelve feet above the traffic lane and horizontally to a lateral distance of approximately twenty two feet from the edge of the traffic lane. There has been insufficient testing to date to support this as a firm conclusion (Table 1 and Figure 1, Appendix A).
