NONDESTRUCTIVE EVALUATION AND ASSESSMENT OF CONCRETE BARRIERS FOR DEFECTS AND CORROSION

Final Report

November 15, 2013

WJE No. 2006.5773 (Iowa DOT, Project Number BARR-010)

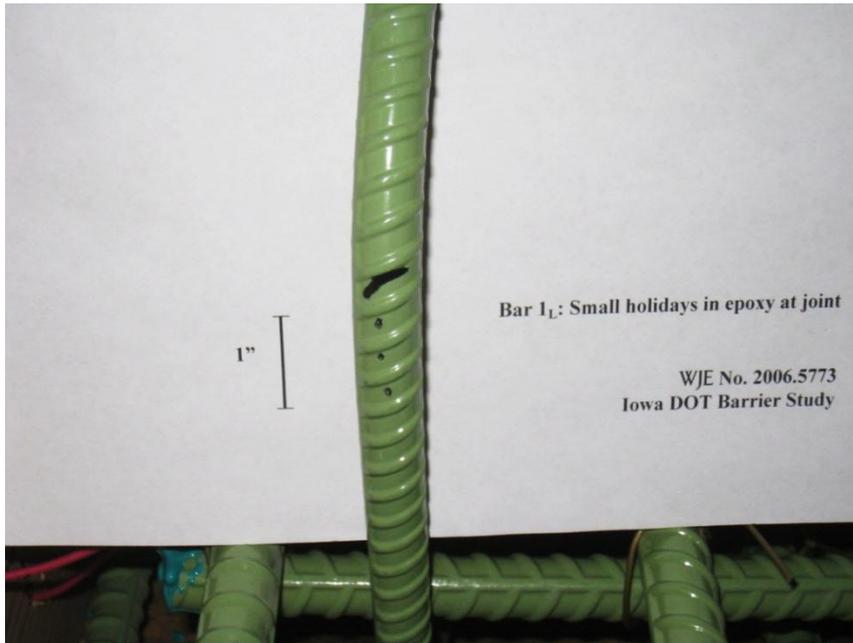
Figure 17. Defect in bar 1L - Small holidays in epoxy at construction joint.

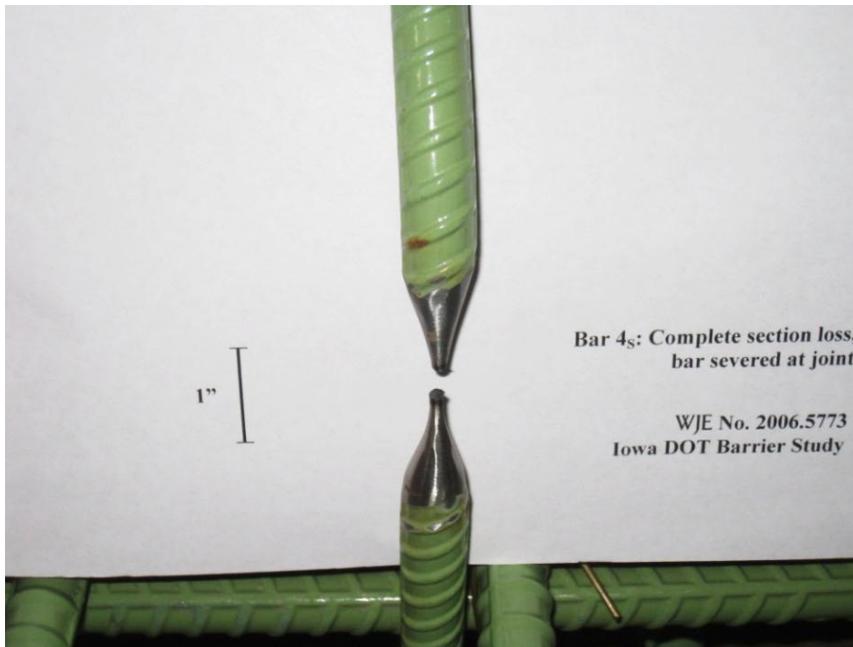
Figure 18. Defect in bar 4S - Complete section loss, bar severed at construction joint.

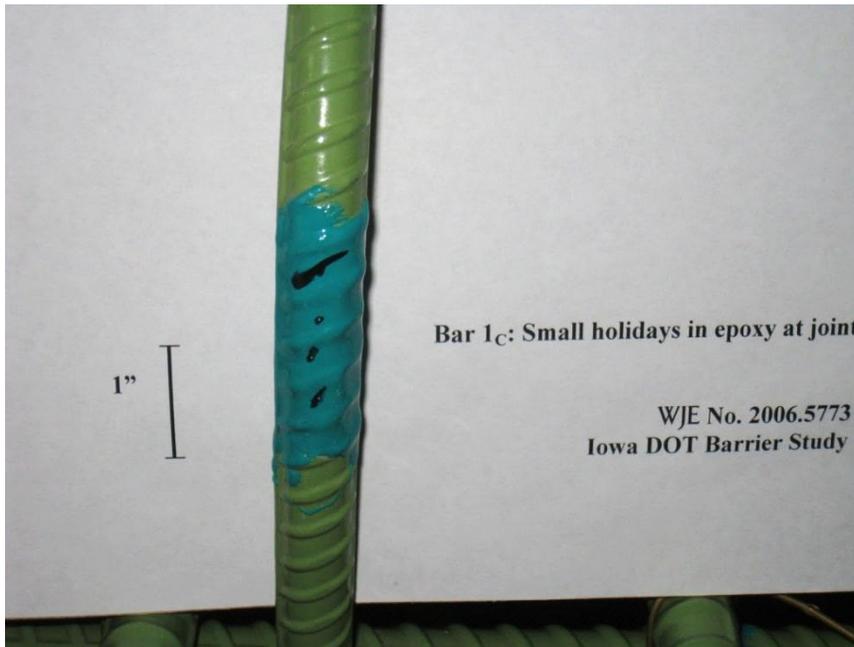
Figure 19. Defect in bar 1C - Small holidays in epoxy at construction joint.

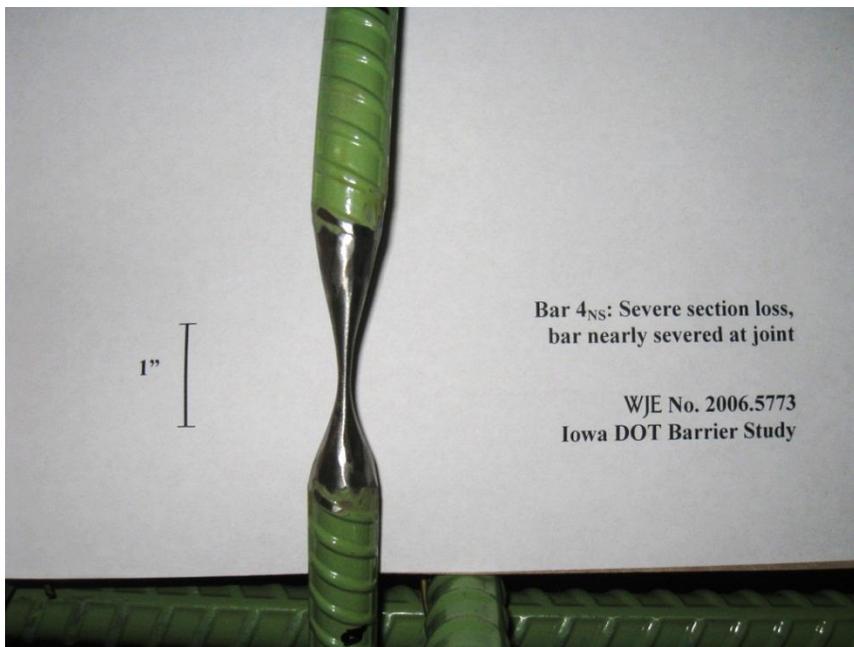
Figure 20. Defect in bar 4NS - Severe section loss, bar nearly severed at construction joint.

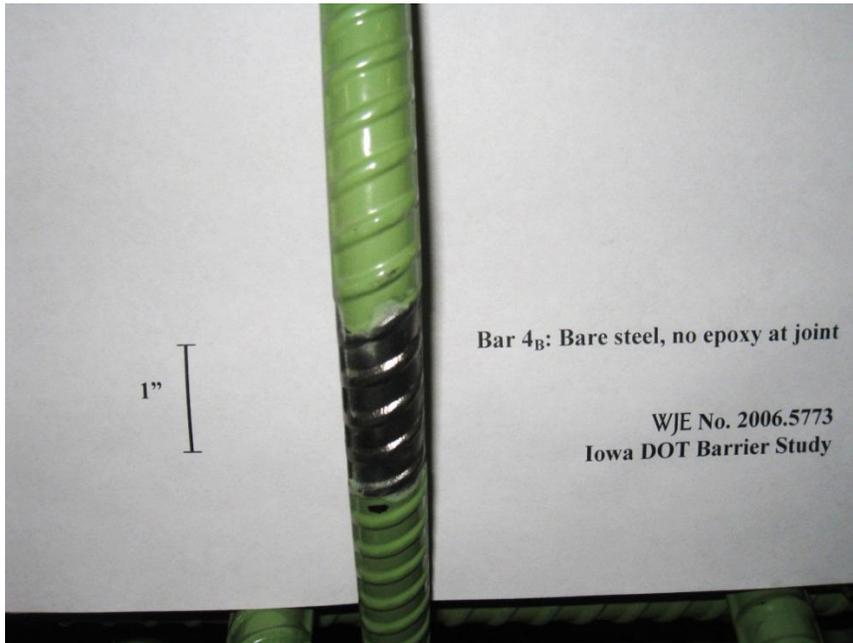
Figure 21. Defect in bar 4B - Bare steel, no epoxy at construction joint.

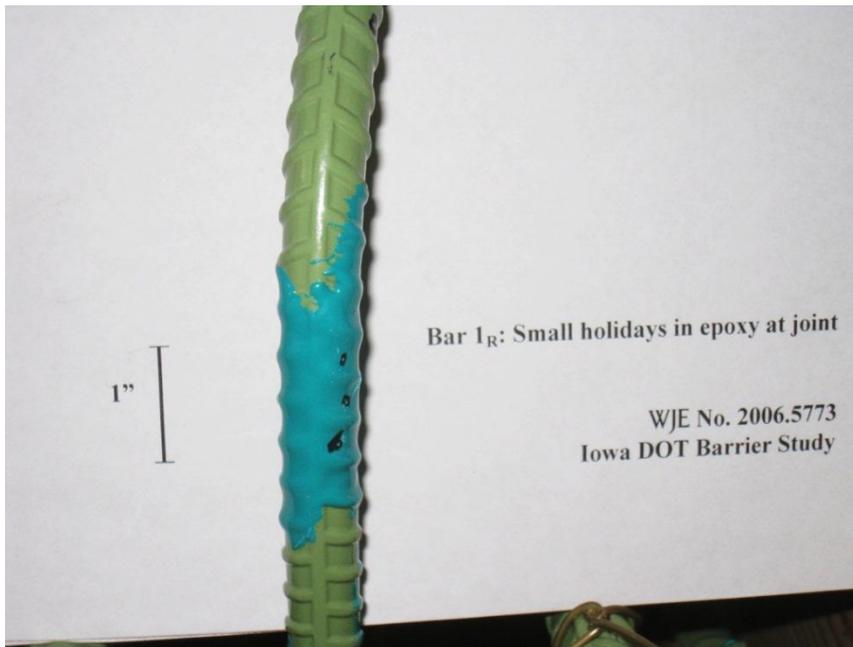
Figure 22. Defect in bar 1R - Small holidays in epoxy at construction joint.

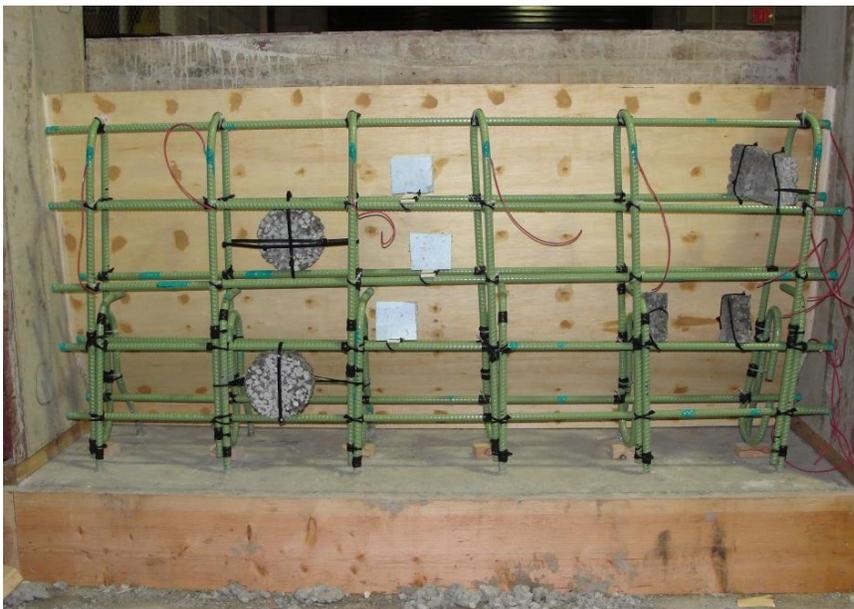
Figure 23. Barrier wall reinforcing bars and concrete internal consolidation voids and defects (view of rear face of barrier wall).

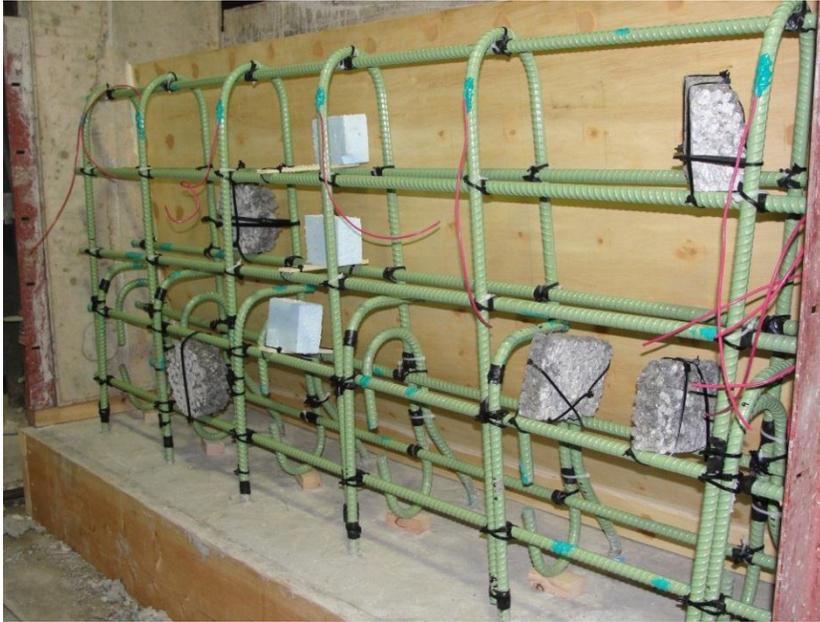
Figure 24. Barrier wall reinforcing bars and concrete internal consolidation voids and defects (angled view of rear face of barrier wall).

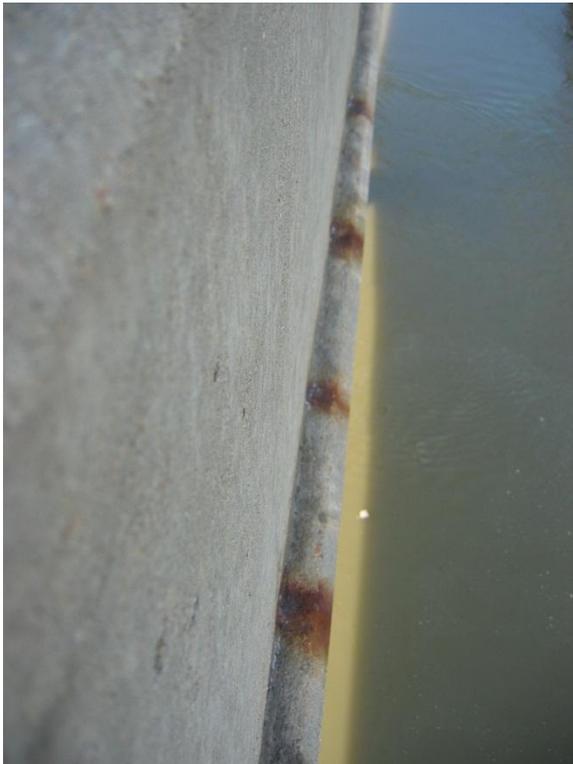
Figure 28. Indications of dowel bar corrosion on backside of barrier wall.

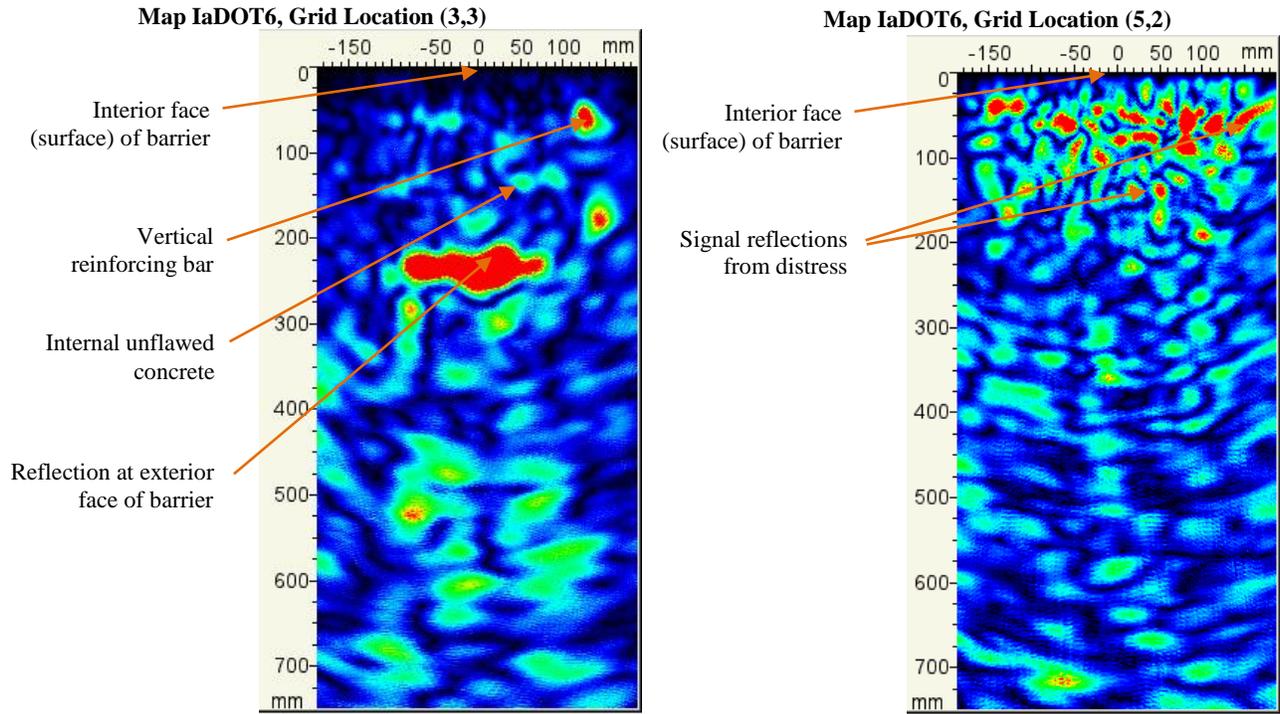
Figure 52. MIRA interior B-scan of the northbound Iowa 150 barrier wall. Left: Test result at unflawed location showing reflection from the exterior surface and embedded reinforcing Right: Test result at flawed location showing reflections resulting from cracking within barrier wall.

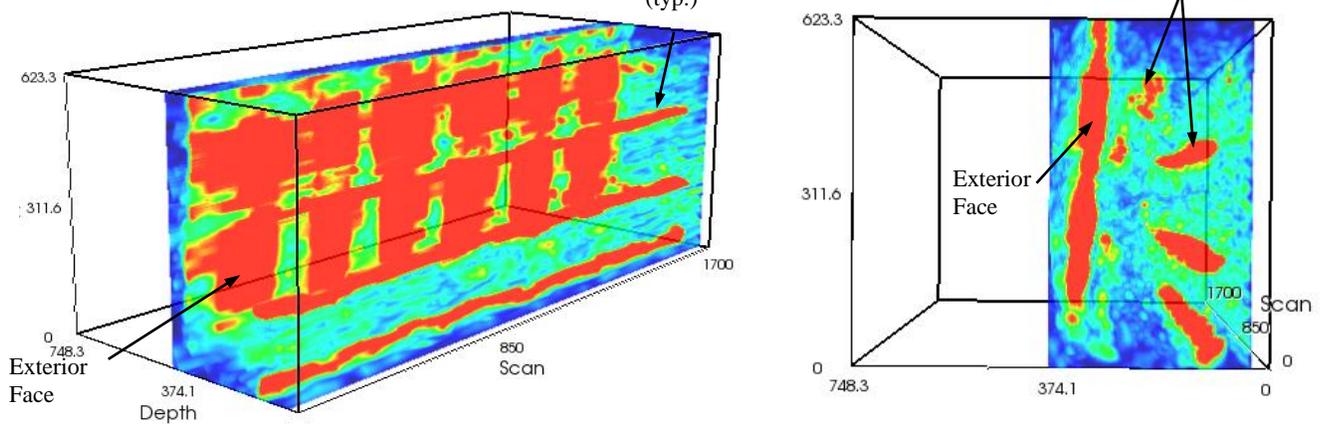
Figure 56. Grid G-2 MIRA Result: Elevation, B-scan, and sliced isometric images. Grid Location: Kickapoo Creek, east barrier, 74'-2" - 80'-0" from N end. MIRA Analysis Results: Interior and exterior reinforcing identifiable, good reflection from back surface, no internal voids observed.

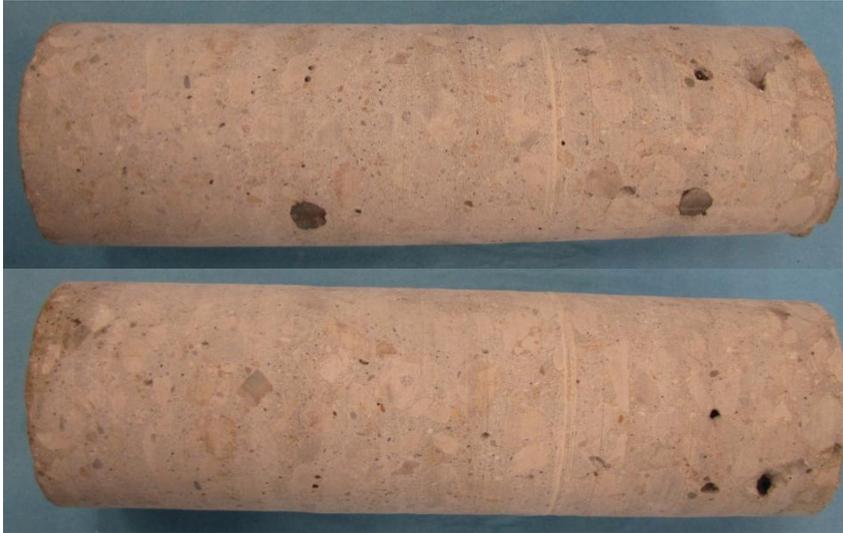
Figure 57. Core H-2. Core Location: Kickapoo Creek, east barrier, 76'-11", 8.5" from top of barrier. Observations: Well-consolidated through core, (1) isolated void (~1/2 inch diameter) near ext. face.

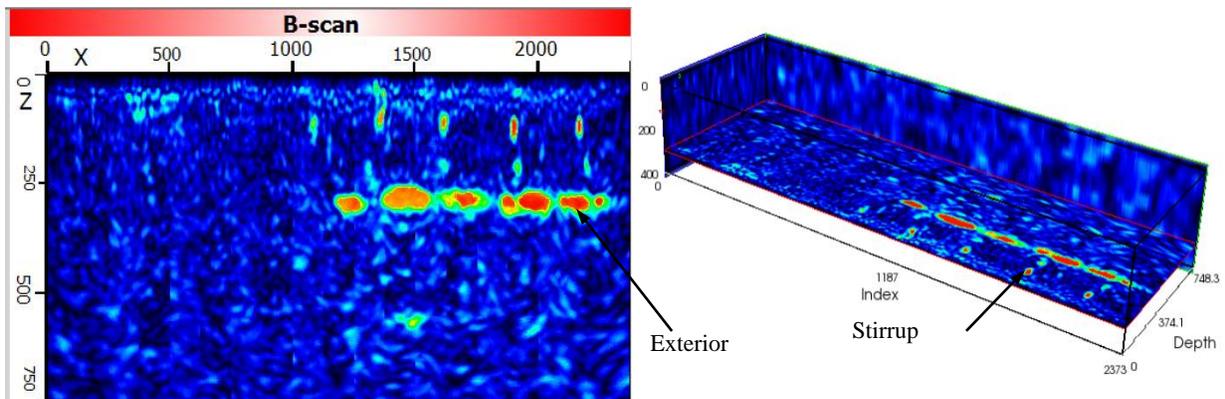
Figure 59. Grid G-2 MIRA Result: Elevation, B-scan, and sliced isometric images. Grid Location: Emden Road, south barrier, 203'-0" - 210'-6" from W end. MIRA Analysis Results: Stirrups and exterior face not identifiable on left side of grid (adjacent to areas that are visibly deteriorated). Extent of deterioration (surface and possible internal cracking) can be seen in MIRA result. MIRA result does not confirm presence of voiding around longitudinal bars.

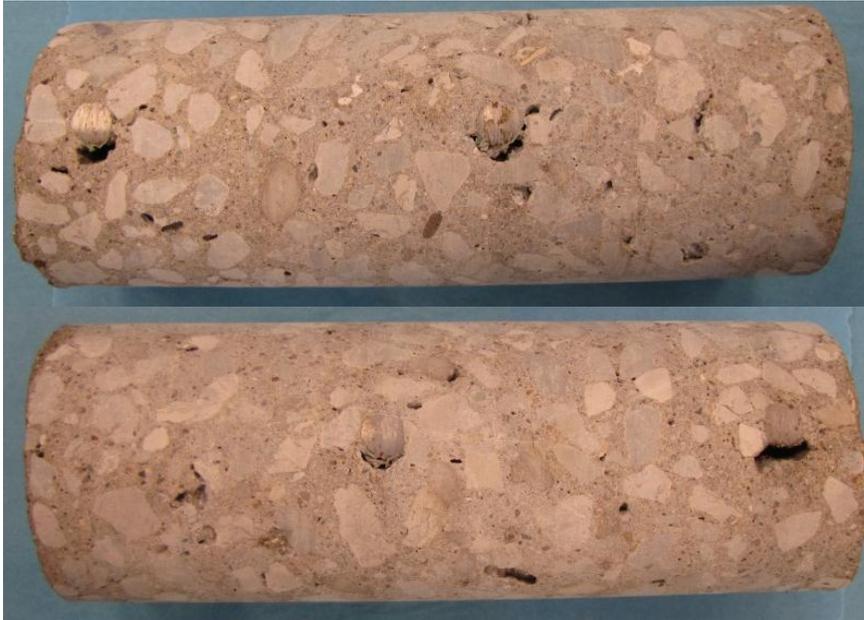
Figure 60. Core G-3. Core Location: Emden Road, south barrier, 206'-6", 5 inches from top of barrier. Observations: Moderate voiding (3/8- to 1/2-inch diameter) behind reinforcing and around aggregate

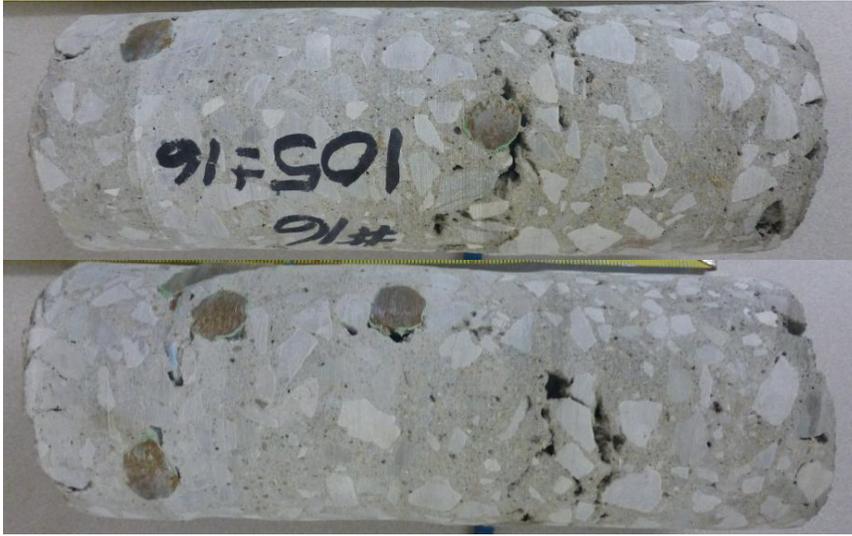
Figure 63. Core IDOT 16. Core Location: MRB Eastbound, south barrier, Sta. 105+16, 8" from top of barrier. Observations: Moderate voiding at interior reinforcing and in surrounding concrete.

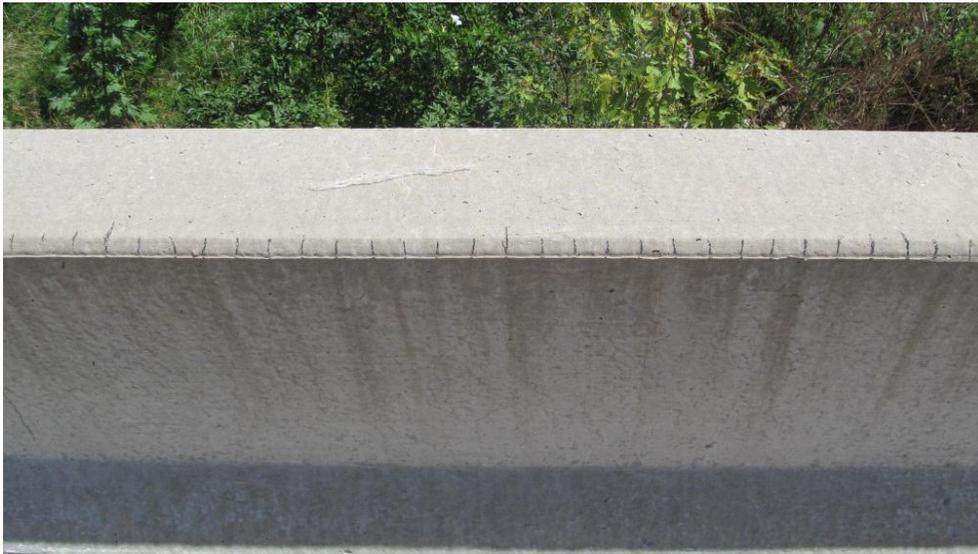
Figure 64. Photograph of longitudinal cracking at top of barrier at Grid H-3. Grid Location: Kickapoo Creek, east barrier, 214' - 220' from N end.

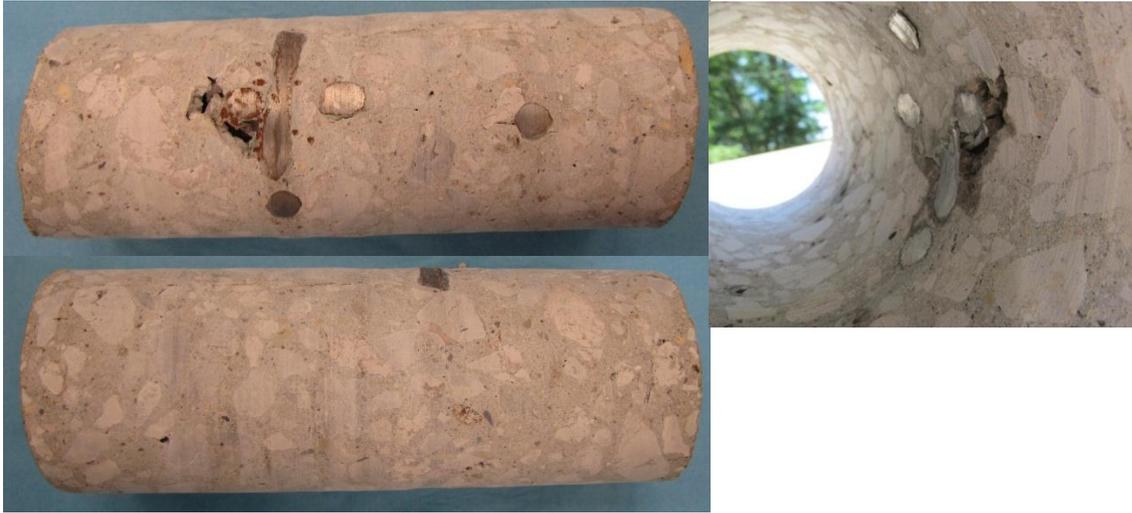
Figure 82. Core F-3. Core Location: Armitage Spur, west barrier, 42'-10" from north end, 4" from top of barrier. Observations: Well-consolidated through core, (1) void (1/4 inch diameter) adj. to ext. longitudinal bar

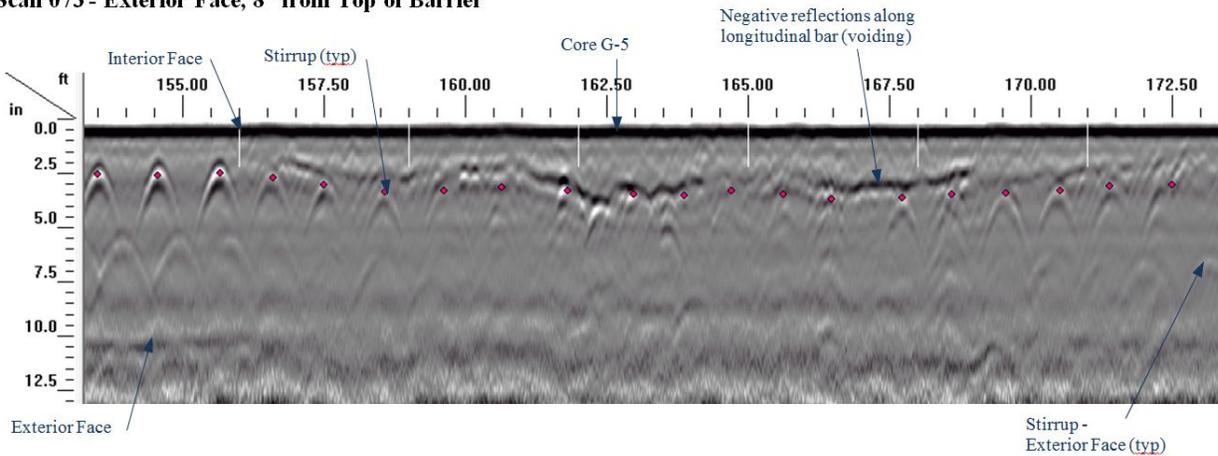
Figure 85. GPR Scan Excerpt: Scan 073 collected on Emden Road, north barrier, exterior face, 8" from top of barrier. GPR Analysis Results: Severe negative reflection along exterior longitudinal bar, wave speed affected by condition, severe voiding identified.

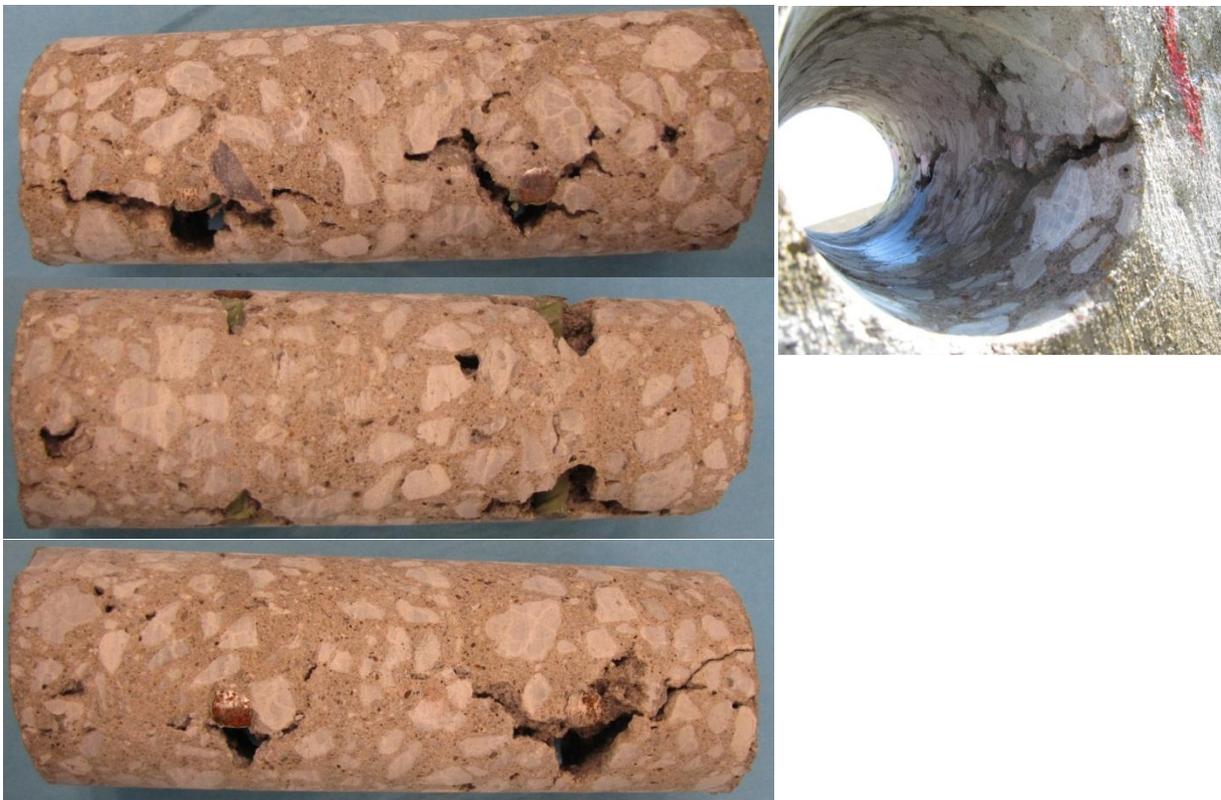
Figure 86. Core G-5. Core Location: Emden Road, north barrier, 162'-7" from north end, 4.5" from top of barrier. Observations: Severe voiding at reinforcing, separation of concrete from reinforcing in plastic state ~1 inch wide

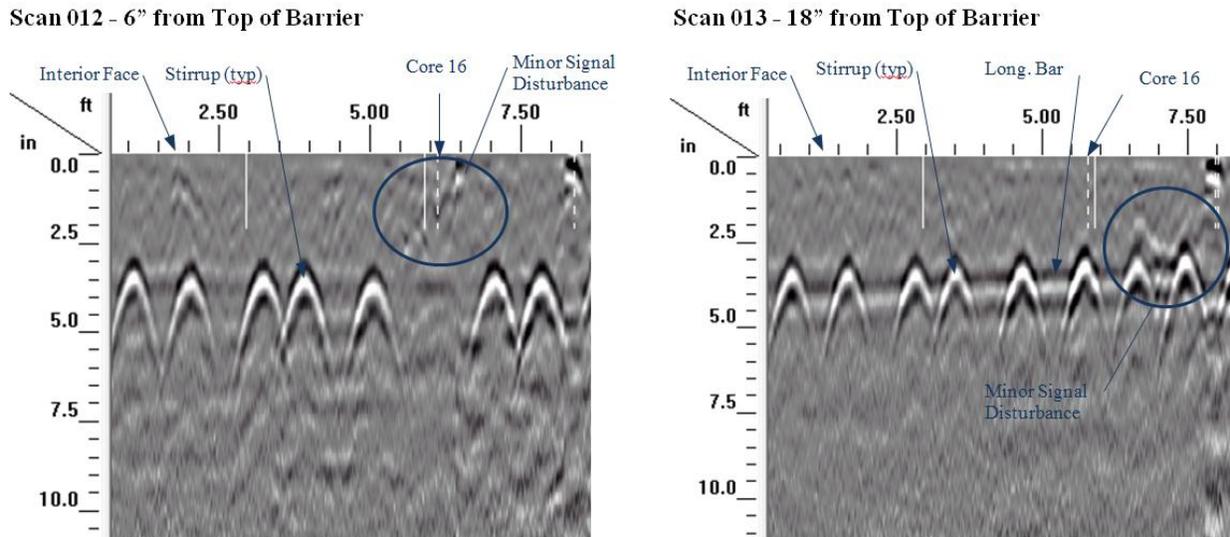
Figure 87. GPR Scan Excerpt: Scan 012, 013 collected on MRB Eastbound, south barrier, north barrier, exterior face, 8" from top of barrier. GPR Analysis Results: Minor internal signal disturbances near IDOT Core No. 16 and east of joint.

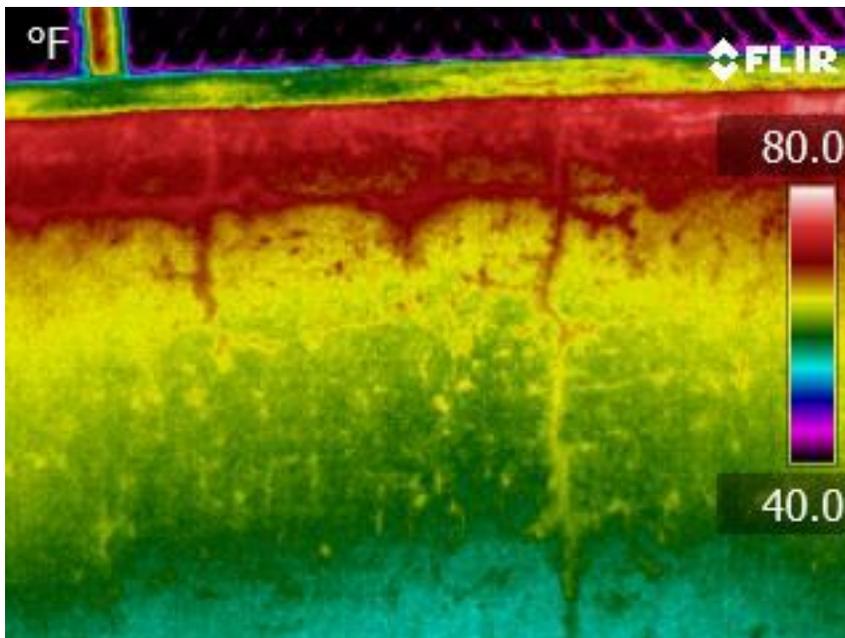
Figure 92. Close-up IR thermogram image of cracking and freeze-thaw distress collected on the northbound barrier of Iowa 150 over the Cedar River during an ambient heating cycle.
