**Evaluation of Microcracking and Chemical  
Deterioration in Concrete Pavements**

**Phase II Progress Report**

**February 28, 1995**

**Iowa DOT PROJECT HR-358  
ERI PROJECT 3711**

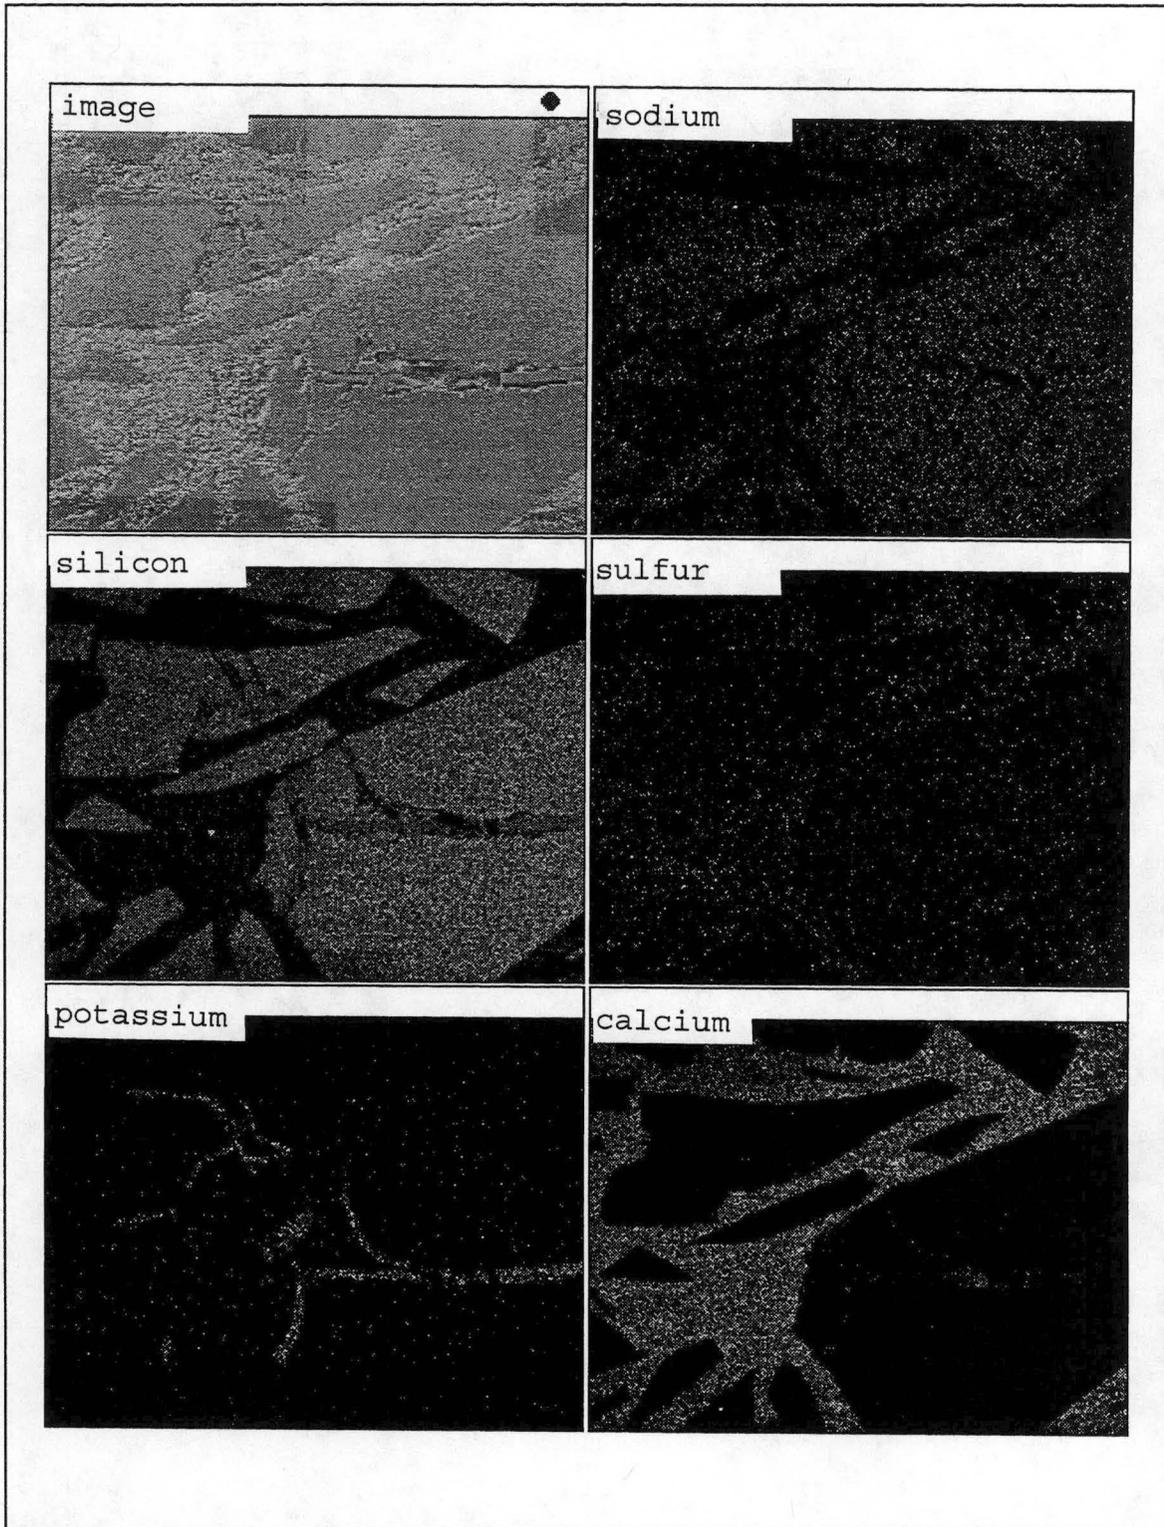
Alkali-silica related cracking is shown in Figure 9. This particular specimen contains only pyrex glass aggregate and a moderate alkali cement. Note in Figure 9, that the upper left always contains a backscattered electron image of the region that has been mapped. Backscattered electron images are sensitive to atomic number; and hence, heavier elements appear brighter. The remaining images each display an individual element (sodium, silicon, sulfur, potassium or calcium in this instance). The cracks evident in the aggregate particles, have been filled with a material enriched with potassium (note the bright areas in the potassium image, see the lower left of Figure 9). The material filling the cracks was also composed of silicon and sodium, plus only a small amount of calcium. This material fits the description of alkali-silica gel (note, that the term "alkali-silica gel" is used generically, and it commonly describes materials with a rather wide range of chemical composition). In this instance, most of the gel has remained within the boundary of the aggregate particle. This information indicates that the documentation of alkali-silica gel can be directly related to the observation of alkalis, plus the proper associated elements, in the cracked aggregates. Quantification of the chemical composition of the gel is currently being studied.

Figure 9. Digital image and X-ray map (magnification =100X) of a mortar bar specimen containing pyrex glass aggregate. Note how cracks mimic the bright areas in the potassium map.

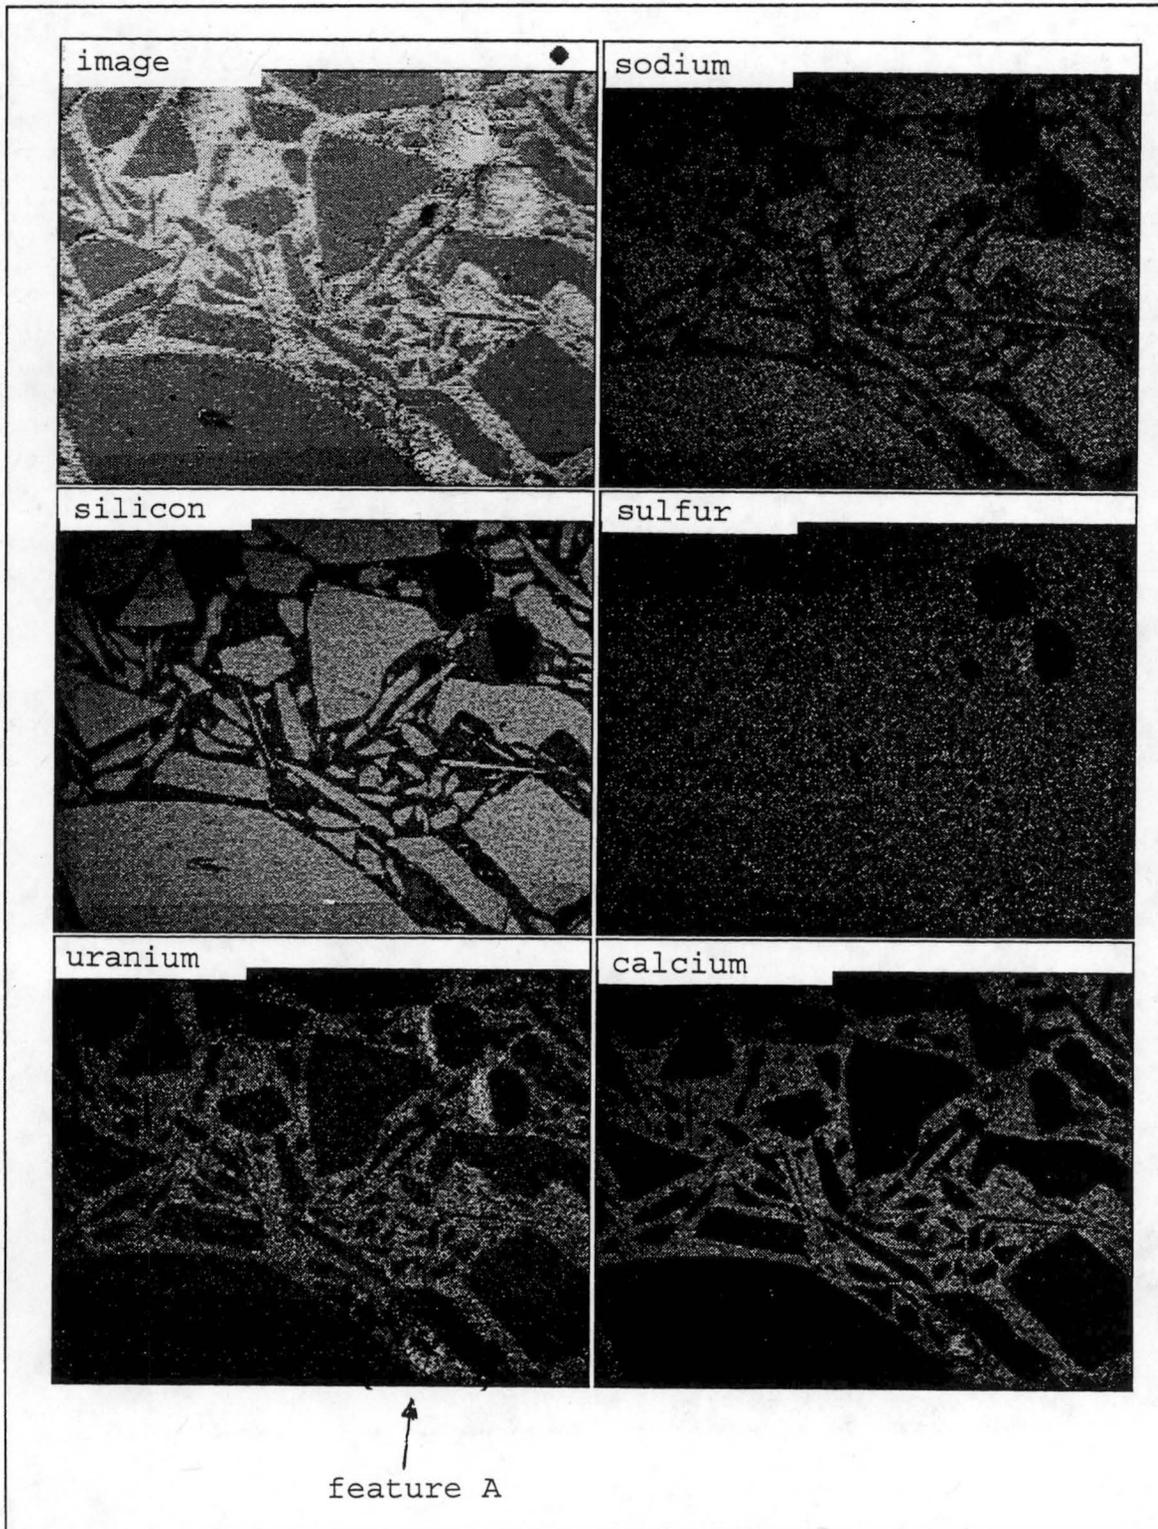
Field studies often make use of the uranyl acetate fluorescence method to obtain preliminary identification of alkali-silica gel [12]. This technique was evaluated to see if it would simplify the routine identification of alkali-silica gel during SEM analysis. Hence, mortar bar specimens containing pyrex glass, moderate alkali cement and 22.5% Council Bluffs fly ash were treated with uranyl acetate as described in reference 12. Figures 10, 11 and 12 illustrate the results of the experiment. At low magnification (30X), the treatment appears to tag several features (see the uranium map in the lower left of Figure 10, note that uranium makes the features brighter because it is a heavy element). Increasing the magnification to 250X (see Figure 11), reveals some alkali-silica gel between two adjacent aggregate particles. The gel exhibits cracking (? due to drying) and contains the appropriate elements. However, the treatment also tended to tag air voids (see Figure 10) and often failed to tag the gel present in the cracked aggregate particles (see Figure 12). Hence, the method requires considerable refinement before it can be used routinely in this research project. This study has also raised a fundamental question

Figure 10. Digital image and X-ray map (magnification =30X) of a mortar bar specimen containing pyrex glass aggregate. This specimen was treated with uranyl acetate to enhance the ASR gel (note the bright regions on the uranium map).

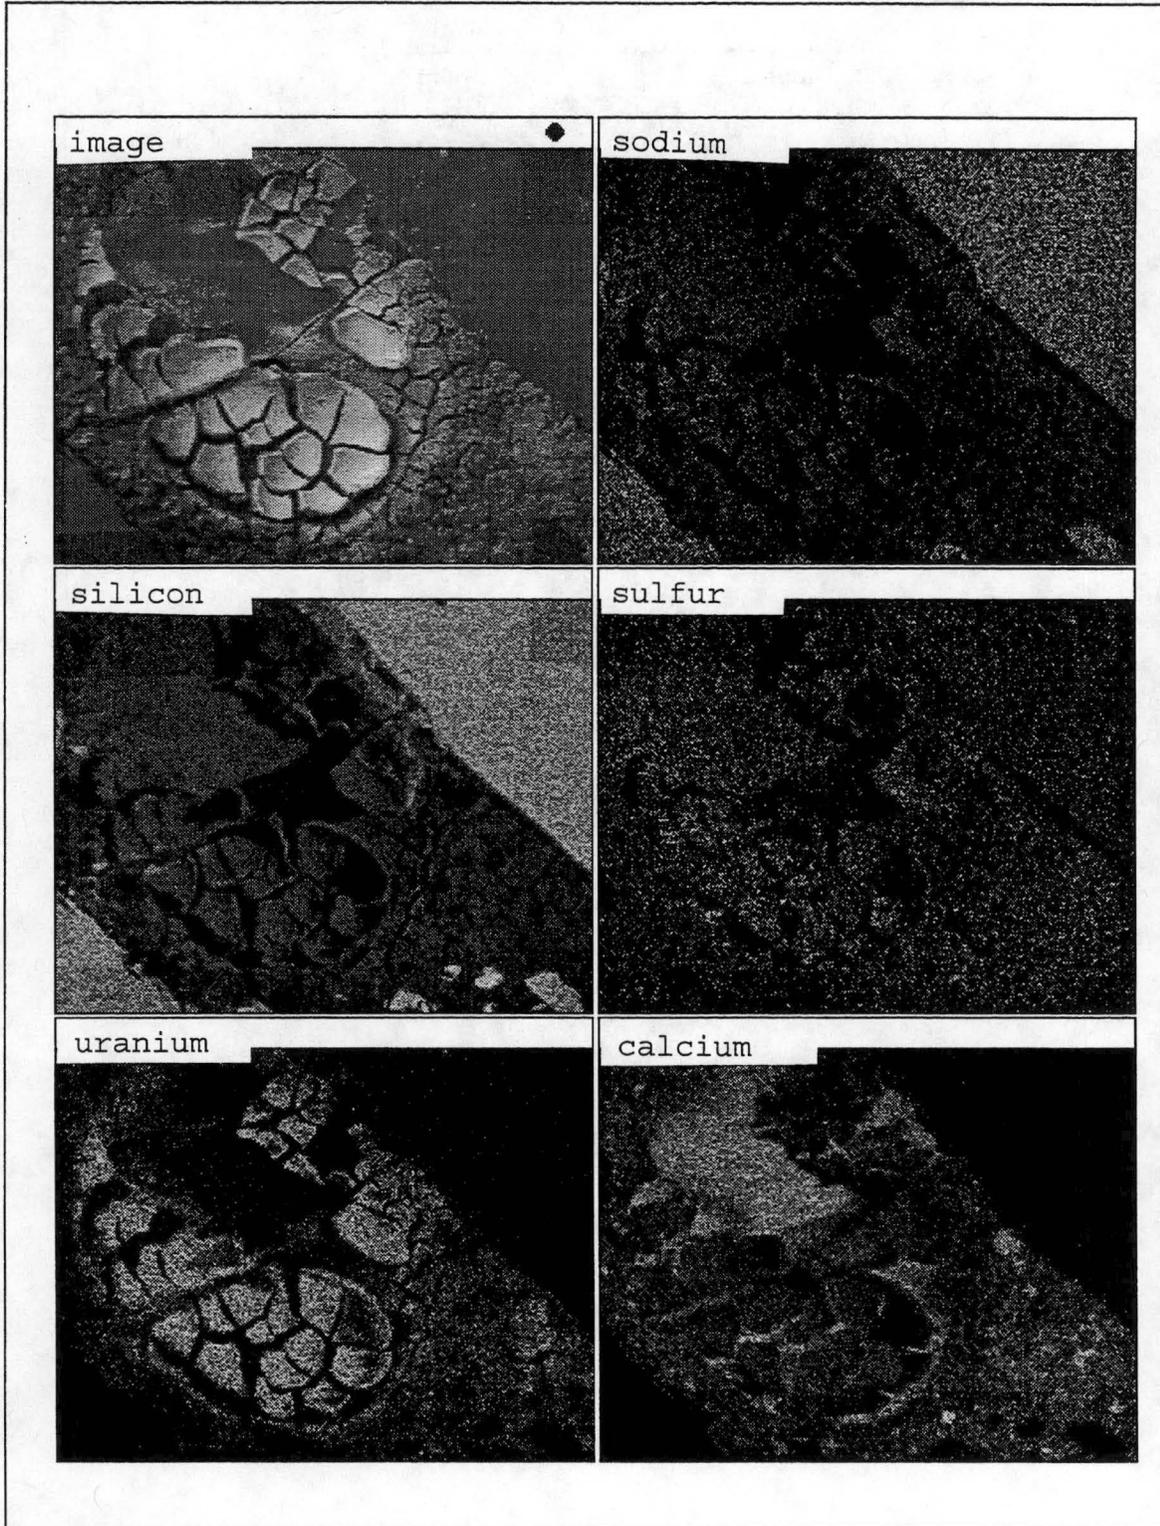
Figure 11. Digital image and X-ray map (magnification =250X) of feature A in Figure 10. This feature is ASR gel between two aggregate particles.

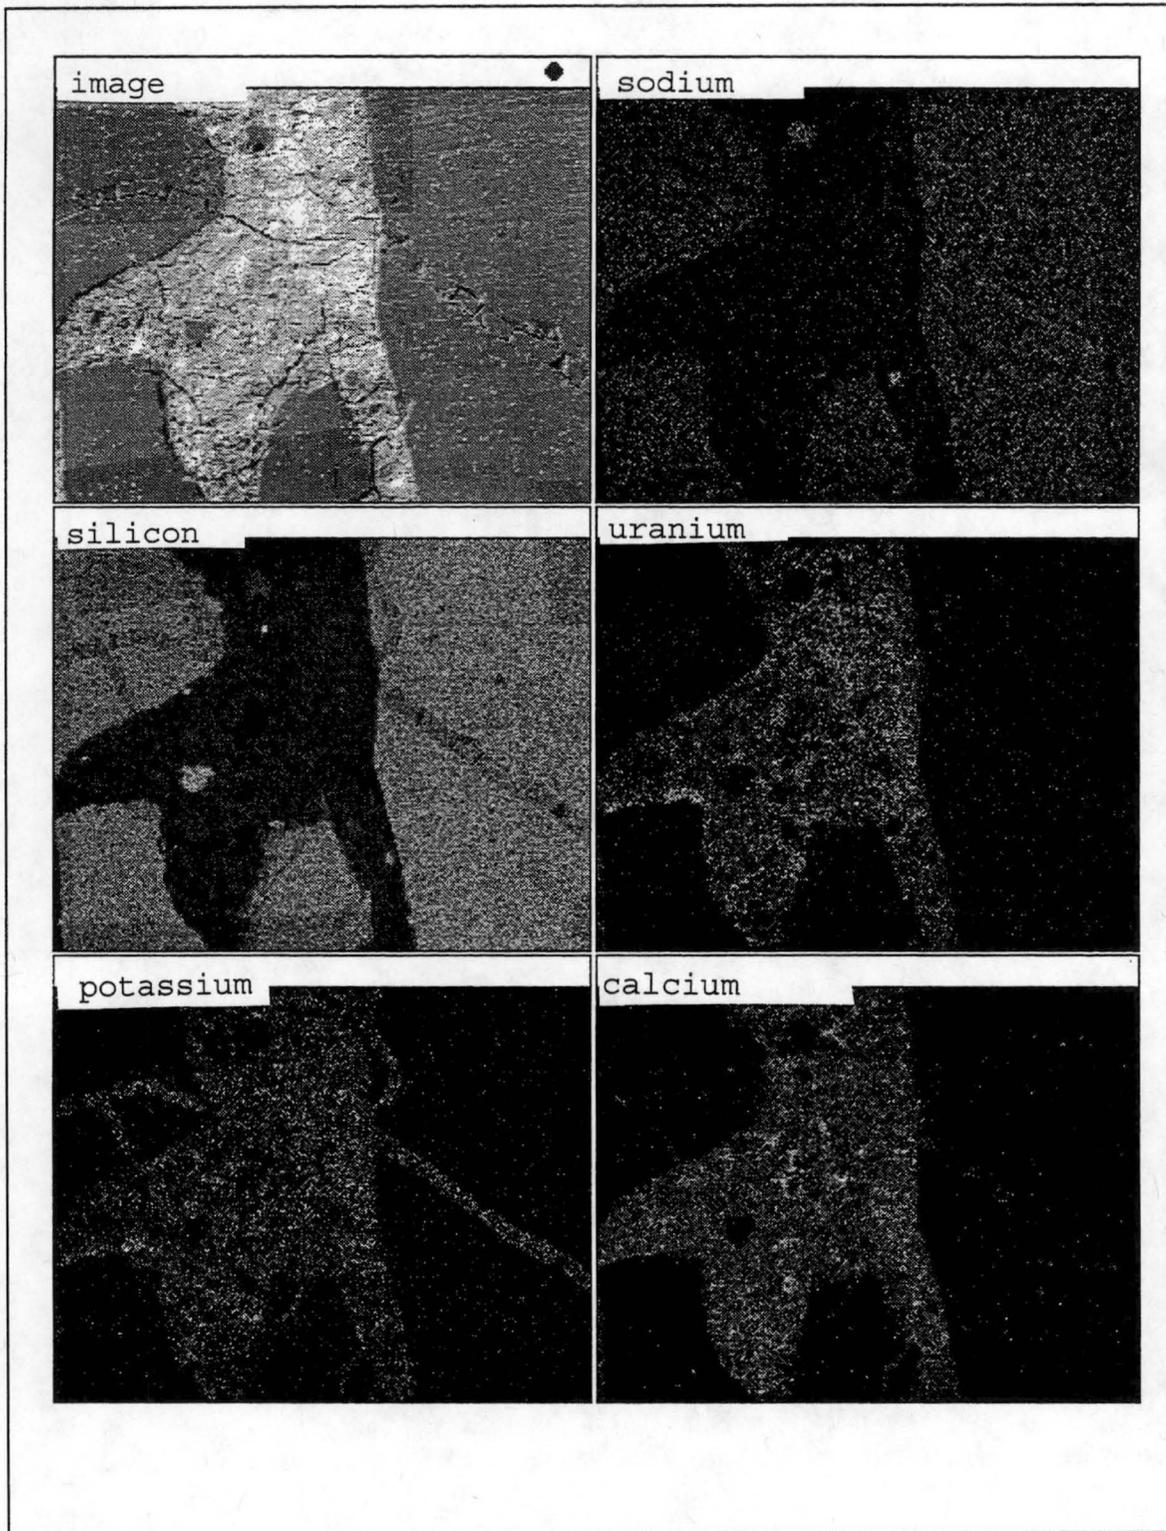
Figure 12. Digital image and X-ray map (magnification =250X) of another region of the specimen described in Figure 10. Note how the uranium map fails to reveal the cracks in the aggregate that are filled with alkali-silica gel (compare to the potassium image).

concerning the mechanism by which the gel is tagged (i.e., "the uranyl ion substitutes for alkali in the gel" [12]). Why is the uranium content so high in the paste fraction and nearly absent in the gel-filled cracks of the aggregate particles? Research is needed to answer this question.

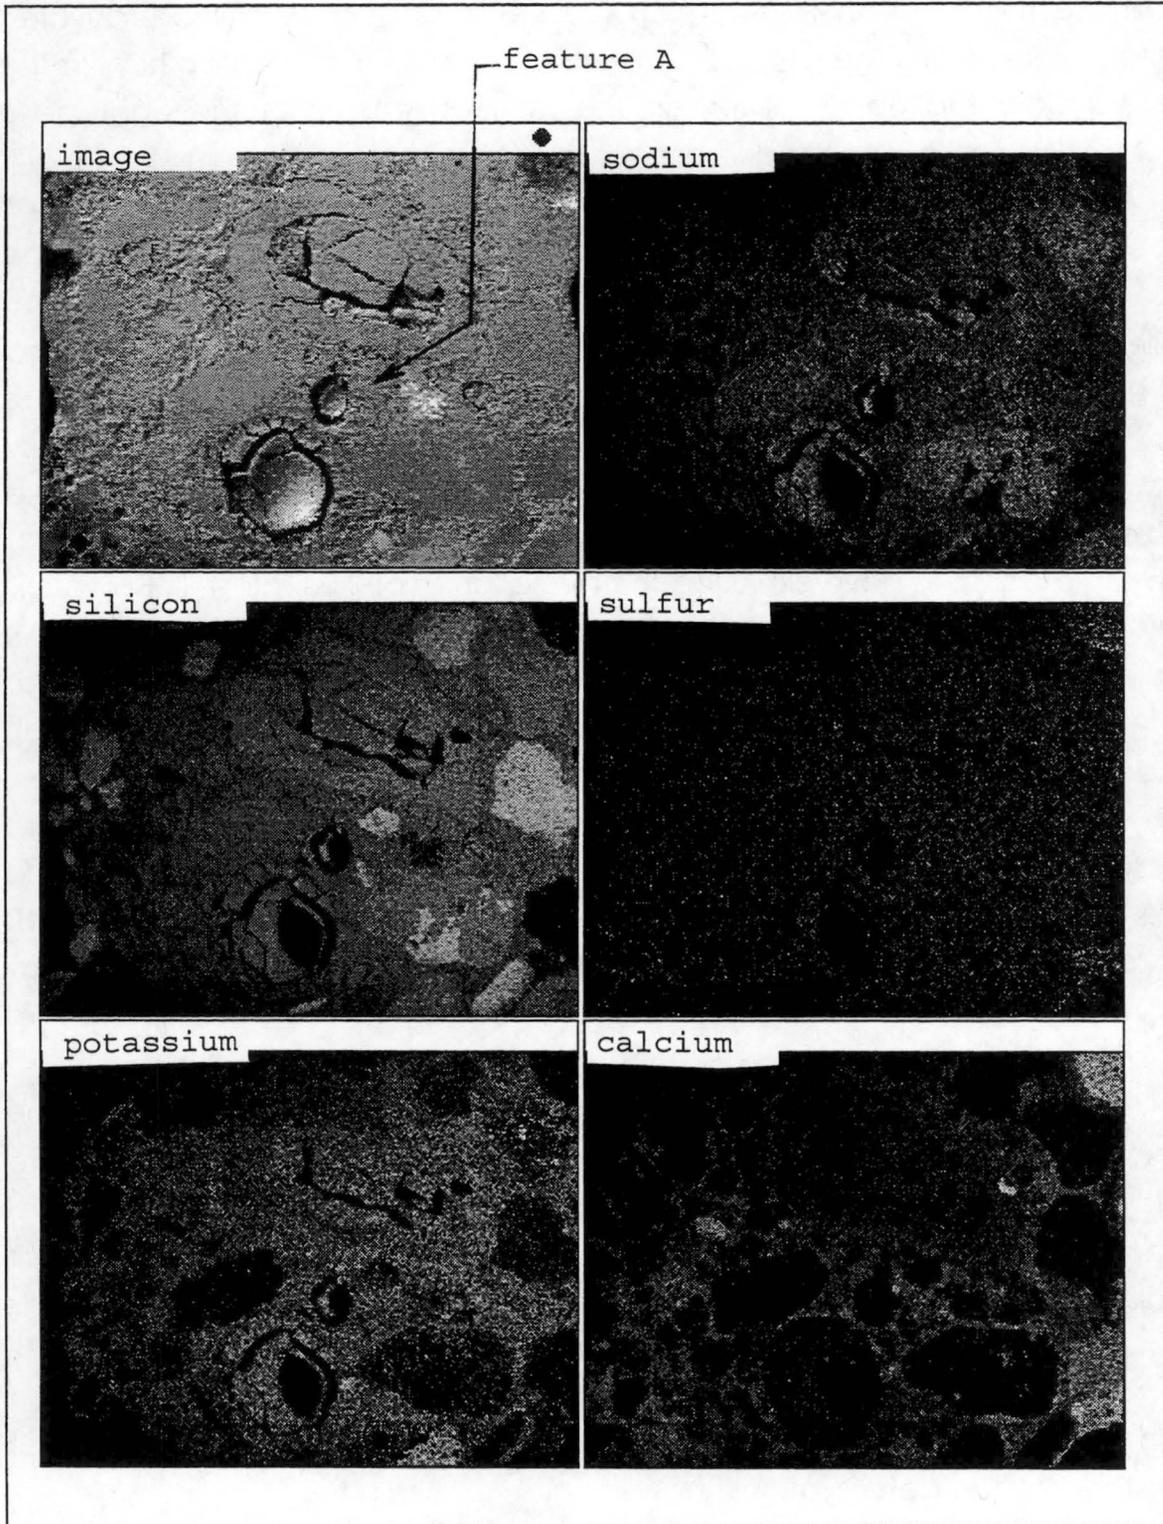
Alkali-silica gel has only rarely been observed in the concrete cores that are being studied for this research project. However, this comment must be considered as "preliminary" because many cores still need to be subjected to detailed investigation. Most commonly, the alkali-silica gel has been observed near shale particles in the fine aggregate fraction of some of the concrete cores. For example, highway 175 has exhibited some areas that clearly contain alkali-silica gel (see Figures 13 and 14). The gel originated from shale particles that were moistened during the sawing and grinding process. Not all of the shale particles have exhibited the formation of alkali-silica gel. However, nearly all of the shale particles exhibit cracking that is evident in both the particle and the adjacent region of cement paste (see Figure 15, this core was taken from highway 520). The cracking rarely extends large distances through the concrete specimen.

Figure 13. Digital image and X-ray map (magnification =30X) of a region of a concrete core taken from highway 175. The shale particle (upper center) has exuded alkali-silica gel which has filled some voids.

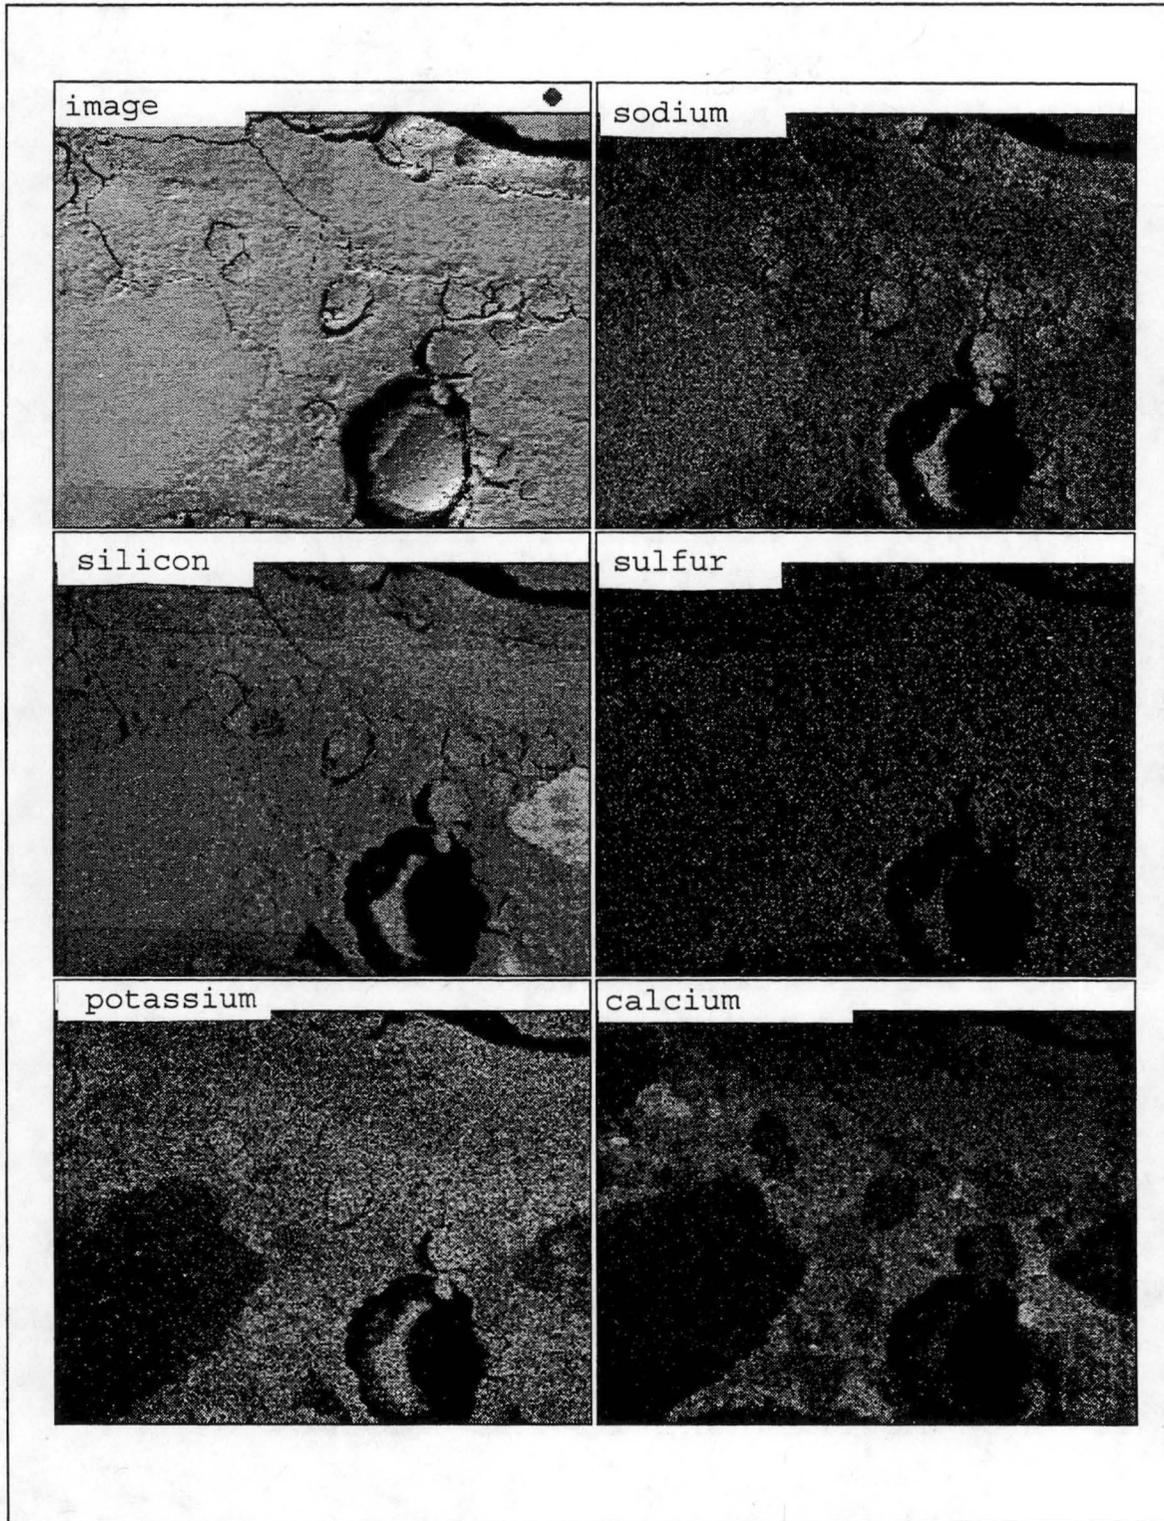
Figure 14. Digital image and X-ray map (magnification =100X) of feature A in Figure 13.

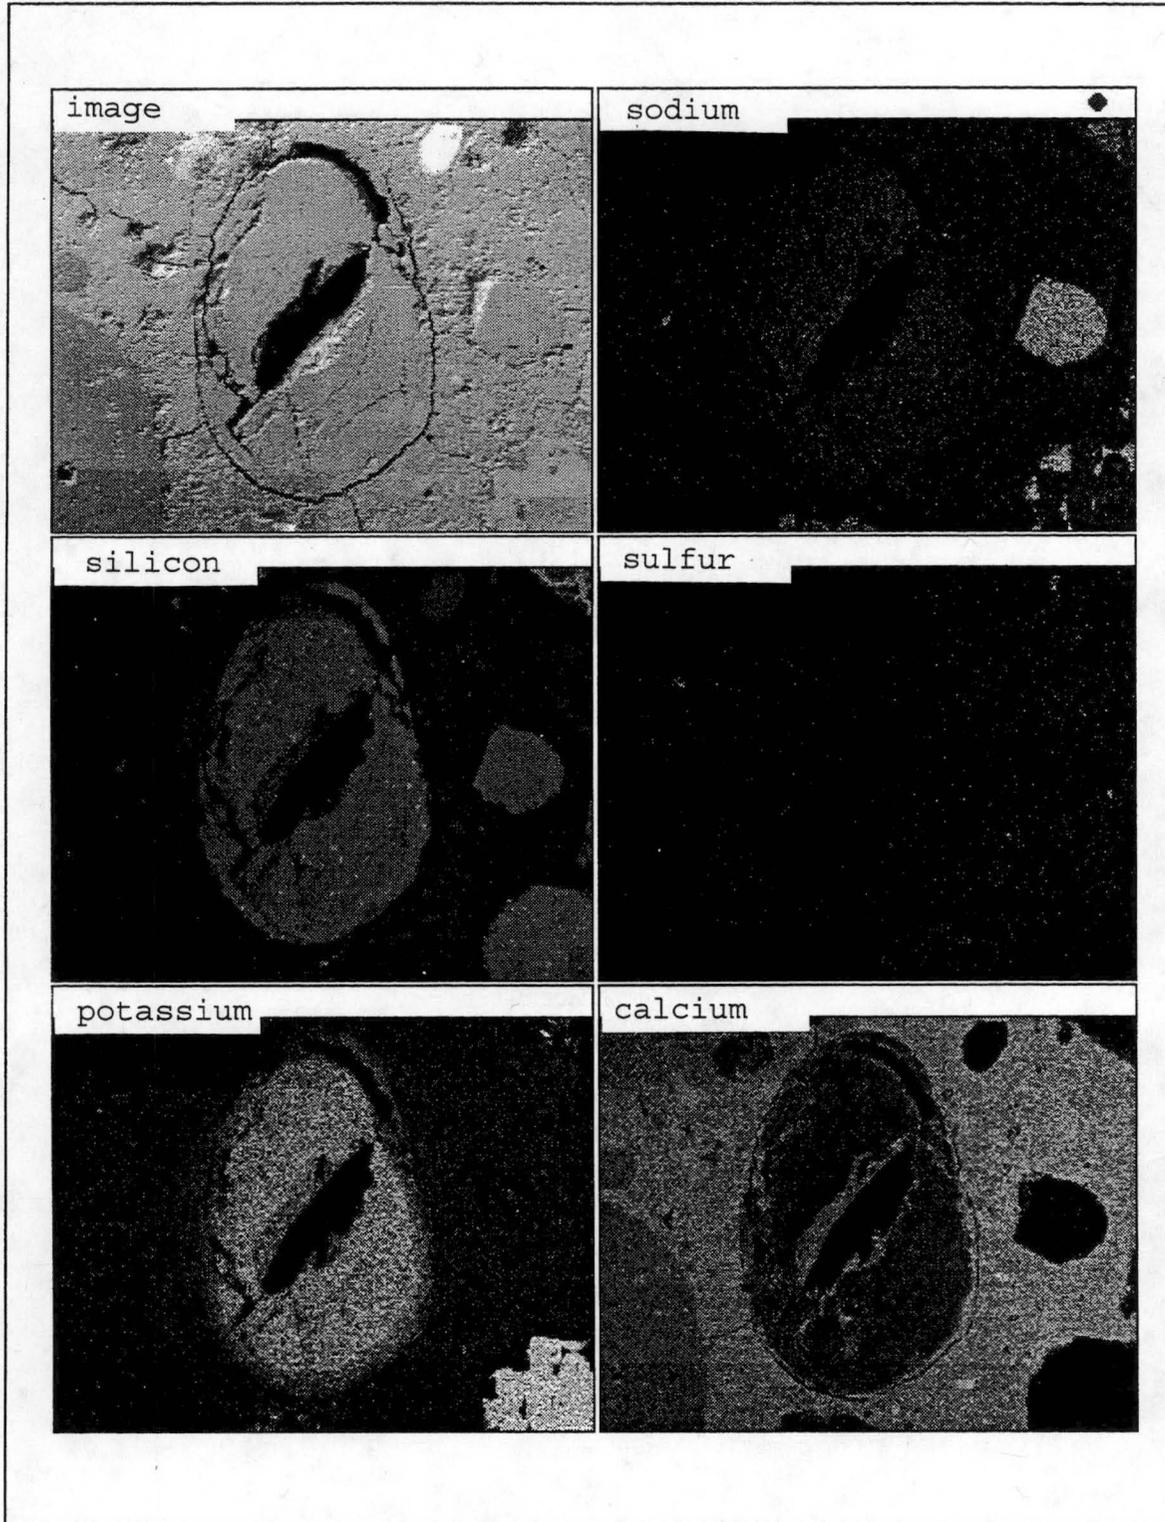
Figure 15. Digital image and X-ray map (magnification =30X) of a shale particle in a core taken from highway 520. Little evidence of ASR gel surrounding shale.

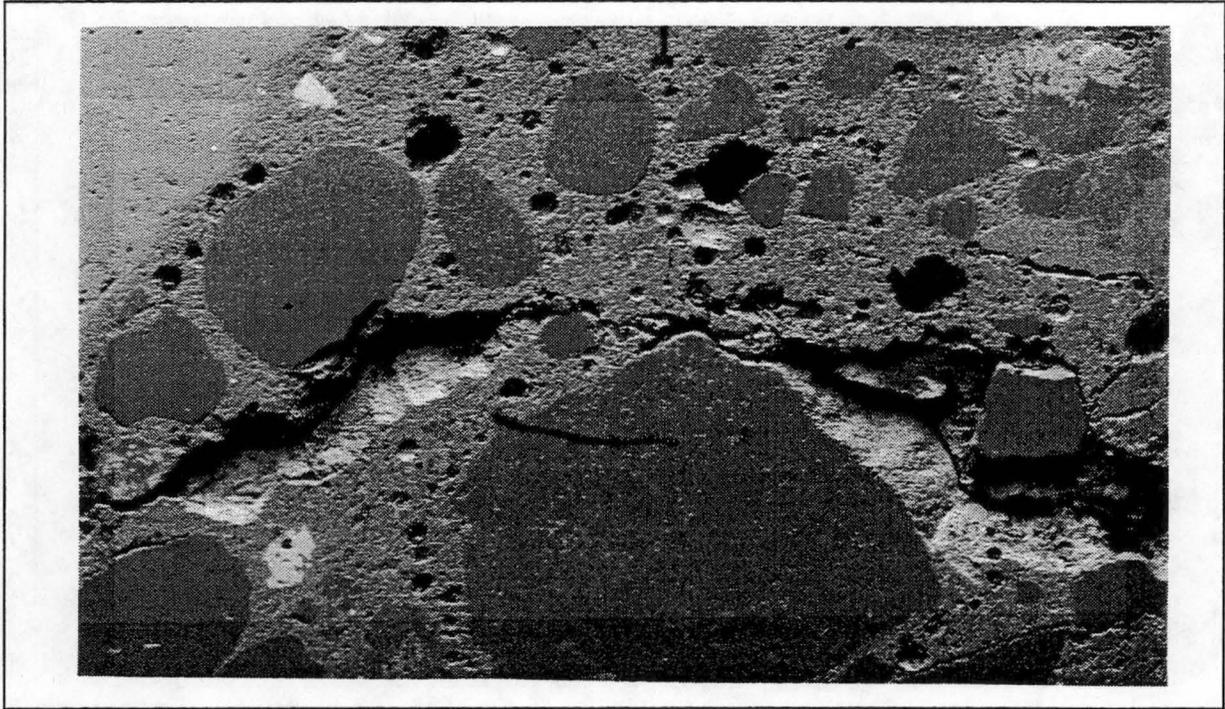
Many of the cracks that are routinely observed in the concrete core specimens appear to be open, and thus, have no apparent material filling the cracks (see Figures 16, 17 and 18). Often, the general cracking pattern tends to go around the aggregate particles and through the cement paste and air voids. Little aggregate related cracking is apparent in the core specimens that have been studied to this point.

Figure 16. Digital image (magnification =18X) of a region of a concrete core from I-35. Note large crack in paste with few cracked aggregates.

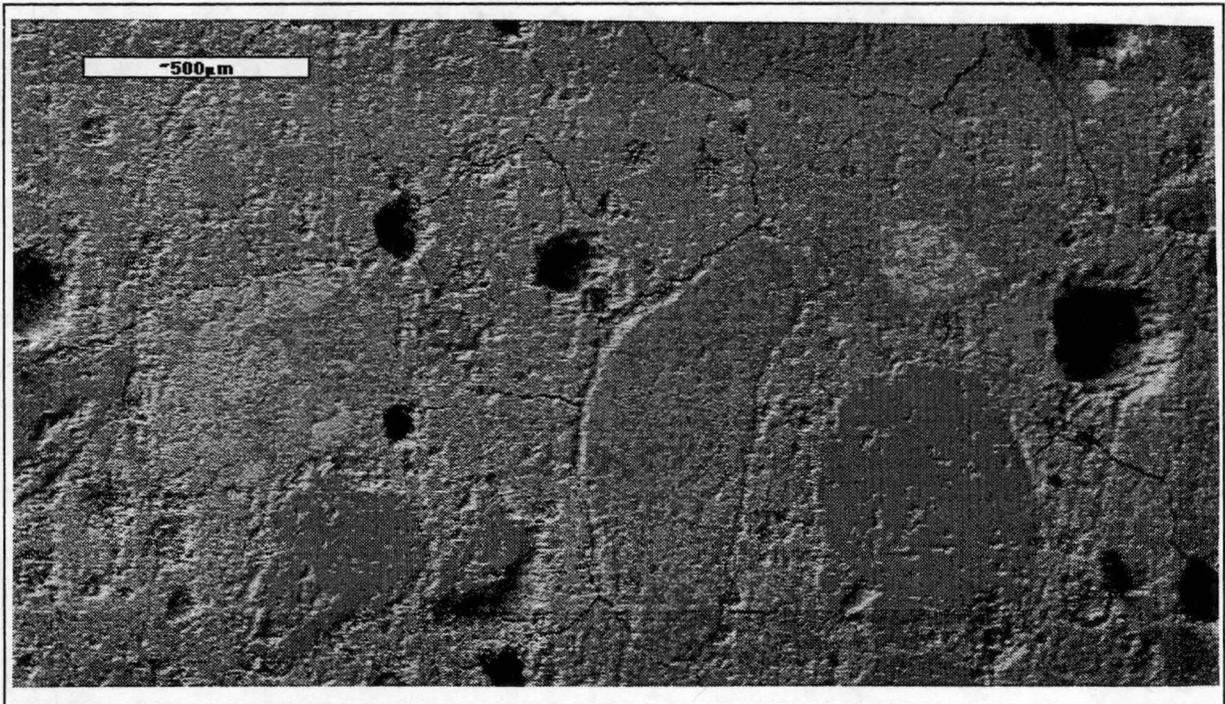
Figure 17. Digital image (magnification = 30X) of a region of a concrete core taken from highway 520. Note cracks in paste with few cracked aggregates. Also, note the filled voids.

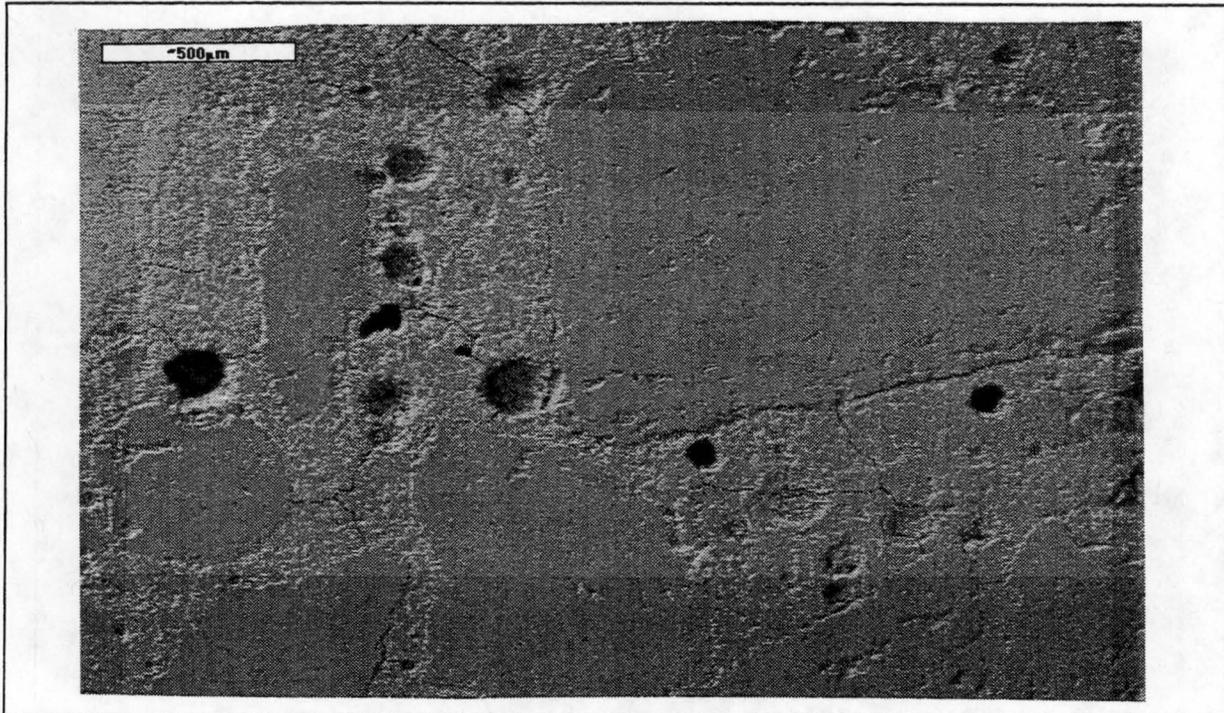
Figure 18. Digital image (magnification = 30X) of a region of a concrete core from I-80. Note cracks in paste with few cracked aggregates.

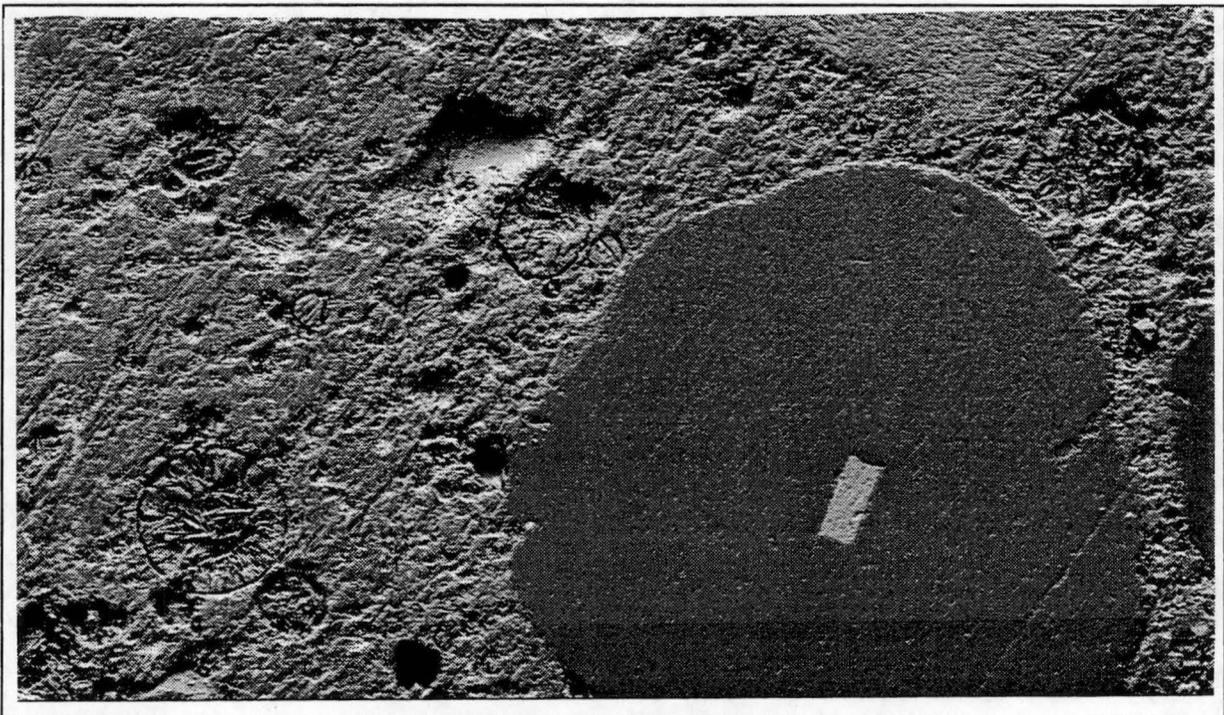
One feature that is common in many of the concrete cores is the presence of sulfate minerals in the entrained air voids, this is illustrated in Figure 19. The digital X-ray map of the region is shown in Figure 20. The chemical composition of the material in the air voids is often quite close to that which is characteristic of ettringite and the material typically exhibits a fibrous morphology. Experts indicate that this observation is not uncommon [6, 8, 13]. Most common petrographic examination guides also suggest that investigators should document these features because they may be important to understanding the deterioration mechanism.

Figure 19. Digital image (magnification = 100X) of a region of a concrete core taken from I-35. Note how the voids have been nearly filled with sulfates.

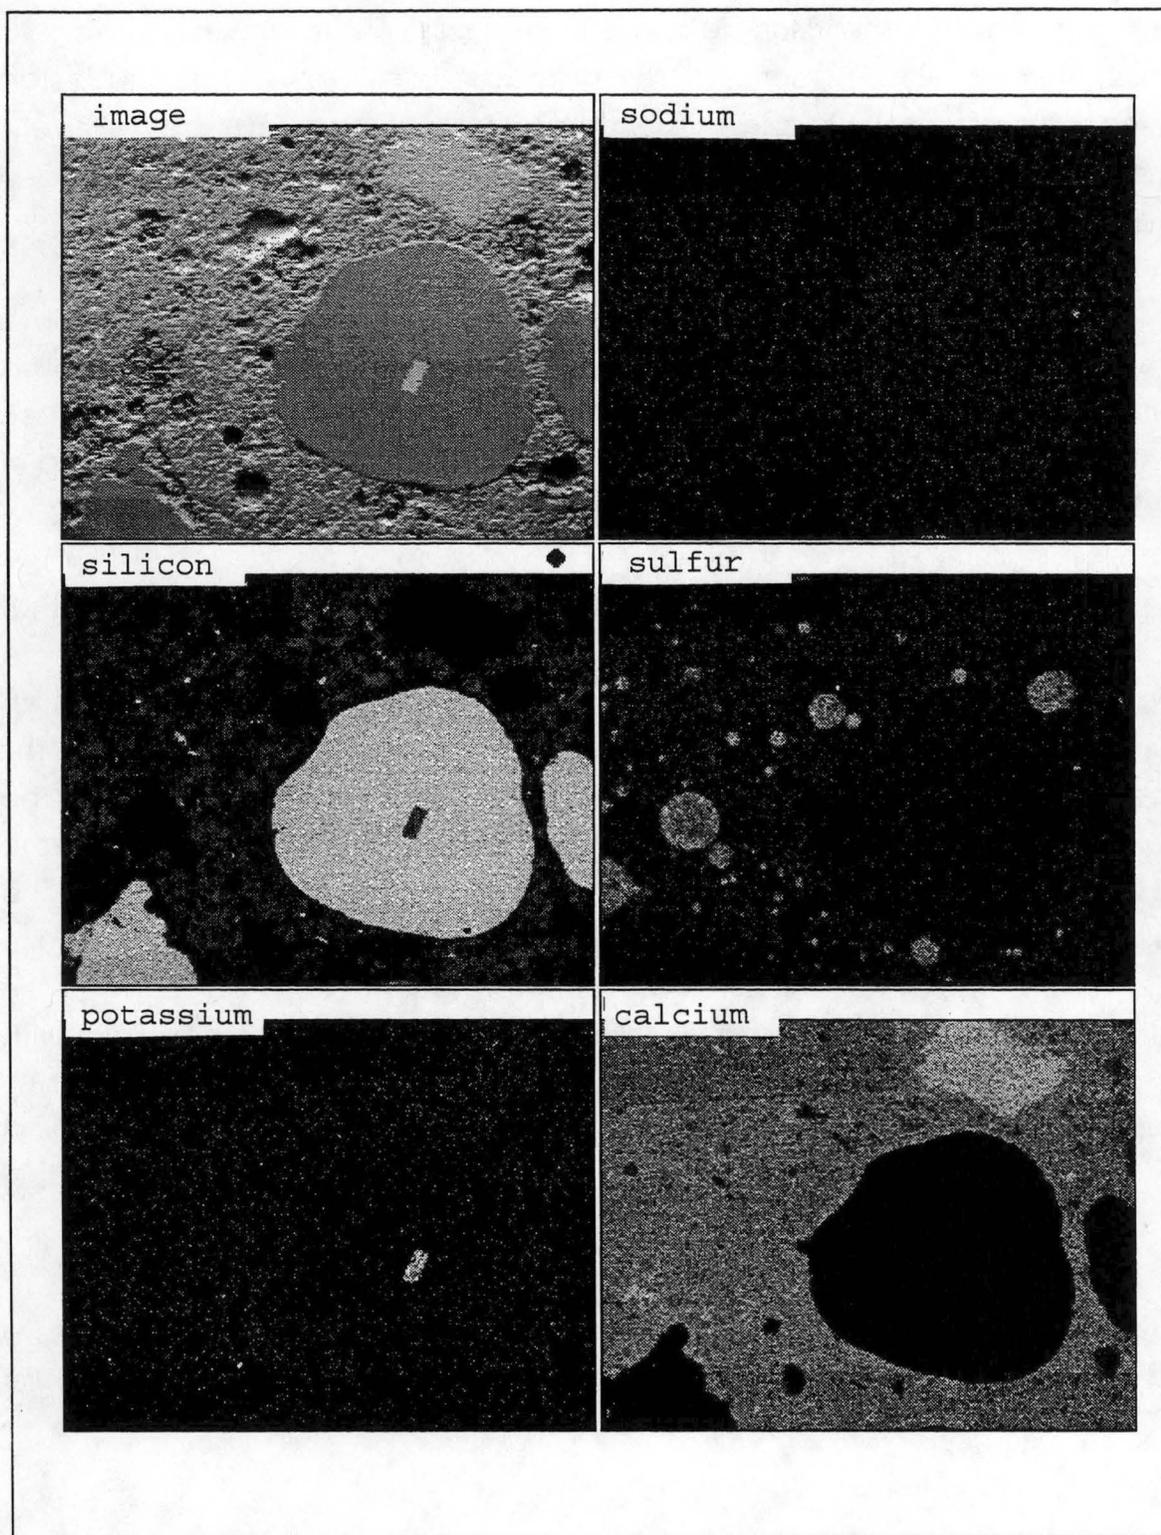
Figure 20. Digital image and X-ray map (magnification =100X) of the region shown in Figure 19. Note how voids are filled with sulfates, not alkalis or silicates.

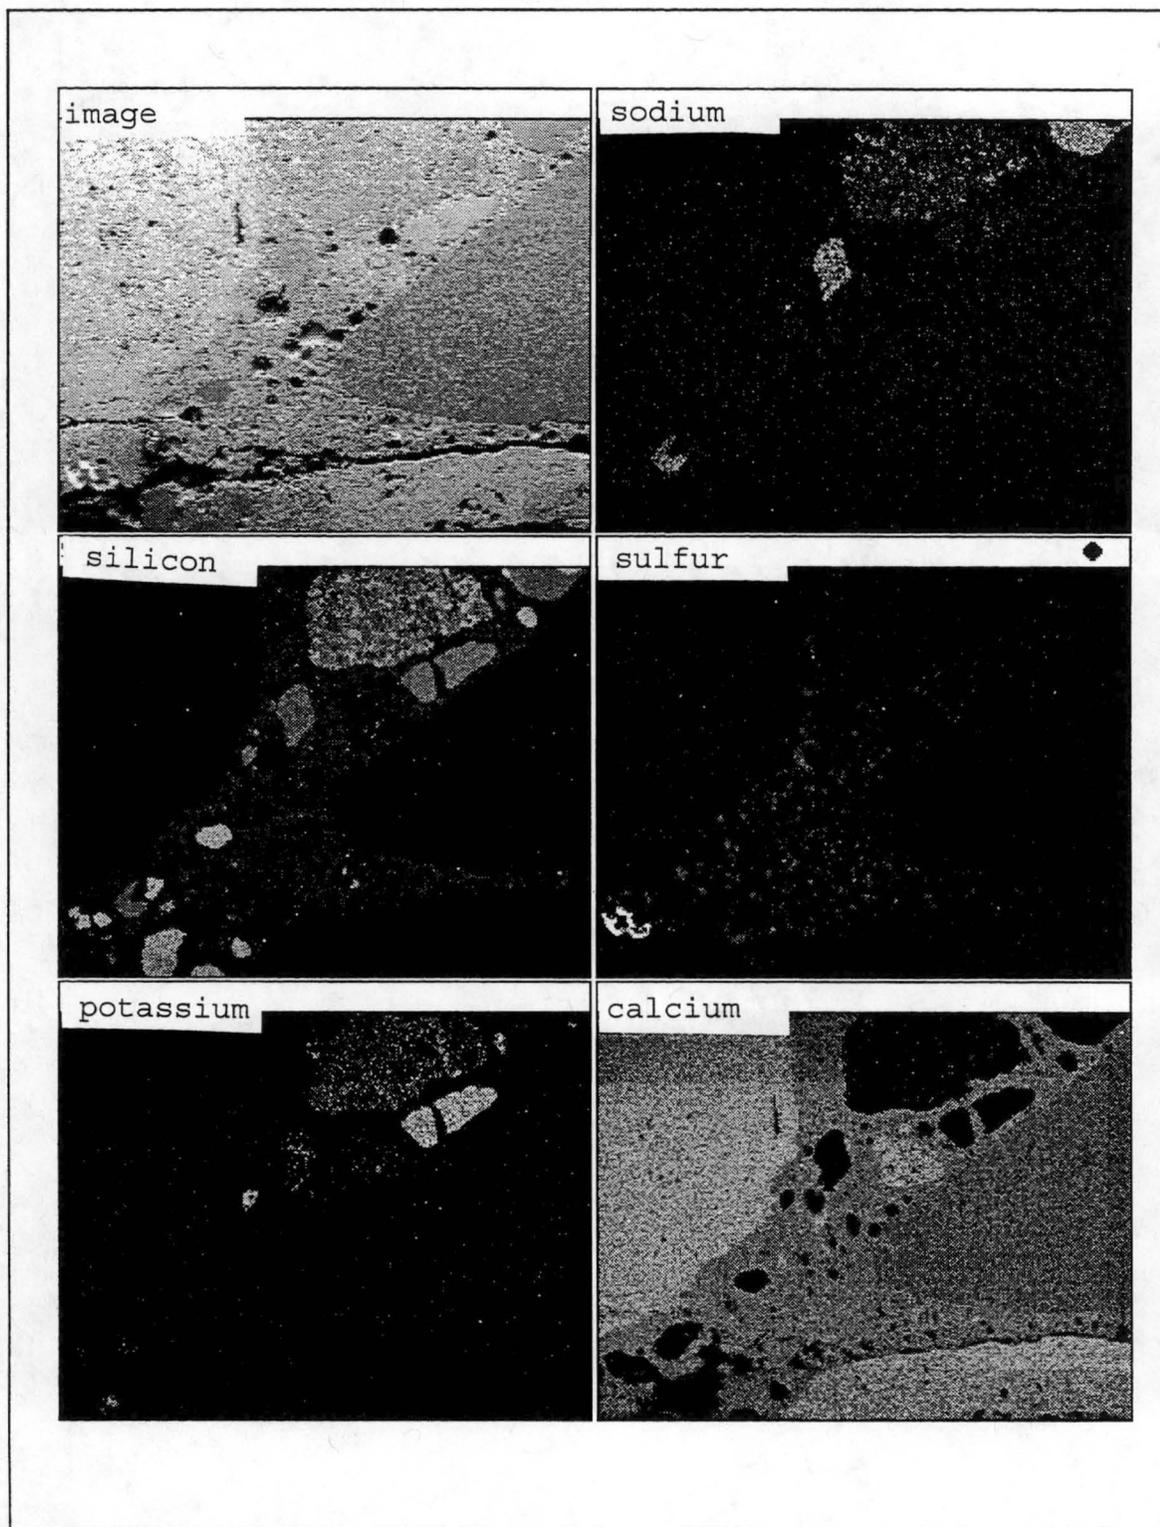
microns have been completely filled. Hence, void filling occurred on both a macroscopic and a microscopic level. This is best illustrated by referring to Figures 21 through 23. This series of digital images and X-ray maps, which start at a magnification of 30X and then increase to 100X and 250X, respectively, clearly indicate that the void system is inundated with sulfates. In fact, each increase in magnification simply shows smaller and smaller air voids that have been filled.

Figure 21. Digital image and X-ray map (magnification =30X) of a large crack in a core taken from I-35. Note voids filled with sulfates (i.e., the sulfur map).
