**Evaluation of Microcracking and Chemical  
Deterioration in Concrete Pavements**

**Phase II Progress Report**

**February 28, 1995**

**Iowa DOT PROJECT HR-358  
ERI PROJECT 3711**

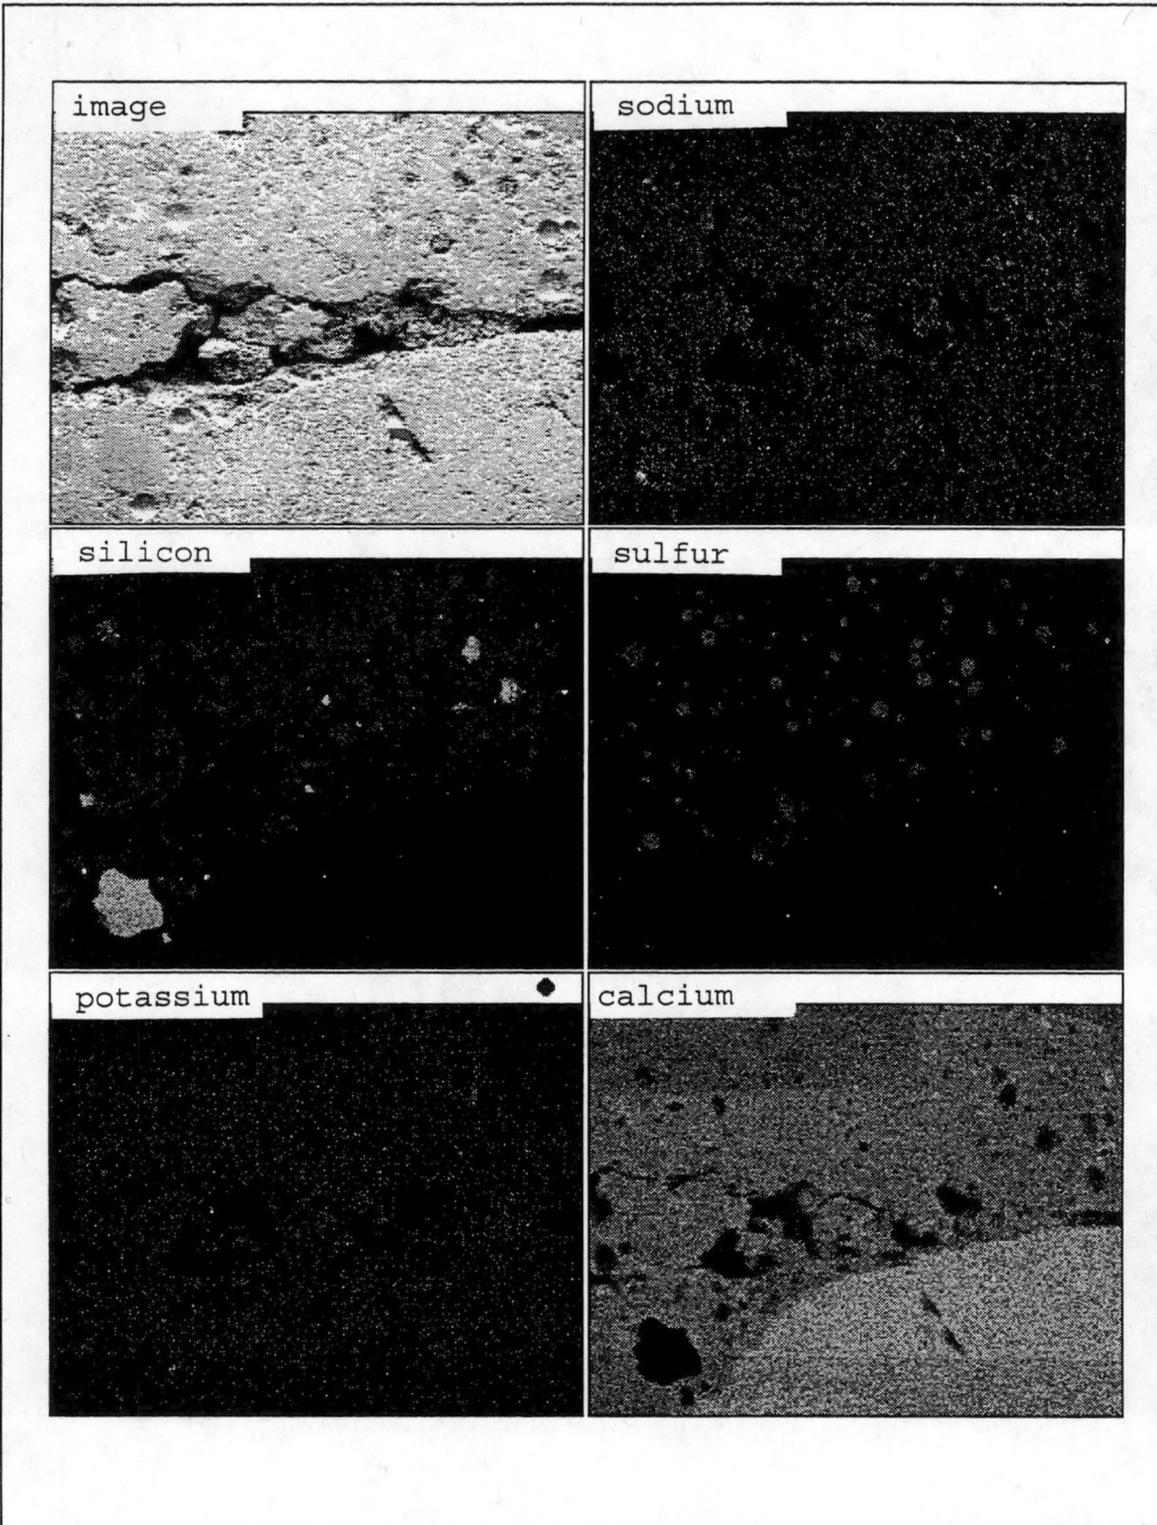
microns have been completely filled. Hence, void filling occurred on both a macroscopic and a microscopic level. This is best illustrated by referring to Figures 21 through 23. This series of digital images and X-ray maps, which start at a magnification of 30X and then increase to 100X and 250X, respectively, clearly indicate that the void system is inundated with sulfates. In fact, each increase in magnification simply shows smaller and smaller air voids that have been filled.

Figure 22. Digital image and X-ray map (magnification =100X) of a large crack in a core taken from I-35. Note voids filled with sulfates (i.e., the sulfur map).

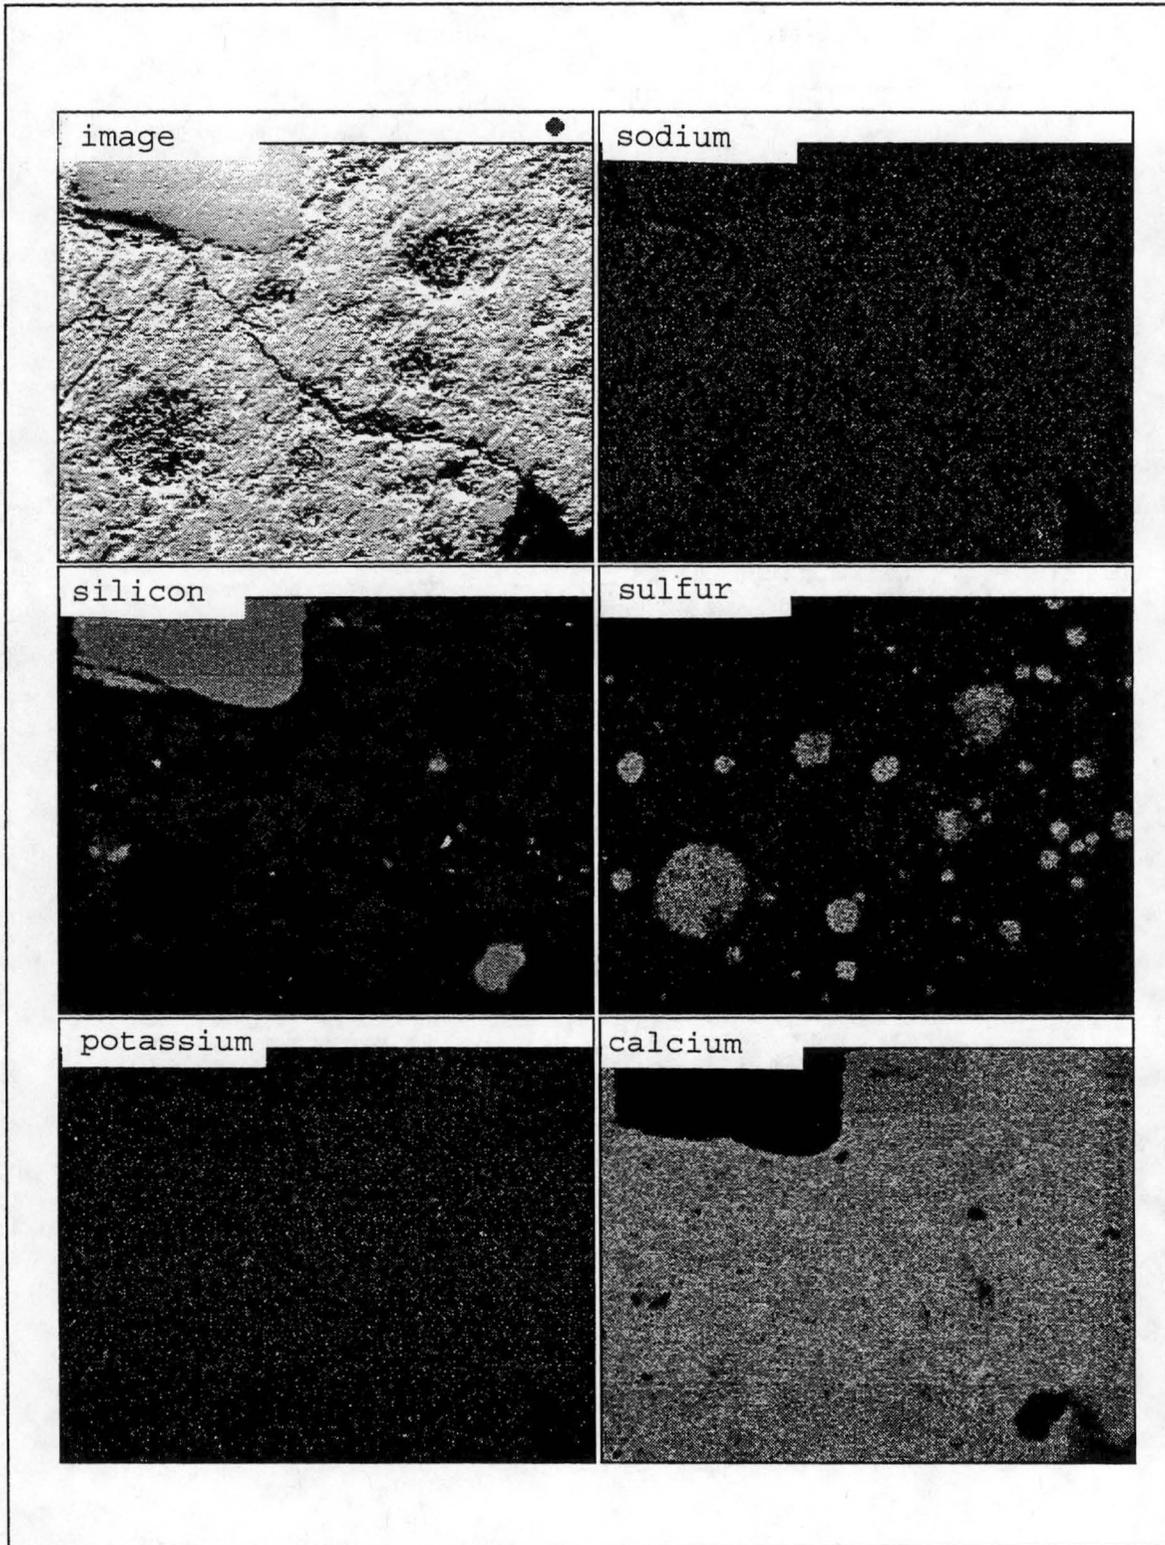
Figure 23. Digital image and X-ray map (magnification =250X) of an area from a core taken from I-35. Note voids filled with sulfates (i.e., the sulfur map).

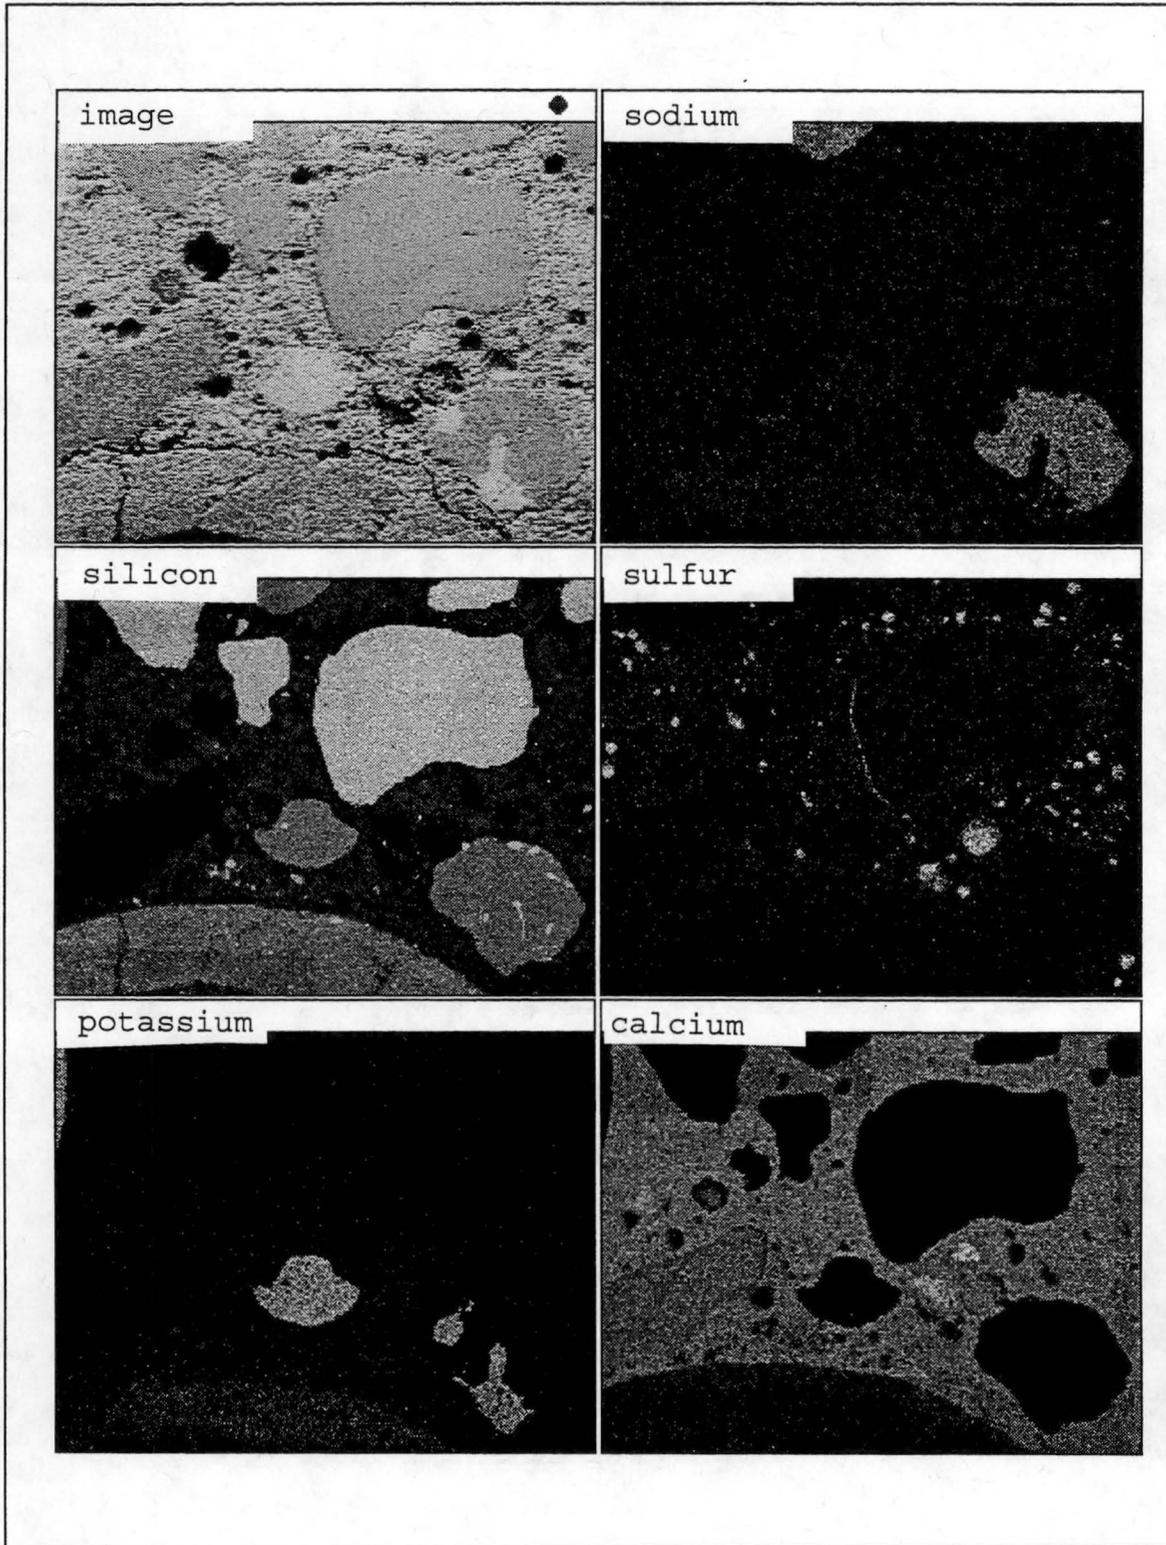
Occasionally, sulfates were also found around the periphery of some aggregate particles (see Figure 24). Alkali-silica reaction cannot cause features of this type [8]. Instead, these types of features are normally attributed to a cement paste matrix that has expanded (possibly due to frost damage or sulfate related reactions [8]). Such features may also be attributed to poor consolidation during field construction.

Figure 24. Digital image and X-ray map (magnification =70X) of an area in a core taken from I-35. Note filling around aggregate with sulfates, plus void filling.

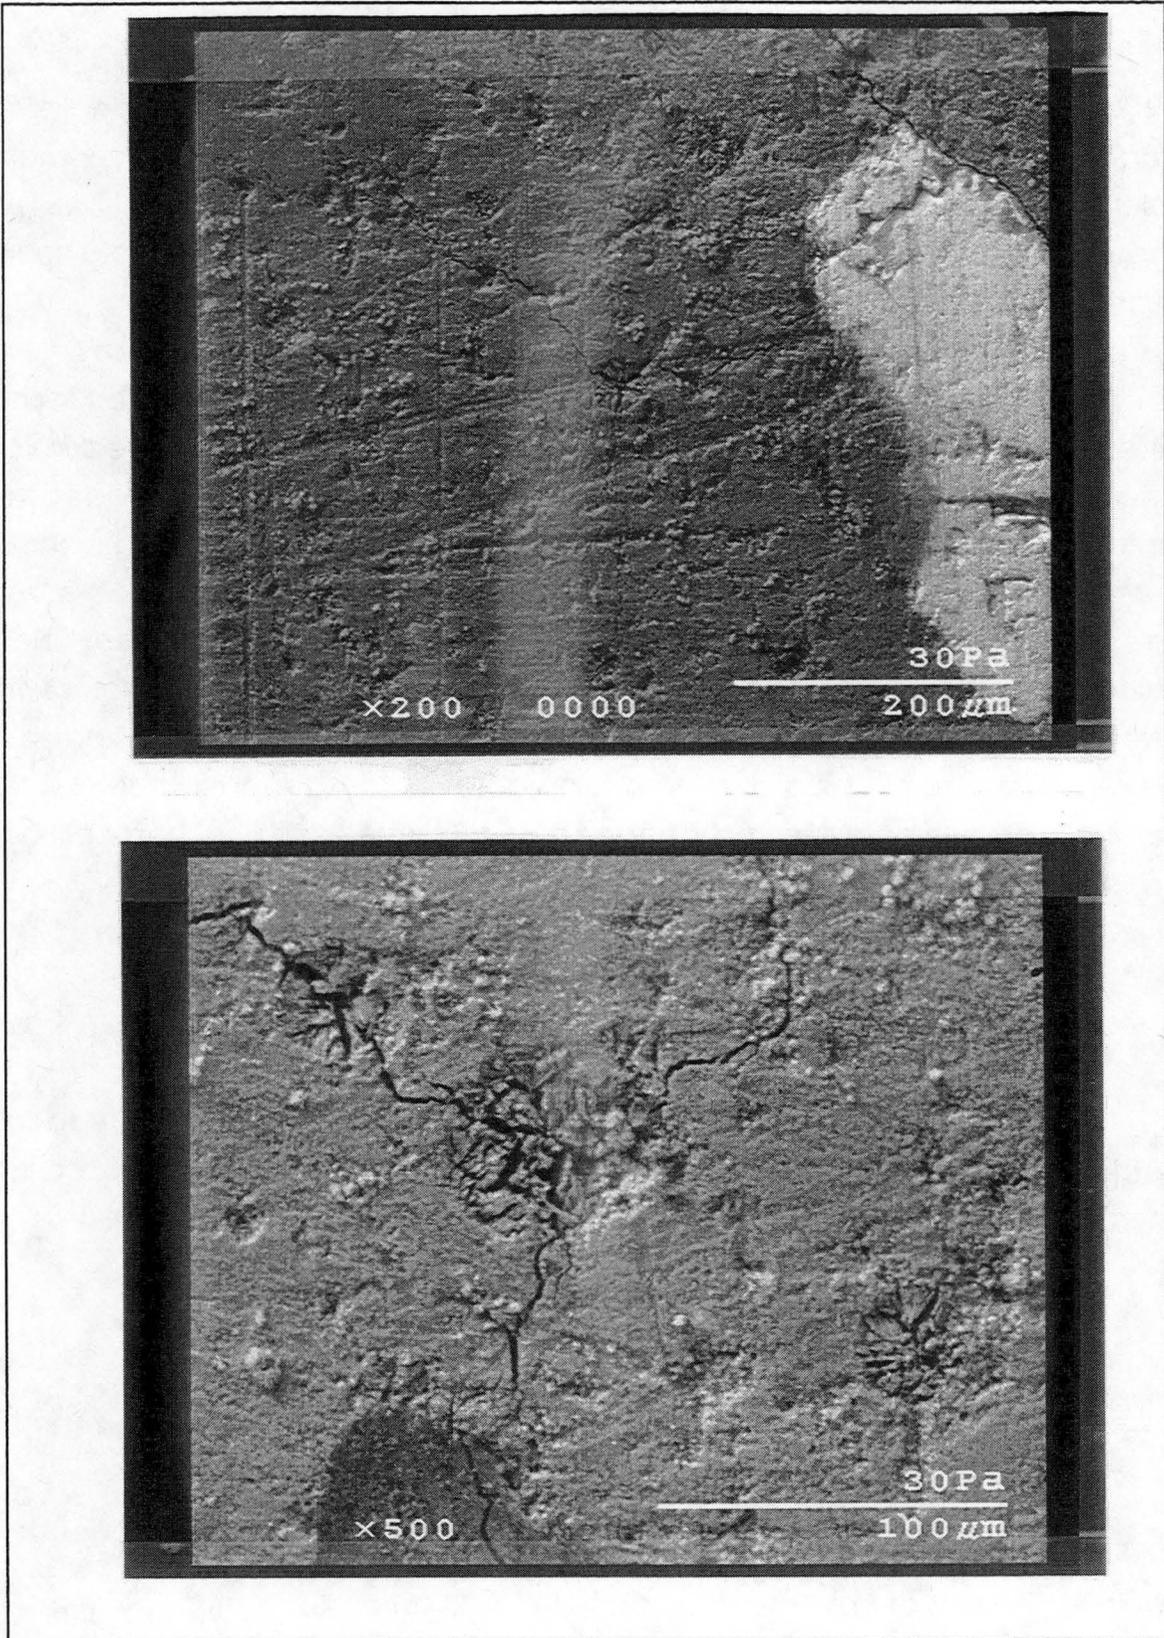
Sometimes the cracking pattern around air voids has suggested that expansion has taken place within the air void (see Figure 25). These voids are typically filled with ettringite, as was noted by Marks and Dubberke [3]. Such features suggest that secondary ettringite formation contributed to the microcracking. However, an alternative interpretation of the feature can be formulated. Such an interpretation would maintain that the void had become filled with water and then subjected to freezing and thawing. Hence, the cracks were generated by the expansion of water and then the ettringite precipitated in the void. This alternative interpretation fails to account for the fact that the cracks remain empty while only the air void has been filled with ettringite, such preferential filling seems odd under such circumstances.

Figure 25. Illustration of cracking patterns through (or from?) air voids in the core specimens.
