# Evaluation of Unbonded Ultrathin Whitetopping of Brick Streets

Construction Report  
August 2002

Iowa DOT Project TR-466  
CTRE Project 01-91

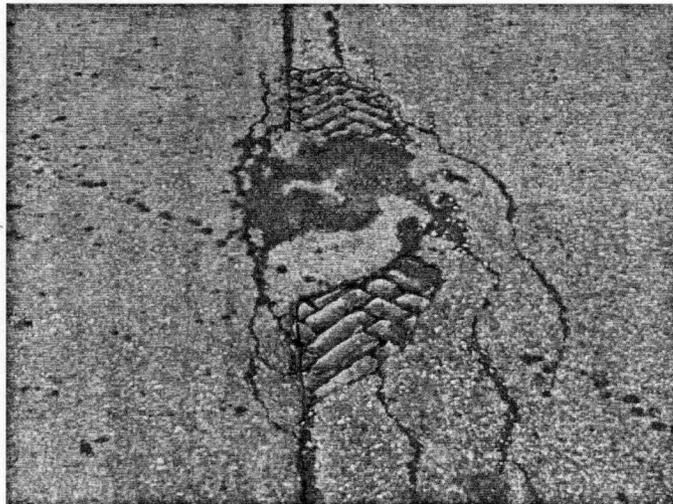
Many cities in Iowa have retained the original brick street surfaces in downtown areas and in older residential areas as the base for modern driving surfaces. The original brick surfaces were not built to handle current and future traffic loadings. In recent years these surfaces have tended to shift and become uneven, creating problems with safety. Asphaltic concrete overlays have been the typical rehabilitation technique in these situations. This has proven to be a successful rehabilitation technique in some cases; in other cases the combination of the movement of the brick and the flexibility of the asphalt has proven to accentuate the original problems. Figures 1 and 2 show exposed brick under the asphalt and the asphalt cracked in several places.

**Figure 1. Asphalt Surface with Exposed Brick**

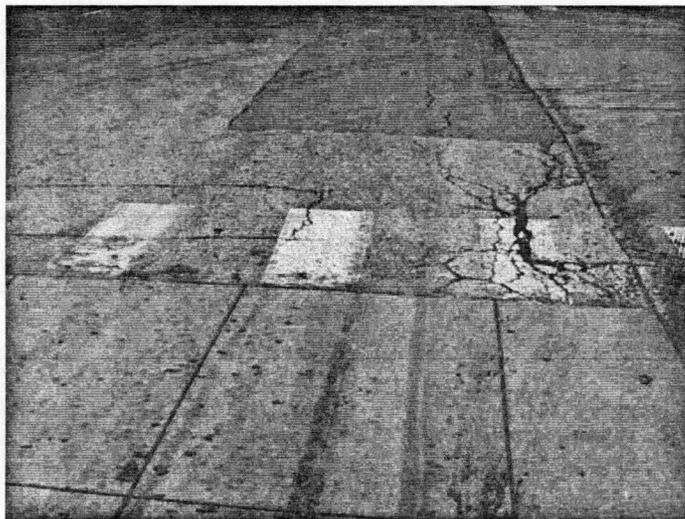
**Figure 2. Deteriorated Asphaltic Concrete Surface**

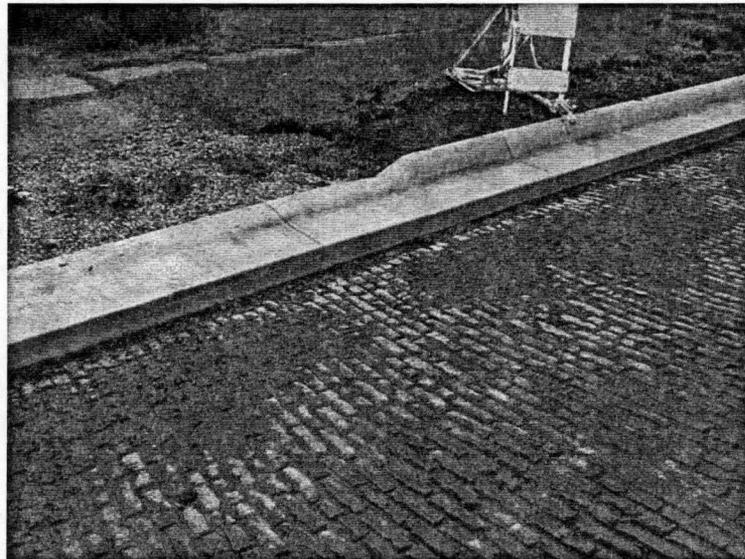
The contractor first removed the existing asphalt overlay by milling and air blasting. The goal was to allow an inch of asphalt to remain on top of the brick surface, but with the weight and vibration of the milling machine all the asphalt came loose and was removed from the bricks. The existing curb and gutter were then removed and replaced, with the contractor raising the elevation to allow for four inches of concrete to be placed on top of the existing brick, as shown in Figure 5.

**Figure 5. Finished Curb and Gutter Unit**

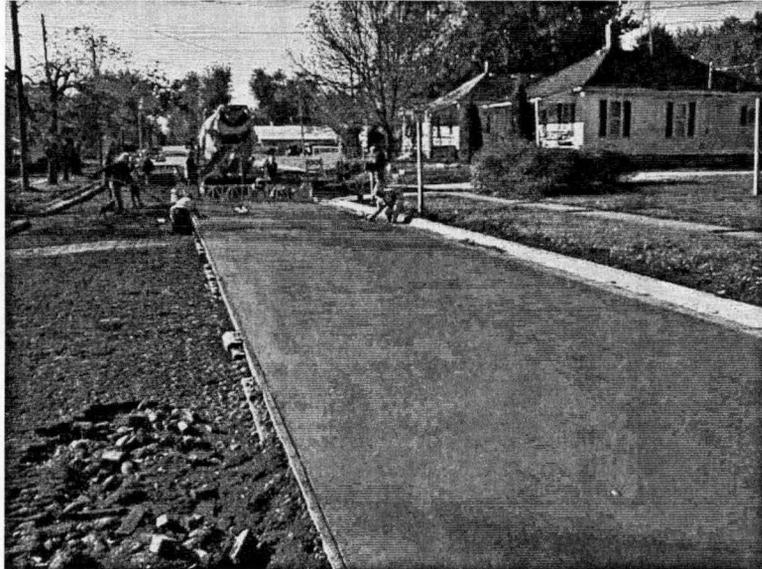
**Figure 6. Southbound Lane Overlay Paving**

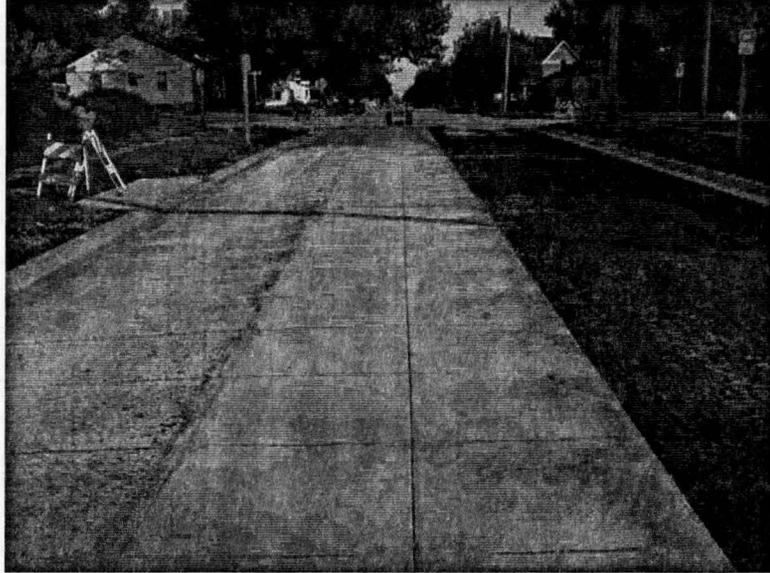
**Figure 7. Southbound Lane Paving Completed**

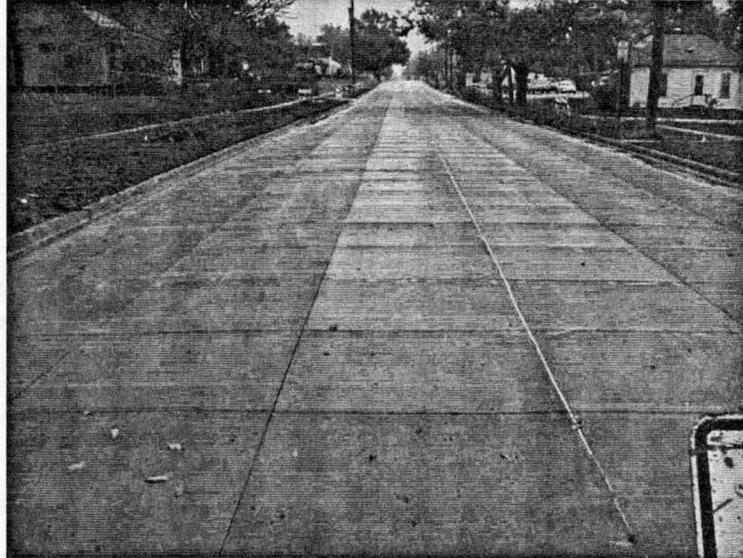
Joints were cut with a dry saw  $\frac{3}{8}$  inches wide, cut to a depth of  $\frac{T}{3}$  or  $\frac{T}{4}$ . The spacing of the joints from Station 0 + 32 to 3 + 82 was as follows: longitudinal joints were cut 59 inches apart and transverse joints were cut 48 inches apart. Curb and gutter sections were cut transversely at 72-inch intervals, which resulted in the curb and pavement joints matching at every third transverse pavement joint. The section from Station 3 + 82 to 4 + 42, is 10 inches in depth, with longitudinal joints every 84 inches and transverse joints occurring every 144 inches. From Station 4 + 42 to 5 + 94, longitudinal joints occur every 43 inches and transverse joints are spaced at 36-inch intervals. Station 5 + 94 to 6 + 10 has longitudinal joints spaced every 43 inches, and a transverse joint cut at 69 inches, then 59 inches, then another at 69 inches. In this area, brick was removed to allow for a thickened end. Figure 8 shows joints after saw cutting.

**Figure 8. Completed Jointing Pattern**

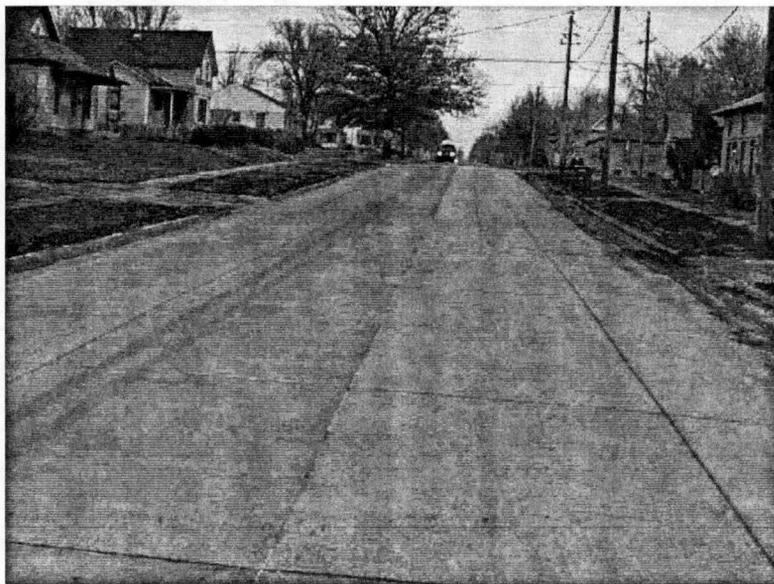
The removal of approximately one foot of brick along each edge was to allow for a thickened edge of concrete along the curb and gutter section. This posed a problem as heavy trucks drove on the brick, causing the bricks to shift and expose the sand and dirt below. A few areas were four feet square, which were filled with concrete to a full depth. Figure 9 shows the completed project.

**Figure 9. Completed Project**
