A CONTINUOUS SPAN ALUMINUM GIRDER CONCRETE DECK BRIDGE

PART 2 OF 2:
FATIGUE TESTS OF ALUMINUM GIRDERS

FATIGUE TESTS OF ALUMINUM GIRDERS

May 1997

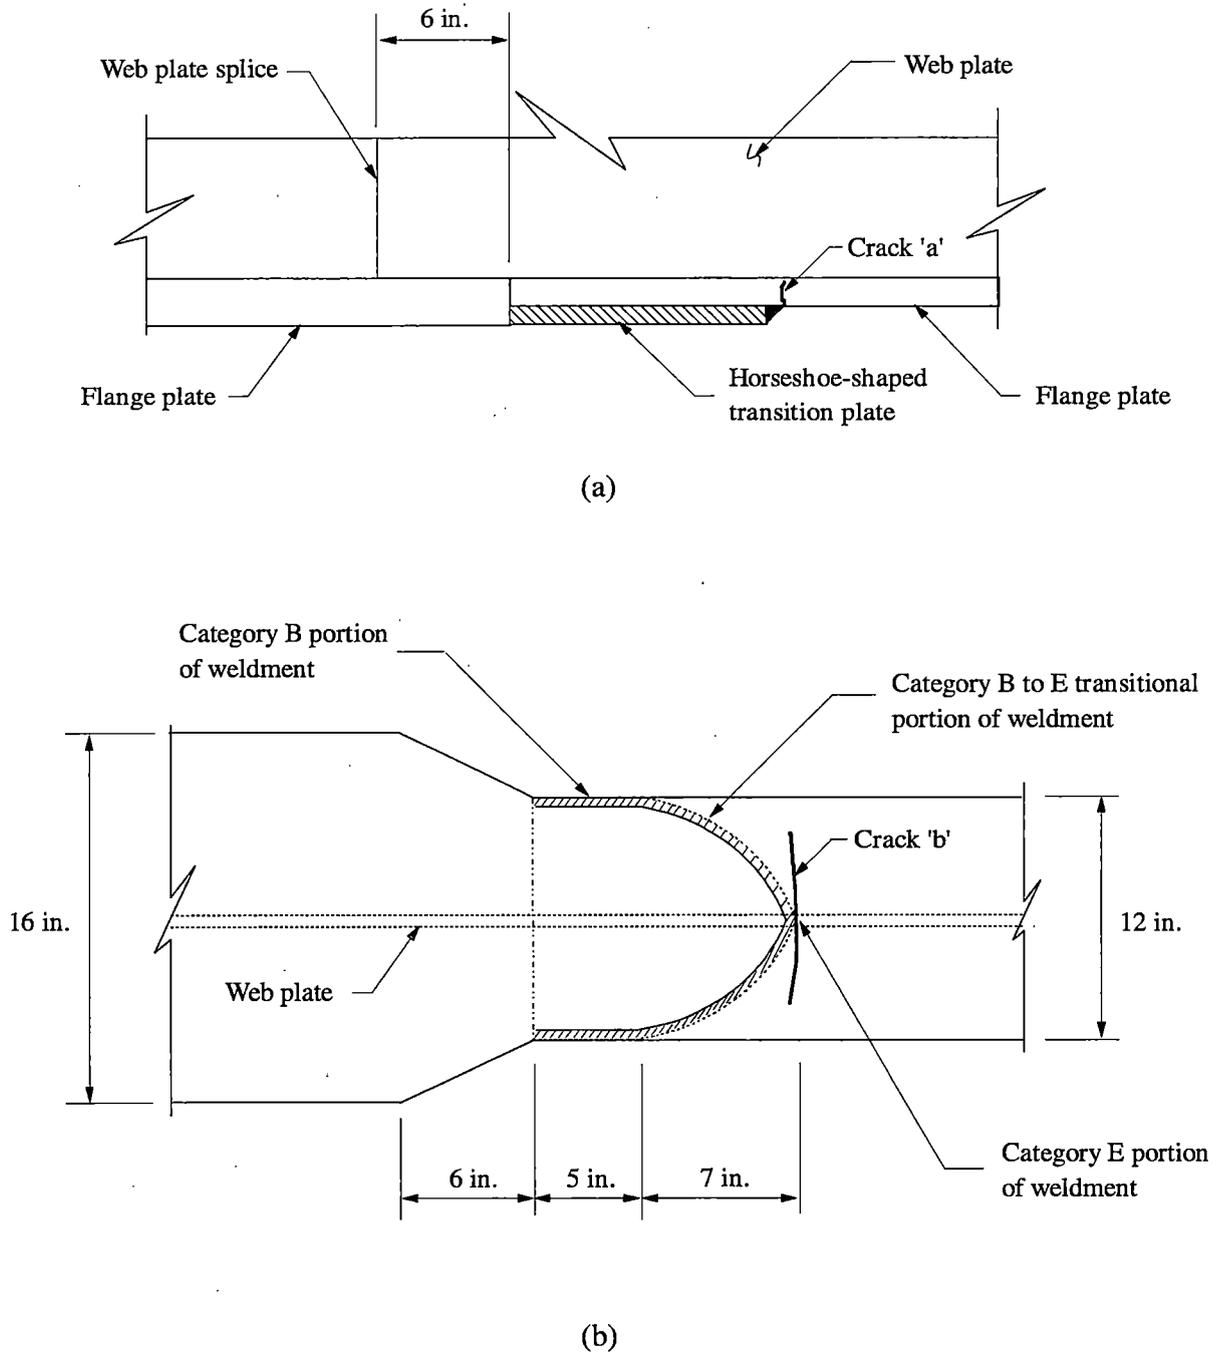
Figure 3.3. Fatigue fracture at the original bottom flange splice in the long exterior girder specimen no. 1: (a) Partial elevation; (b) Underside of the bottom flange

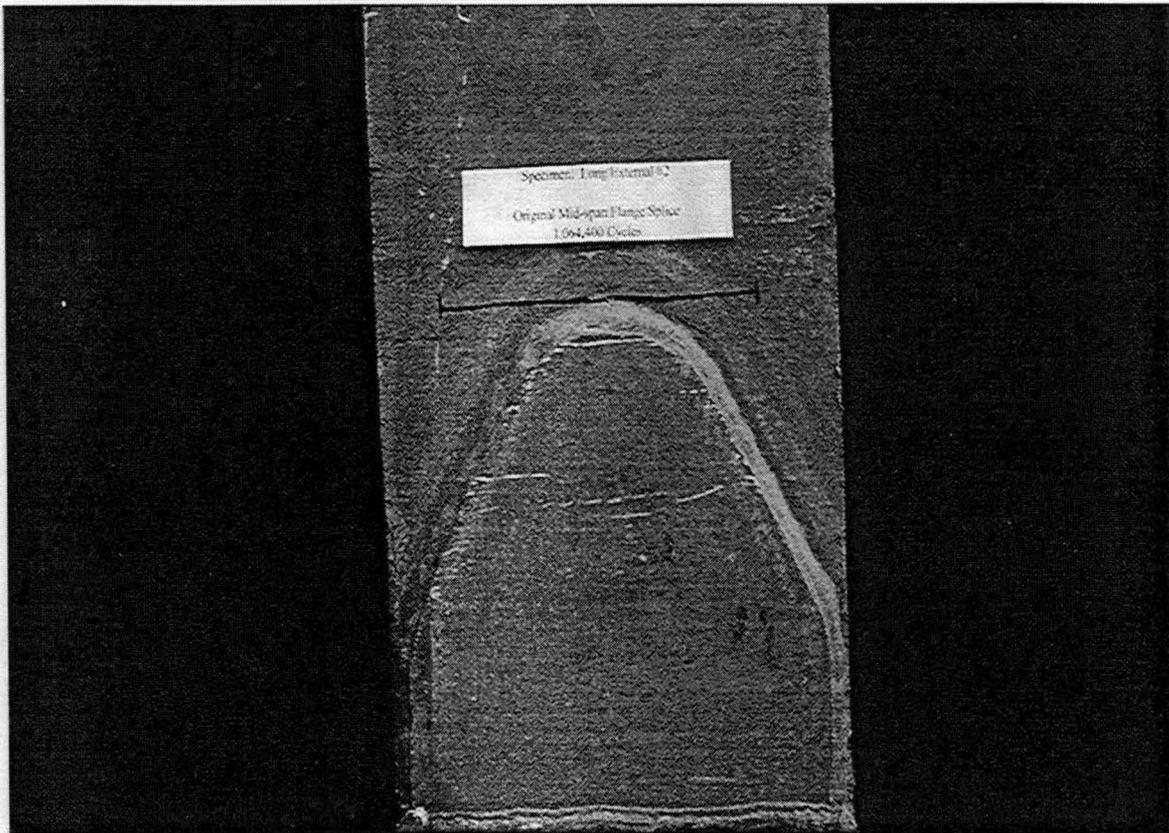
Figure 3.4. Photograph of the fatigue fracture at the original bottom flange splice in the long exterior girder specimen no. 2

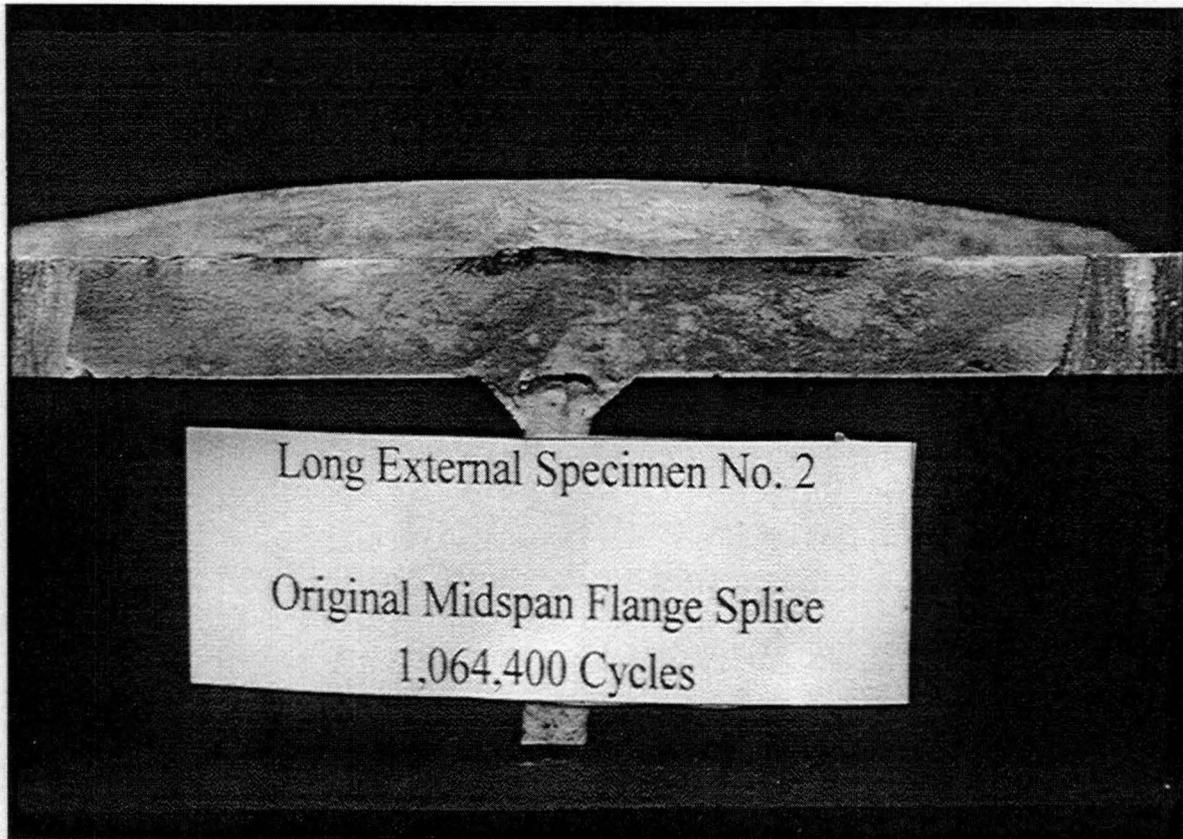
Figure 3.5. Photograph of the fatigue surface at the original bottom flange splice in the long exterior girder specimen no. 2

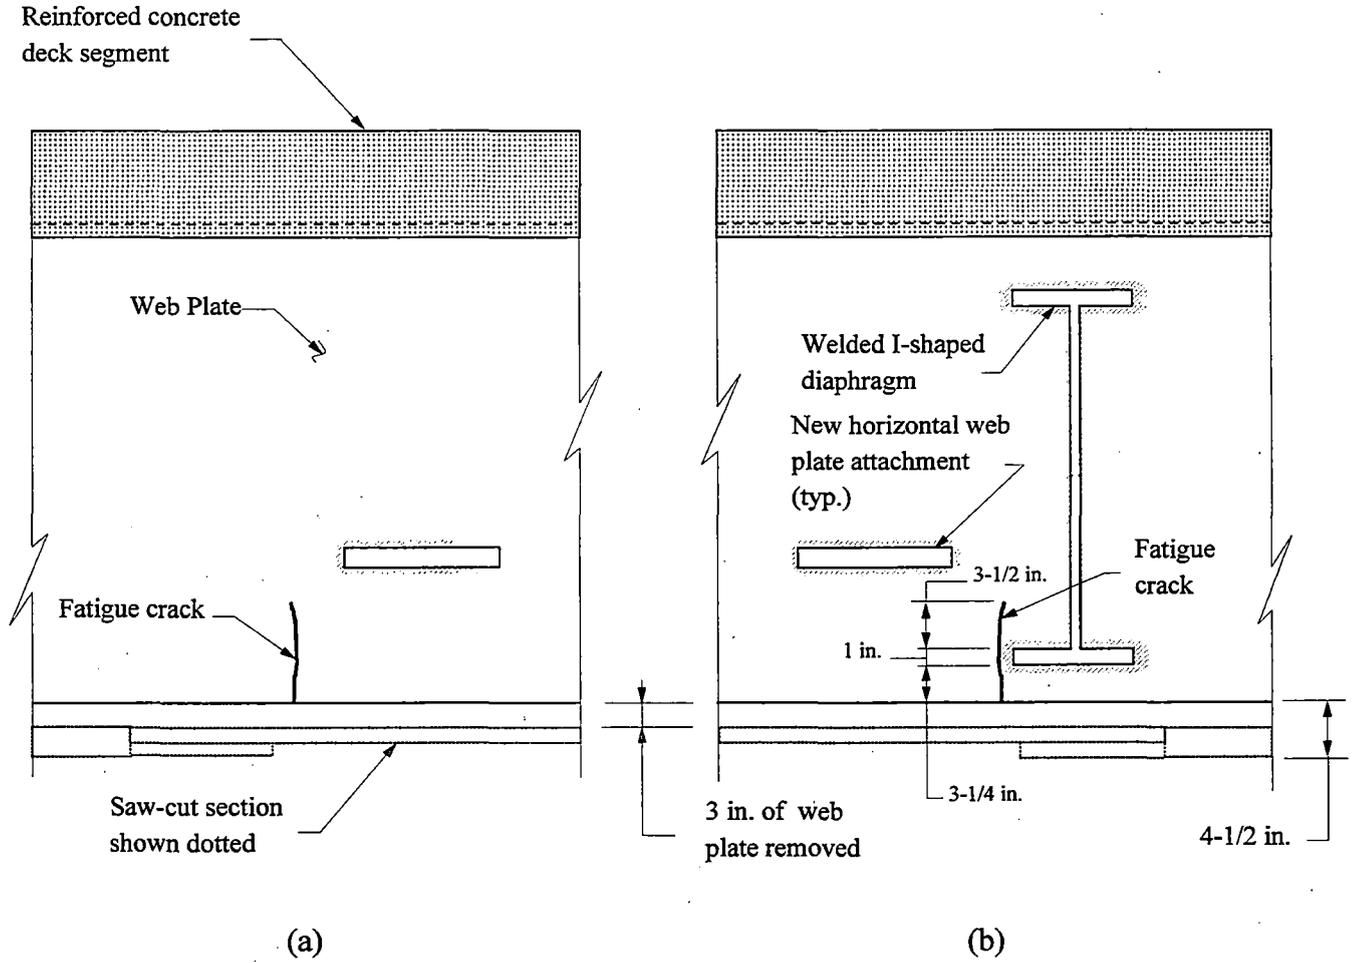
Figure 3.6. Fatigue fracture at the tip of the bottom flange of the I-shaped diaphragm connection on the long exterior girder specimen no 1: (a) Front elevation; (b) Back elevation

existed at the same location in the exterior girder specimens. The presence of the girder web plate slot caused this detail to be extremely susceptible to a fatigue fracture. This type of a weld detail has not been addressed by the Aluminum Association design specifications [8].

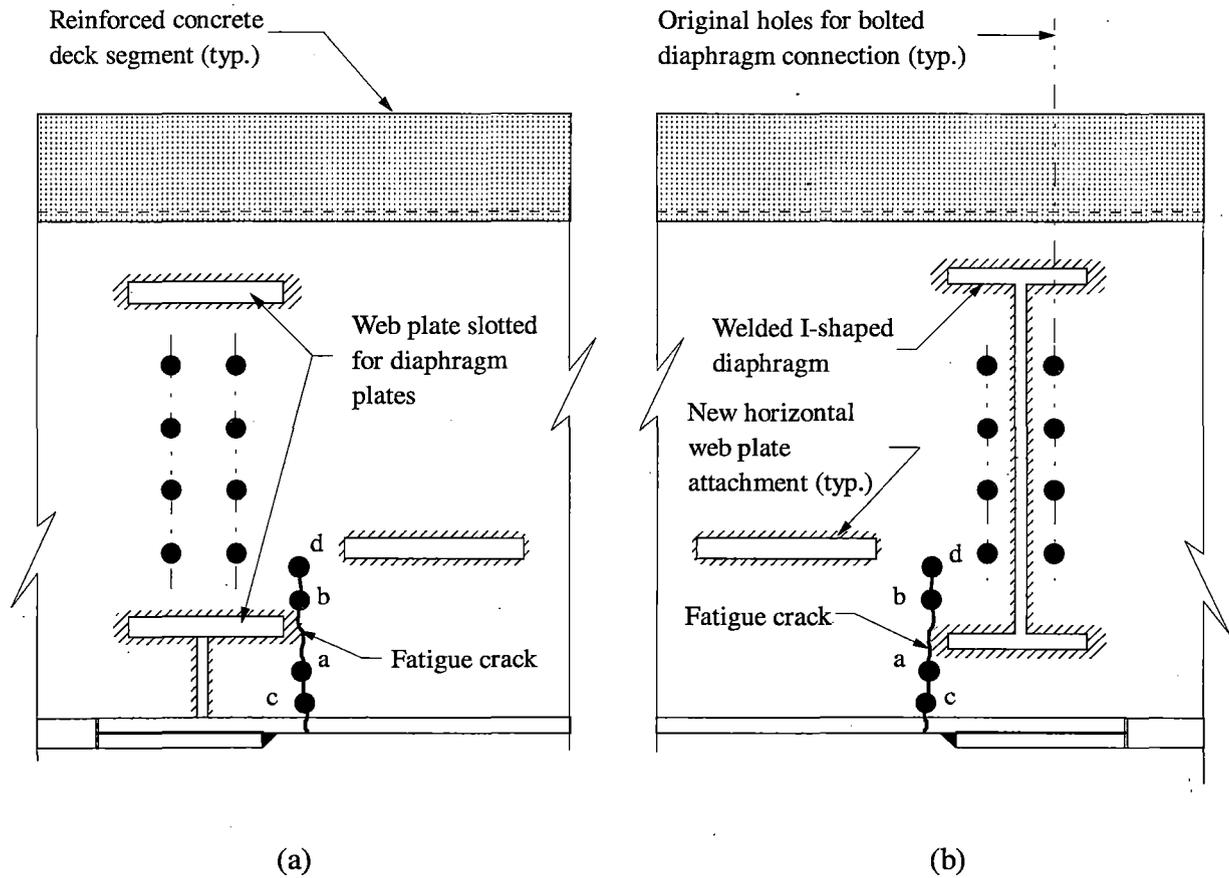
Figure 3.7. Fatigue fracture at the diaphragm connection in the long interior girder specimen no. 1: (a) Front elevation; (b) Back elevation

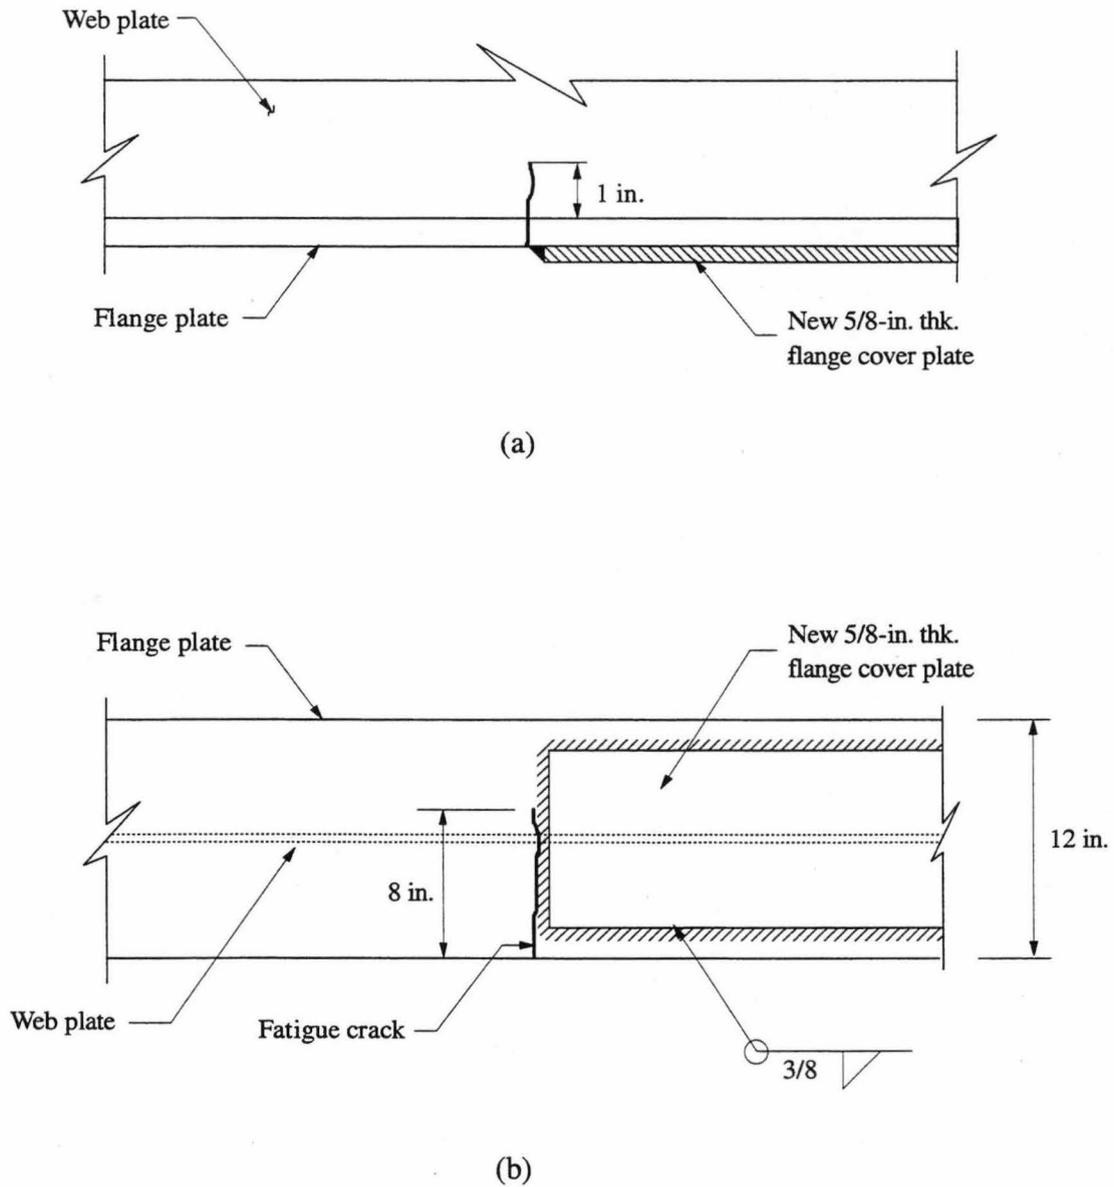
Figure 3.8. Fatigue fracture at the new bottom flange cover plate no. 2 on the short exterior girder specimen no. 1: (a) Partial elevation; (b) Underside of the bottom flange

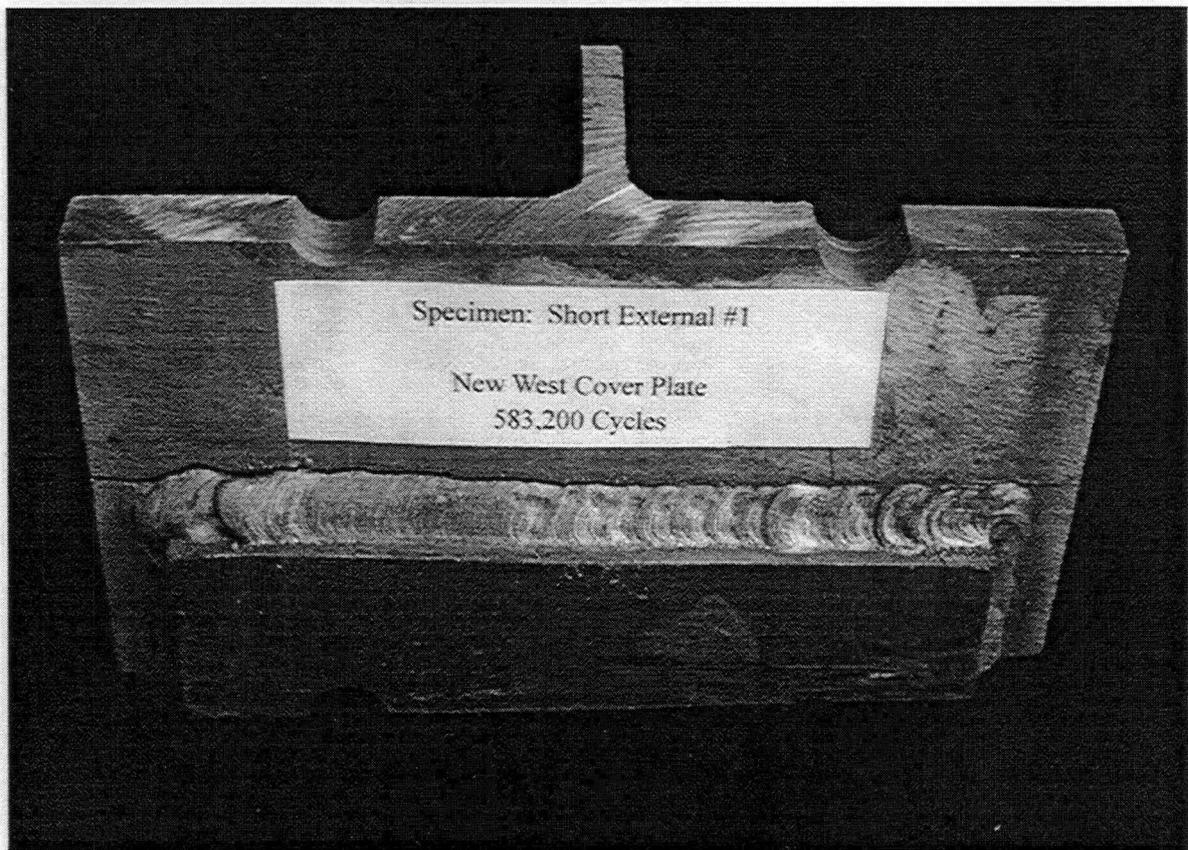
After the fatigue tests were completed, the portions of the girder specimens that contained fractures were removed for closer visual examinations. Figure 3.9 is a photograph of the fatigue

Figure 3.9. Photograph of the fatigue fracture at the new bottom flange cover plate no. 2 on the short exterior girder specimen no. 1

crack that developed along the toe of the fillet weld between the new, bottom flange, cover plate no. 2 and the bottom flange of the short, exterior girder specimen no. 1. The partial holes shown in the photograph were used to attach a steel reinforcing plate to the specimen after this flange failure had occurred, to permit additional testing of another weld detail. This flange fracture was carefully cut open to expose the interior fracture surfaces. Figure 3.10 is a photograph of the two surfaces along the plane of the fracture. The upper T-shaped portion contains the flange cover plate and the cover plate weld. The lower T-shaped portion was rotated 180° about a horizontal axis so that the left flange tips on both T-shapes are essentially in vertical alignment. A visual examination of the fracture surfaces revealed that the fatigue fracture may have propagated from an overlap in the weld

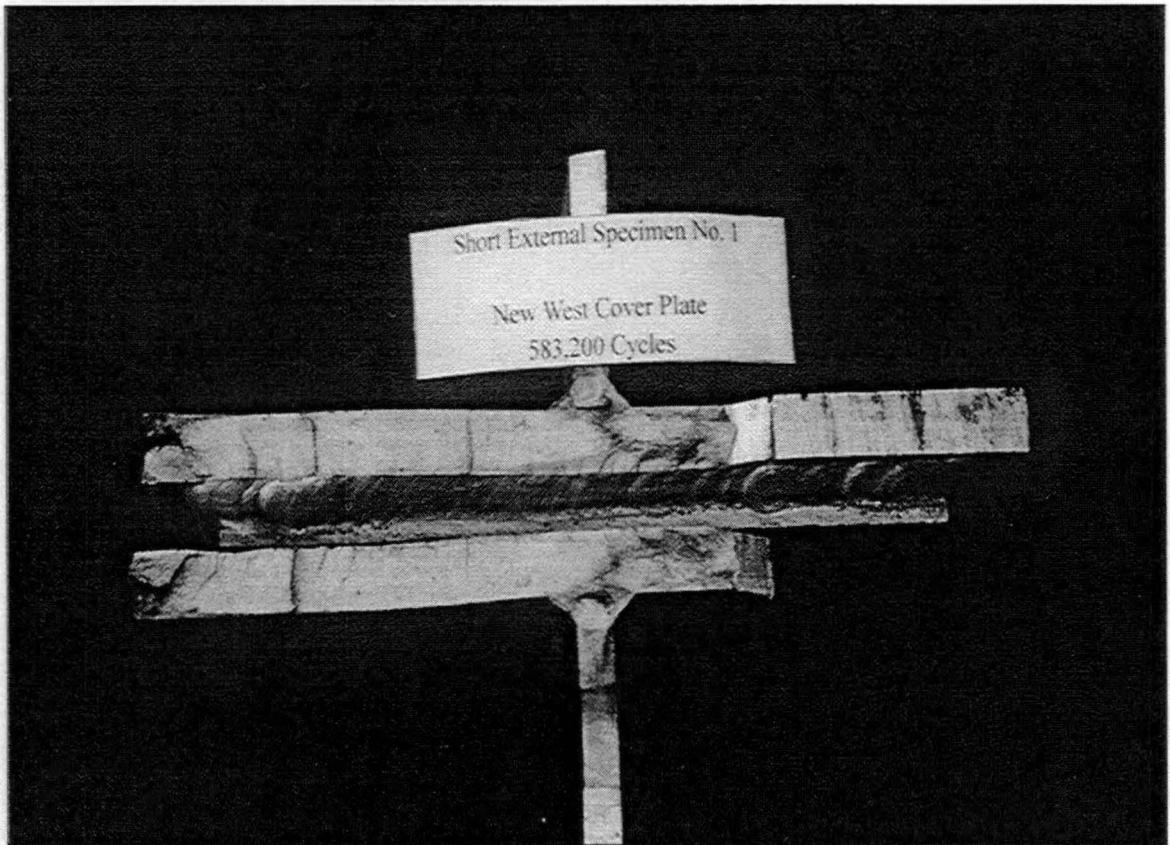
Figure 3.10. Photograph of the fracture surface at the new bottom flange cover plate no. 2 on the short exterior girder specimen no. 1

metal near the end of the cover plate. This type of discontinuity in the weld metal represents an interior flaw that could permit the development of a premature fatigue fracture.

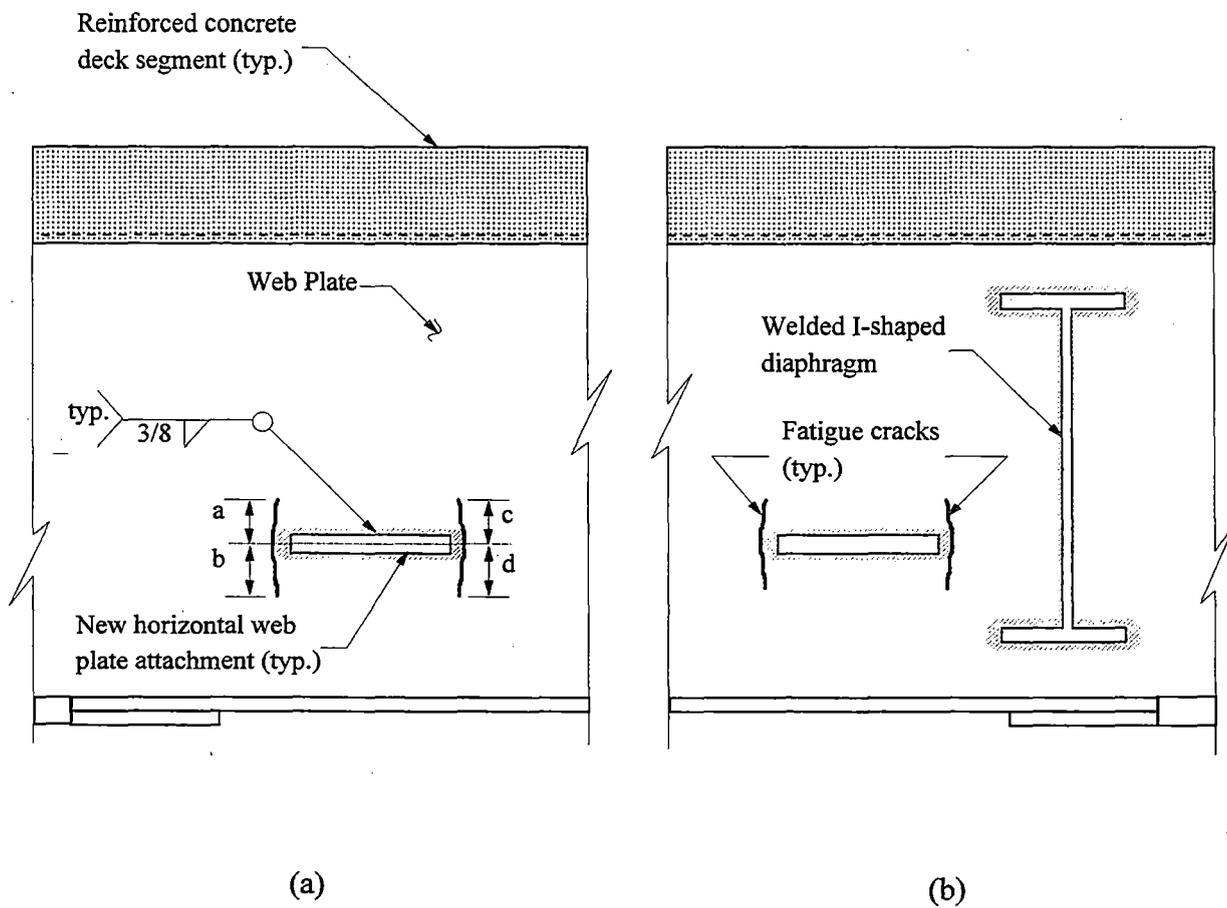
Figure 3.11. Fatigue fracture at the new horizontal web plate attachment no. 1 on the long exterior girder specimen no. 2: (a) Front elevation; (b) Back elevation

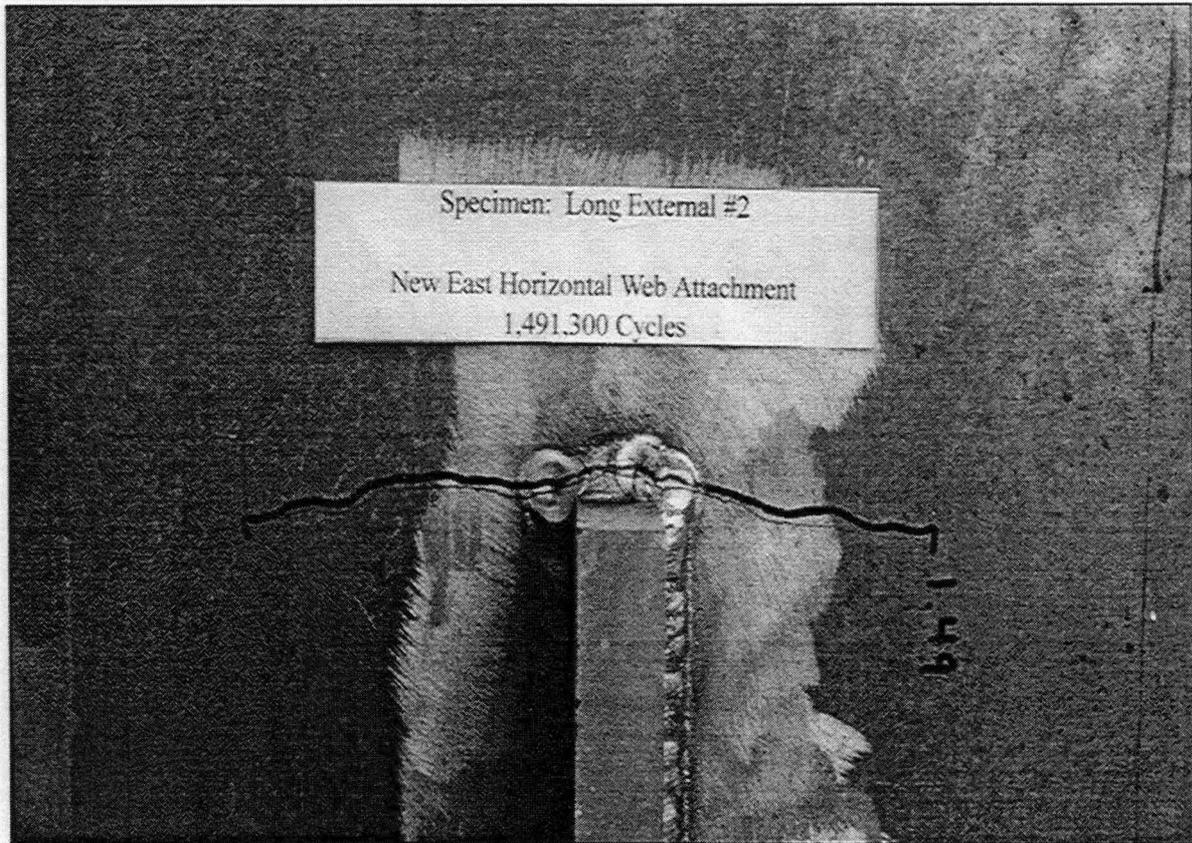
Figures 3.12 and 3.13 are photographs of the front and back faces, respectively, of the web plate on long, exterior girder specimen no. 2, that show the fatigue failures at the new, horizontal, web attachments no. 1. These photographs show the web plate attachment orientated in the vertical direction. A visual examination of this fatigue fracture revealed that the crack originated at a point of surface porosity in the weld metal. As discussed in Chapter 2, the web plate attachments were first tack-weld at their ends to the girder web plate before the longitudinal fillet welds were deposited along the plate lengths. Surface porosity is a weld defect that greatly reduces the fatigue life of a weldment [24,32,50]. The fatigue fracture shown in Fig. 3.13 passes through the weld metal, while that same fracture shown in Fig. 3.12 passes through the base metal along the toe of the fillet weld. Except for the new, horizontal, web plate attachment no. 2 in long, exterior girder specimen no. 2, the web plate attachments were accidentally misaligned by approximately 1/4 in. along the length of the specimens. Therefore, a fatigue fracture could propagate through the weld metal on one face of the web plate and through the base metal on the other face of the web plate.

Figure 3.12. Photograph of the fatigue fracture at the new horizontal web plate attachment no. 1 on the front face of the long exterior girder specimen no. 2

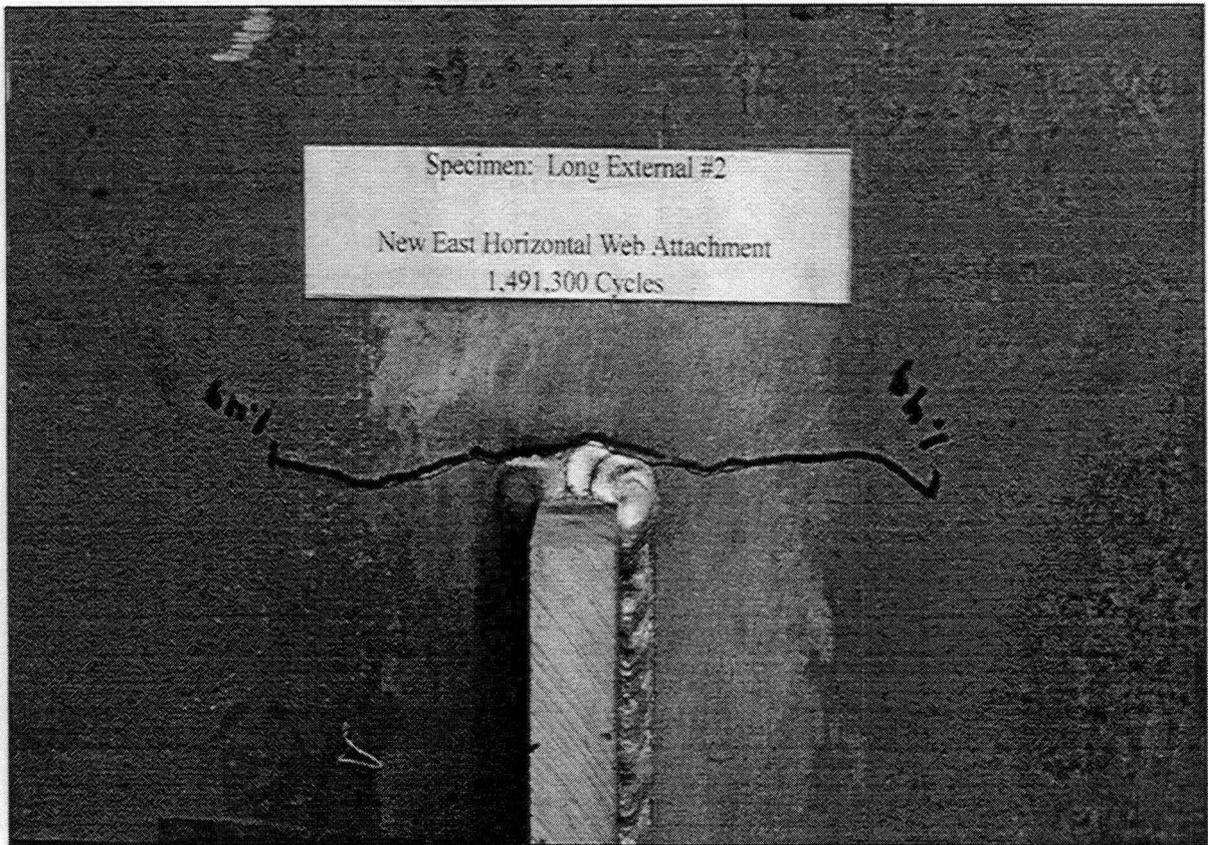
Figure 3.13. Photograph of the fatigue fracture at the new horizontal web plate attachment no. 1 on the back face of the long exterior girder specimen no. 2
