Development of In-Situ Detection Methods for Materials-Related Distress (MRD) in Concrete Pavements

Phase 1 Report
July 2003

CTRE Project 00-96

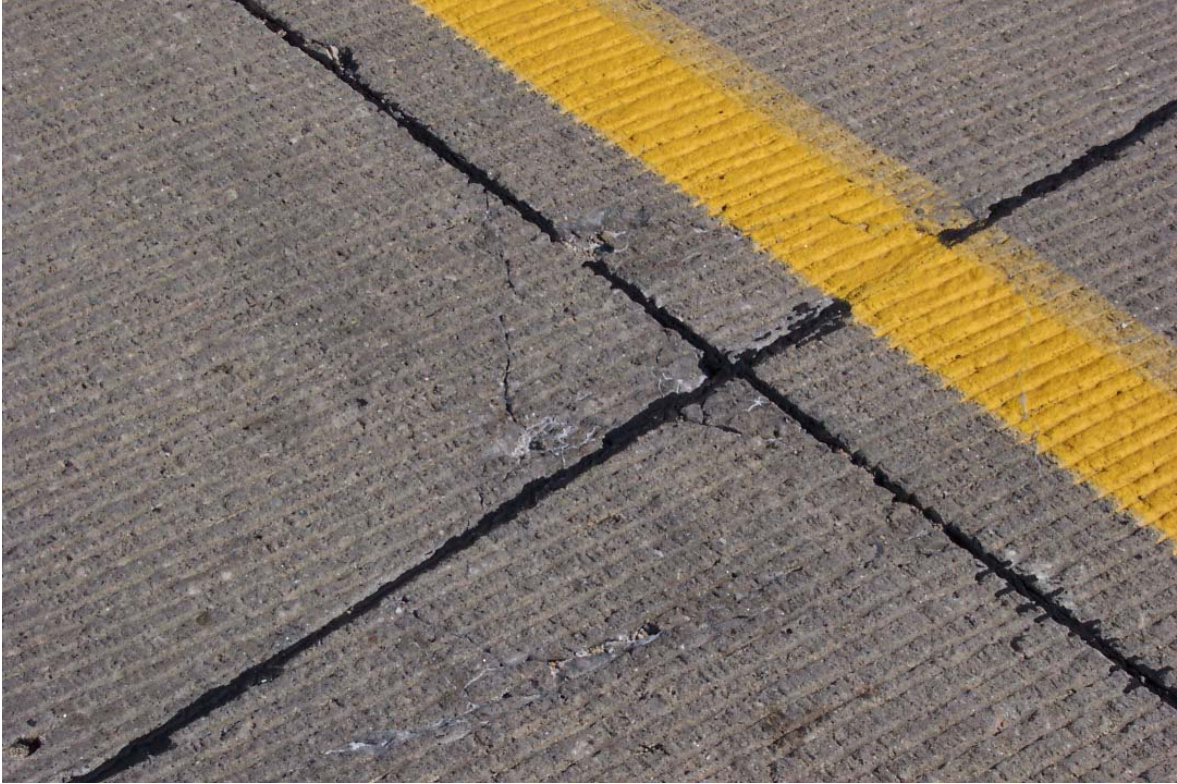
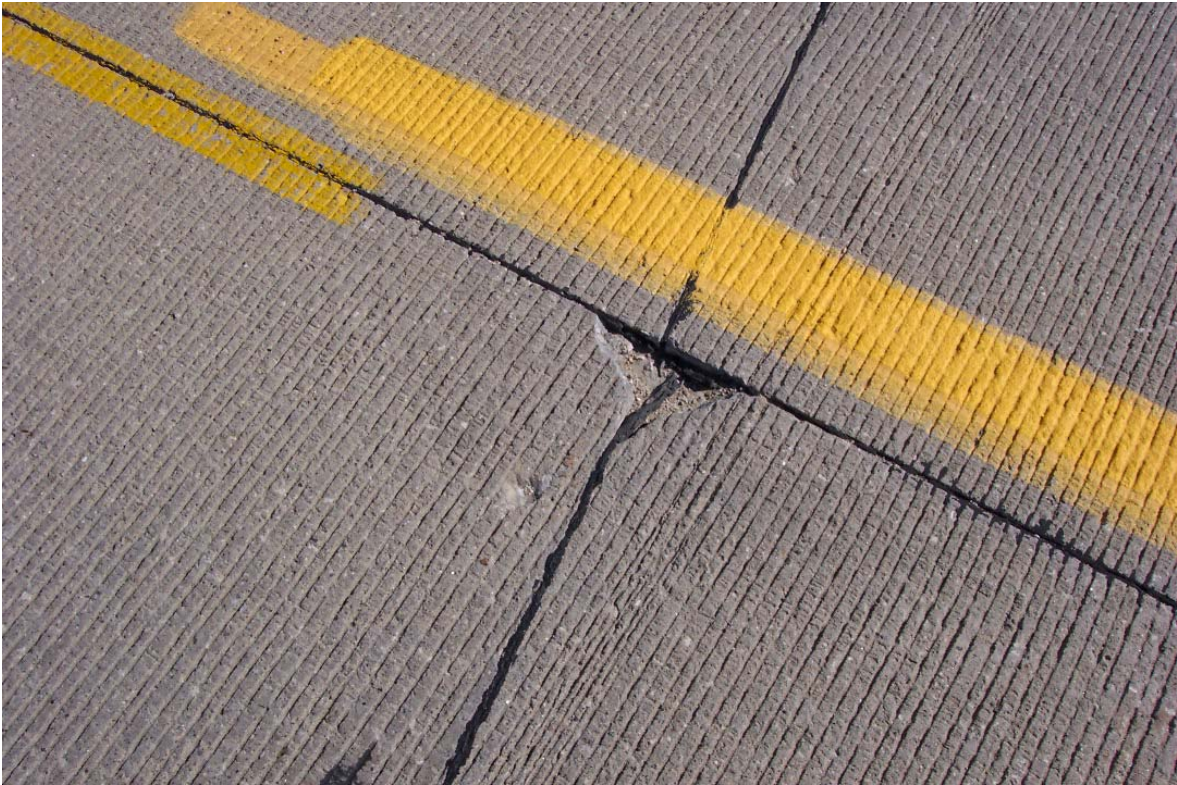
Figure 13. Typical Distress Features Noted on US 63 (note cracking in top photo)

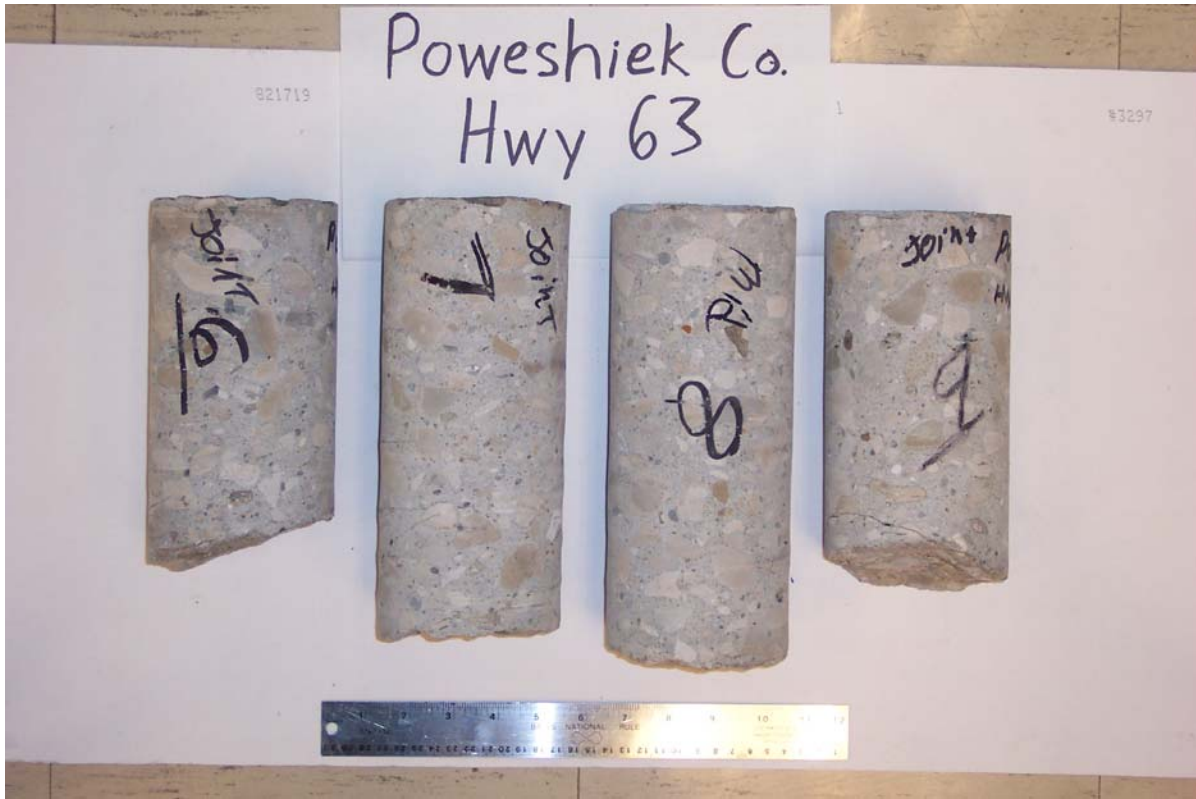
Figure 14. Cores Extracted from US 63 (note deterioration at the base of the cores)

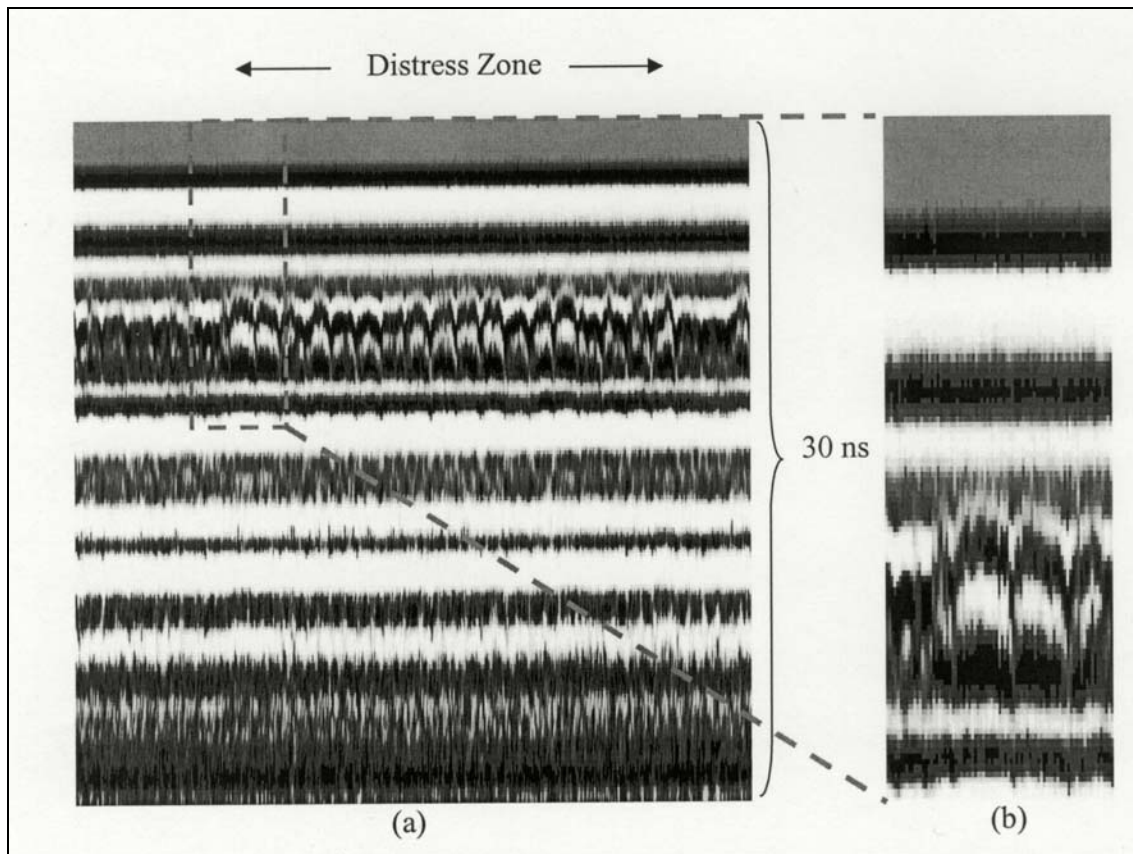
Figure 16. Magnified View of the GPR Data in the Distress Region (900 MHz antenna)

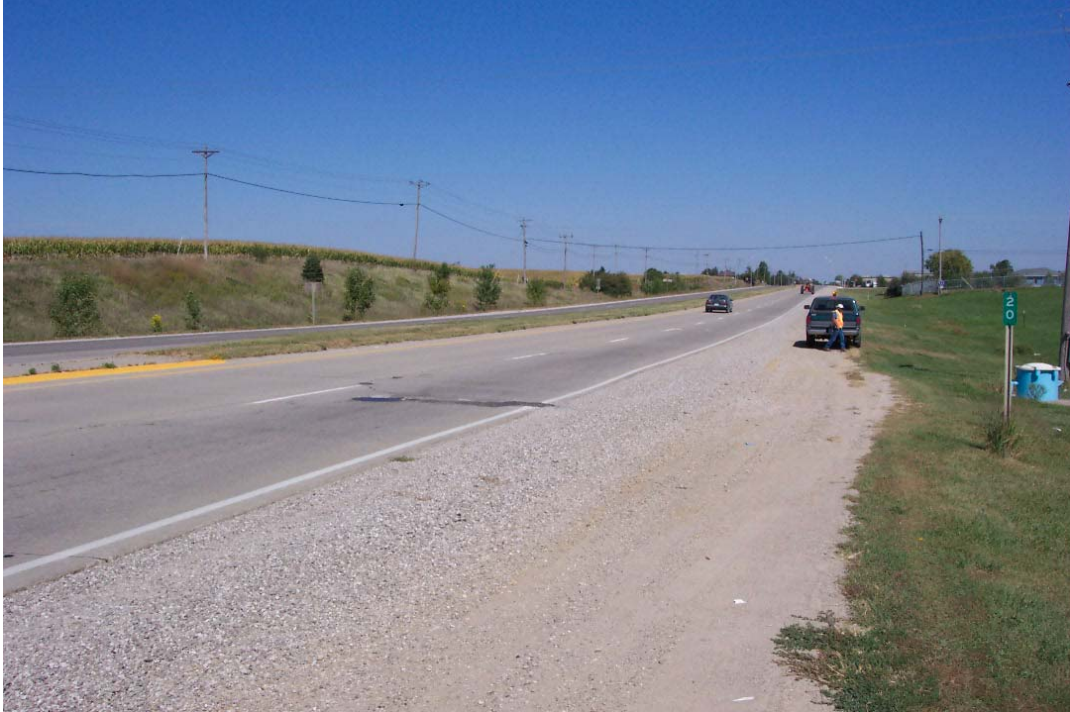
The pavement exhibited some signs of distress (note the patches in Figure 18); however, this was commonly limited to small spalls or corner breaks (see Figure 19). Little cracking was noticed in other regions of the pavement slabs. Cores extracted from the pavement exhibited cracking near the base of the slab (see Figure 20). Steel bars (3/8" nominal diameter) were observed in the bottom third of the cores extracted from the joint region of the pavement slab. Cores extracted from the pavement joints tended to show more deterioration than cores extracted from the mid-panel region. However, the distress noted in the cores from Highway 146 was not as severe as the distress observed in cores from US 63. Petrographic examination of the cores indicated that the cracking was again related to a failure of the coarse aggregate particles (see Appendix B). This is consistent with "normal" behavior for coarse aggregate from Malcom mine. Note that the concrete in US 63 is about three years older than the concrete in Highway 146; this may partially explain the difference in distress noted at the two sites.

Figure 18. Overview of Hwy 146 Pavement Site (looking north, note patches)

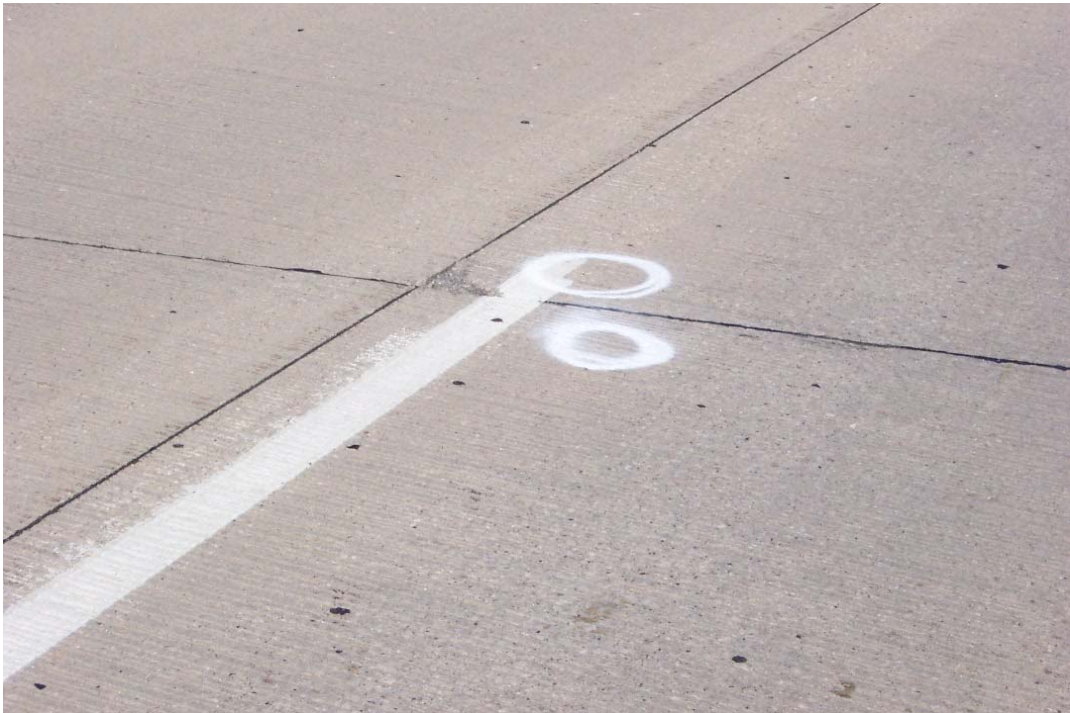
Figure 19. Common Distress Features at Hwy 146, Spalling or Corner Breaks

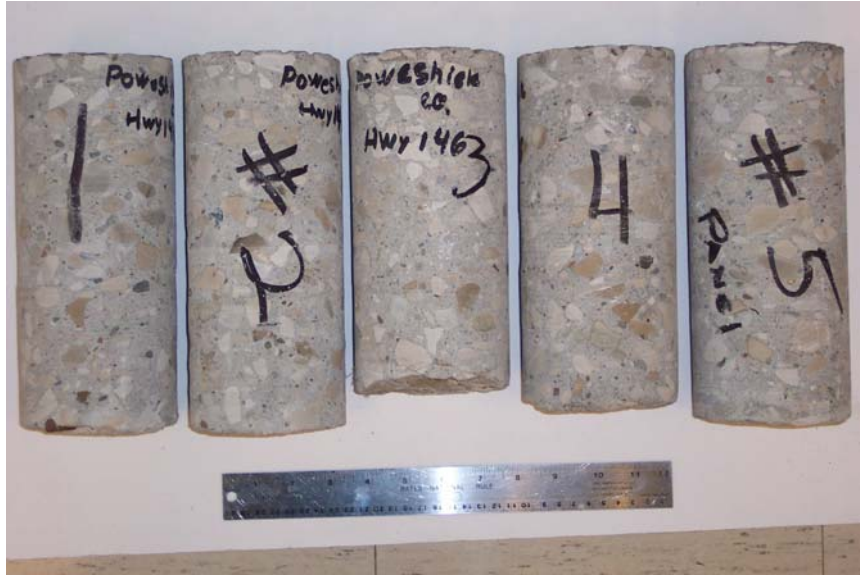
Figure 20. Cores Extracted from Hwy 146 (note deterioration at base of cores)

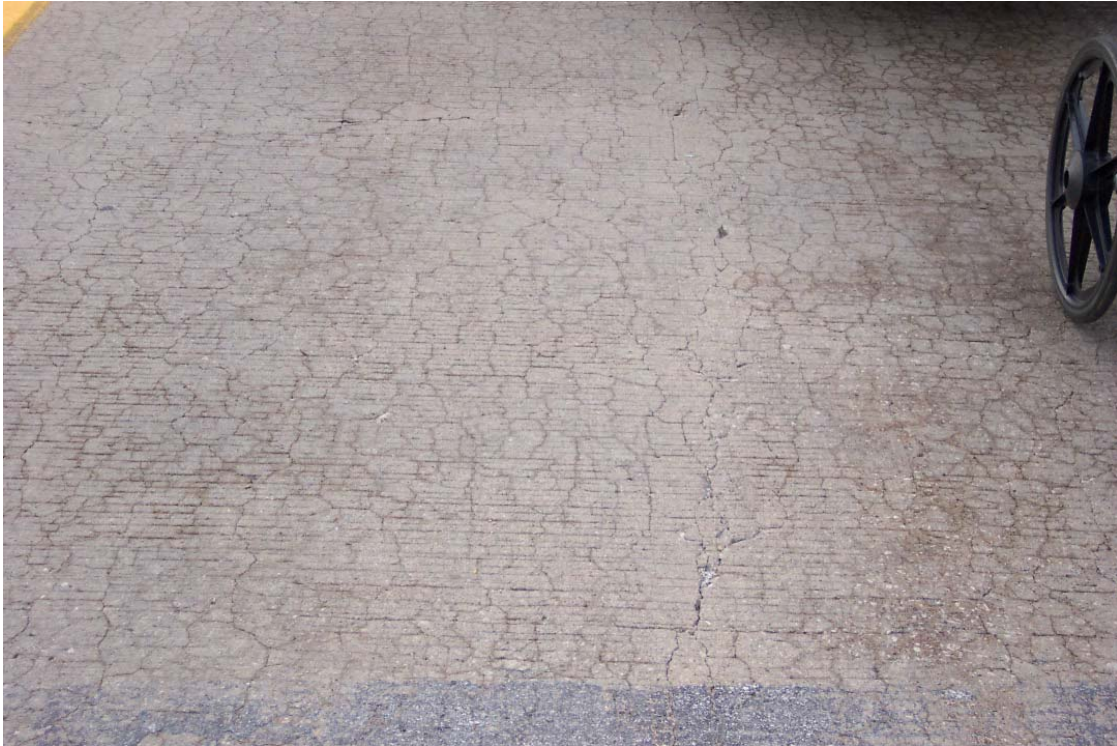
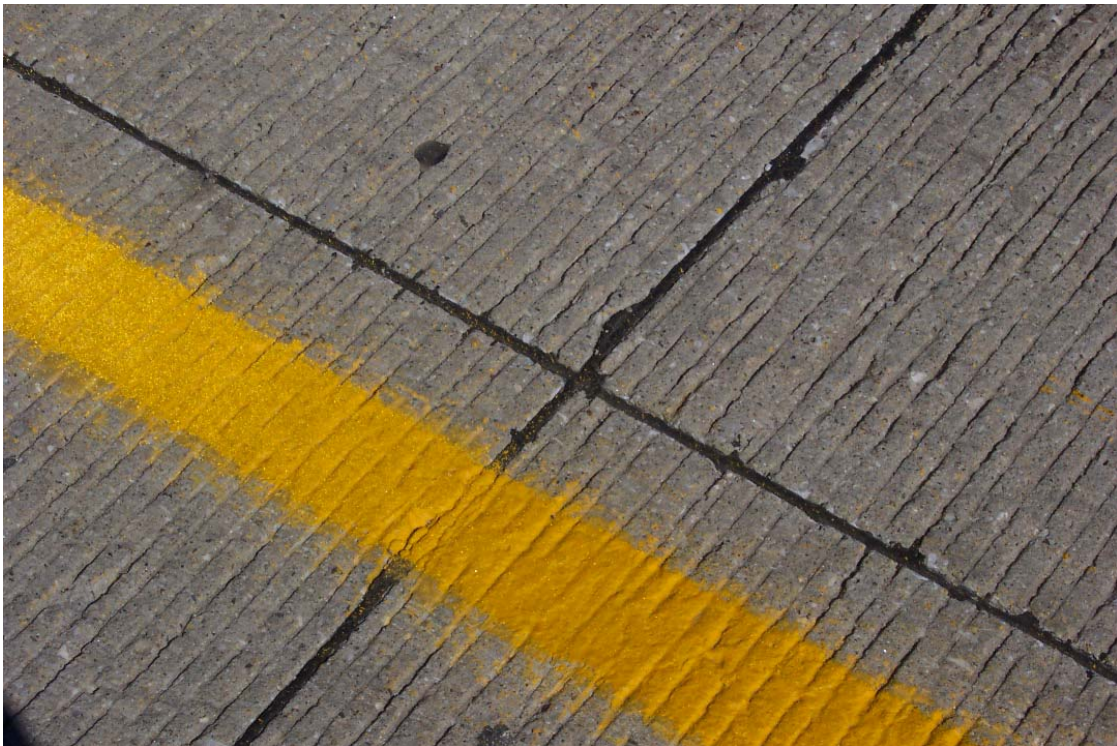
**Figure 23. Distress Noted on P 73
(top, map cracking over much of slab; bottom, not distinct at joints)**

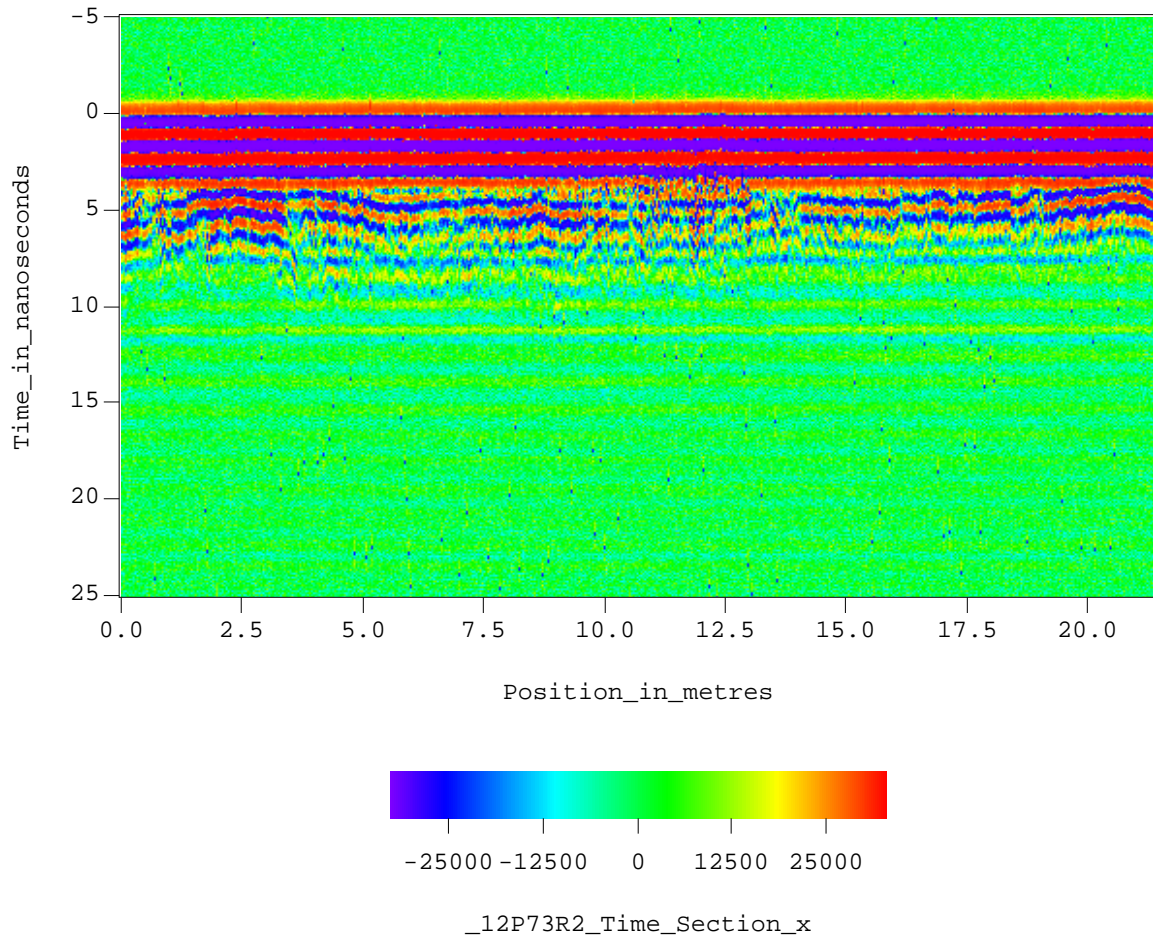
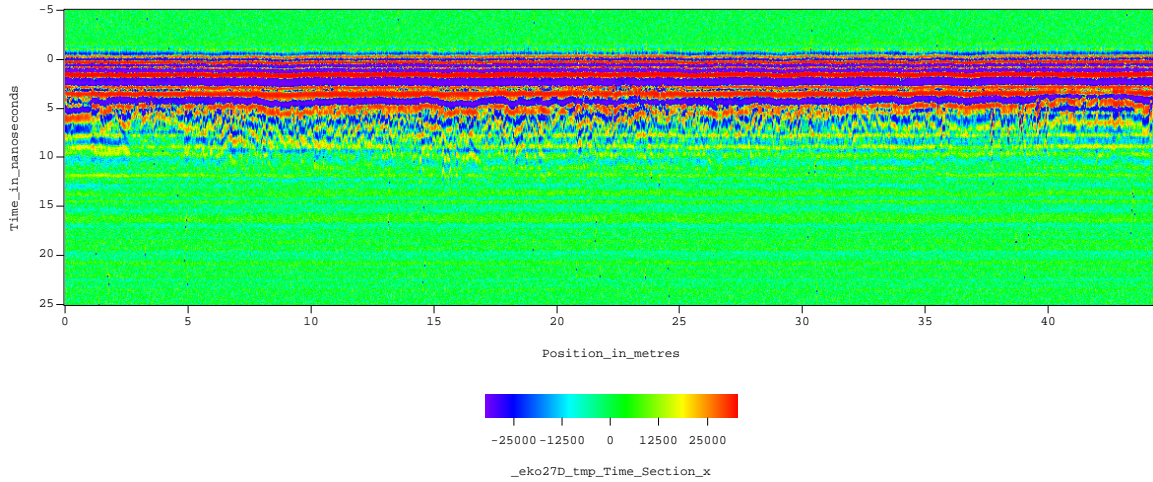
Figure 26. High-Resolution GPR Data from P 73 (note lack of distress features in signal)

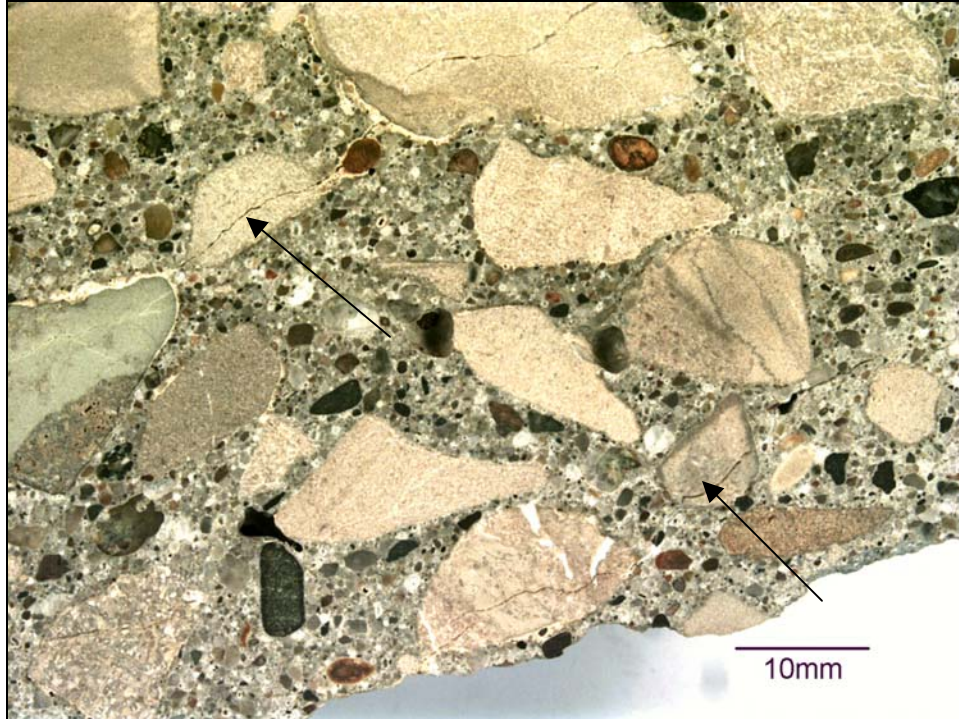
Distress was the results of fractures occurring at the base of the slab. The fractures were sub-parallel to the base. Distress was worse at the joints than the mid-panel, although the core from the mid-panel showed some distress in the form of fractured coarse aggregate particles. Fractures were seen at the paste/aggregate interface and in the interior of the aggregate particles. Some of the fractures terminated in the paste. The paste was discolored around some of the coarse aggregate particles. In the coarse aggregate particles, both coarse and fine-grained particles contained fractures. There was no indication of alkali silica reactions (ASR) or alkali carbonate reactions. The most likely cause for the distress was failure of the coarse aggregate particles, possibly due to the capillary pore system. The distress may have been magnified due to poor drainability of the subbase and possibly due to anti-icing brines leaking through the joints.

Figure A.5. Base of core from near a joint shows sub-parallel fractures also parallel the base of the slab.

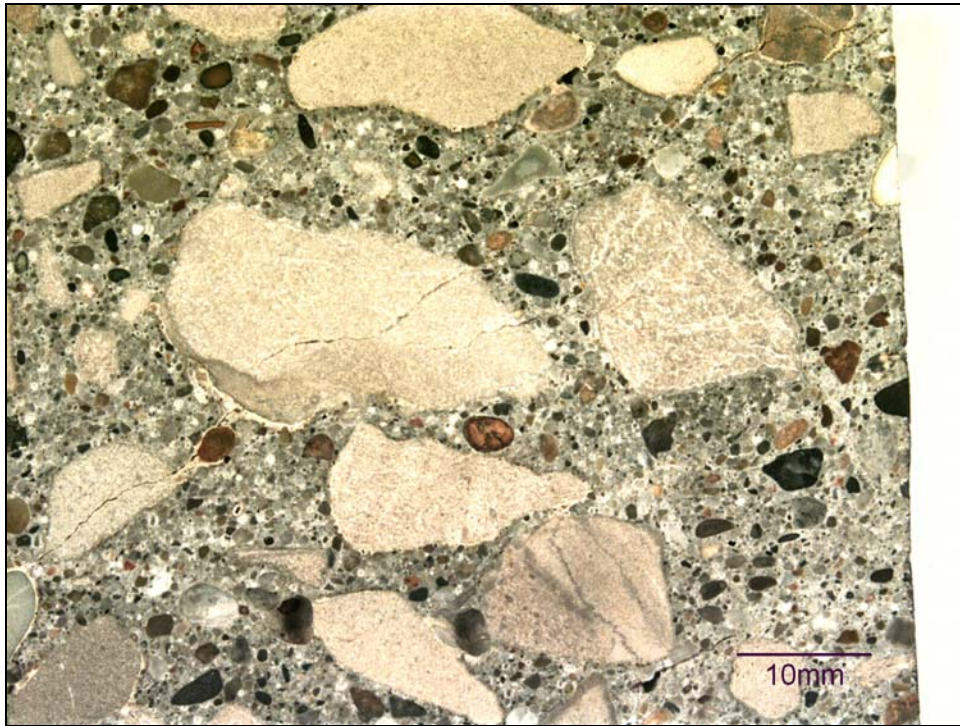
Figure A.6. Most of the fractures were through the interior of the coarse aggregate particles. Fractures can be traced through multiple aggregate particles.

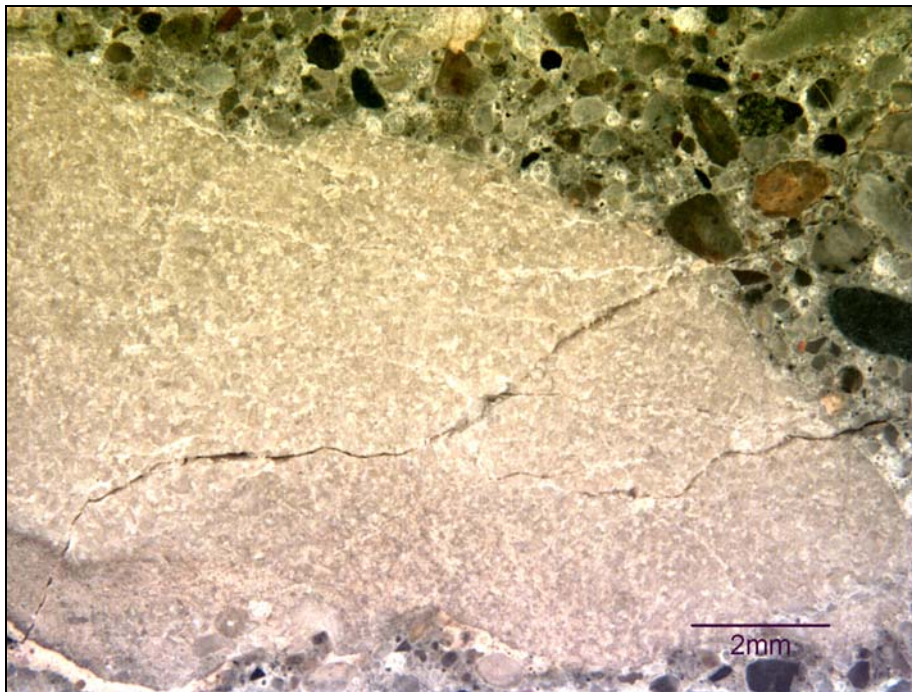
Figure A.7. Fracture pattern in a coarse aggregate particle in the bottom of the core from near the joint.

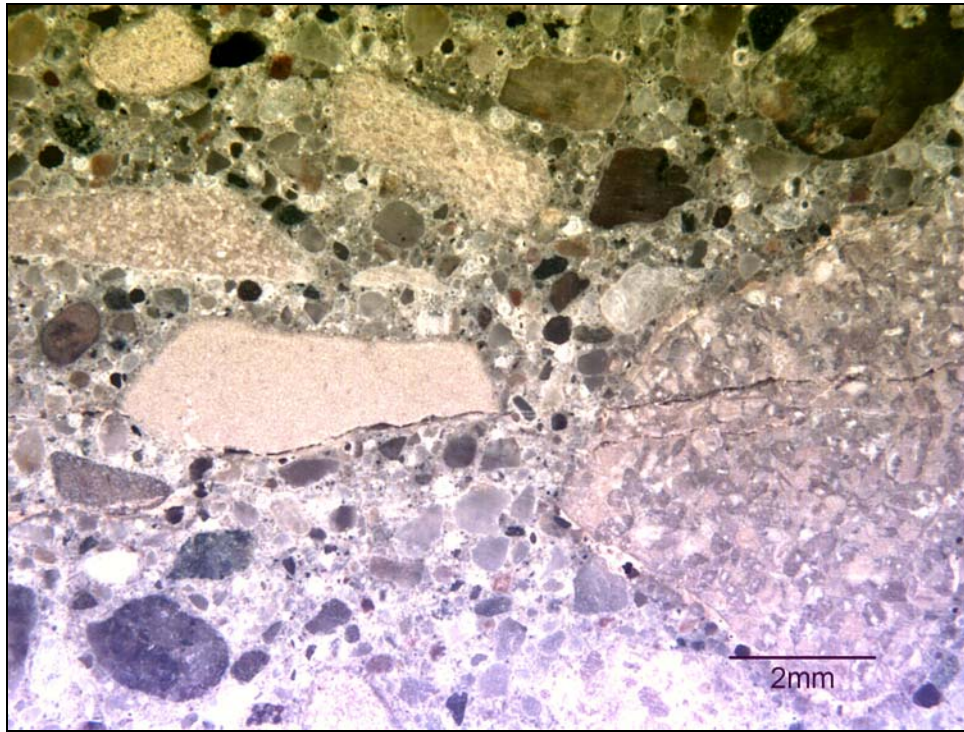
Figure A.8. Some fractures were at the aggregate paste interface and others passed through the interior of the aggregate (bottom of the core near joint).

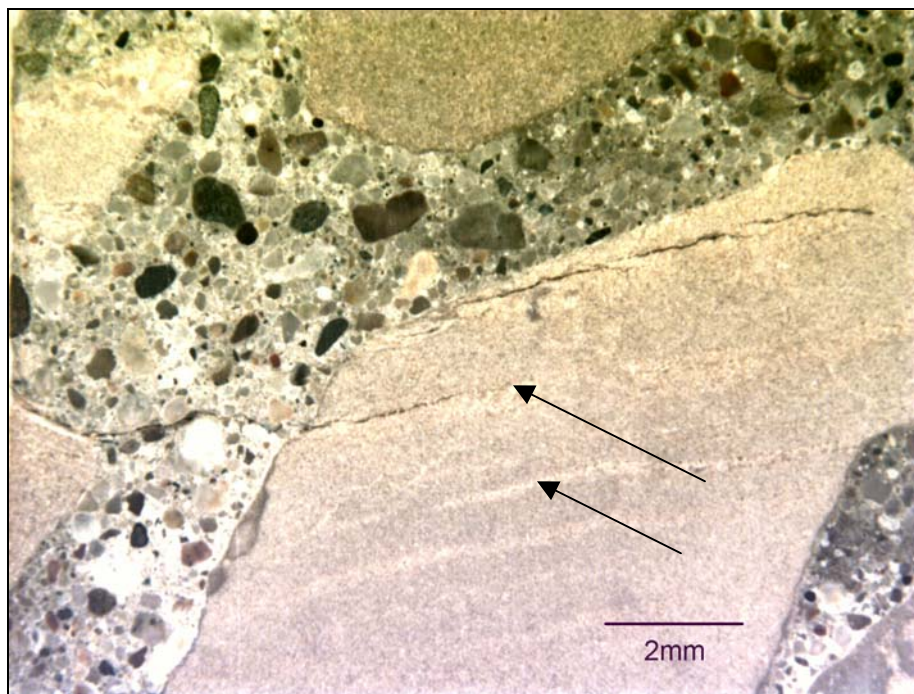
Figure A.9. Light colored bands in this coarse aggregate particle were zones of weakness that resulted in fractures.

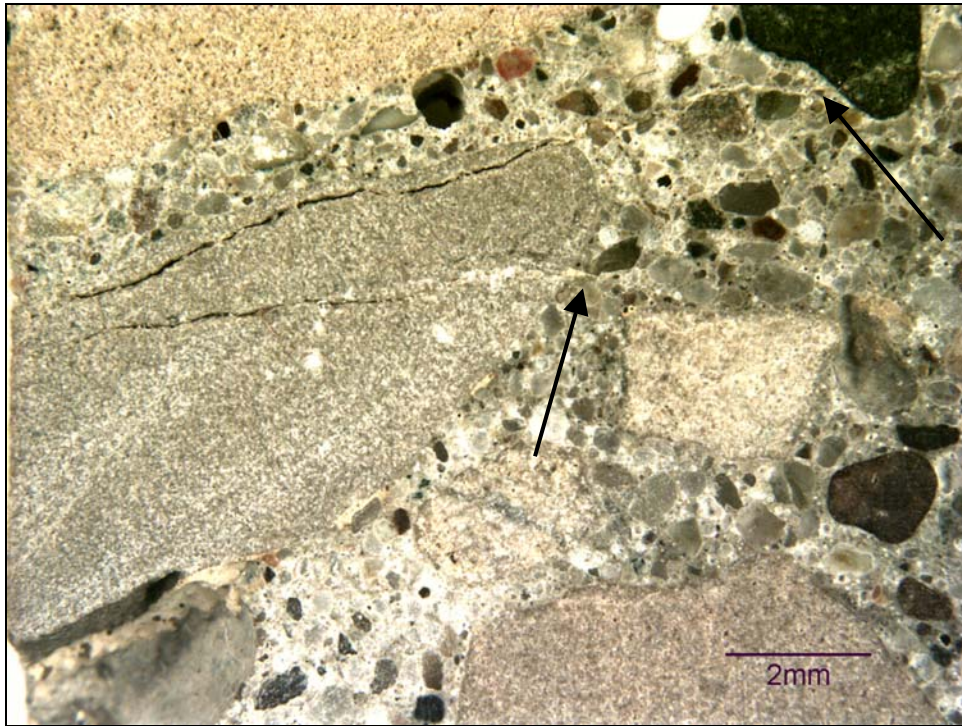
Figure A.10. Some fractures extended into the paste and others terminated within the paste.

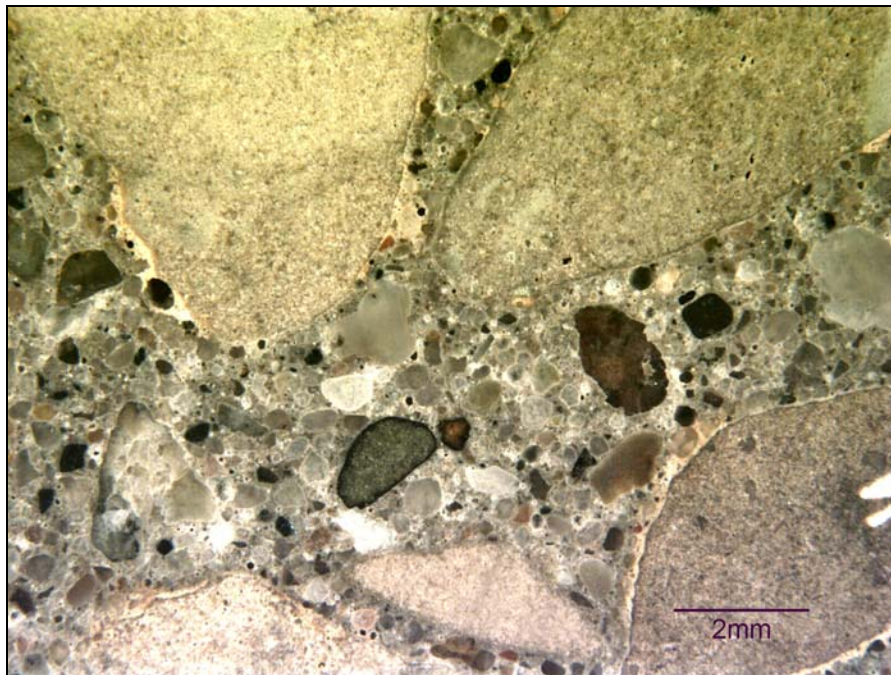
Figure A.11. Discoloration of the paste at the paste aggregate interface. Core was from the bottom of the mid-panel.

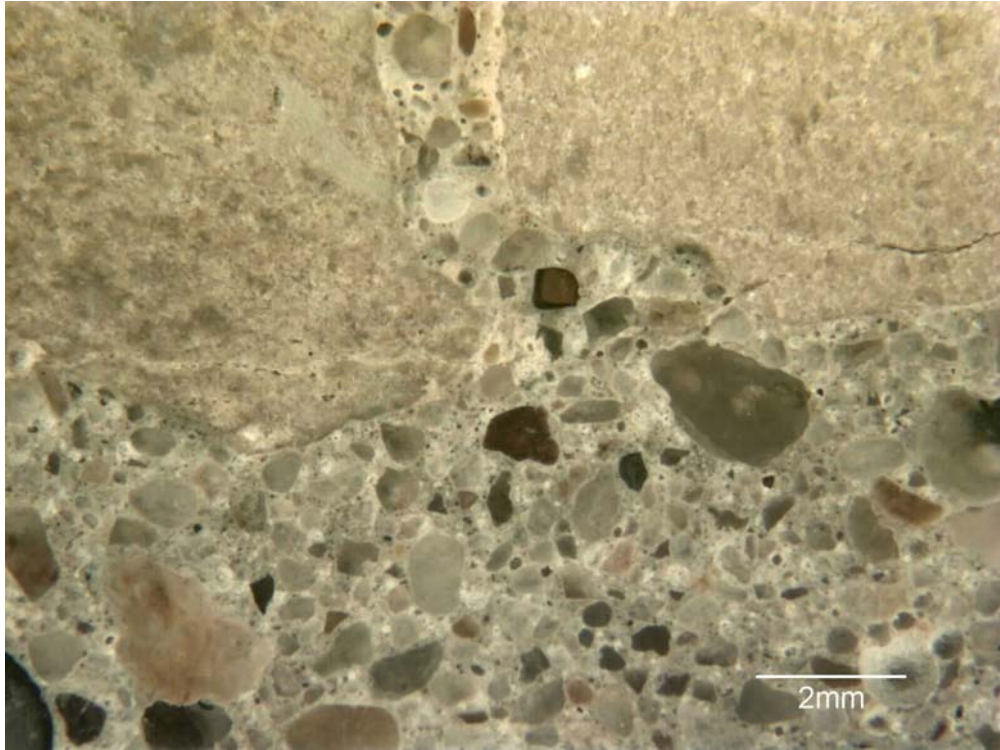
Figure B.2. Core 3: note crack in coarse aggregate particle terminating in paste

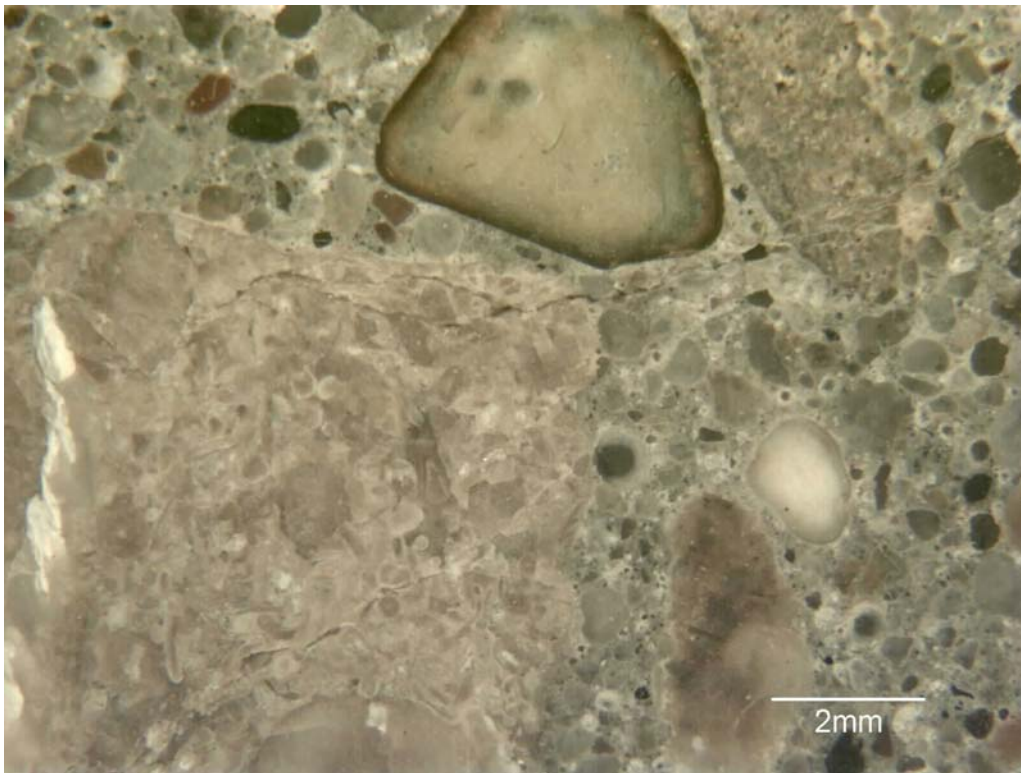
Figure B.3. Core 3: note crack in coarse aggregate particle terminating in paste

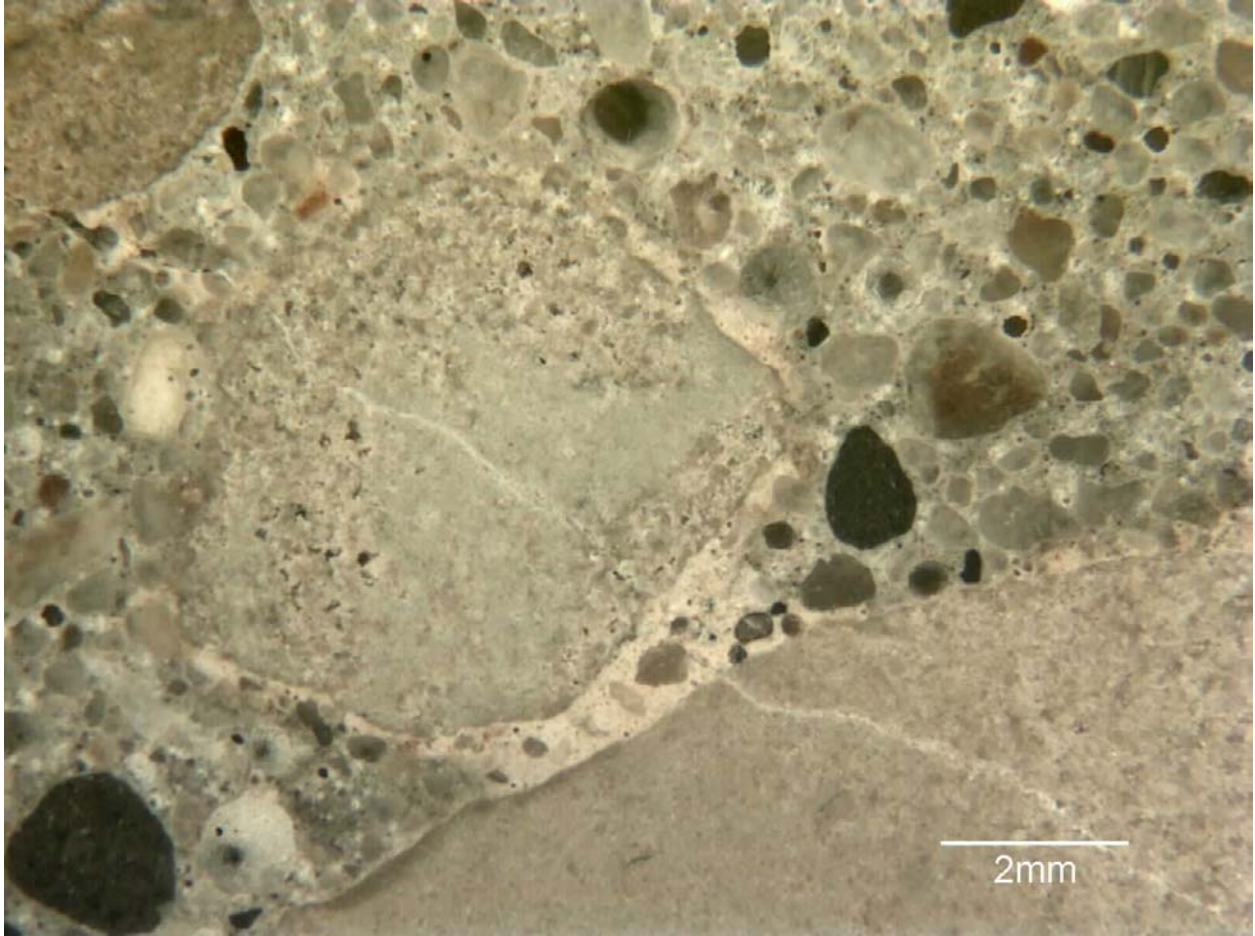
Figure B.4. Core 3: note discolored paste adjacent to coarse aggregate particle. The crack in the aggregate particle near the middle of the image suggests the presence of some ASR.

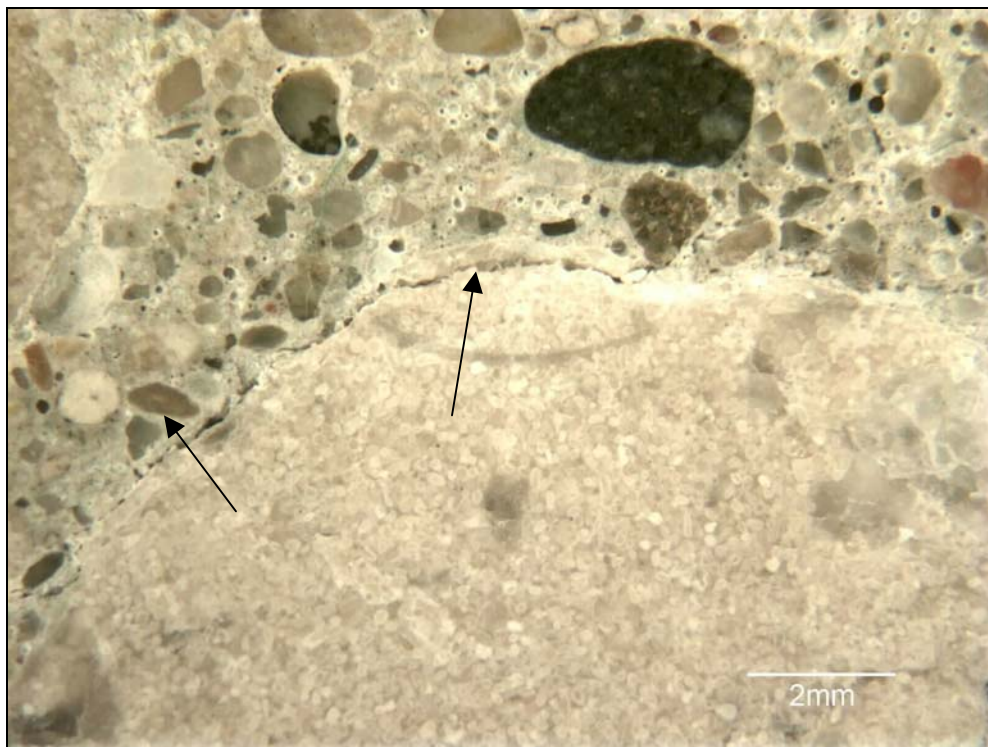
Figure C3. Optical photomicrograph from the polished section from core 2 showing an oolitic and fossiliferous coarse aggregate particle. Fractures are seen at the aggregate/paste boundary.

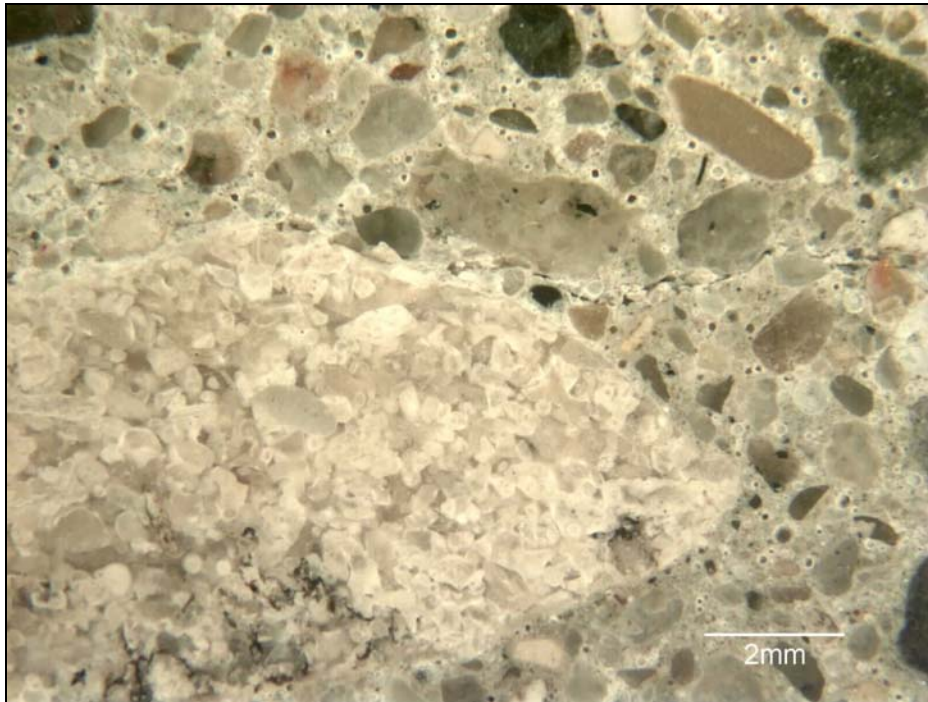
Figure C.4. Optical photomicrograph from core 2 showing another oolitic/peloid coarse aggregate particle. In this case, the fracture extends from the aggregate/paste boundary into the cement paste (core 2).

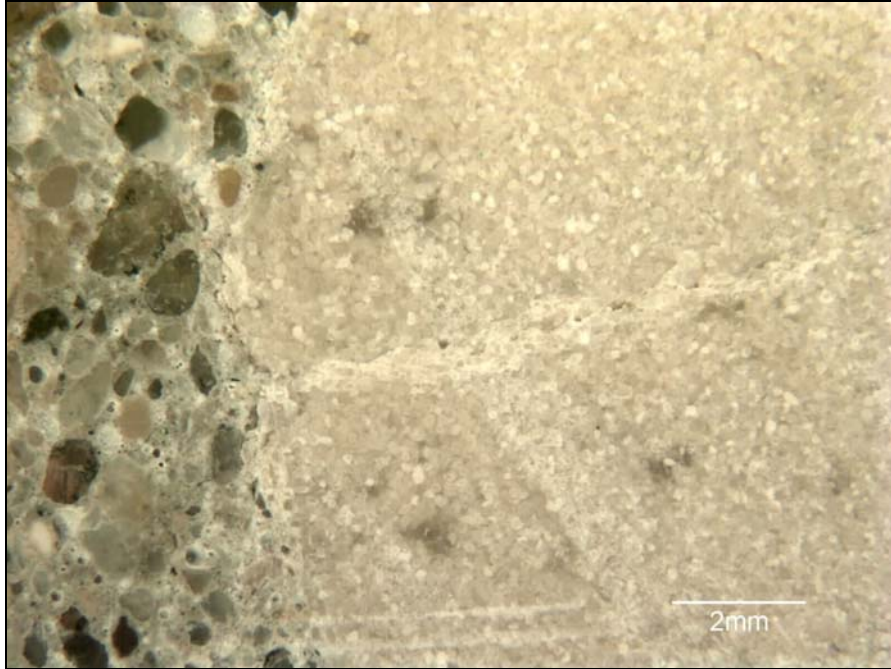
Figure C.6. Example of a fracture in a coarse aggregate particle, which terminates at the paste boundary (core 2). Features such as this indicate the pavement failure was not due to aggregate problems.

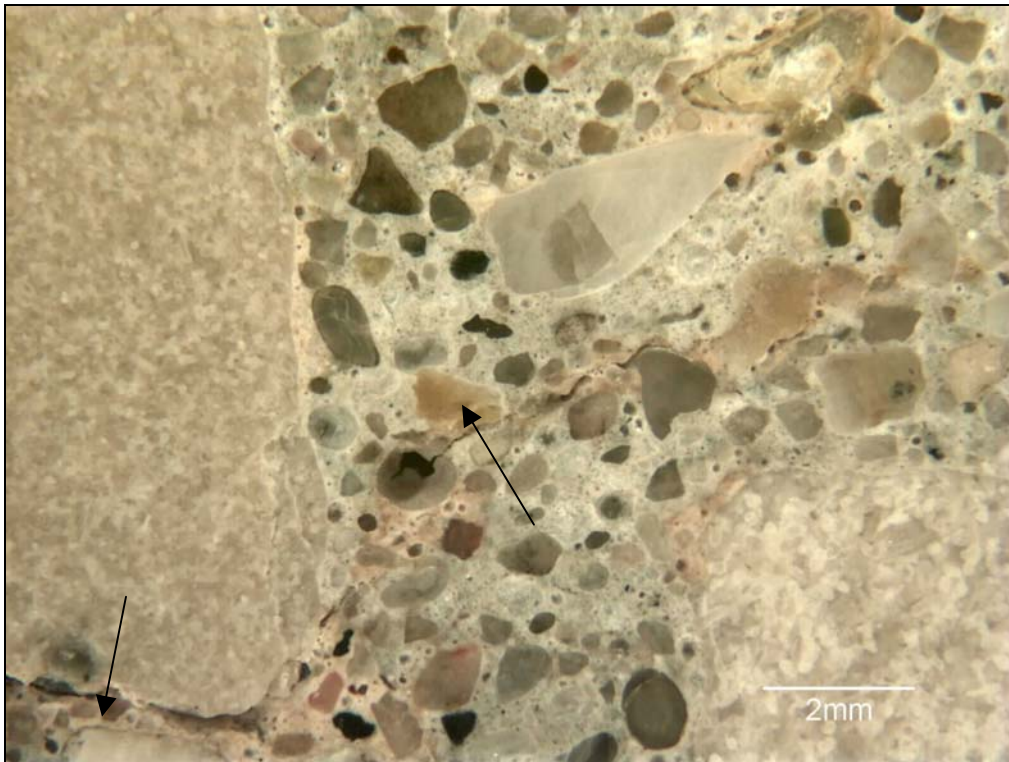
Figure C.7. Example of a fracture along the aggregate/paste boundary extending into the cement paste (core 1).

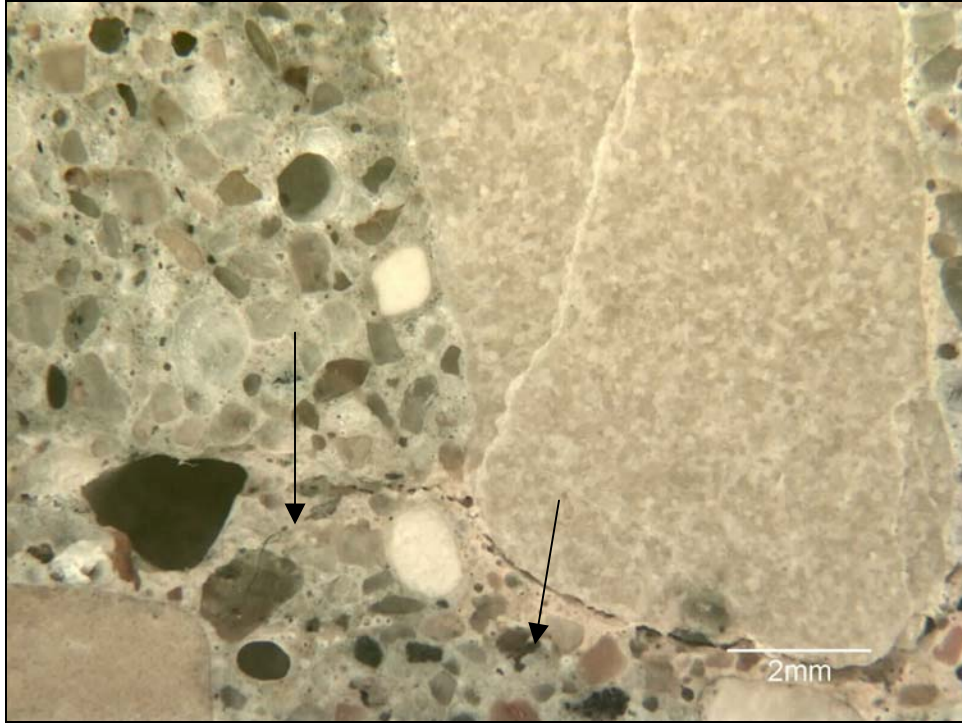
Figure C.8. The fracture along the aggregate paste boundary extends into the paste while the fracture in the aggregate terminates at the paste (core 1).

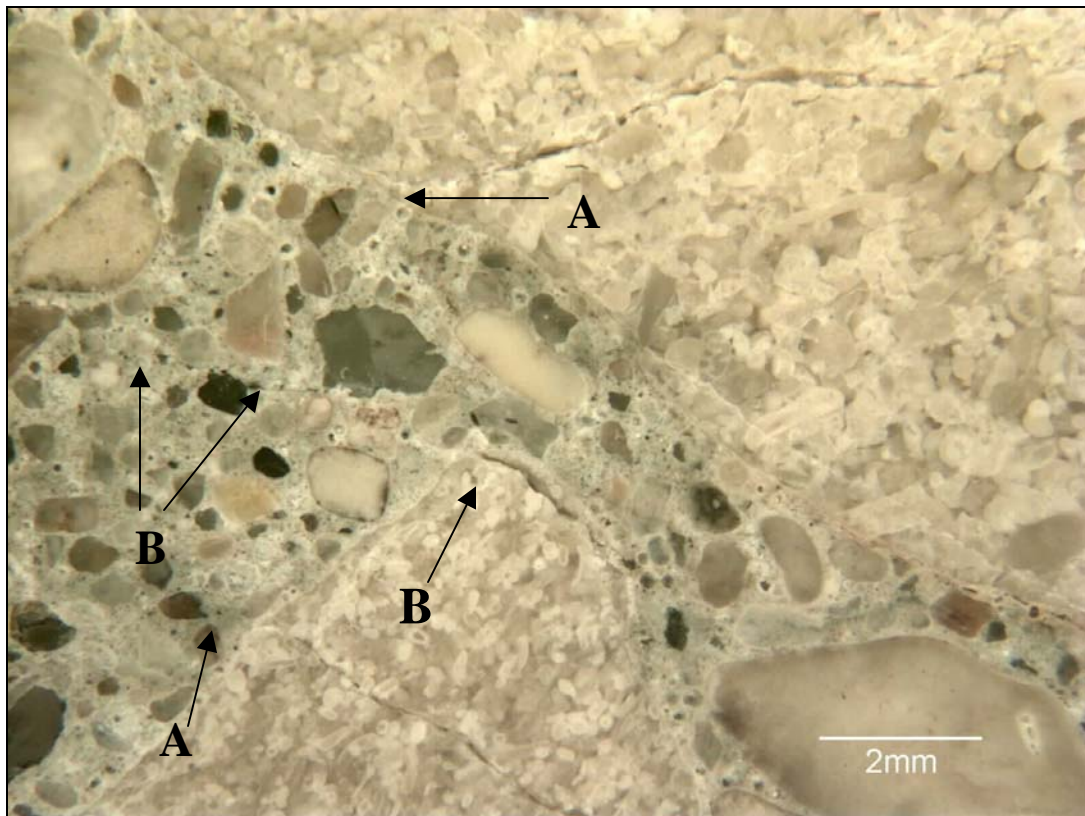
Figure C.9. Fractures in the aggregate (A) terminate at the edge of the particle while fractures at the aggregate/paste boundary extend into the paste.
