Performance Evaluation of Recent Improvements of Bridge Abutments and Approach Backfill

Tech Transfer Summary

November 2018

TR-736

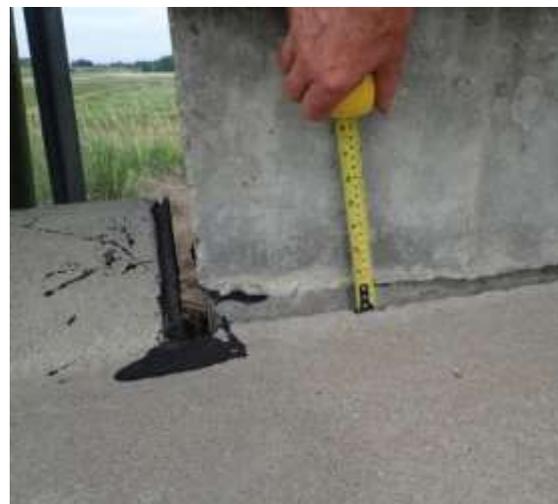
2. Failed joints between the barrier walls and the approach slabs of the integral abutment bridges were typically observed. The resulting gaps were large, measuring more than 1 inch in some cases, and would allow large volumes of water to drain from the deck under the approach slab.

Gap between north barrier and approach slab at west approach of bridge 5627.1O061.

The results show that integral abutment bridges had larger voids, which leads to two discussion points. First, the larger voids are partially attributable to the cyclic longitudinal movement of the abutment; however, the voids are exacerbated by the gap between the bridge barriers and approach slabs. Failure of the sealant is likely caused by large differential movements between the approach slab and the barrier. This gap allows deck runoff water to saturate the backfill below, causing the backfill to compact and erode. While none of the bridge approaches had experienced enough settlement to be a concern, extensive erosion may eventually lead to deterioration and failure of the bridge approach slab due to loss of support.

1. A new maintenance plan incorporating more frequent inspection and/or maintenance should be implemented to improve the condition of the joints.
2. A joint sealant capable of tolerating the large differential movements between the barriers and the approach slabs should be applied in existing bridges. For new bridges, methods eliminating this differential movement should be applied, such as casting the barriers as part of the approach slab system.

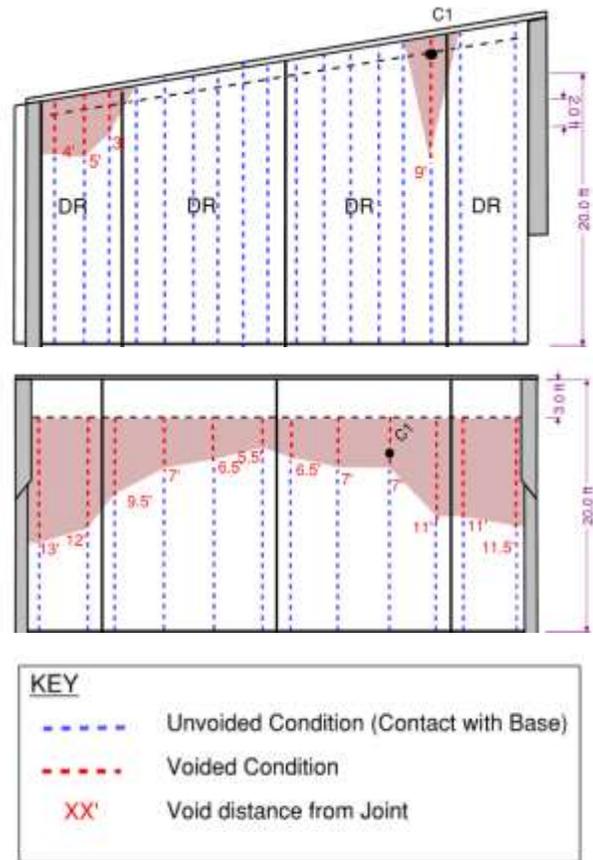
4. GPR testing indicated presence of voids under the approach slabs adjacent to the abutments at the three integral bridges inspected in detail, and limited voiding under the approach slabs at the stub abutment inspected in detail. Void extents varied. The voids extended approximately 4 feet into the approach slab from the expansion joint near the centerline of the pavement to a maximum void length of 13 feet at the barriers.

Void conditions at east approach of bridges 5111.5O034 (top, stub abutment) and 5126.5S078 (bottom, integral abutment) according to GPR.

4. GPR surveys should be included in future inspections if voiding under slabs is a primary concern due to the technique's effectiveness and reliability.

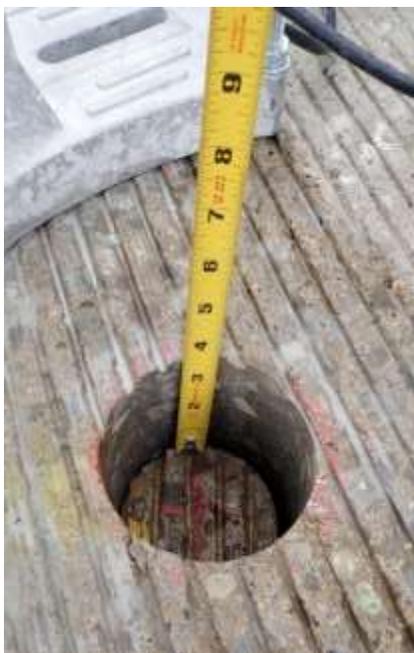
5. Cores collected at all four bridges confirmed the presence of voids detected by GPR. The core drop was only 0.25 inches at the stub abutment bridge while core drops varied up to 6.25 inches across the integral abutment bridges. The maximum drop was observed at bridge 5624.2O061.

View of core drop (3.5 inches) at Bridge 5126.5S078.

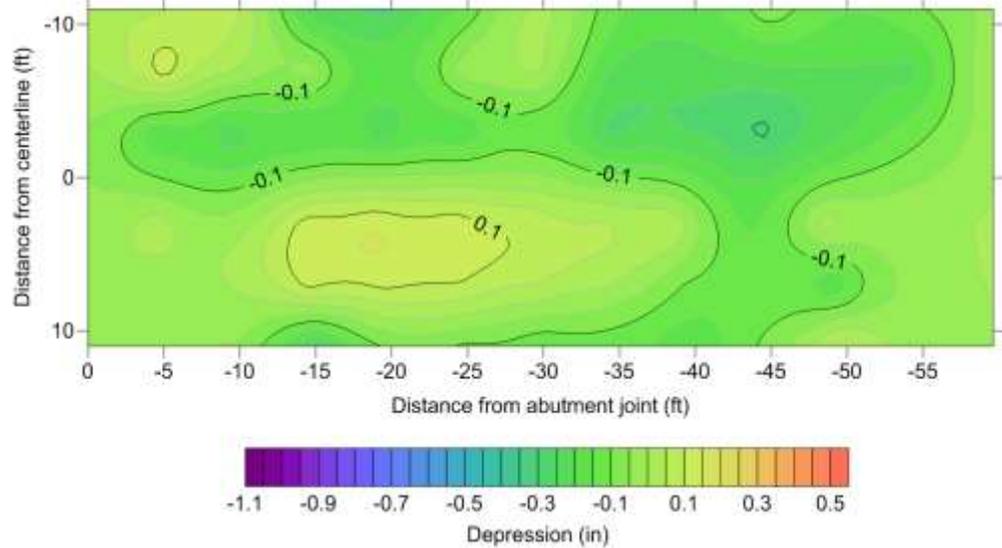
7. The survey data showed that the inspected bridge approaches are generally performing adequately. Although some settlement was observed, the maximum settlement measured was approximately 1.0 inch. The maximum settlement typically occurred in the first span of the approach slab from the bridge towards the midspan of the slab. The maximum differential elevation was 0.4 inches at bridge 5624.2O061.

Contour map of the depression experienced by the east approach of bridge 5624.20061 according to surveying data. On the horizontal axis, 0 ft refers to the location of the abutment joint and -60 ft refers to the location of the roadway joint.
