# Best Practices for Bridge Approaches

tech transfer summary

Identification of the Best Practices for the Design, Construction, and Repair of Bridge Approaches (TR-481)

January 2005

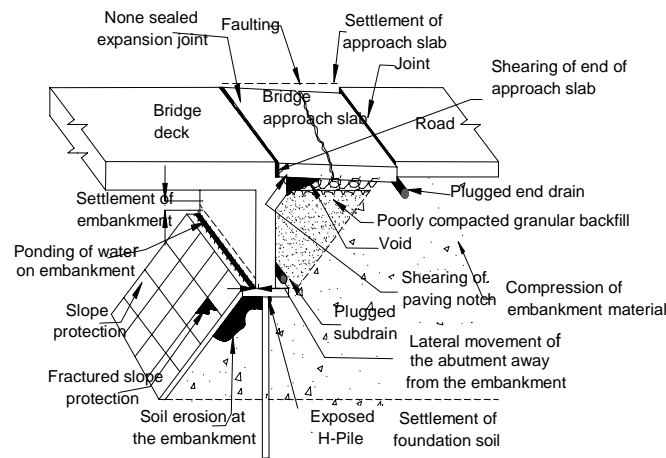
- Inadequate drainage, or otherwise poor water management, was a major problem at most of the bridges inspected. Erosion leads to void development under the approach slab, faulting of the approach slab, and failure of slope protection, and exposes the H-pile supporting the abutments, which can contribute to corrosion.

*Common problems at bridge sites*

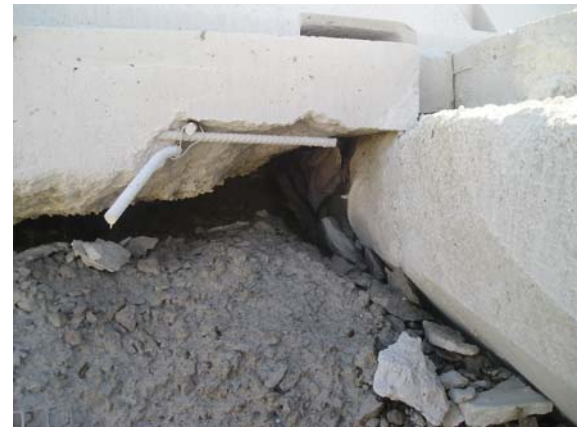
- Void development under the bridge approach was commonly observed on bridges within one year of construction, indicating insufficiently compacted and erodible backfill material.

*A 9-inch void under the approach slab and spalling of concrete from the paving notch and the approach slab*

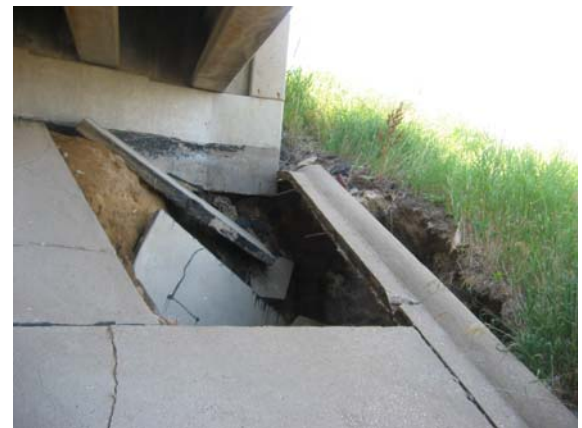
*Failure of concrete slope protection due to erosion*

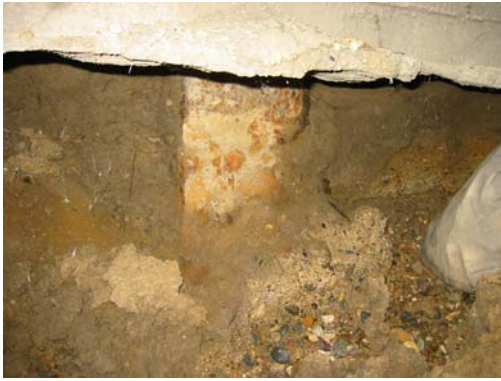
*Exposed H-pile caused by soil erosion under the abutment*

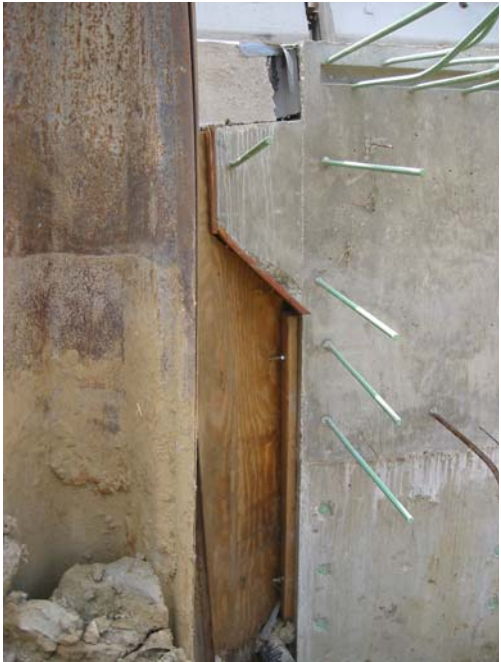
*Inclined paving notch observed during construction of a new bridge*

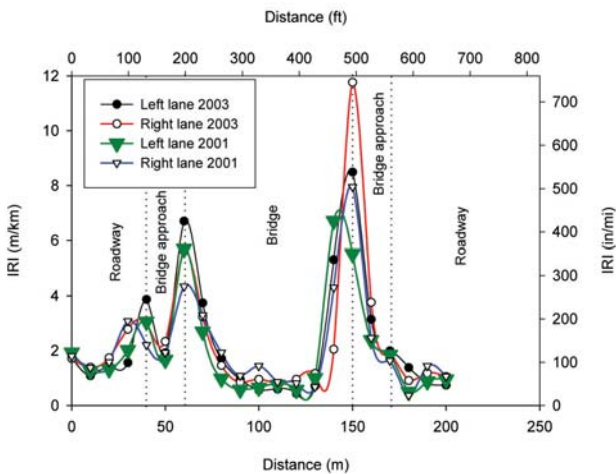
*Increase of IRI with time*

- Maximum values of IRI were observed at the transition between the bridge and the approach slab, and the approach slab EF joint.
- IRI values at the bridge approach increased with time, indicating progressive bridge approach settlement problems.
