# Evaluation of Transverse Joint Forming Methods for PCC Pavement

National Concrete Pavement  
Technology Center

**Final Report**  
**January 2006**

**Sponsored by**  
the Iowa Highway Research Board (IHRB Project TR-532)

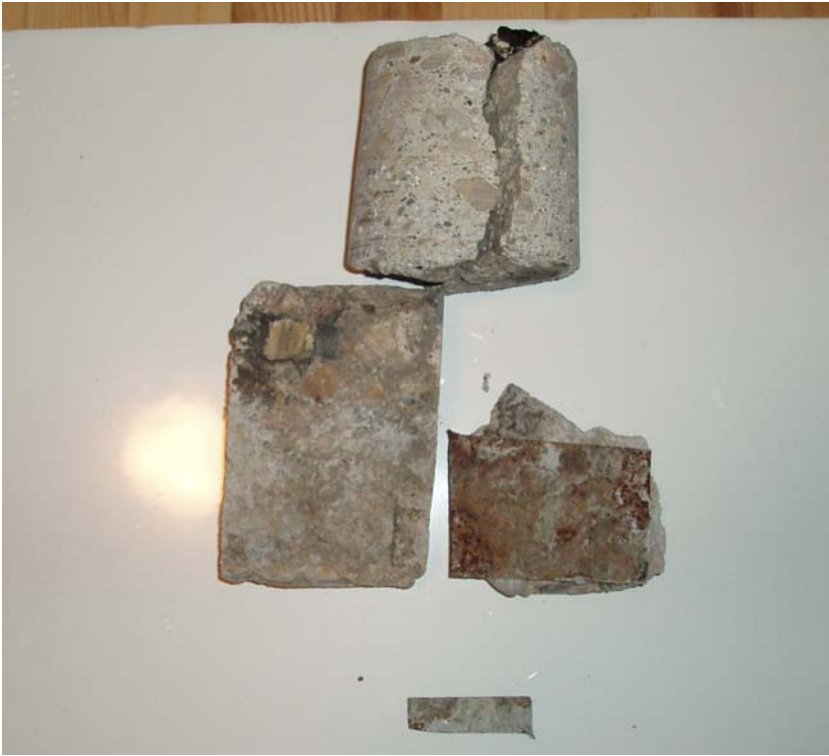
Inspiration for the present research arose from two sources. The first source is two cores taken from a former state highway in north-central Iowa. The two cores of transverse cracks, taken at random locations in a 16-km (10-mile)-long project, yielded vertical steel materials at the bottom of the slab. These cores are shown in Figures A1–A3 in Appendix A. The cracks had migrated from the top of the steel strip to the pavement surface. The steel material was 76–89 mm (3 to 3.5 inches) in height and 3.2 mm (1/8 inch) in thickness. The crack formation and the randomness of the cores taken would indicate that the metal extends across the width of the slab. The surface cracks were very straight in alignment across the slab and had not spalled over time. The concrete in Figures A1 and A2 is approximately 24.1 cm (9.5 inches) in depth, and the core in Figure A3 is 27.9 cm (11 inches) in depth.

**Figure A1. Core 1**

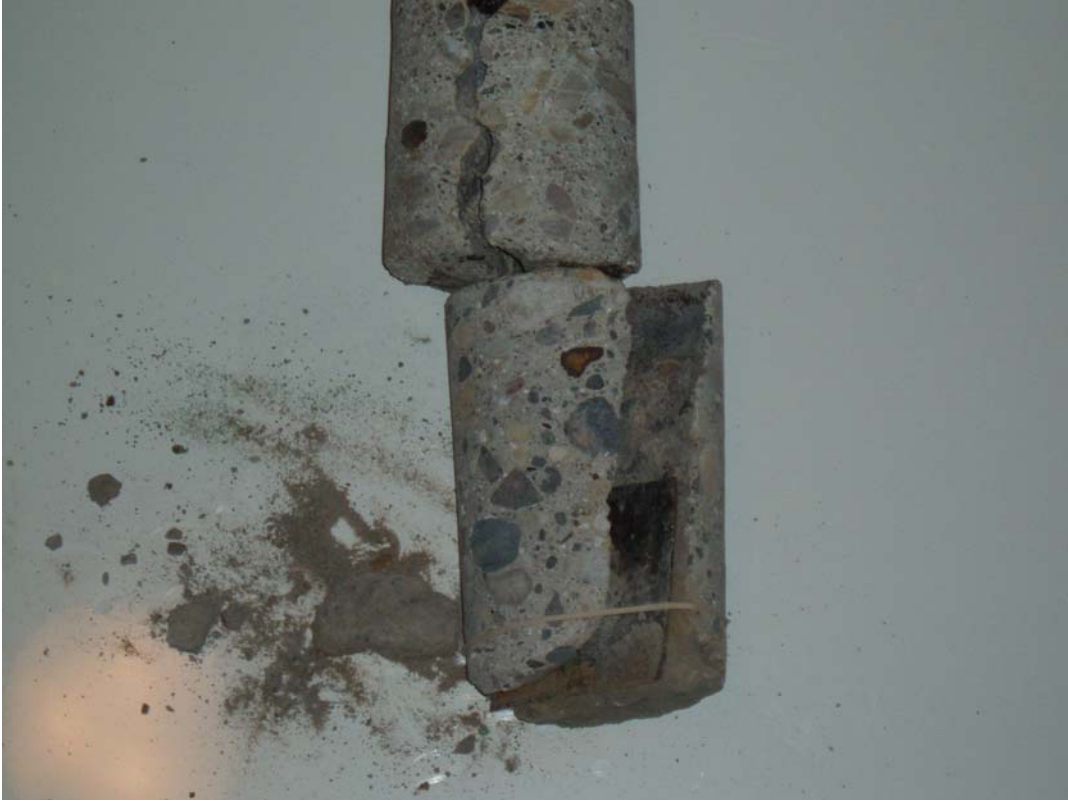
**Figure A3. Core 2**

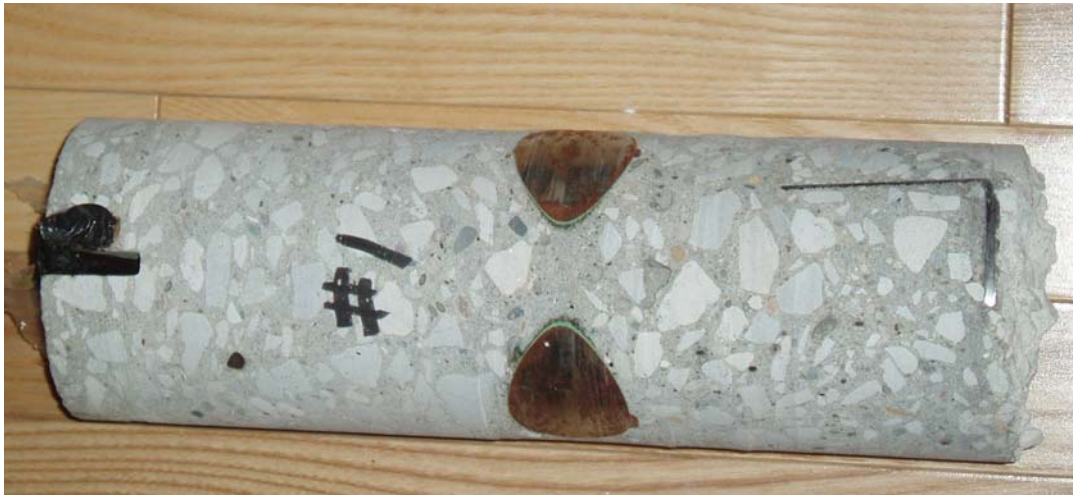
**Figure G1. Test section 1 core**

Second, in most of the core locations the metal joint former is offset from the sawed joint by up to 25 mm (1 inch) or more. The location is offset because the saw crew followed crude paint lines on both edges of the slab, which the research crew placed to help locate the joint-former crack. The saw crew connected these lines with the sawed joint. This process may have created a long-term spalling problem or an irregular crack in the surface. To date, no such activity has been noted.

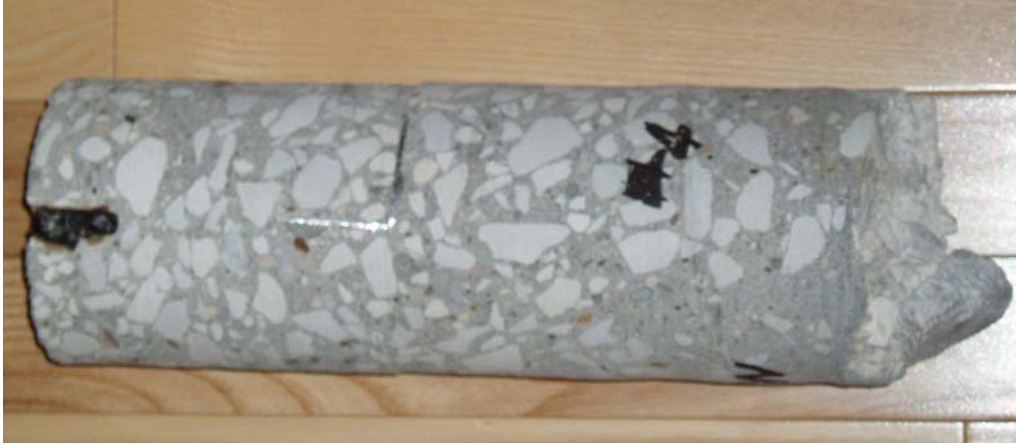
The cores indicate two specific details that may be of interest in the future. First, in section four the joint former is above the dowels and, as indicated in the photos, contains a crack that extends between the top of the metal and bottom of the sawed joint. The crack is highlighted by the center black ink mark in Figures G5 and G6 in Appendix G. It is not possible to tell which way this crack initiated, but the crack is of interest to the research.

**Figure G4. Test section 4 core**

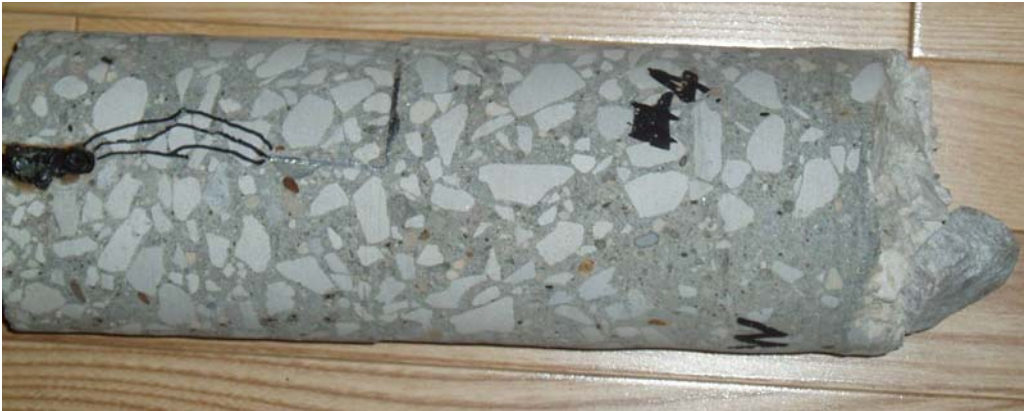
**Figure G5. Crack in test section 4 core**

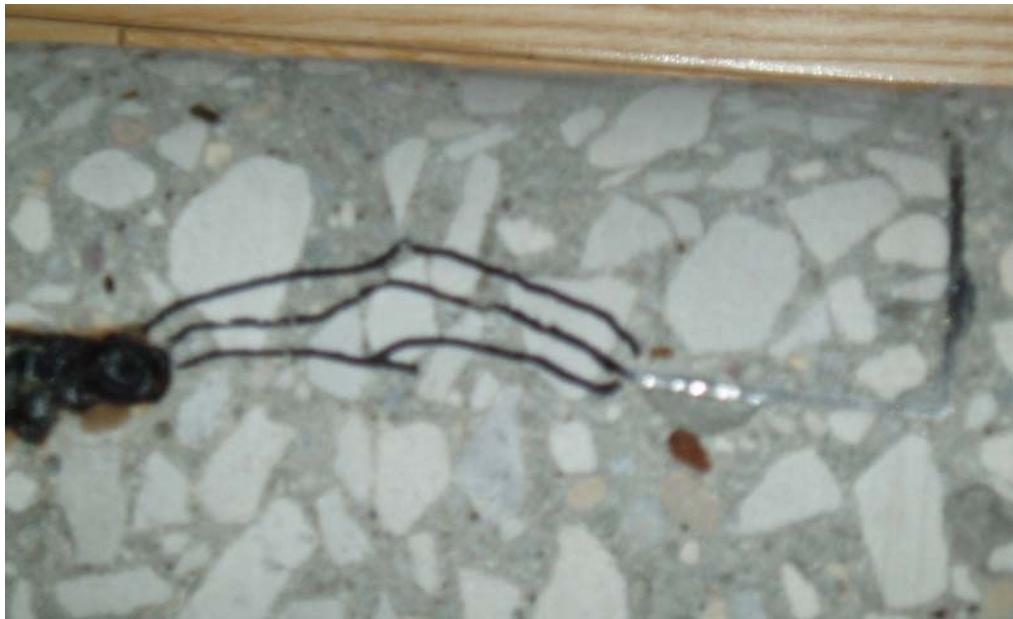
**Figure G6. Close-up of crack in test section 4 core**
