Evaluation of Microcracking and Chemical
Deterioration in Concrete Pavements

Final Report

Iowa DOT PROJECT HR-358

Sponsored by the Highway Division of the Iowa Department of
Transportation and the Iowa Highway Research Board

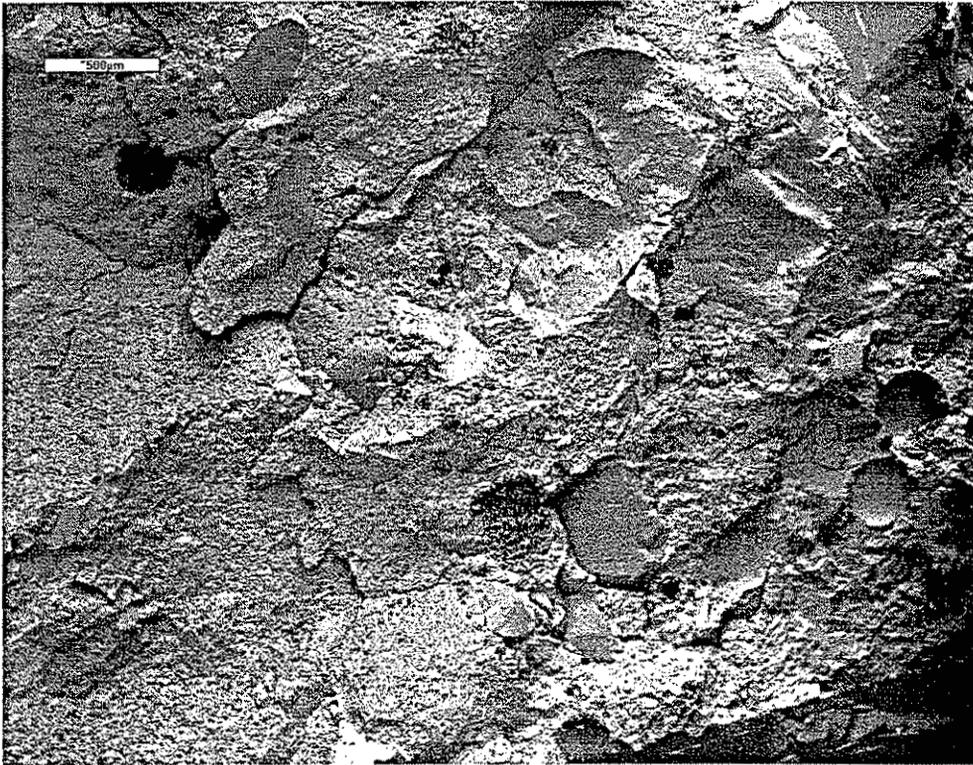
Images from a freshly fractured specimen surface are shown in Figures 13 through 17. The first two figures clearly illustrate the presence of filled air voids. In fact, the images give a better illustration of the three dimensional nature of the air voids. The X-ray map (see Fig. 15) contains many shadows (due to topography) which make interpretation difficult. Figures 16 and 17 show a large shale particle that was uncovered during the fracturing process. The shale particle is surrounded by voids that have been filled with ettringite. None of the voids give any evidence of being filled with alkali-silica gel. However, this statement must be tempered by the fact that surface topography has distorted both the image (this is why the lower-right half of the image is poorly focused) and the elemental map.

Figure 13. US 20, fractured surface, 30X magnification.

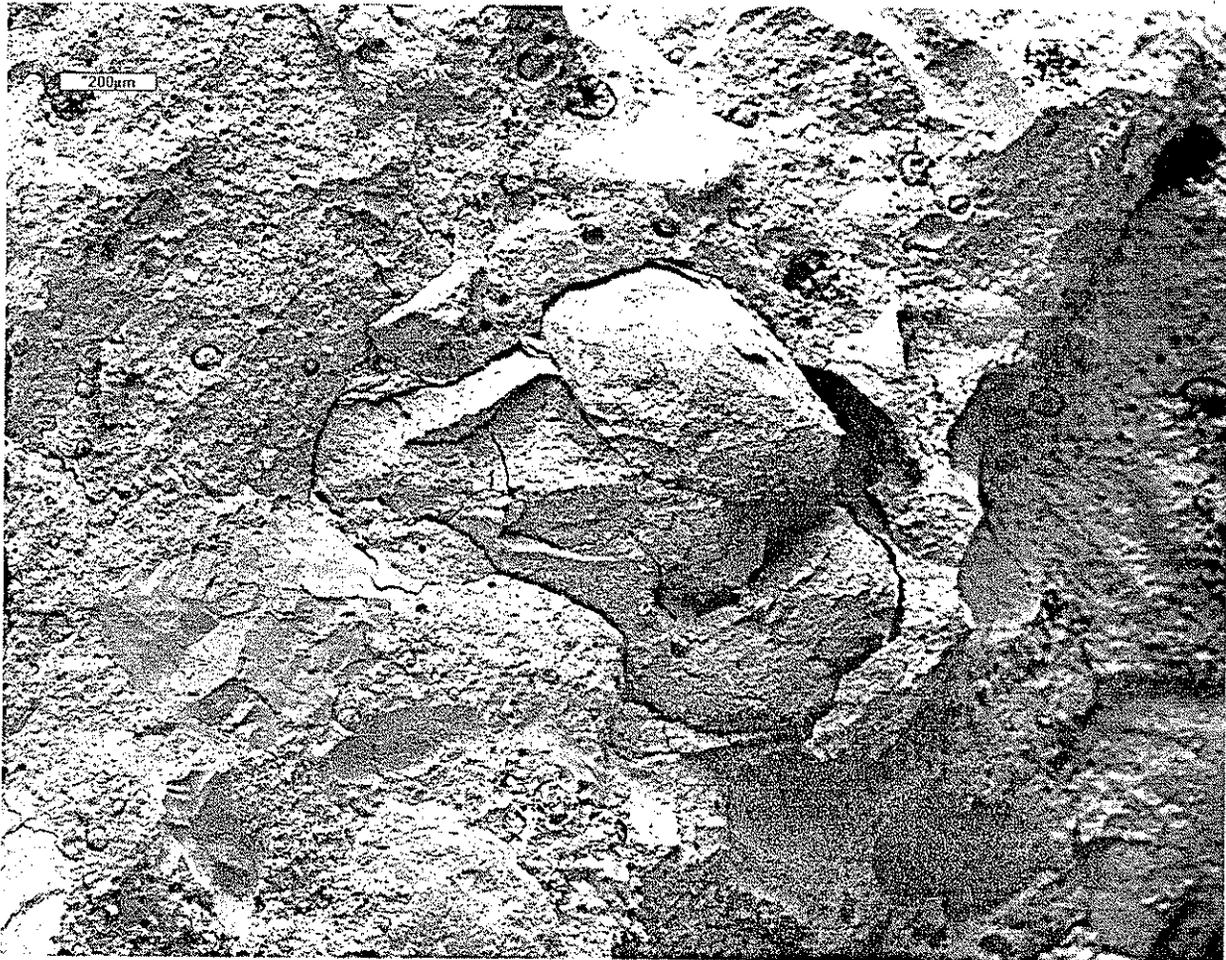
Figure 16. US 20, fractured surface, shale particle, 50X magnification.

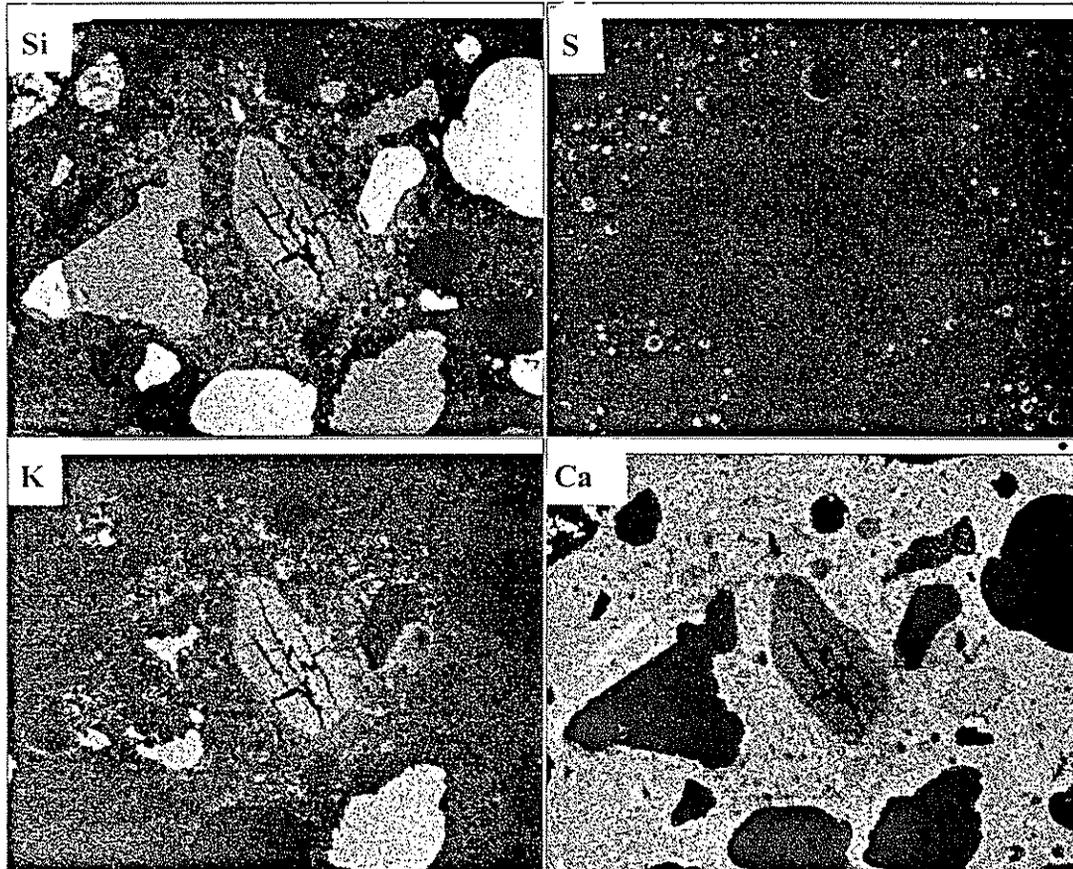
The coarse aggregate (Ft. Dodge crushed limestone) was found in all of the cores. The fine aggregate contained some reactive particles that had produced alkali-silica gel. Most of the reactive aggregates were shale particles and all of the core specimens (cores 9 through 20 plus CMI-5 and CMI-6) contained cracked shale particles. Some of the cracked shale particles had produced alkali-silica gel while many others had not. The cracks associated with the shale particles were extremely fine and typically did not propagate far into the cement paste (see Figures 25 through 27). Other reactive aggregates were only very rarely observed in the fourteen core samples. Sand-sized dolomite particles were observed in all of the cores from US 20.

Figure 25. US 20, core 17B, ASR near shale particle; 50X magnification.

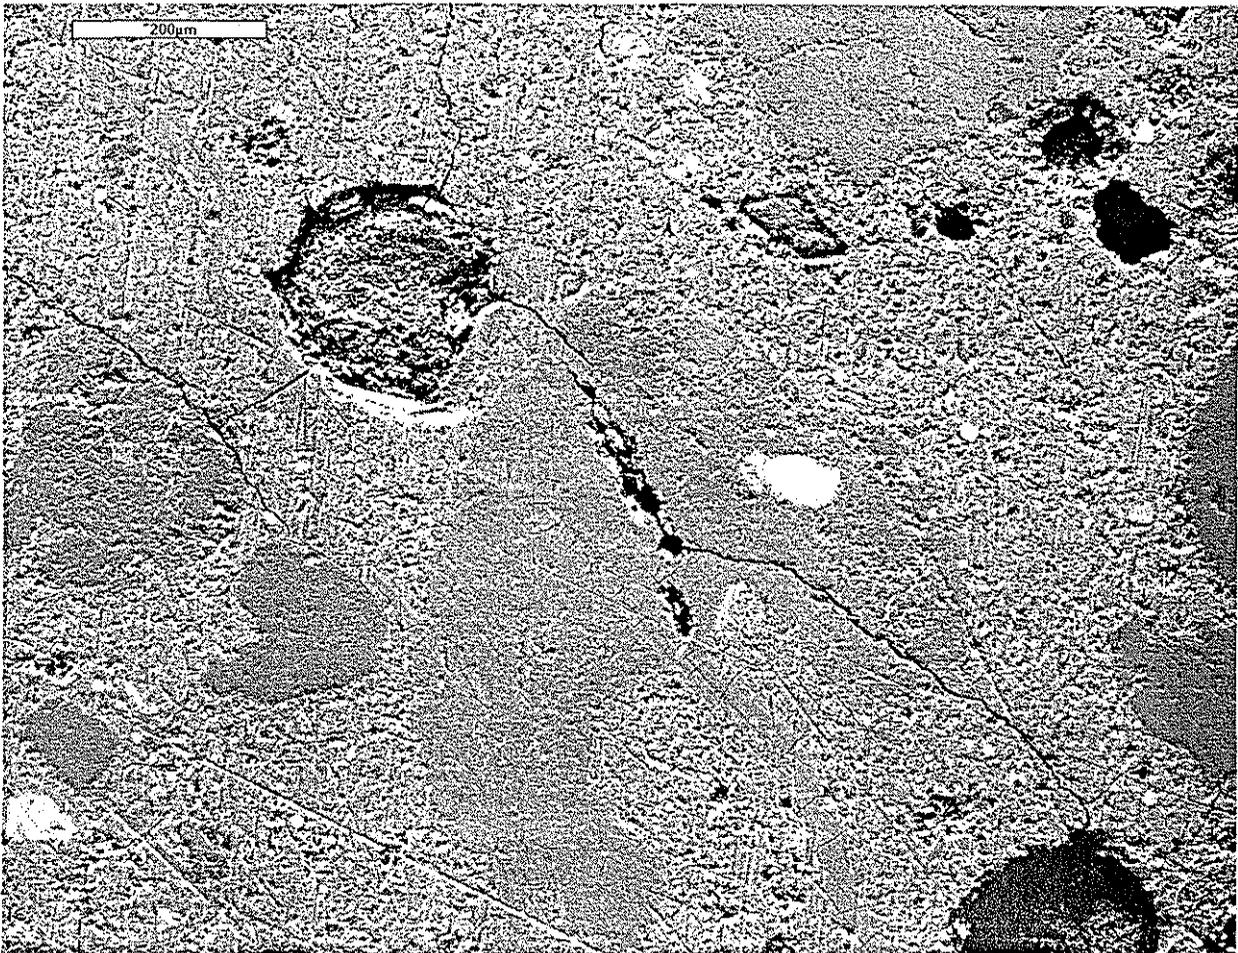
A reactive particle, which had produced disruptive expansion by the production of alkali-silica gel, was found in the top specimen of core 12 (see Figures 28 and 29). This particular particle is an excellent example of alkali-silica reaction and it will be used to demonstrate how alkali-reactive aggregates can be identified using the scanning electron microscope. First, notice in Figure 28, that a cracked aggregate is present in the field-of-view. The cracks tend to radiate from the reactive particle into the cement paste (several millimeters in this instance, they actually pass out of the field-of-view). Several cracks appear to be filled with a material that has a "mud-cracked" appearance, this is the normal morphology of alkali-silica gel in a scanning electron microscope.

Figure 28. US 20, core 12B, deleterious ASR cracking; 100X magnification.

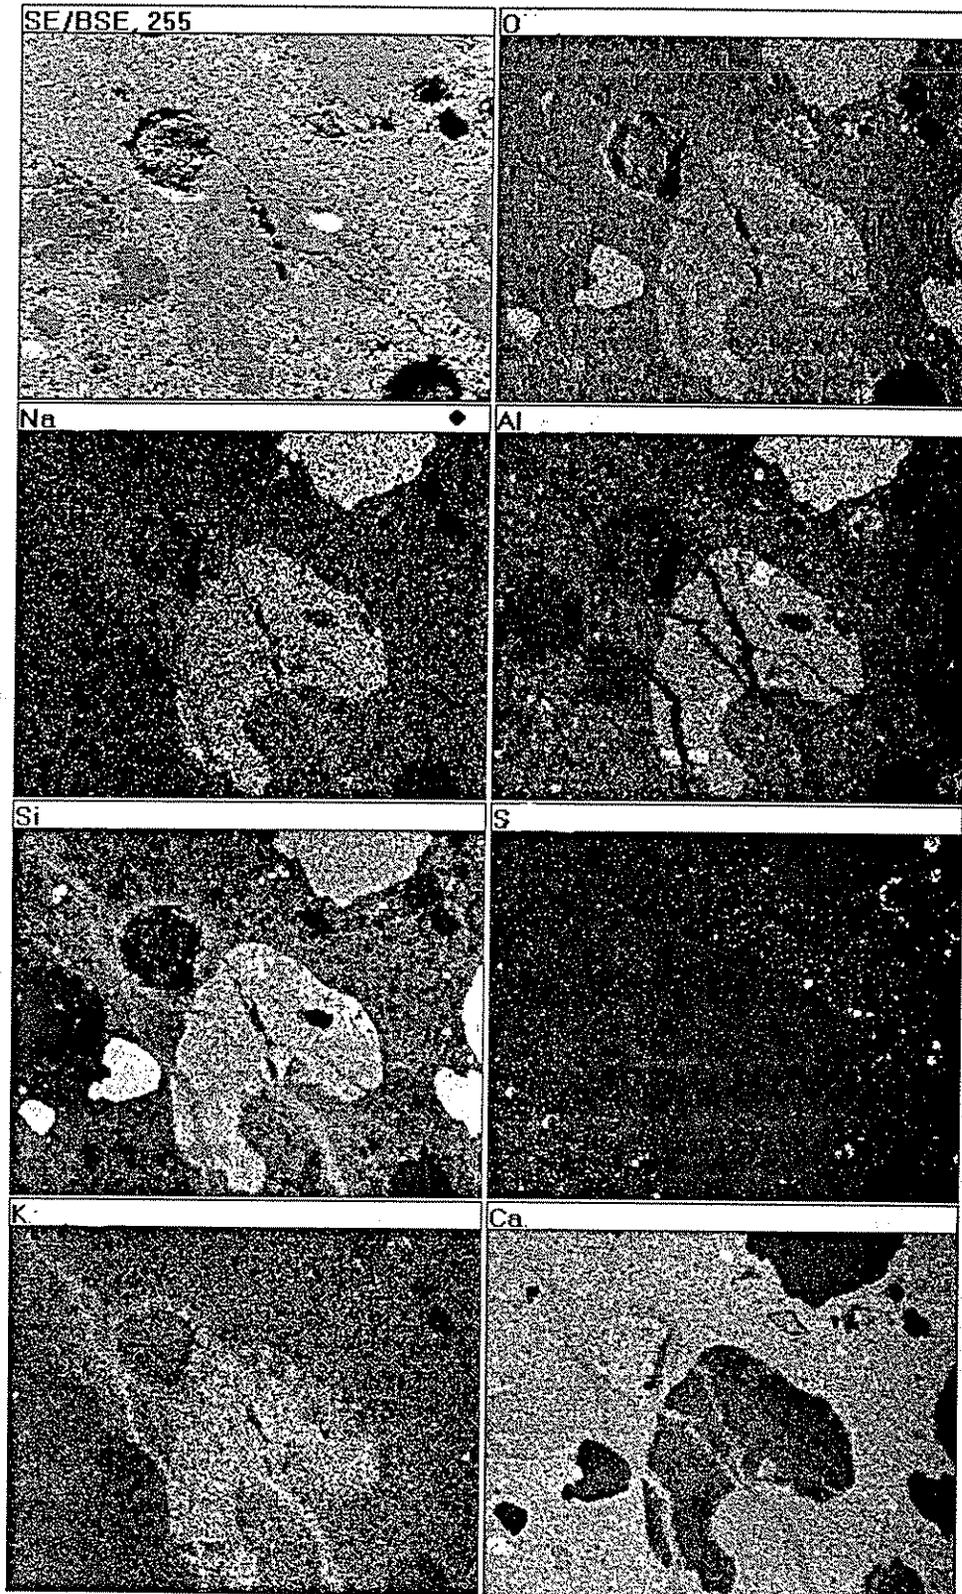
Figure 29. X-ray map of the area shown in Fig. 28; 100X magnification.

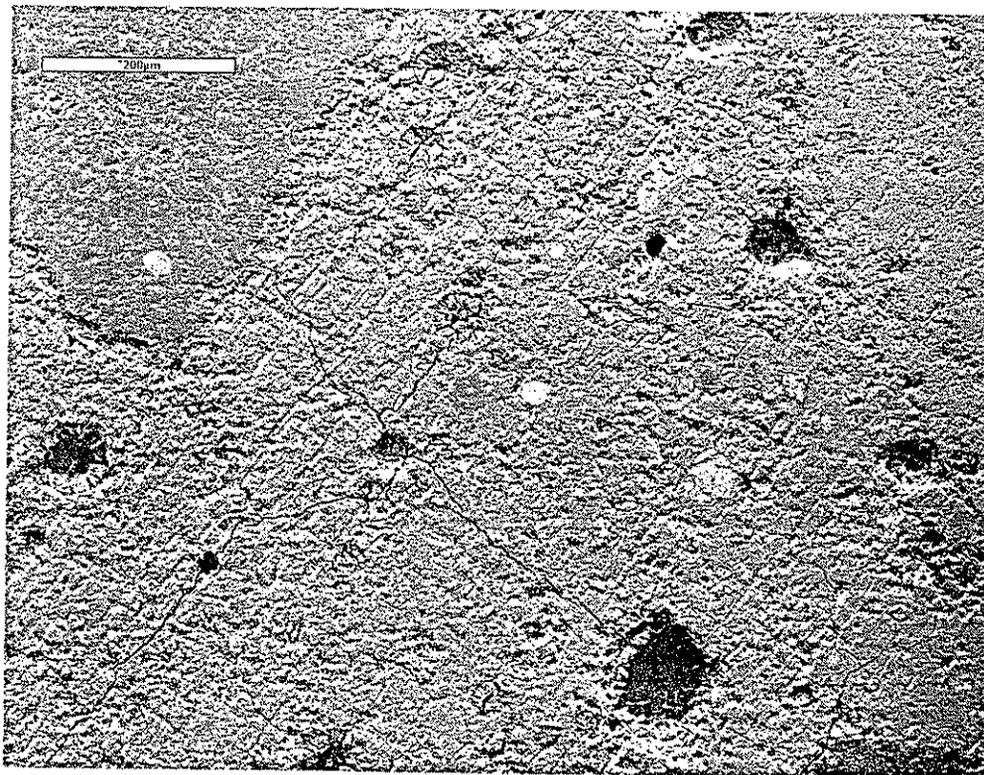
Figure 39. I-35, core 3B, 125X magnification; note general paste cracking.

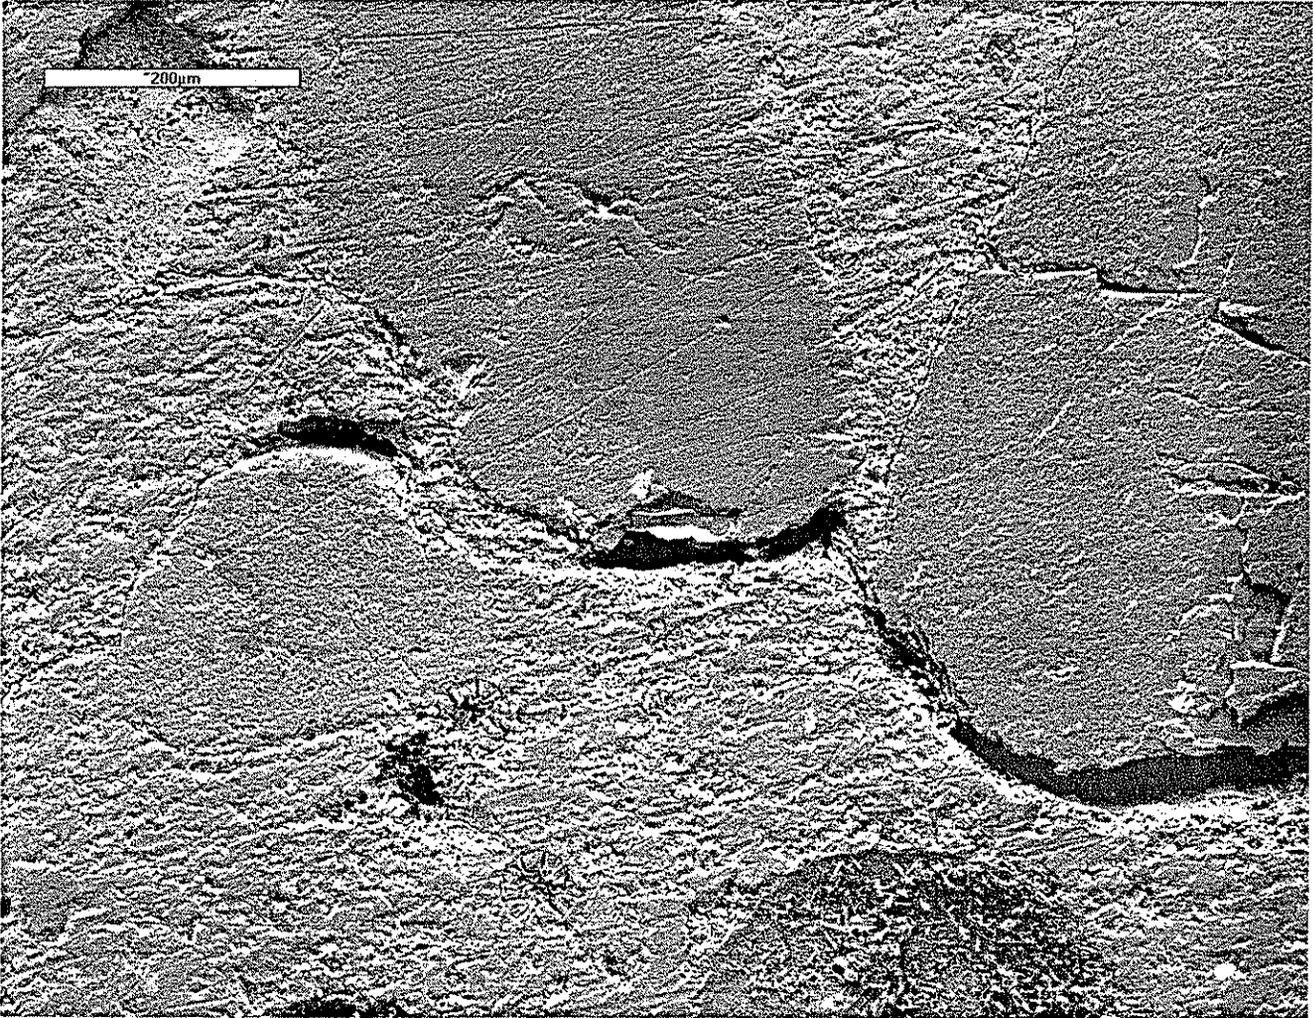
Figure 40. I-35, core 7B, 125X magnification; note gaps around aggregate particles that have been filled with ettringite.

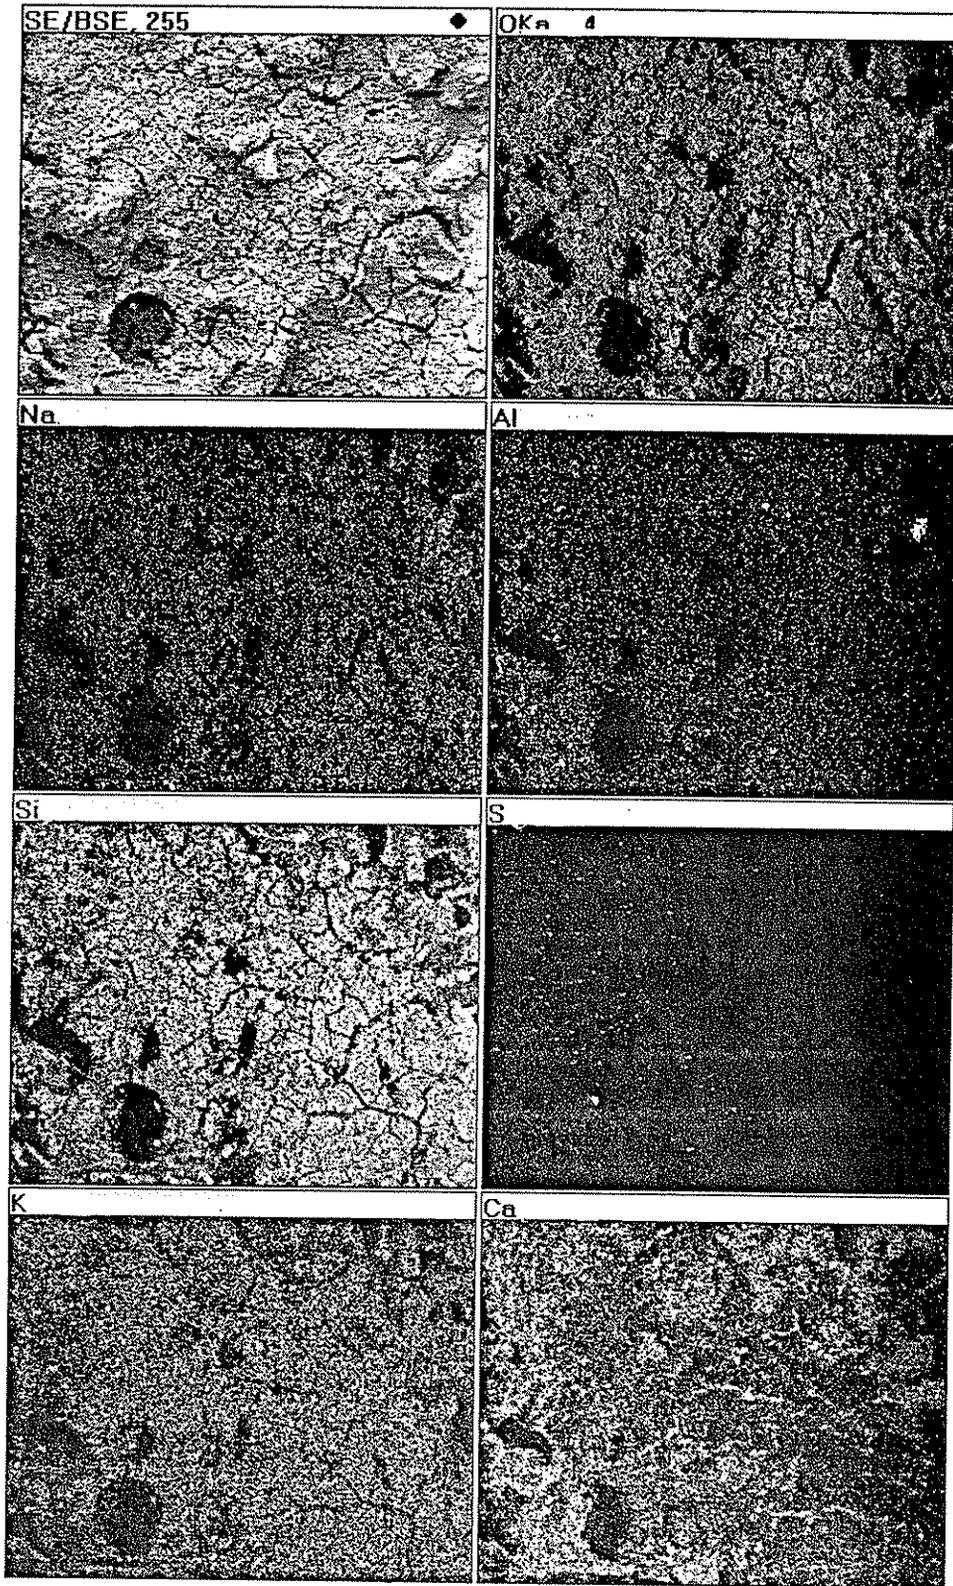
Figure 42 X-ray map of shale pop-out from I-80, core 24; 100X magnification.

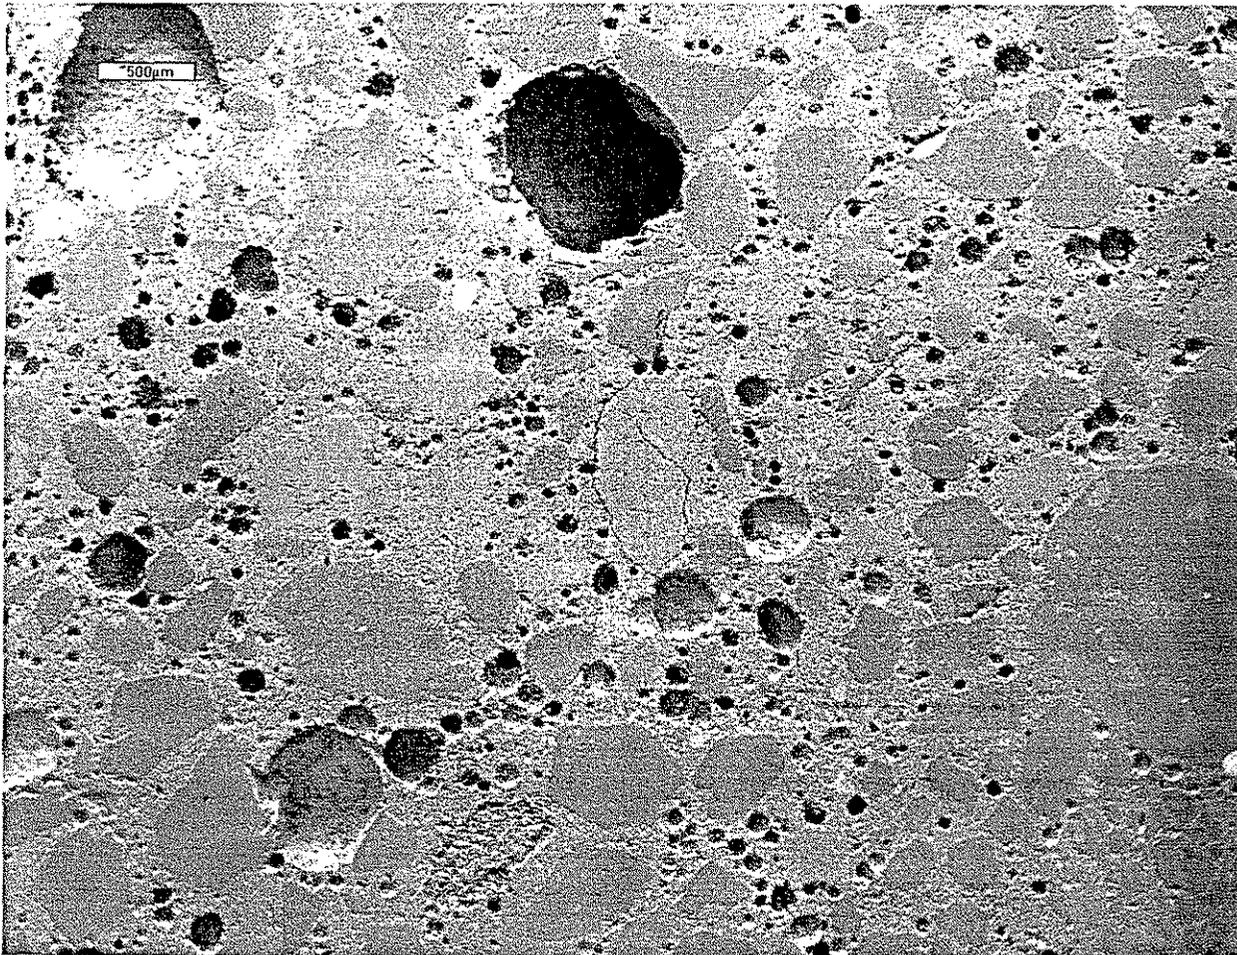
Figure 54. Highway 175, class F fly ash, 20X magnification.

pavement cores that did not contain fly ash, or that contained Class C fly ash, had produced alkali-silica gel. None of the shale particles in the section containing Class F fly ash exhibited any signs of alkali-silica gel. The cracks associated with the shale particles (see Figure 54) were small and typically did not propagate far into the cement paste. Other reactive aggregates were not observed in the five core samples. Sand-sized dolomite particles were observed in all of the cores taken from Highway 175.

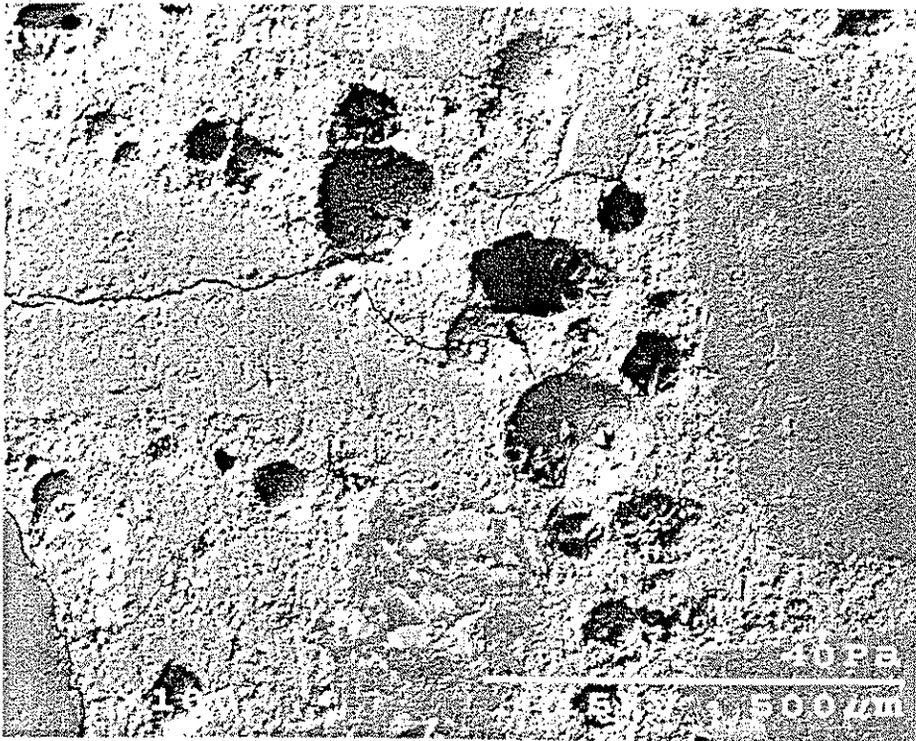
The paste fraction of the cores taken from Highway 175 appeared reasonably uniform. It did contain some very fine microcracks that could be observed at magnifications of about 100X (or more); however, they appeared randomly oriented. The samples contained entrapped air voids, but few exceeded about 3 millimeters in diameter. The entrained-air voids were often lined with ettringite (see Fig. 55); however, they were never totally filled (even the small air voids).

Figure 55 Highway 175, core containing no ash; 100X magnification.

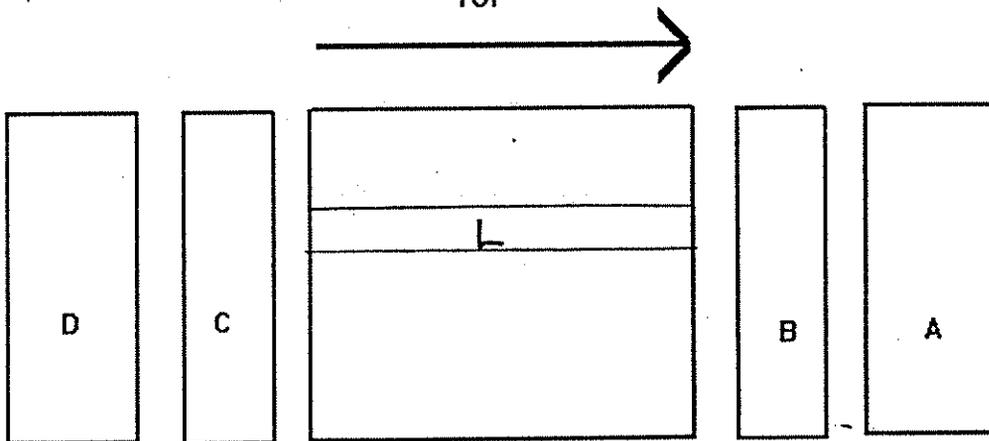
VERY LARGE VOIDS NOTED WITH CRACK EXTENDING FROM THEM PARALLEL TO TOP SURFACE TOP

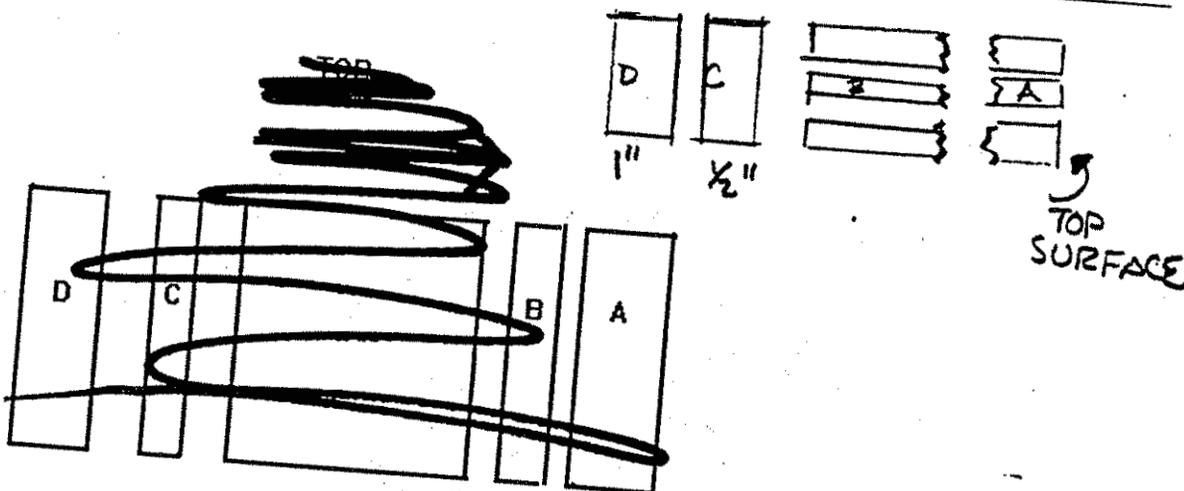
@ 7cm DOWN FROM TOP SURFACE. CORE IS IN TWO PIECES AS A RESULT ALSO, CRACK STARTING @ 7cm FROM BOTTOM SURFACE. BOTH CRACKS RUN PARALLEL TO TOP SURFACE.

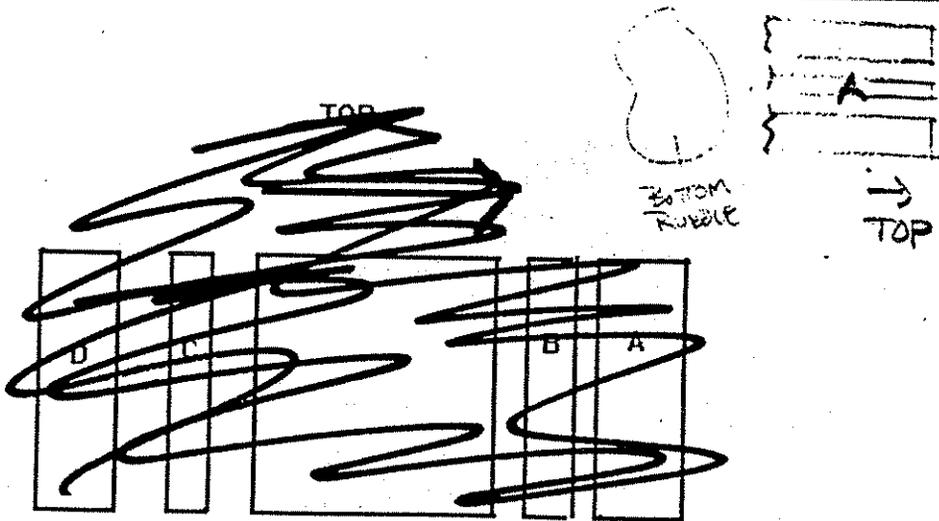
PORTION APPROX. 5CM THICK WITH TWO MAJOR
CRACKS PARALLEL TO TOP SURFACE @
1 & 3 cm FROM TOP. AGGREGATES REACTING
