# Flame Hardened Snow Plow Blades

Final Report

RB13-012

## **SPR Equipment Purchase Final Report Flame Hardened Underbody Plow Blades**

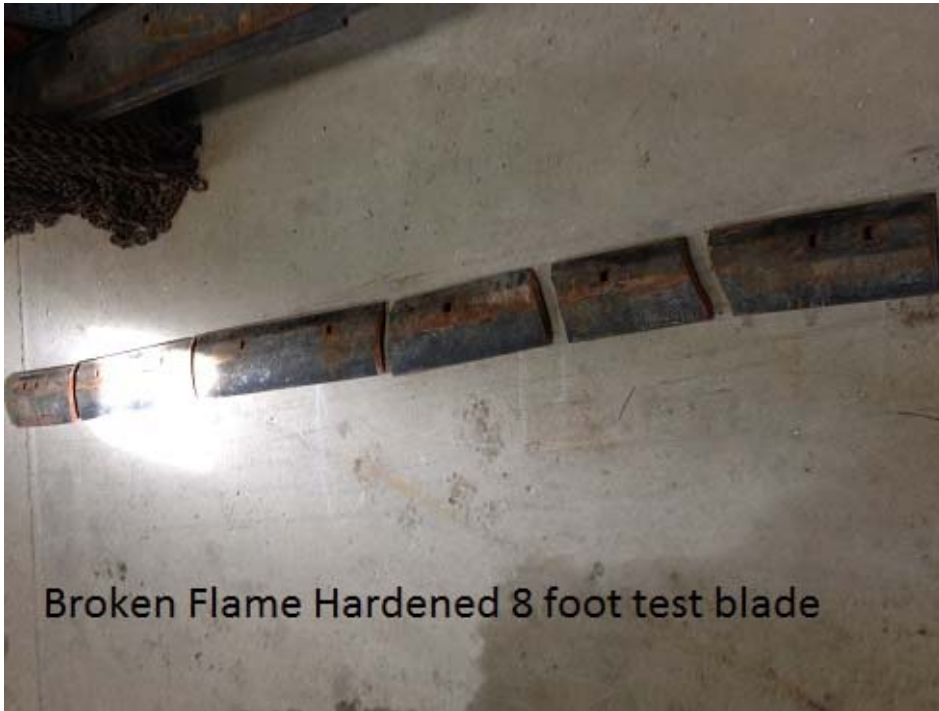
Seventy-five percent of the flame hardened blades were found to have vertically broken into two or more pieces causing one garage to remove the blade with usable life remaining due to safety concerns. The testing garages indicated that this is not typical with our current blades.

Broken Flame Hardened 8 foot test blade

It is not recommended that the DOT pursue the purchase of these blades at this time due to the increased cost without seeing significantly increased lifespan and the safety concerns associated with broken blades.
