ASSESSMENT OF WEATHERING STEEL BRIDGE PERFORMANCE IN IOWA AND DEVELOPMENT OF INSPECTION AND MAINTENANCE TECHNIQUES

Final Report
SPR 90-00-RB17-012
February 21, 2013
WJE No. 2011.1671

Sponsored by:
Iowa Department of Transportation
Office of Bridges and Structures
800 Lincoln Way
Ames, IA 50010

Prepared by:
Wiss, Janney, Elstner Associates, Inc.
330 Pfingsten Road
Northbrook, Illinois 60062
847.272.7400 tel | 847.291.4813 fax

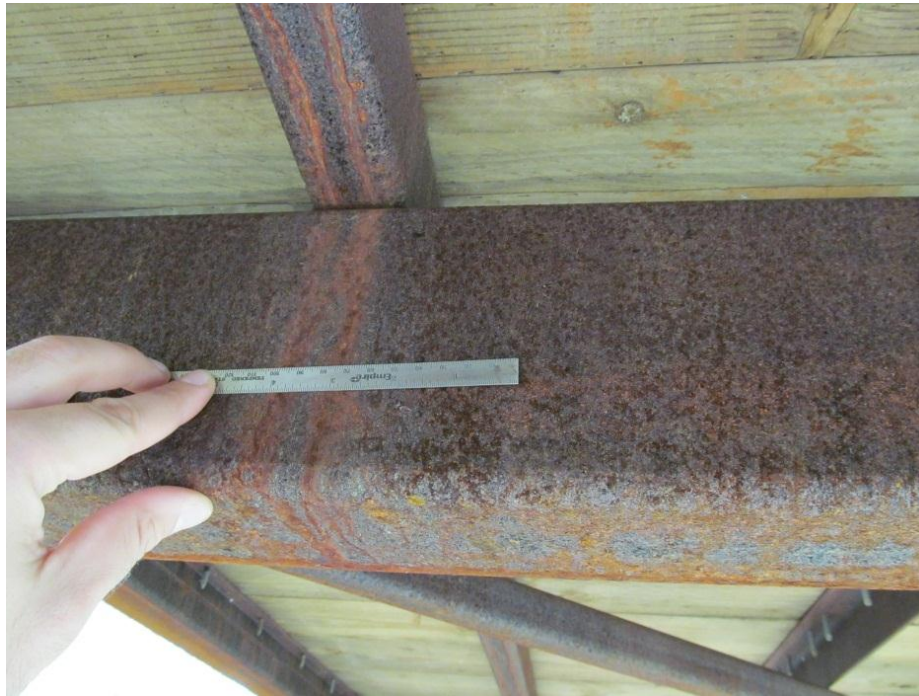
Figure 4. Apparent nonprotective patina on the floor beams and bottom chords of this 10 month old wood-decked pedestrian bridge.

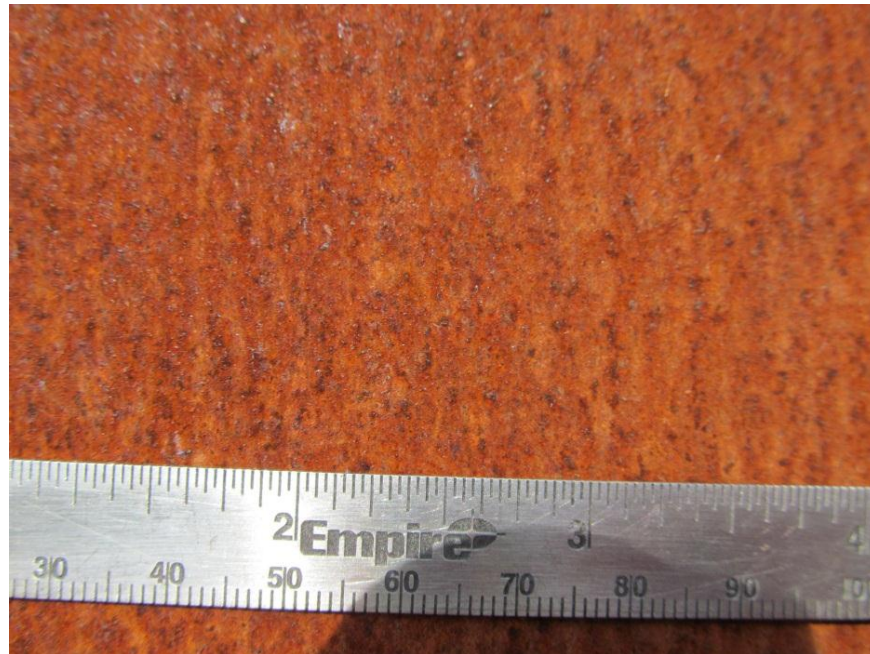
Figure 16. Close-up photo of Category 5 patina taken from Illinois pedestrian bridge truss. Only isolated regions of Category 5 patina, likely due to mill scale, were observed on Iowa bridges.

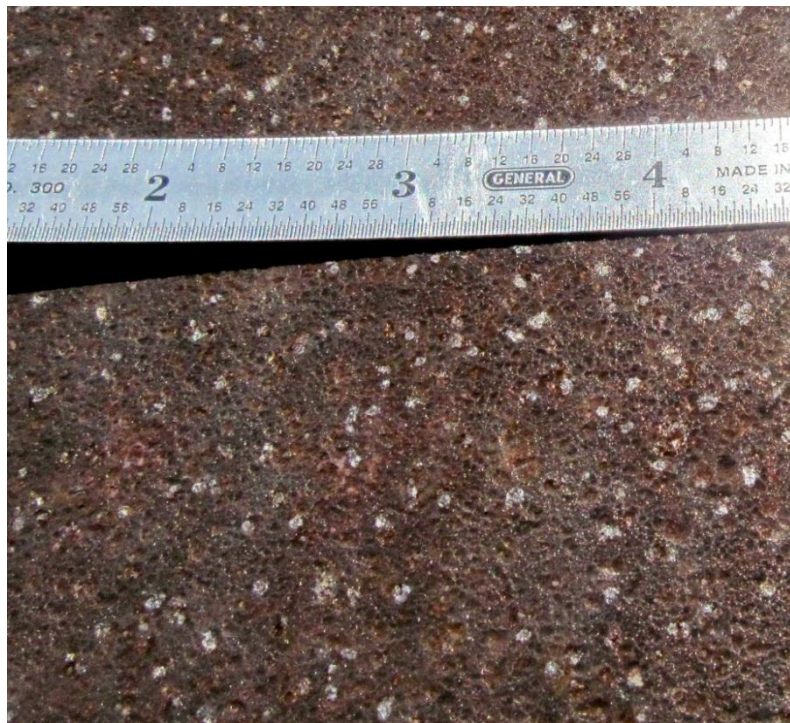
Figure 17. Close-up photo of Category 4 patina commonly observed on exterior web of fascia girder. Surface is textured but tightly adherent, and rust formations are small. No loose flakes are present.

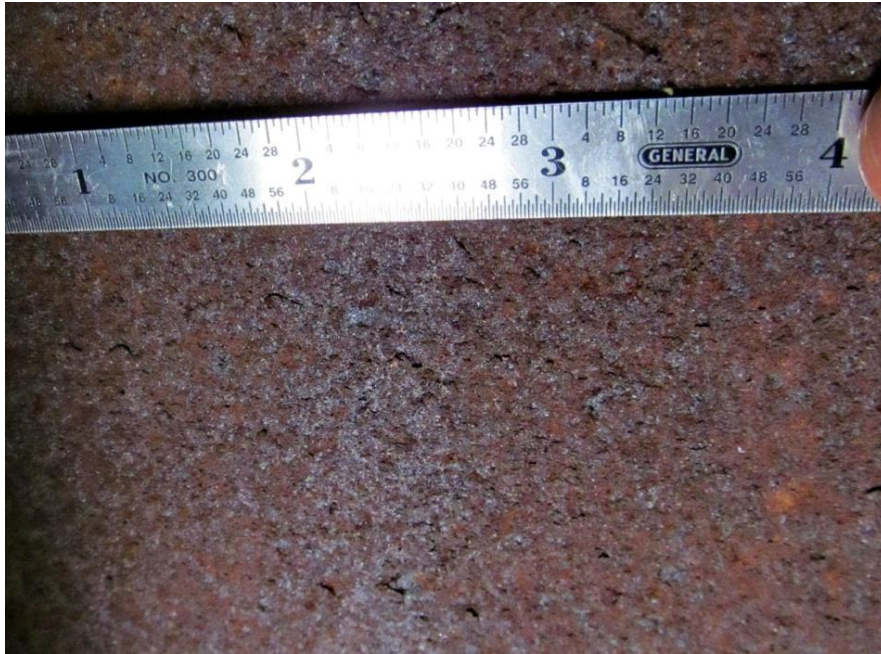
Figure 18. Close-up photo of Category 3 patina on bottom of interior girder web. Texture is less uniform but still generally adherent, with some small loose flakes.

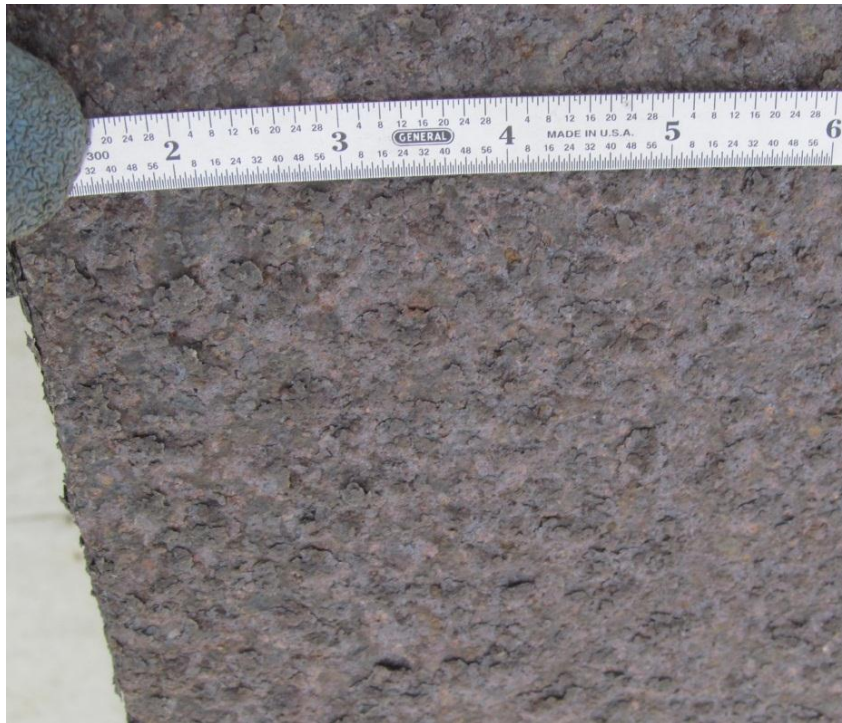
Figure 19. Close-up photo of typical Category 2 patina on the underside of an interior girder bottom flange. Medium size flakes are easily peeled away with a fingernail.

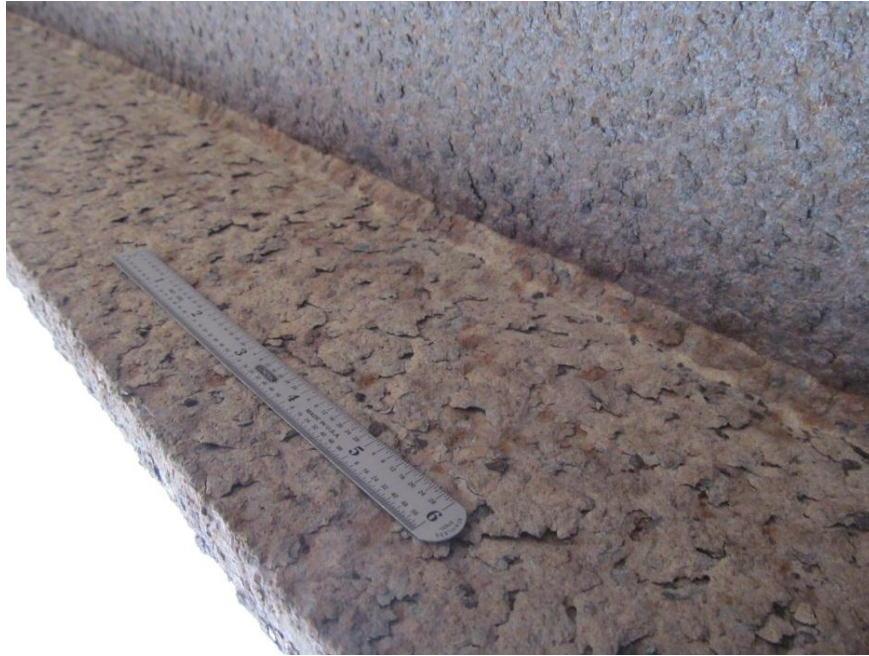
Figure 20. Category 1 patina on top of an interior girder bottom flange; note the large, loose, thick flakes that cover virtually the entire surface. Section loss is not yet apparent in this case.

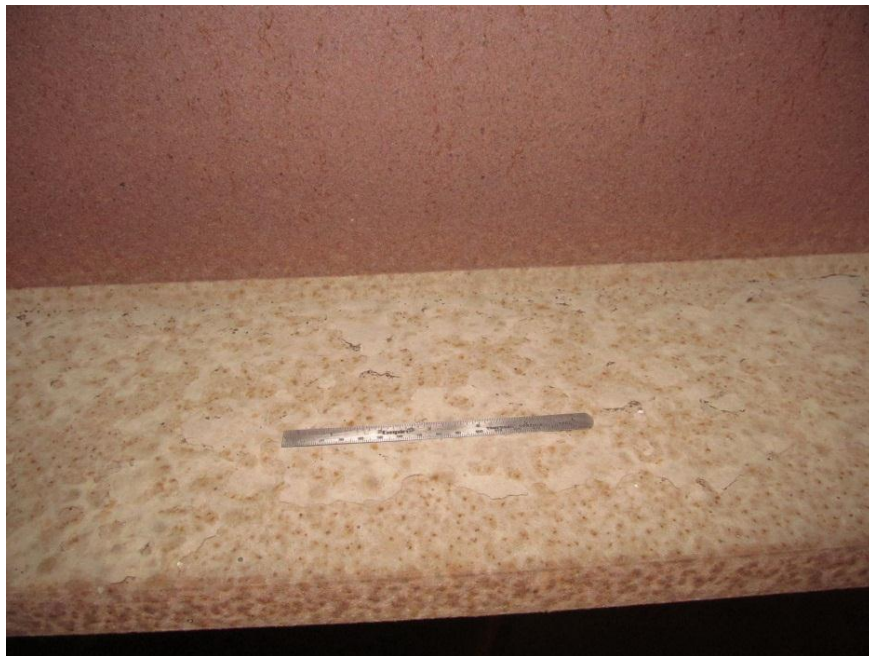
Figure 21. Poultice corrosion on an interior girder flange in downtown Des Moines. This is typical of conditions observed on the tops of many interior horizontal elements. Close examination and testing confirms this chalky film is primarily a mixture of dirt and salts.

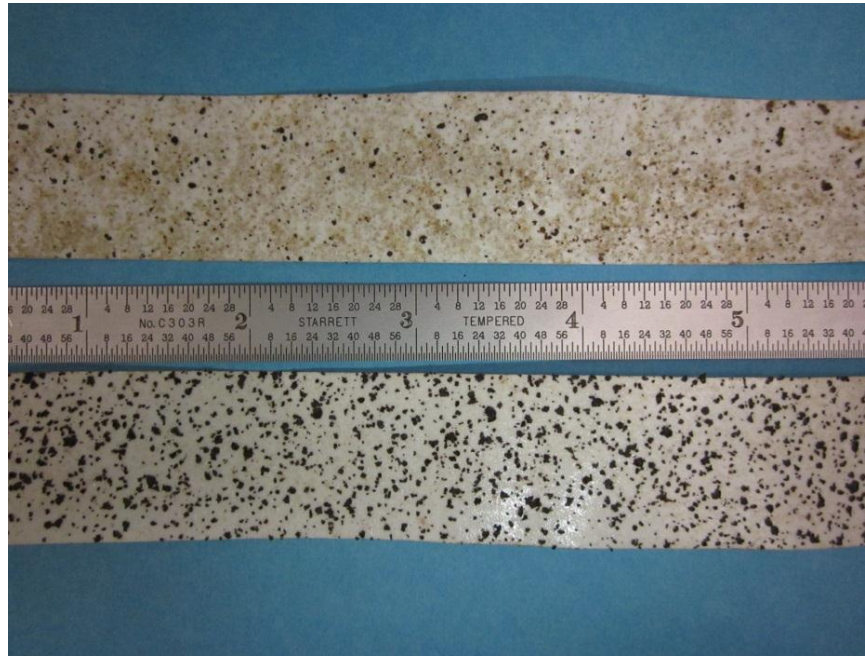
Figure 22. Tape test comparison of heavily chalked interior (top sample) and exterior (bottom sample) fascia girder bottom flange; note lighter coloration of salt and dirt deposits compared to rust flakes in poultice corrosion sample (top sample). Patina index rating for both of these specimens is 3.5.

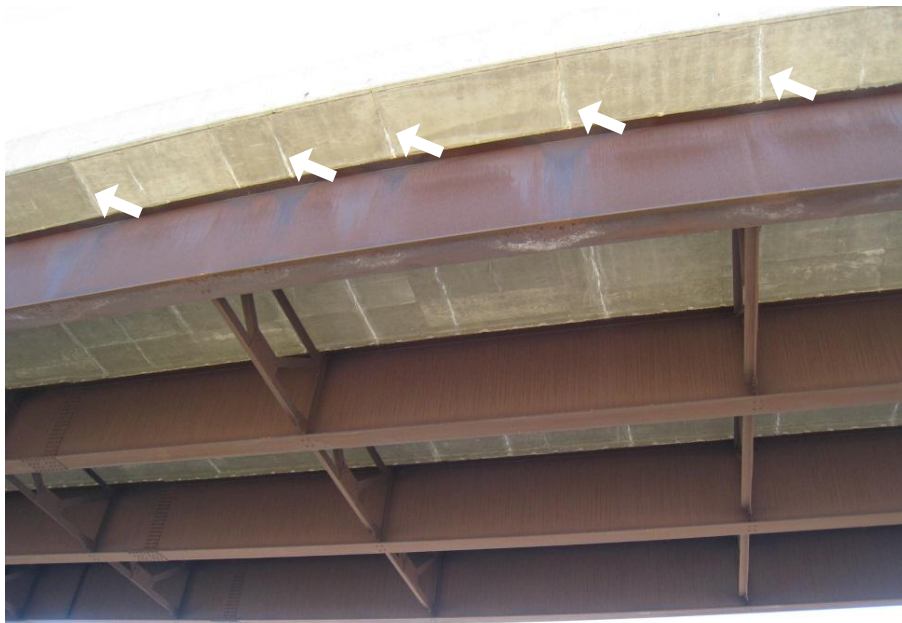
Figure 35. Cracking with efflorescence noted in the concrete deck (arrows) at Structure 9799.5L075, Field Selection 10. Note areas of non-uniform, black weathering steel patina and salt staining on the bottom flange below each crack in the deck.

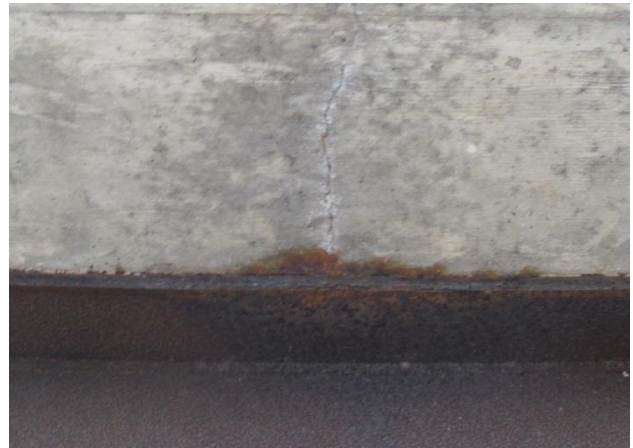
Figure 2. Top flange deterioration beneath concrete deck crack; possibly index rating of 1 on hidden top.

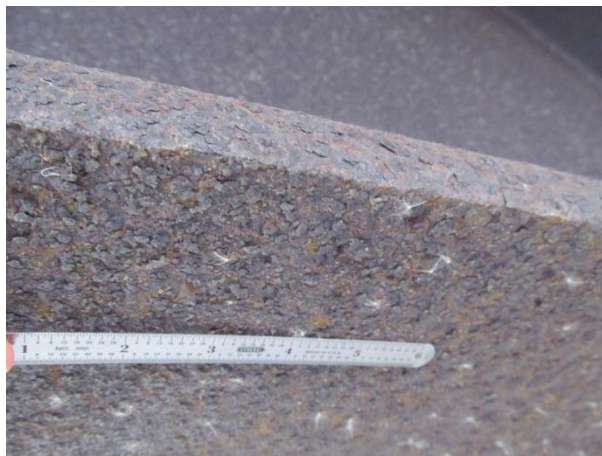
Figure 3. Flakiness on interior bottom flange near south abutment (Index = 2.5). Worse than over traffic on north half of bridge.

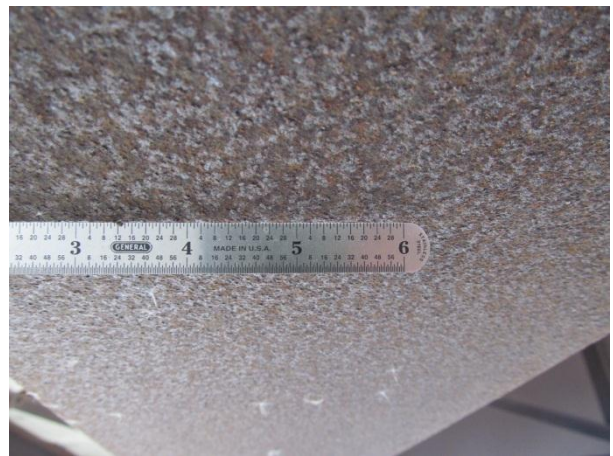
Figure 4. Interior bottom flange condition near north abutment; index here is 3.5. Contrast with Figure 3 from identical location at south end.

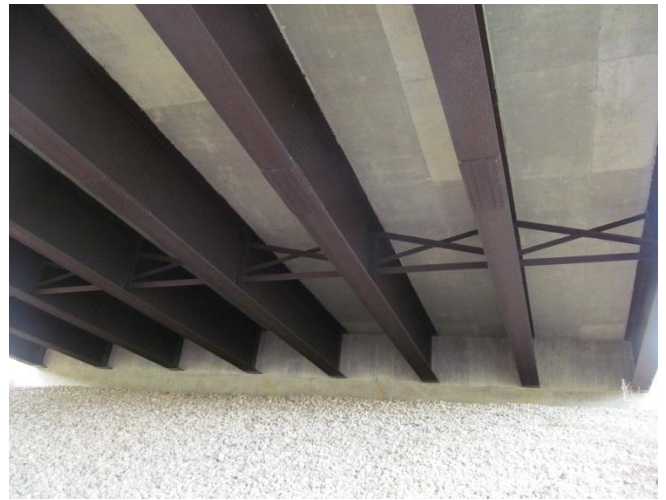
Figure 2. Typical conditions underneath interior of both bridges. Index = 3.5 to 3 on bottom flanges. Sound deck prevents water infiltration from above.

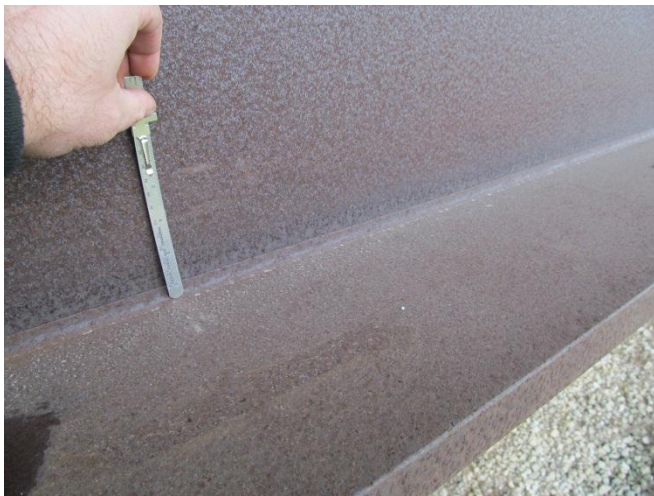
Figure 3. Index 4 and 3 patina on web and top of bottom flange, respectively, near fascia girder tape and chloride tests on 608020.

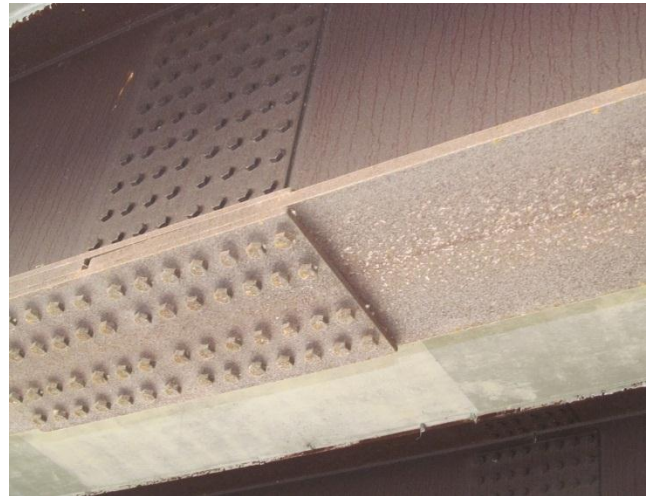
Figure 4. Mild salty staining and flakiness visible on bottom flange near girder splices over shoulder. Patina Index = 3.

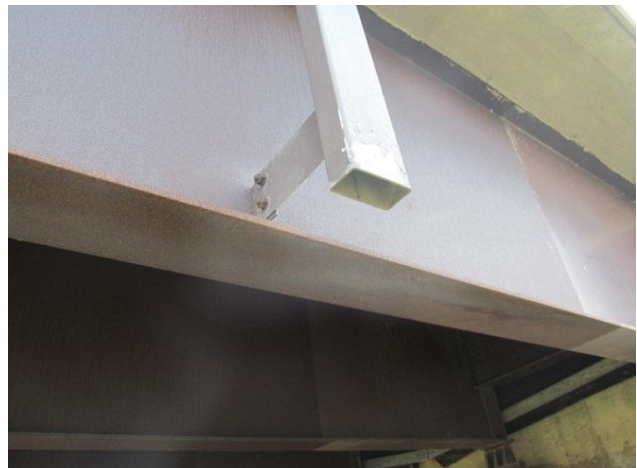
Figure 6. View of downspout; bottom flange corrosion extends away from spout, primarily in direction of girder slope.

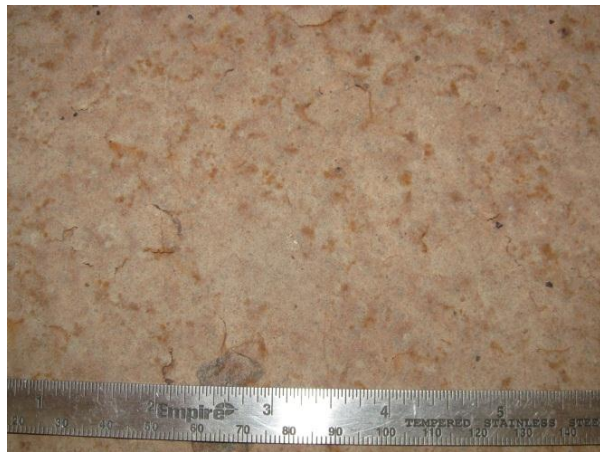
Figure 1. Top of bottom flange poultice prior to washing; Index = 2, chlorides measured = 20 ppm.

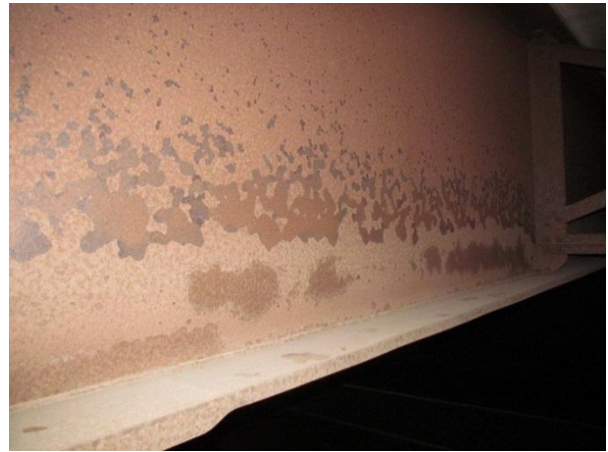
Figure 2. Typical widespread delamination on web above traffic. Lower delaminations appear older, beginning to deteriorate again.

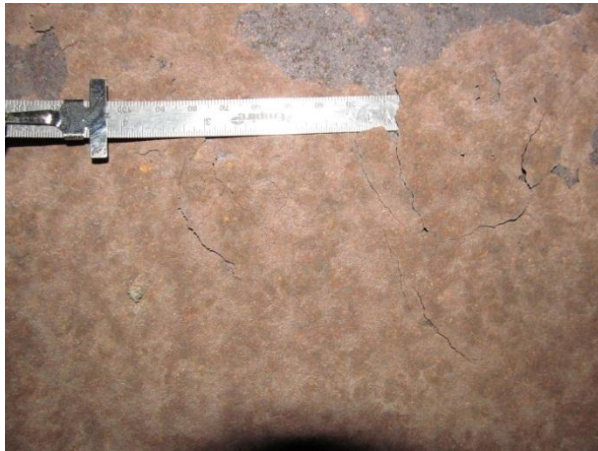
Figure 3. Close-up of web delamination progressing with scale inserted behind loose flake

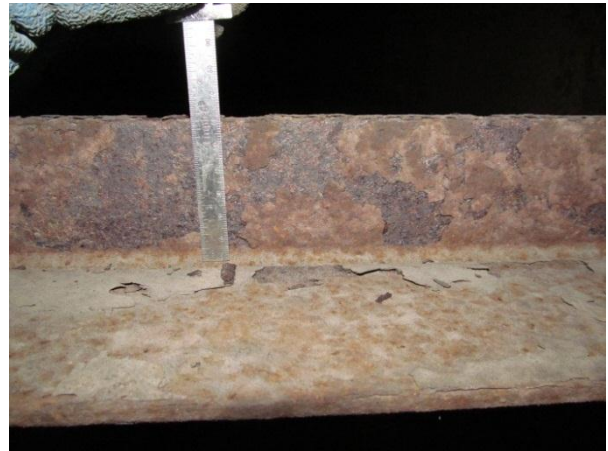
Figure 4. Heavy deterioration typical of cross-frame members over traffic lanes.

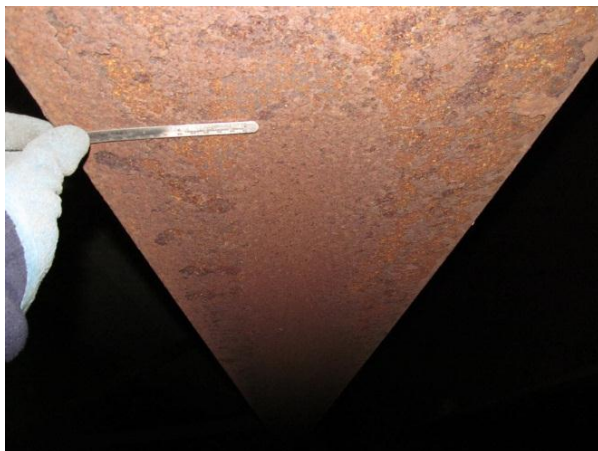
Figure 5. Flaking and small delaminations on bottom of flanges over traffic.

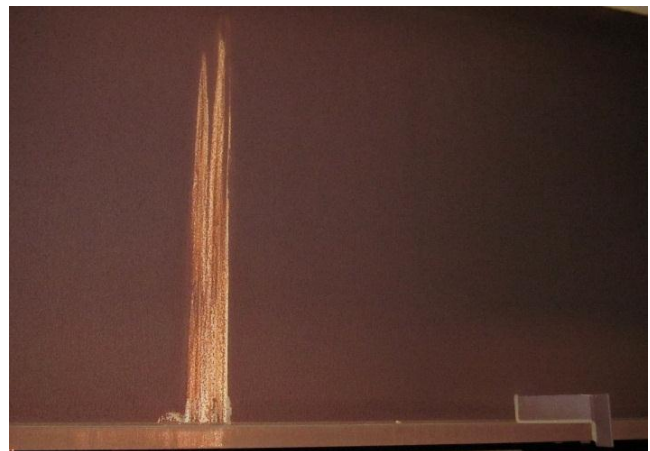
Figure 6. Example of staining on fascia girder. Patina locally under-developed underneath.

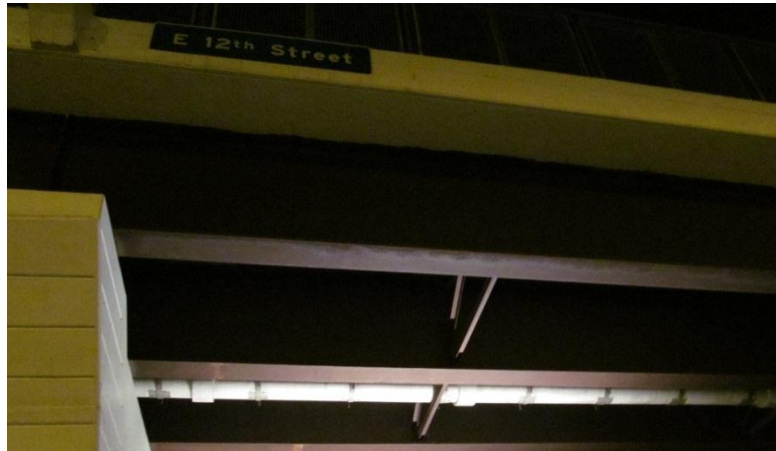
Figure 1. White, salty staining on west fascia girder (toward oncoming traffic) bottom flange south of pier.

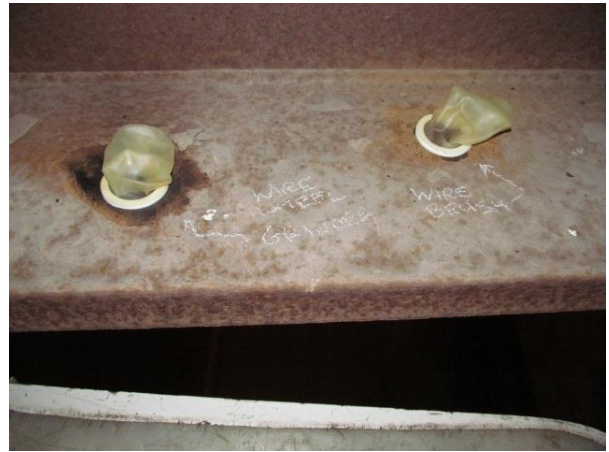
Figure 2. Chloride tests with some leaking on chalky poultice of bottom flange before washing.

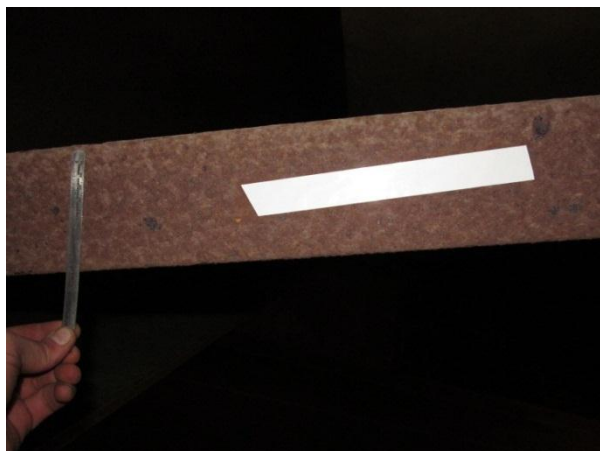
Figure 3. Index = 2 patina on vertical face of cross-brace where tape test conducted.

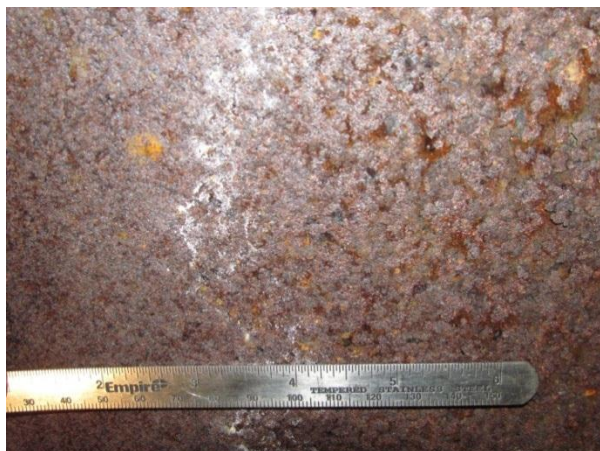
Figure 5. Close-up of discoloration and flaking on bottom flange adjacent to staining, Index = 2.

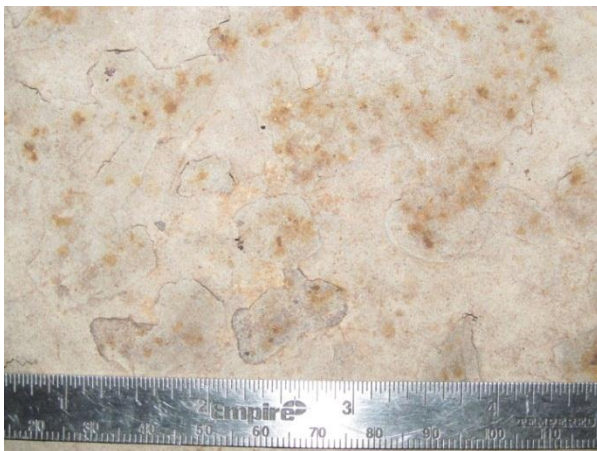
Figure 5. Delaminating patina with heavy poultice corrosion on interior girder bottom flange.

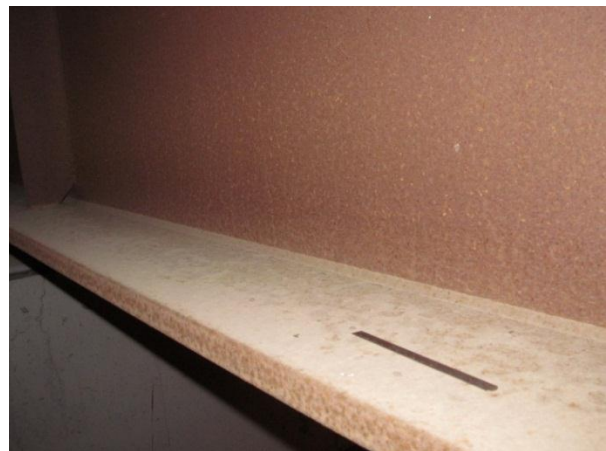
Figure 6. Interior girder bottom flange with heavy poultice corrosion viewed from arm's length.

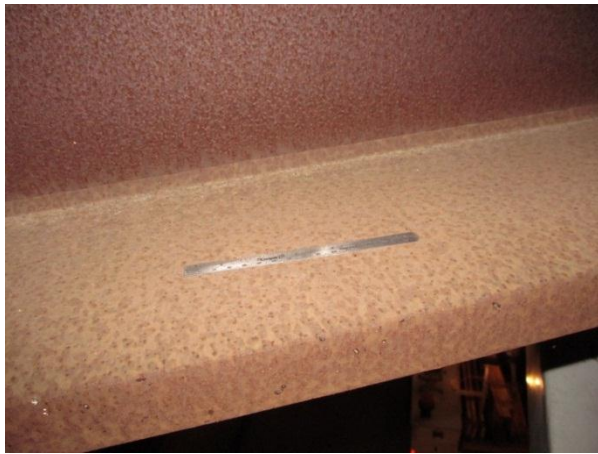
Figure 3. Light poulitice corrosion without flaking or deterioration on fascia girder flange.

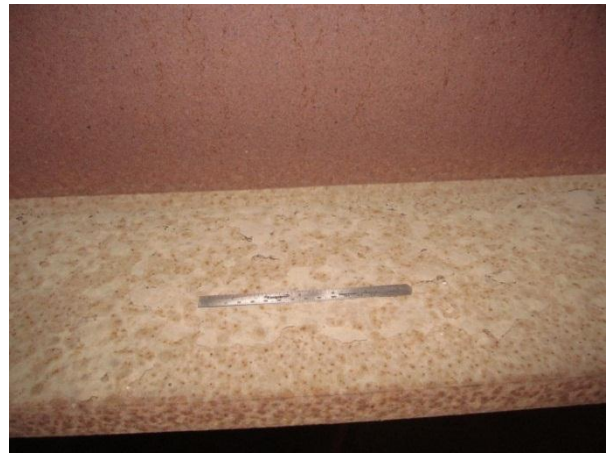
Figure 4. Heavy poulitice corrosion with delaminated flaking on interior bottom flange.

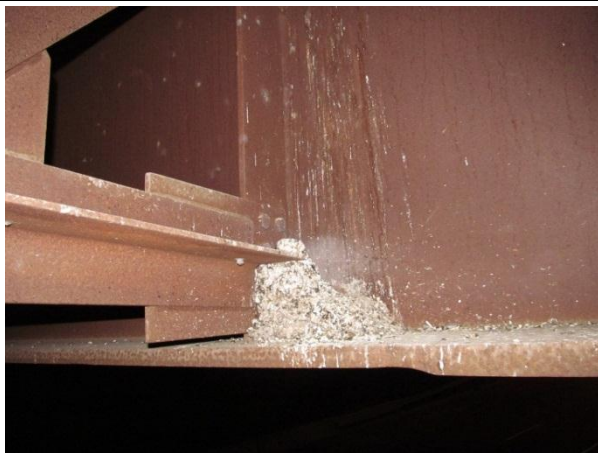
Figure 5. Bird droppings contributing to poulitice on interior bottom flange.

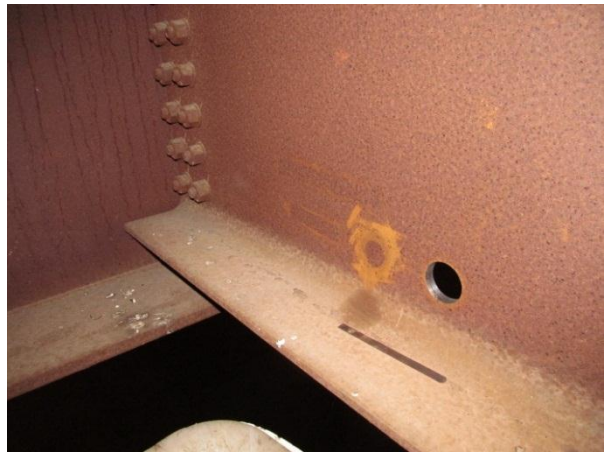
Figure 4. Heavy poutlice corrosion on diaphragm and girder flange at core location.

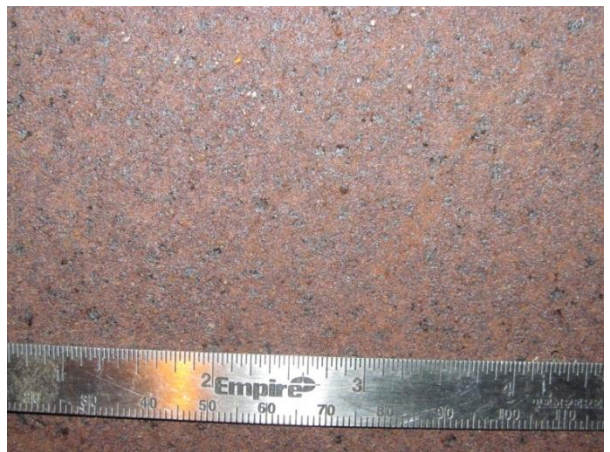
Figure 6. Detail of patina condition on diaphragm web adjacent to core. Index=3.5.

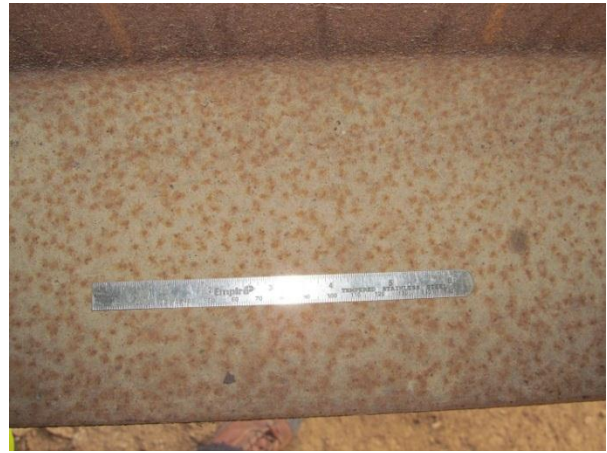
Figure 4. Interior top of bottom fascia flange with light poultice corrosion, but minimal flakiness.

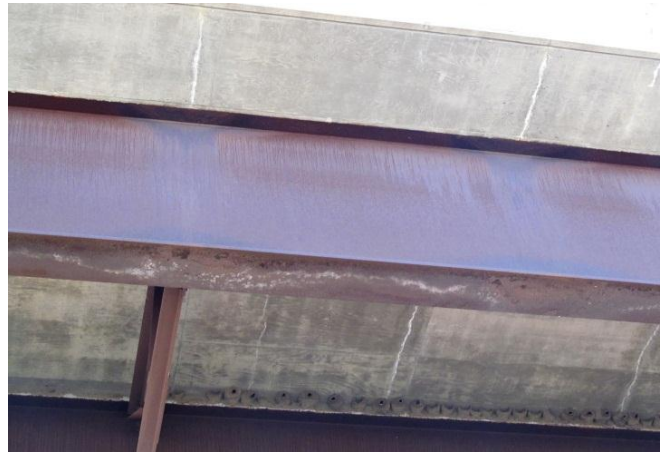
Figure 2. Exterior of west fascia girder on southbound bridge showing localized patina deterioration on all surfaces beneath cracks.

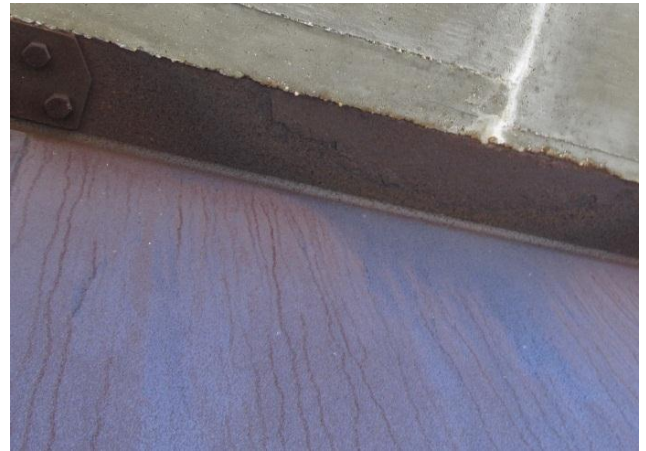
Figure 4. Heavy deterioration/delamination of west fascia girder top flange at crack, possibly Index = 1.

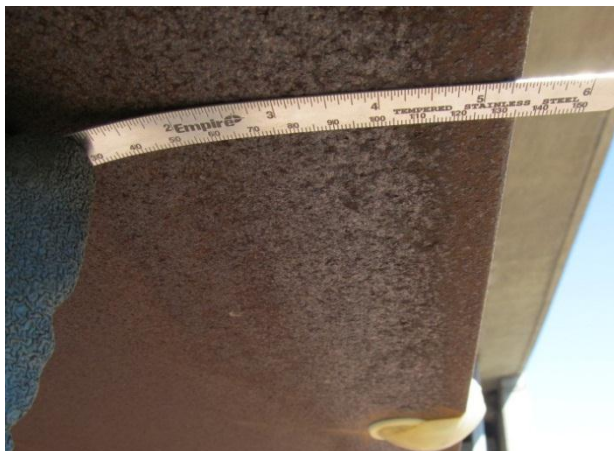
Figure 5. Condition of bottom of flange of east fascia near north abutment considerably better than west fascia (Index = 3).

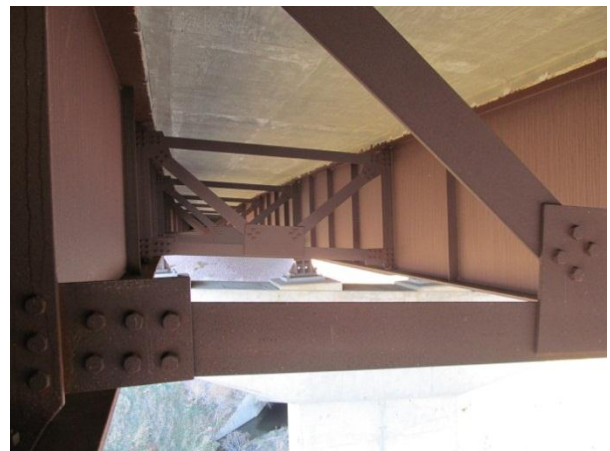
Figure 6. Typical condition of other interior surfaces away from deck cracks typically Index = 3 to 4, with little to no surface chlorides measured.

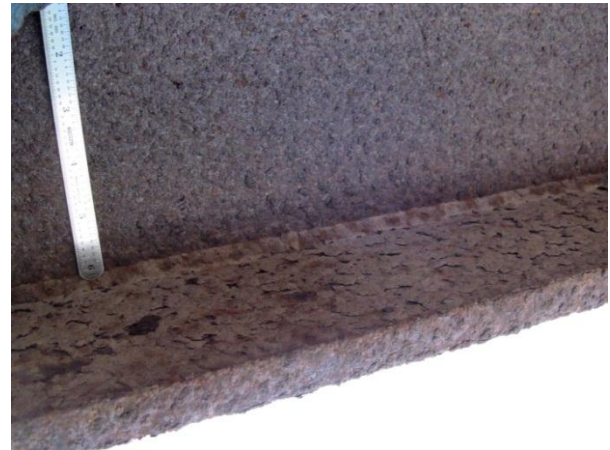
Figure 2. Interior surfaces over traffic showing signs of long-term deterioration.

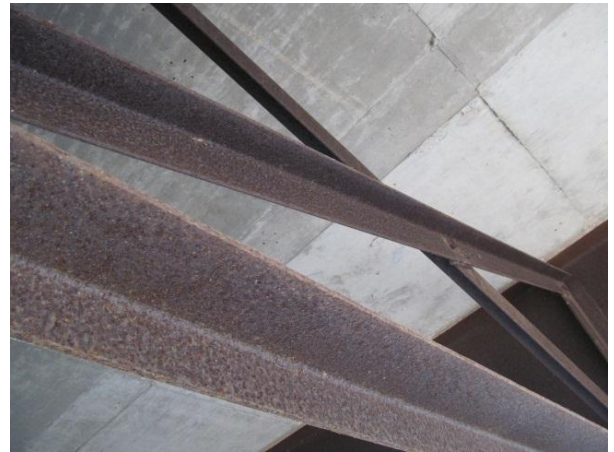
Figure 4. Typical cross frame condition near south abutment. Index = 3.

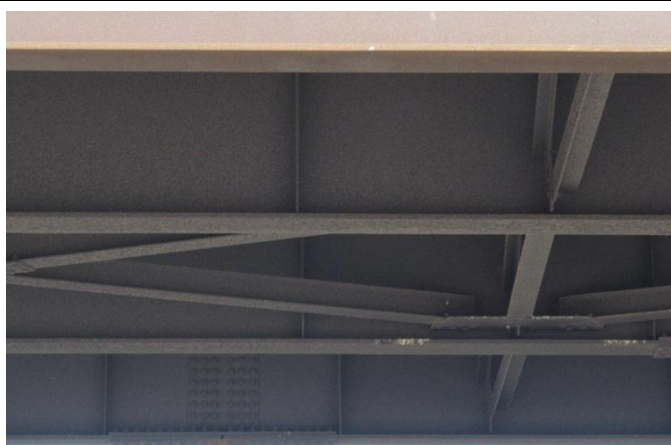
Figure 5. Heavy flaking visible from the ground on interior flanges and webs over traffic lanes; Index = 2.
