# Laboratory and Field Testing of an Accelerated Bridge Construction Demonstration Bridge: US Highway 6 Bridge over Keg Creek

**Final Report**  
**April 2013**

**Sponsored by**  
Federal Highway Administration  
Iowa Department of Transportation  
(InTrans Project 11-411)

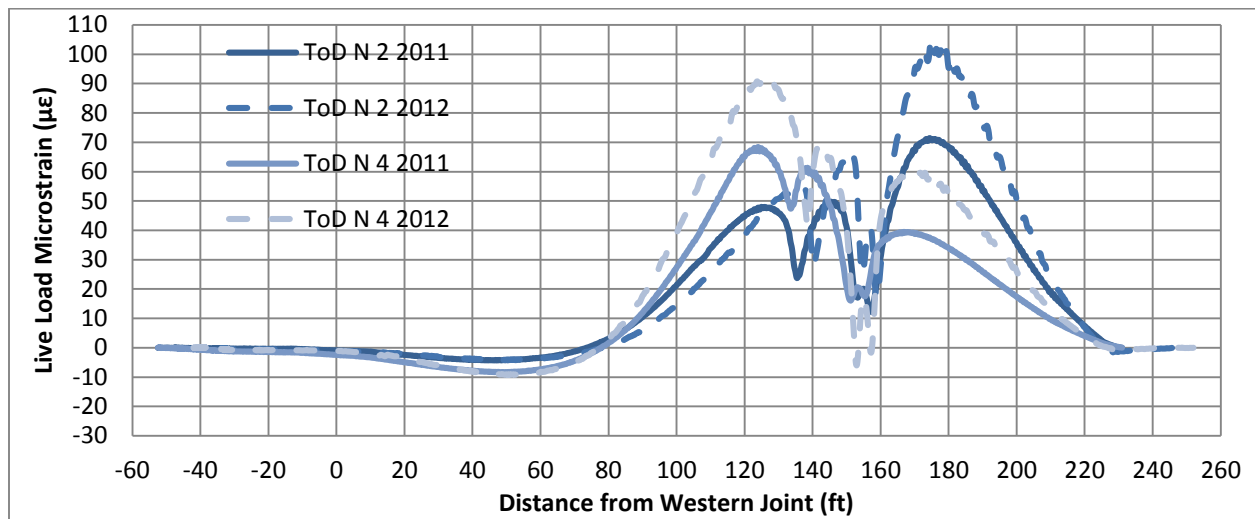
There also seems to be a consistent increase in maximum strain values between the 2011 and 2012 test with almost all maximum strains now being found at the HPC/UHPC interface locations. The most drastic increases in strains seem to be occurring at these interface locations

**Figure 4.11. Comparison of live load strains from 2011 to 2012 of surface-mounted transducers spanning interface load path 2**

A couple of things could cause the increase in strain from test to test. One explanation could be a relaxation of the post-tensioning utilized across the transverse joint. However, this scenario is not supported by the collected data. A decrease in compressive force from the post-tensioning rods would result in a significant increase in tensile strains for all gauges at the transverse joint, not only the gauges spanning the interface. Therefore, the increase of tensile strain from test to test is much more likely explained by a breaking down of the bond between the UHPC and HPC at the joint interface, which would localize the larger increases in strain to the joint interface as seen in the data.

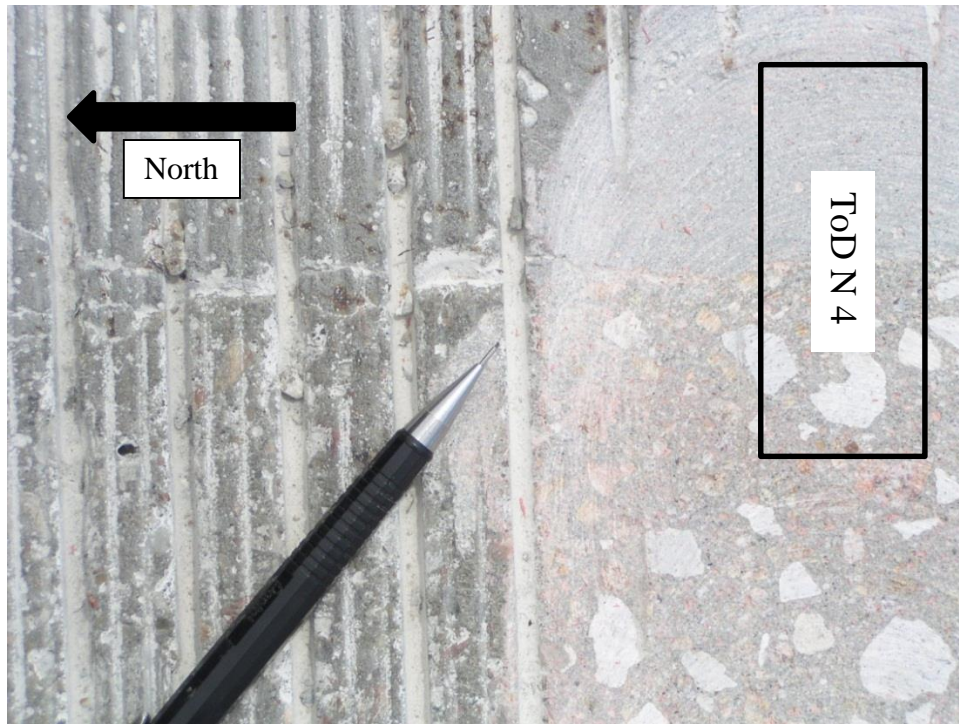
As recorded strain values have increased between the 2011 and 2012 test, the maximum tensile strains of the 2012 test ( $\sim 106 \mu\epsilon$ ) have gotten much closer to the cracking strain of the HPC ( $\sim 132 \mu\epsilon$ ). Upon visual inspection, many cracks were noticed on the top of the deck. A large majority of these cracks were noticed at the interface between the UHPC joints (both longitudinal and transverse) and the precast HPC deck modules.

The photos in Figure 4.13 through Figure 4.16 were taken at the time of the second test in May 2012 showing cracking along the joint interfaces and leakage through the bridge deck.

**Figure 4.13. Observed cracking at instrumented joint at location of ToD N 4 transducer**

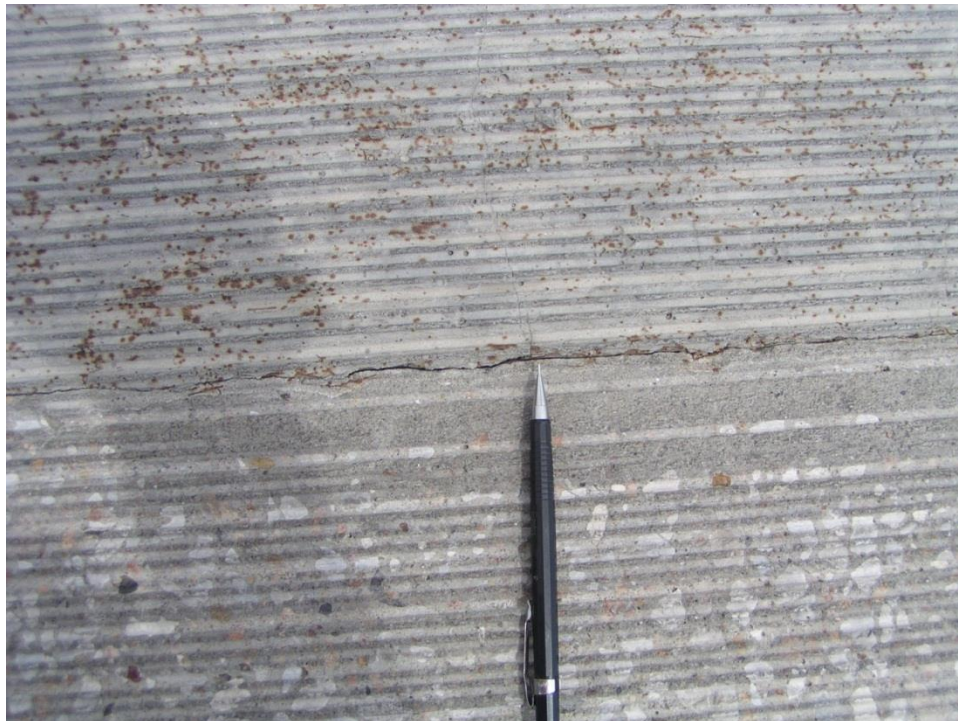
**Figure 4.14. Observed cracking of longitudinal joint between modules 2 and 3**

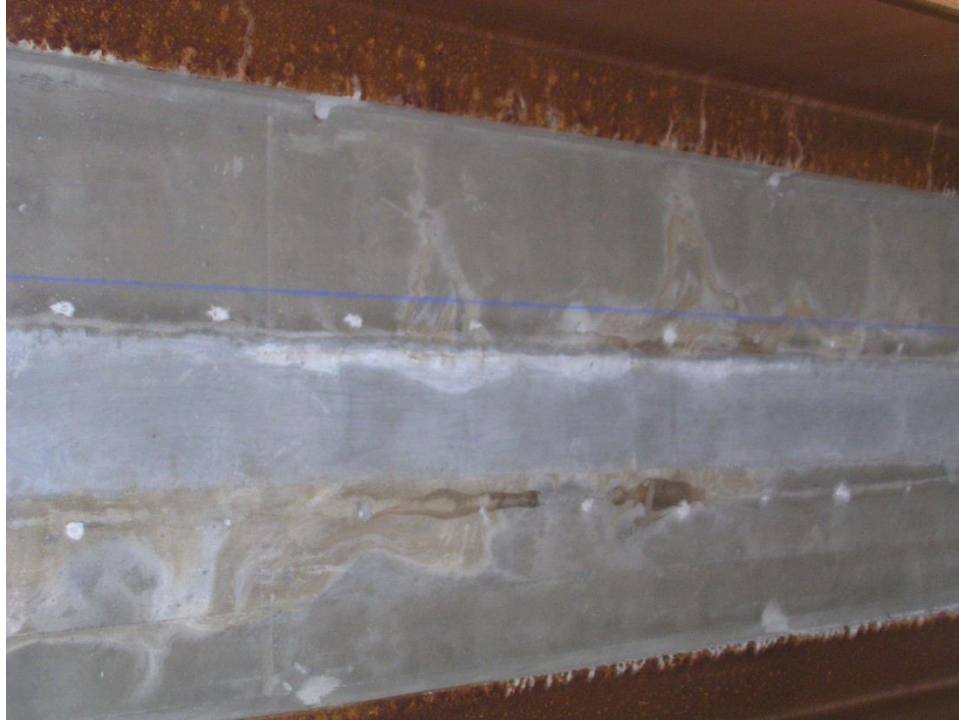
Visual inspection, as well as evaluation of the collected data, showed a breakdown of the bond between the interface of the HPC and UHPC at the joints. The breakdown of this bond resulted in cracking of the deck allowing an ingress of road salts, which is verified by the presence of efflorescence on the underside of the bridge deck at joint interfaces.

**Figure 4.15. Observed efflorescence between modules 2 and 3 on bottom of deck**

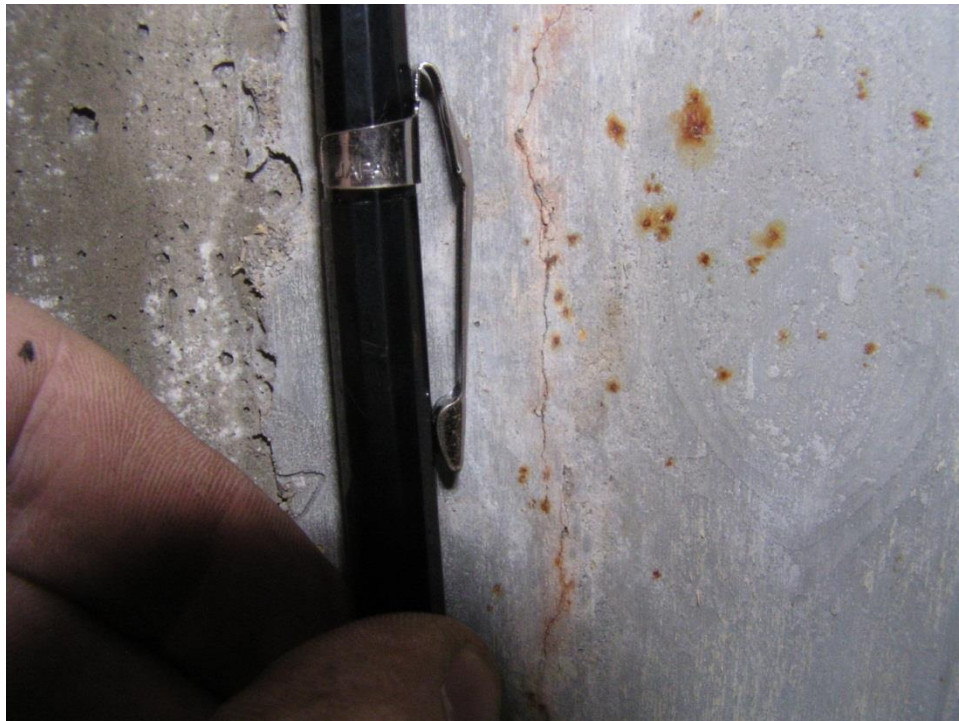
**Figure 4.16. Close-up of cracking and efflorescence observed between modules 2 and 3 on bottom of deck**

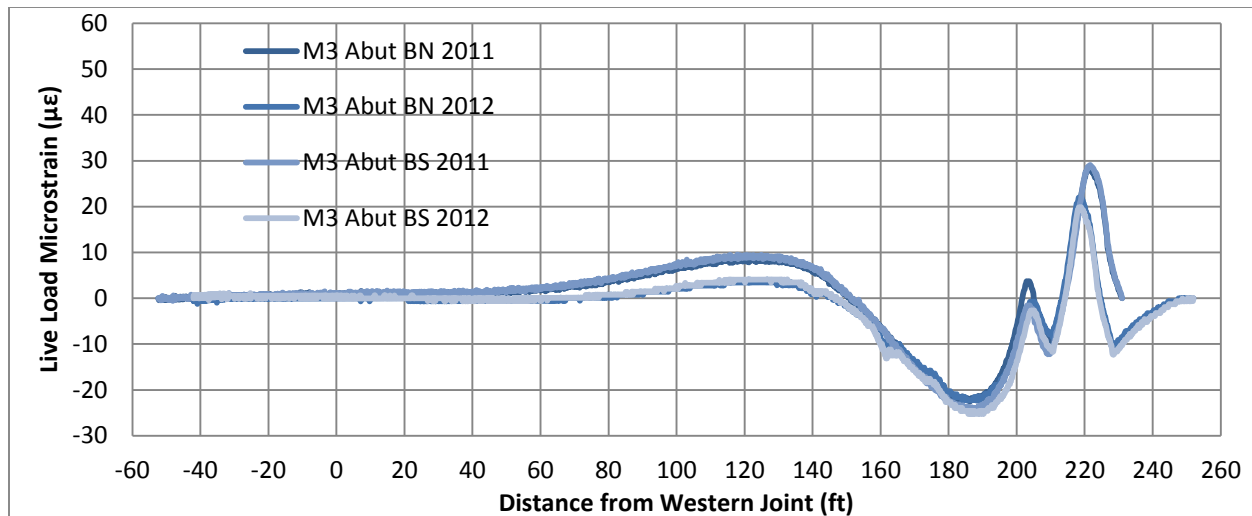
**Figure 4.23. Comparison of live load strains from 2011 to 2012 of transducers on bottom flange of girder at abutment for module 3 from load path 3**

In this figure, it can be seen that maximum strain values recorded in the bottom flange for a majority of the load paths have shifted from tensile in the 2011 test to compressive in the 2012 test. This is due to the fact that data stopped being collected as soon as the rear axle left the bridge span in the first test while, in the second test, data was collected until the rear axle was approximately 20 ft past the east joint. Therefore, the behavior of the semi-integral abutment was captured as the test truck exited on the approach slab in the data from the 2012 test.

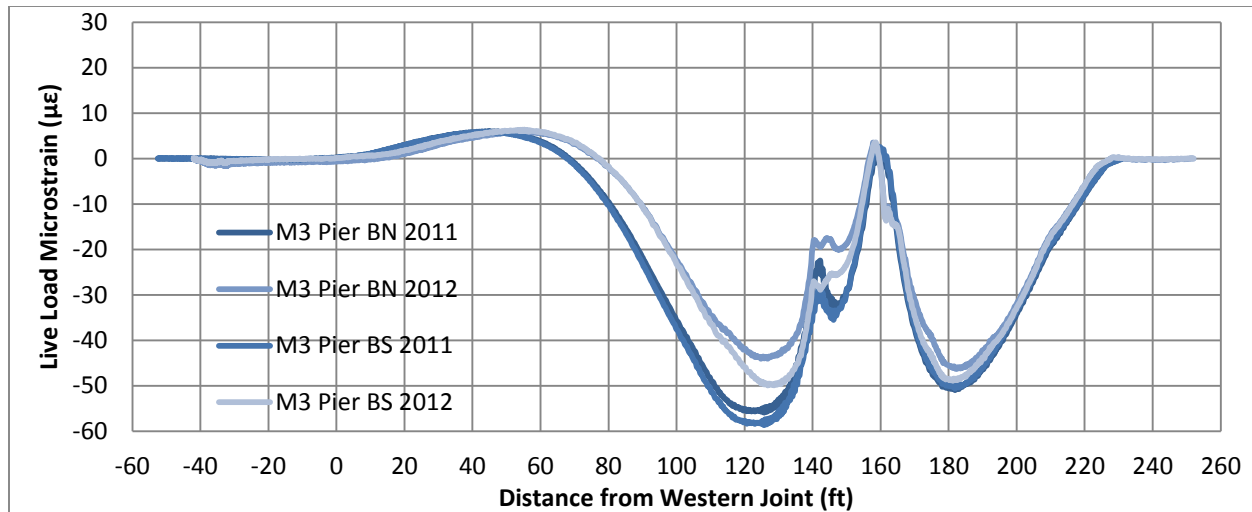
**Figure 4.24. Comparison of live load strains from 2011 to 2012 of transducers on bottom flange of girder at pier for module 3 from load path 3**

This loss of compressive strain shows a reduction in the magnitude of the negative moment seen at the pier. This is indicative of a loss of continuity to some degree at the east pier location and moving more toward a simply supported condition. This would also be supported by the indication of loss of bond between the precast HPC deck panels and the UHPC transverse joint as was reported previously.

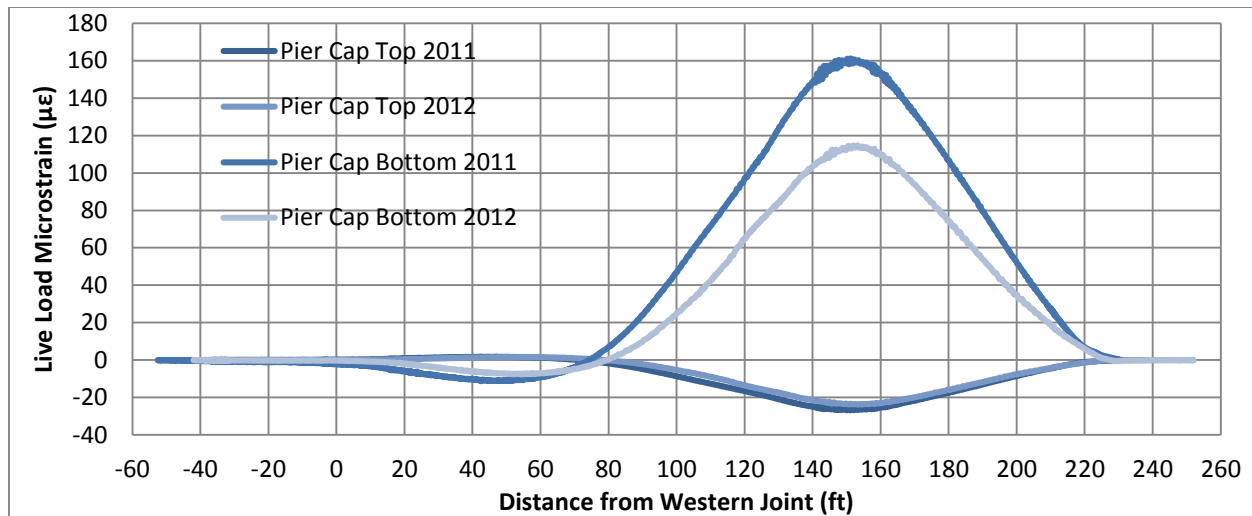
**Figure 4.25. Comparison of live load strains of pier cap**

The difference between tests can be explained by a couple of occurrences. First, it is possible that the transducer of the first test was located over a crack location, which would result in a greater strain value. Also, there could be strain relief occurring from the first test to the second test as a result of development of more cracks over time.
