Bridge Deck Rehabilitation Rebonding a Delaminated PCC Overlay By Epoxy Injection

**Final Report for
Iowa DOT Project HR-1036
FHWA Project DTFH 71-83-51-1A-06**

January 1989

IOWA RESEARCH PROJECT
HR 1036

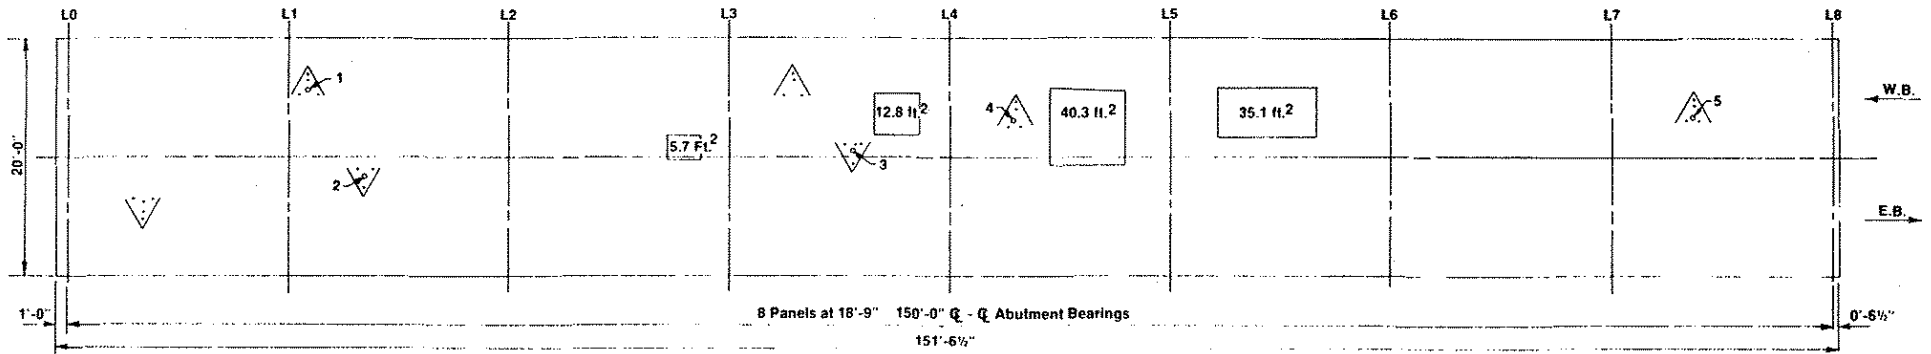
FIGURE 1
PRE-PROJECT LAYOUT

The four breakout areas were repaired with low slump dense concrete using Iowa's standard procedures with the one exception that during removal, no attempt was made to extend the repair area to sound concrete at all edge boundaries. Figure 1 is a layout of the work completed prior to beginning the demonstration project.

Five four inch diameter cores were cut from injection test sites May 10, 1983. These are shown in Figure 1. Visual-examination indicated good rebonding of the fracture plane in cores 1, 2 and 5. Core number 4 was partially rebonded; the remainder of the interface appeared to be coated but not filled with epoxy.

The overlay was not bonded to the substrate in Core 3. The layer of epoxy was bonded to the overlay. The face of the substrate exhibited a layer of powdery contaminant. Part of the contaminant adhered to the epoxy and the remainder, a thin layer, prevented bond of the epoxy to the solid substrate. This core was obtained from a test site near an overlay repair area (L3-L4).

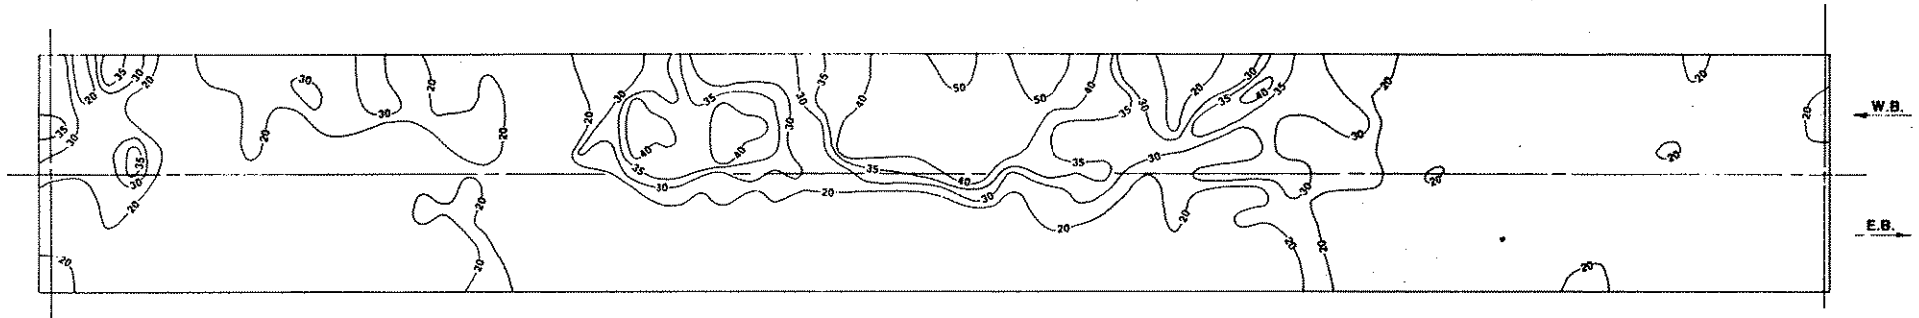
FIGURE 2
BEFORE CONDITION SURVEY
HALF CELL ELECTRICAL POTENTIAL

Field data were collected on June 13, 1983. A delamect survey of the deck and electrical potentials were obtained. Copper-copper sulfate half cell readings were taken on a two foot by two foot grid. Figure 2 shows the contour plot from the electrical potential survey. Figure 3 shows the results of the delamect survey.

The delamect survey indicated that 693 sq. ft. were delaminated in the westbound lane and 192 sq. ft. in the eastbound lane. Half cell tests indicated that almost all of the eastbound lane was in the range of 0 to -0.20 volts as was about thirty five percent of the westbound lane. Nearly one-half of the westbound lane showed potentials at or higher than -0.35 volts, the generally accepted corrosion threshold level.

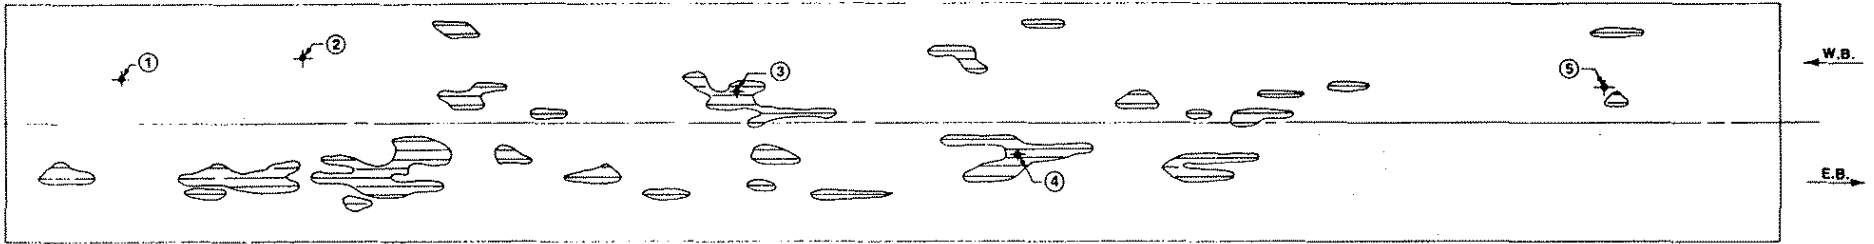
FIGURE 4
AFTER CONDITION SURVEY
DELAMTEC CORES

A post-treatment delamtect survey was conducted August 22, 1983. This survey indicated that 77 sq. ft. of delaminated PC overlay remained in the westbound lane and 143 sq. ft. remained in the eastbound lane. The original total delaminated area of 885 sq. ft. had been reduced to 220 sq. ft. This is a reduction from 29.2% to 7.2% or 22% of the total deck area. Delamination in the westbound lane where epoxy injection was preformed was reduced from 45.7% to 5.1% of the gross area of the lane. In the eastbound lane, a reduction from 12.7% to 9.4% occurred as carry over from treating the westbound lane.

The remaining areas of delamination in the eastbound lane are readily understood. The areas remaining in the westbound lane warrant additional analysis. A review of the post treatment delamtect plot, Figure 4, superimposed over the plot of pre-treatment test sites and overlay repair areas, Figure 1, shows a relationship between the pre-treatment activities and the remaining delamination (see Figure 5). The delamination near L2 is at the boundary between the end of first day treatment and the beginning of second day activity. With these factors taken into account it is estimated that, without pre-treatment interference, over half of the remaining delamination in the westbound lane would have been rebonded. It is presumed, also, that technique can be improved to reduce the failure to rebond at boundaries between days work areas such as at L2.

Five four inch diameter cores were cut from selected locations on August 31, 1983. The locations from which these cores were obtained is shown in Figure 4. Cores were located to avoid top reinforcing, cut to a partial depth to contact bottom layer reinforcing, then broken out by wedging. Cores 3 and 4 were deliberately selected where delamination was indicated in an attempt to evaluate failure to rebond. In both cases, the top portion of the core had rotated to destroy conditions at the delamination interface. No evidence of epoxy indicates failure to inject at these points. No evaluation could be made to confirm the presence of a contaminant such as observed in pretest core Number 3, see Appendix A.

Cores 1, 2 and 5, by visual examination, indicated successful rebonding. Core 1 broke too close to the bond plane to be shear tested. Cores 2 and 5 were tested in shear at the bond plane and in substrate. Core 5 contained a sufficient depth of overlay concrete to permit a test in this zone also.

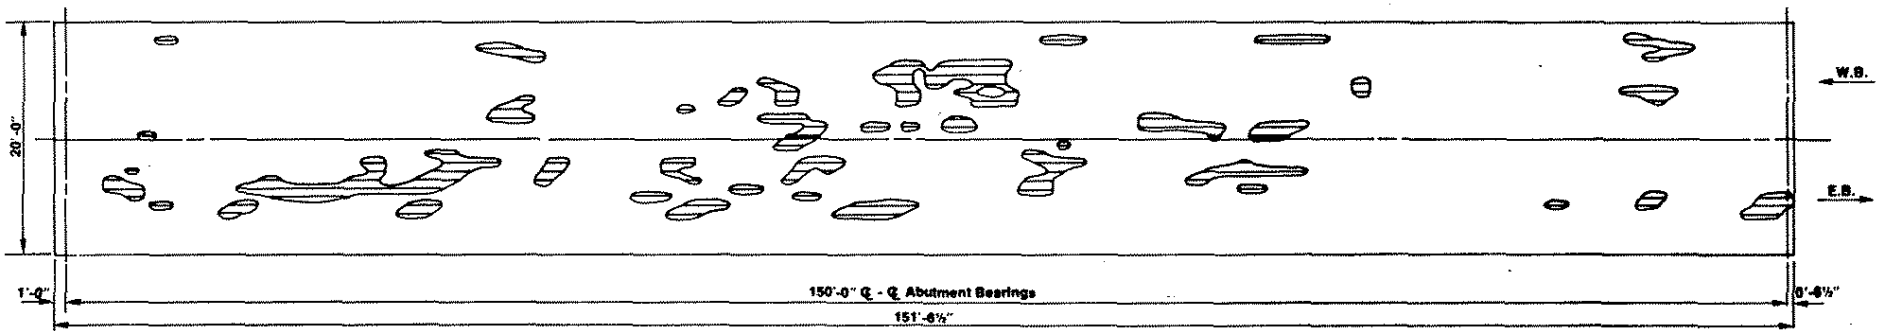
FIGURE 6
1984 DELAMINATION SURVEY

The survey rerun was performed on September 19, 1984. Results of the strip chart interpretation indicated total delamination of 222 sq. ft., only 2 sq. ft. different from that indicated in August 1983. This time, however, the westbound lane indicated 98 sq. ft. of delamination and the eastbound lane indicated 124 sq. ft. Each of these indications varies from the August 1983 results by about 20 sq. ft. but in opposite directions to result in a total that represents virtually no change.

applicable. The variation in test results are within a range of about 1.5 percent of the gross area surveyed. It is concluded that results with a higher degree of accuracy probably cannot be obtained. It is also concluded that there is no essential change in the condition of the bridge deck since the epoxy injection was completed August 9, 1983.

Figure 6, attached, is a deck plot of the September 19, 1984 delamination survey.

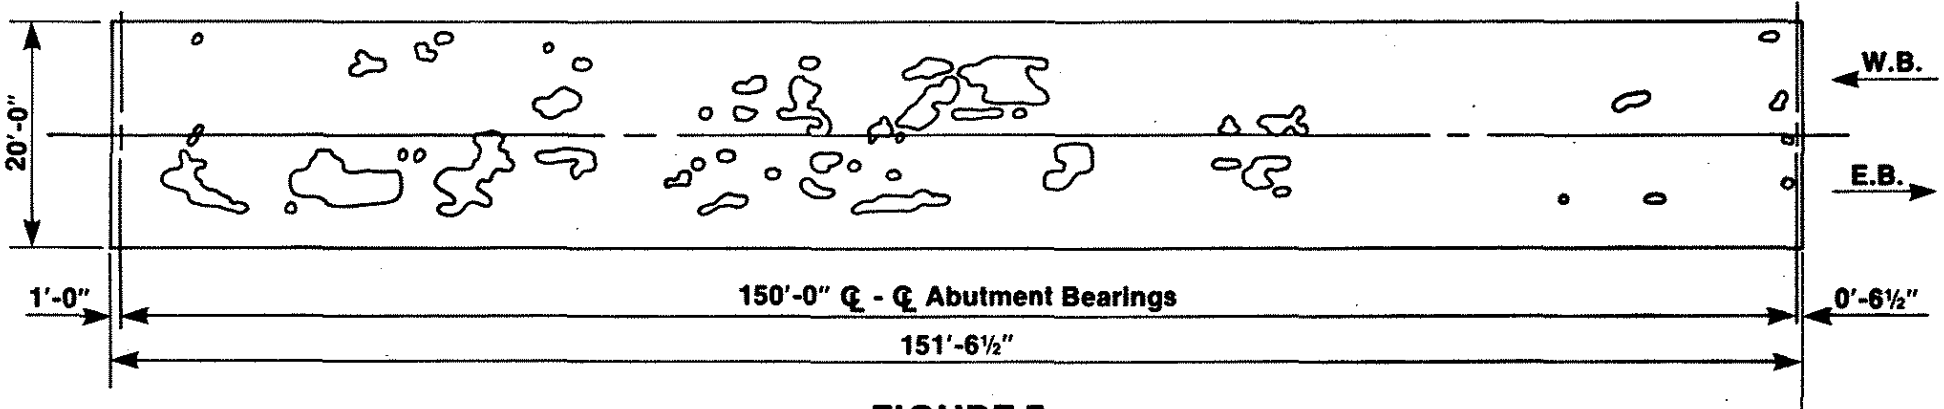
FIGURE 7
1988 DELAMINATION SURVEY

A final survey of the bridge deck was performed on May 23, 1988. Visual observations indicated no change in the appearance of the deck surface from previous post-treatment observations. The delamtect survey provided results very similar to previous observations, nearly identical to the results obtained in April 1984. Figure 7 is a deck plot of the delamination survey conducted May 23, 1988.
