Improvement of Longitudinal Joints in Asphalt Pavement

**Final Report
Iowa Highway Research Board
Project HR-215**

Highway Division
January 1987

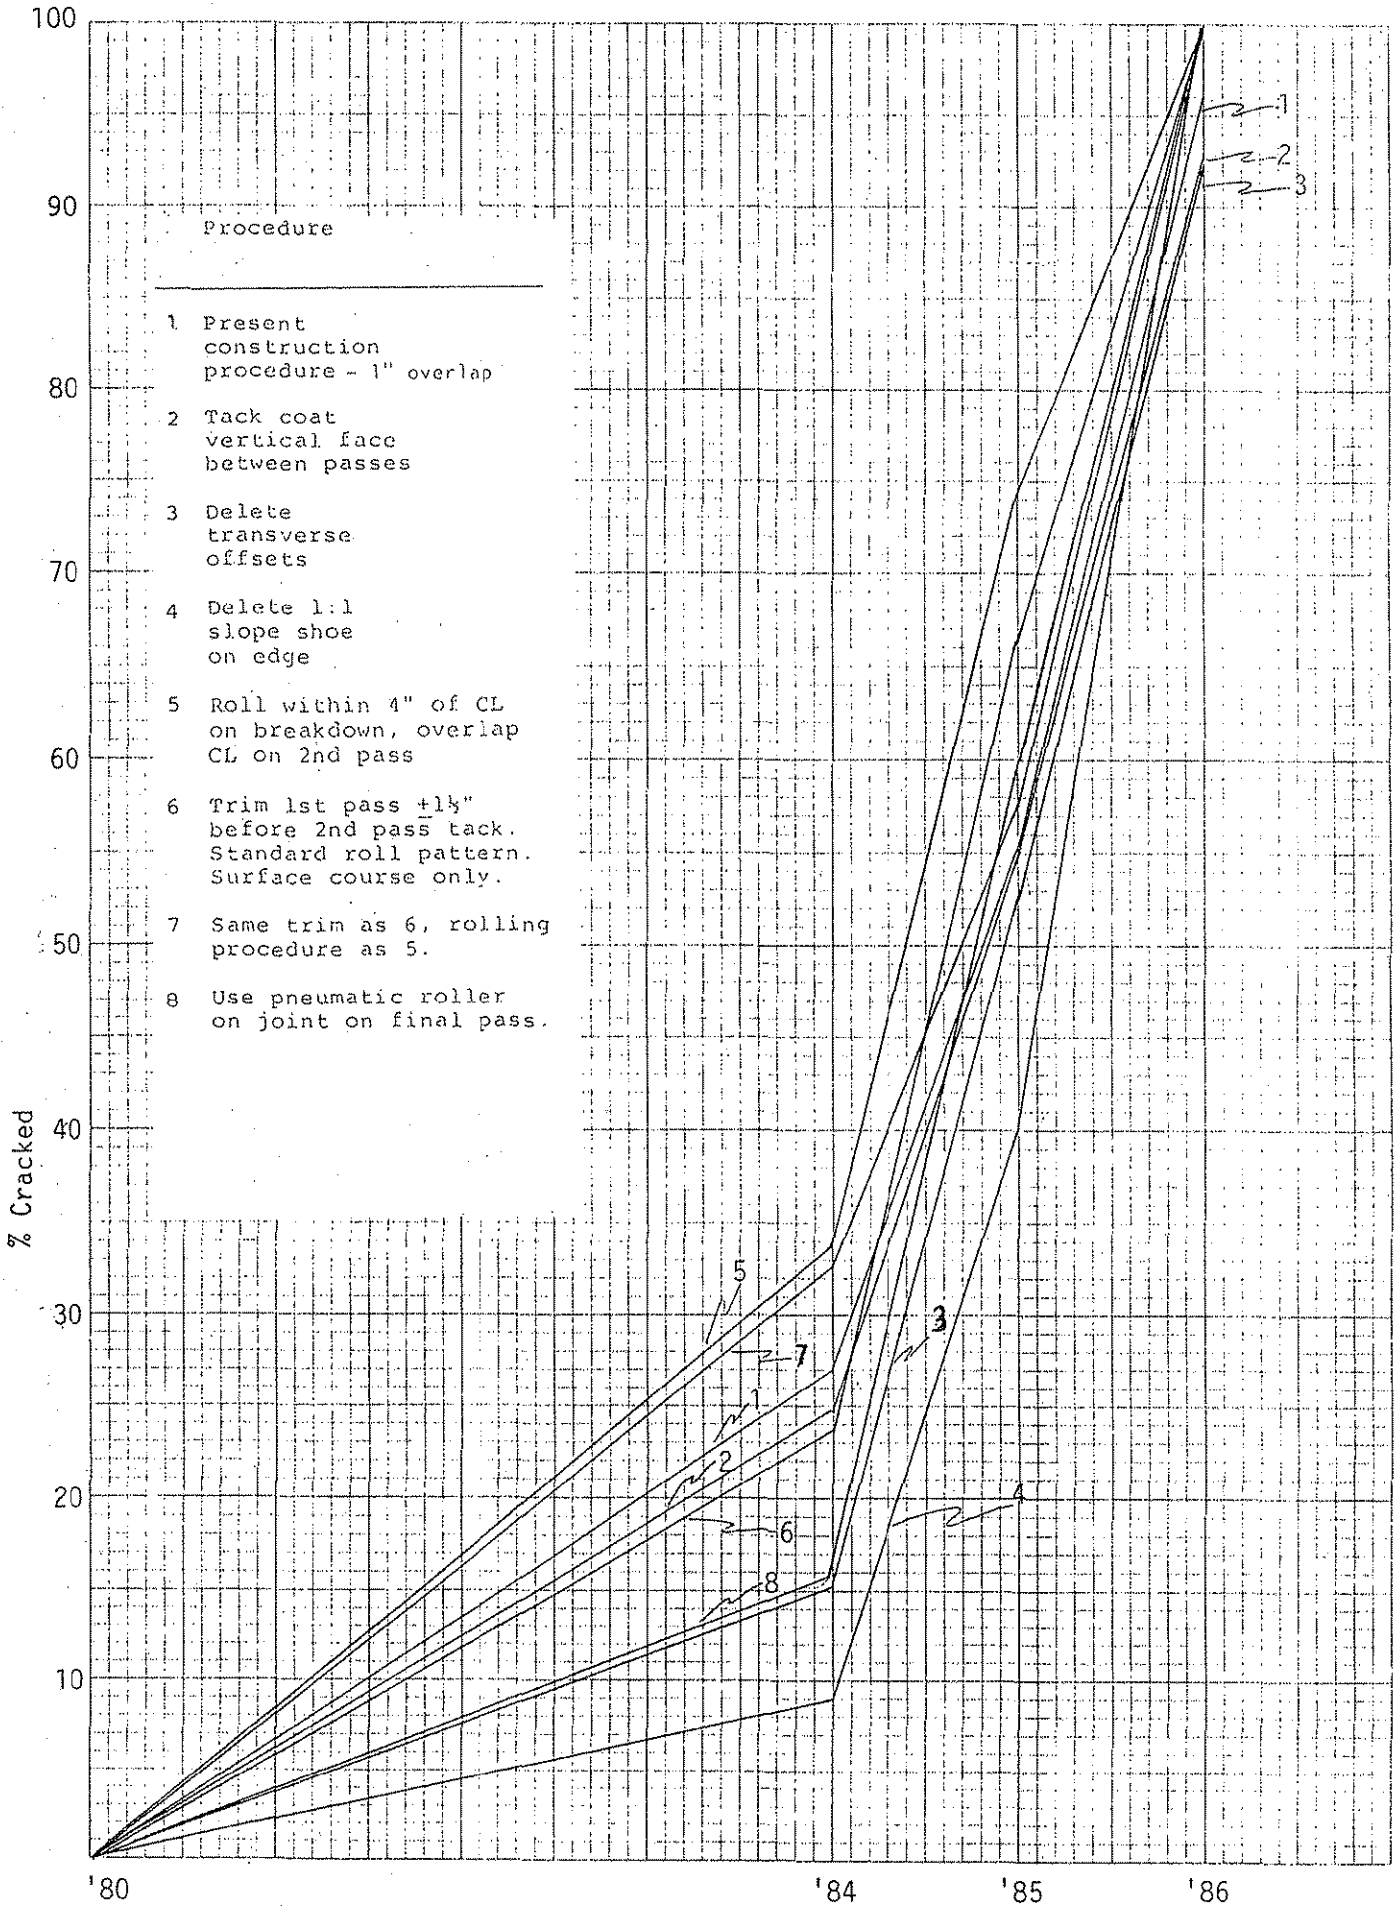
Figure 2: Rate of Cracking

All but procedures 1, 2, and 3 had cracked 100% of their length by November 1986, and they were cracked 96.1%, 92.7%, and 92.5% respectively. Each of those procedures had one section that was 100% cracked. The percentage of cracking by section and year is listed in Table II along with the densities near the centerline that were determined after construction in 1980. After 1984, all procedures exhibited a very steep slope in the rate of cracking (Figure 2).

Between four and six years of service the rate of cracking for all methods used on this project was about the same. Overall, there was no one method that out performed the others in this project.
