PIPE REHABILITATION WITH POLYETHYLENE PIPE LINERS

**Construction Report for
Iowa Highway Research Board
Project HR-370**

March 1995

**Iowa Department
of Transportation**

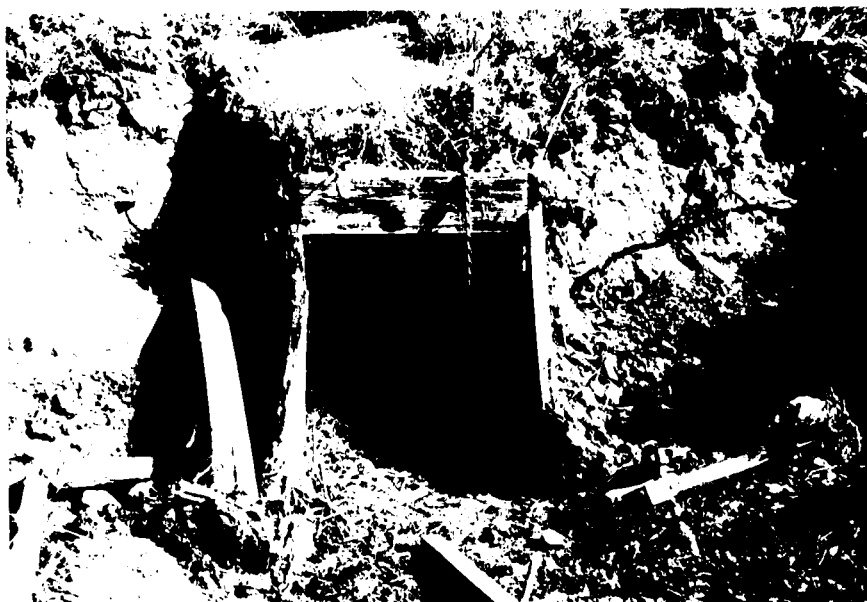
The project site is 0.3 km (0.2 mi.) east of Umber Avenue on 195th Street (see map, page 28). The existing drainage structure was a 1.1 m (3.5 ft.) square wood box culvert (see photo 1, page 37) with a length of approximately 11 m (35 ft.). The wood had deteriorated, and granular material from the roadway was falling through the top of the culvert.

Photo 1
Wood Box Culvert in Jefferson County

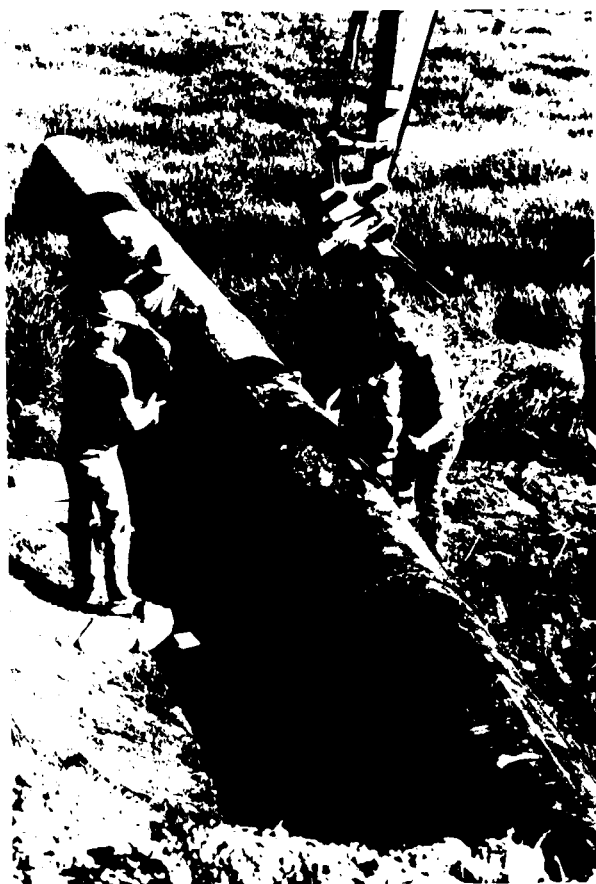
The "Snap-Tite" liner was assembled at the north end of the pipe. The two segments were connected using a pair of chains and winches (see photo 2, page 37). One chain was tightly wrapped around each pipe segment. The winches were connected to the chains, and the two segments were pulled until they locked together. The complete pipe liner was pulled through the wood box culvert. Earth was placed around the end of the liner to form earth dams for the placement of flowable mortar.

Photo 2
Connecting "Snap-Tite" Liner Segments
Jefferson County

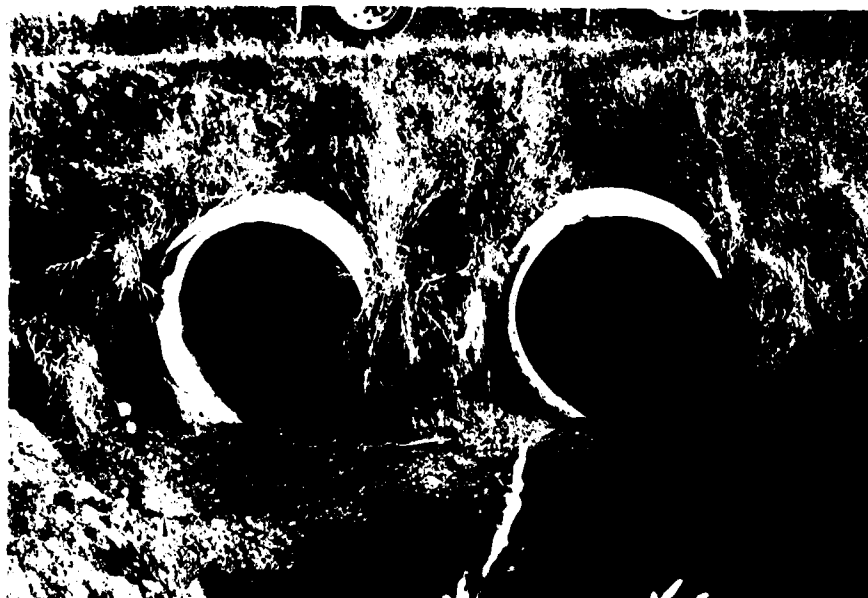
The project site is 2.2 km (1.4 mi.) east of US 151 on county road E23 (see map, page 29). The existing pipes are twin 1400 mm (54 in.) diameter concrete pipes (see photo 3, page 38). The joints between the concrete pipes have separated, and the pipes are showing signs of concrete deterioration. The road above the pipe has been replaced once because of excessive settlement probably due to piping. It has settled again. The road exhibits cracking, and a 25 mm (1 in.) fault has occurred at the centerline.

Photo 3
Twin Concrete Culverts in Jones County

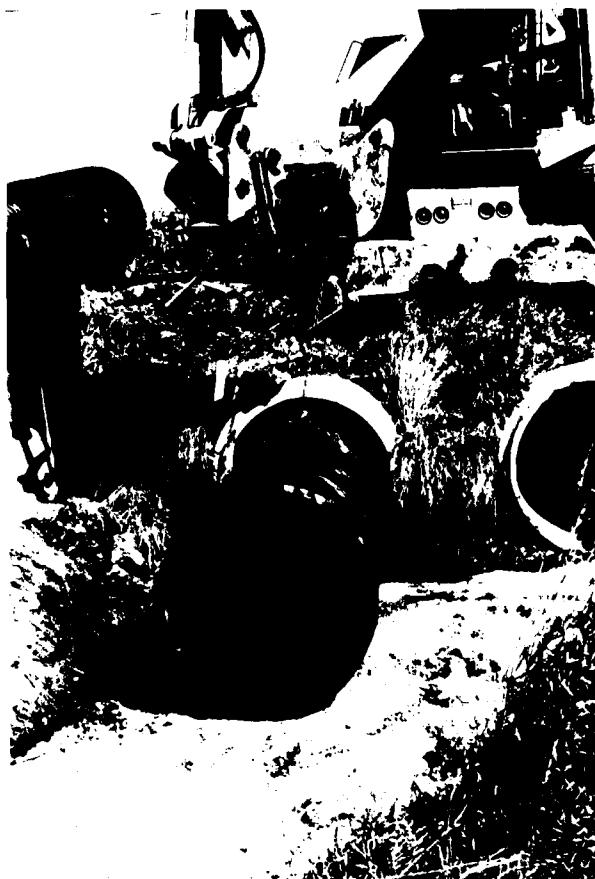
Photo 4
First Segment of "Culvert Renew" Being
Pulled Into the Concrete Culvert (Jones County)

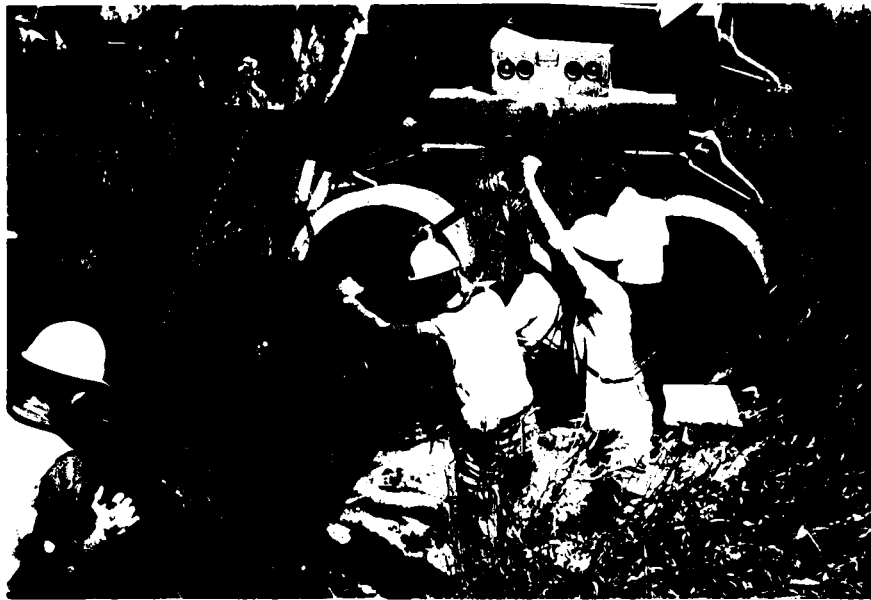
Photo 5
Threading "Culvert Renew" Liner Segments in Jones County

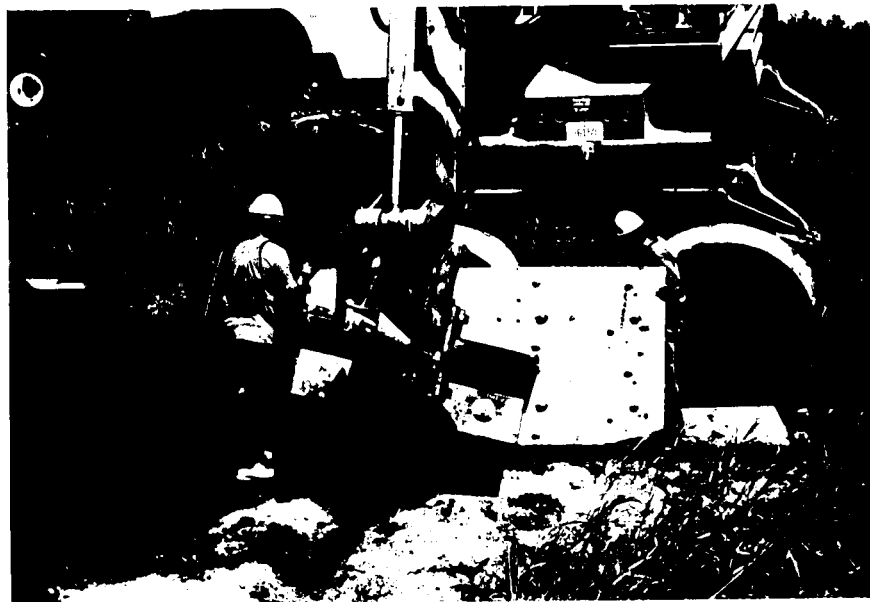
Photo 6
Use of a Board to Protect the Culvert Liner While it is Pushed
into the Concrete Culvert (Jones County)

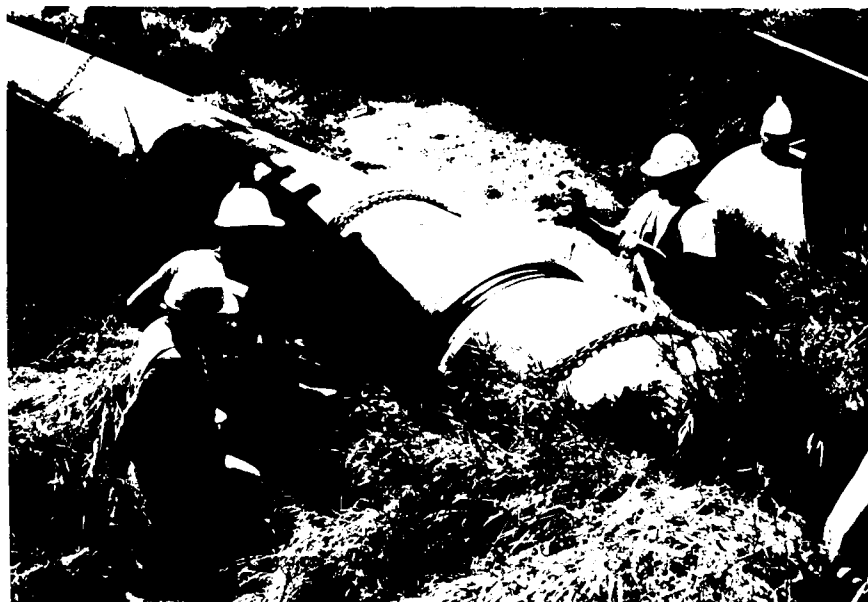
pair of winches was used to pull the two pipes together (see photo 7 and 8, page 40). The process was difficult because the liner segments had slightly deformed into an oval shape. The crew had to use a pry bar and a screwdriver to help the liners snap together. The liner segments were inserted until 2 m (7 ft.) of the liner remained exposed. The third segment was attached in a similar process. This time attention was given to align the oval shape of the pipe segments. The joint went together without any problem from the ovalization of the pipe segments.

Photo 7
Connecting "Snap-Tite" Liner Segments (Jones County)

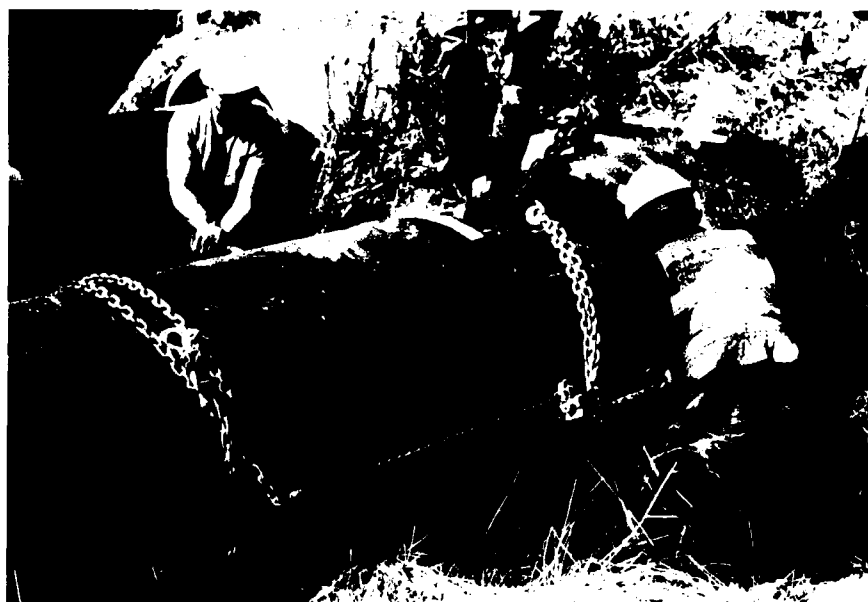
Photo 8
Connecting "Snap-Tite" Liner Segments (Jones County)

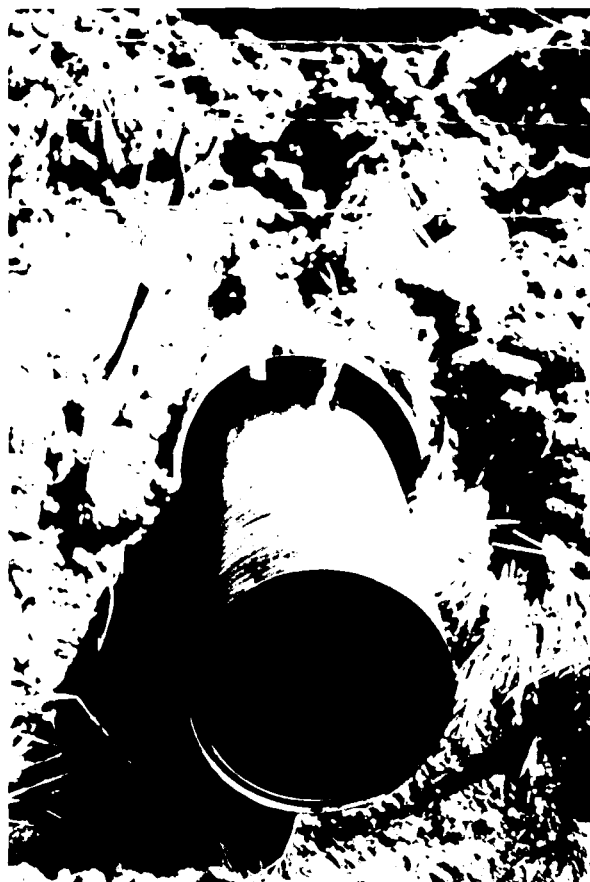
Photo 10
Approximately 1.5 m (5 ft.) of liner
is Left Exposed to Attach the Next
Segment (Mahaska County)

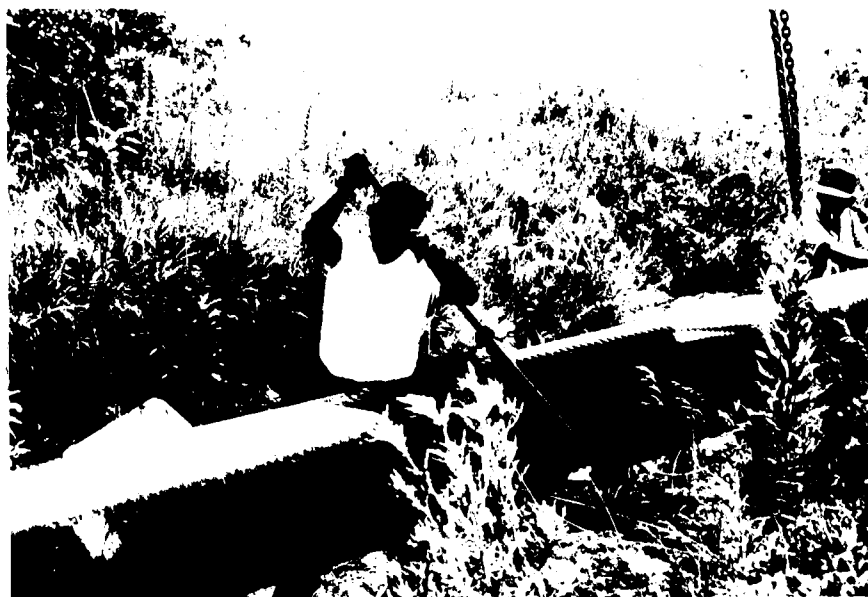
a chain and a steel bar (see photo 11, page 42). The chain is wrapped around the pipe. The steel bar is placed in the chain and twisted to tighten the chain. The bar is then used as a leverage device to turn the pipe which threads the liner. The connected segment was pushed into the CMP by the backhoe until 1.5 m (5 ft.) of liner was left exposed. An old sign was placed between the liner and the bucket to prevent the bucket from damaging the pipe. The process was repeated for the rest of the liner.

Photo 11
Threading "Culvert Renew" Liner
Segments (Mahaska County)

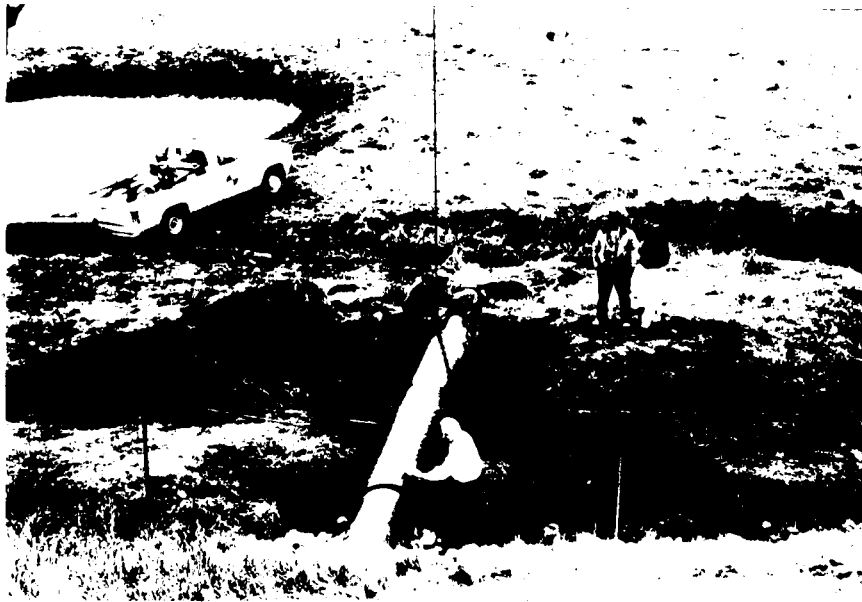
While the pipe was suspended by the crane, two laborers threaded the pipe segments together. The pipe was threaded by hand without a chain and torque bar (see photo 14 and 15, pages 43 and 44). Then, the dragline pulled the liner into the CMP. The process was repeated until the culvert was lined. The nose cone was cut off the pipe.

Photo 15
Work Area for Assembling Liner
(Taylor County)
