**Longitudinal Grinding  
and Transverse Grooving  
to  
Improve Frictional  
and  
Profile Properties**

Project HR-1035

June 1983

**Iowa Department  
of Transportation**

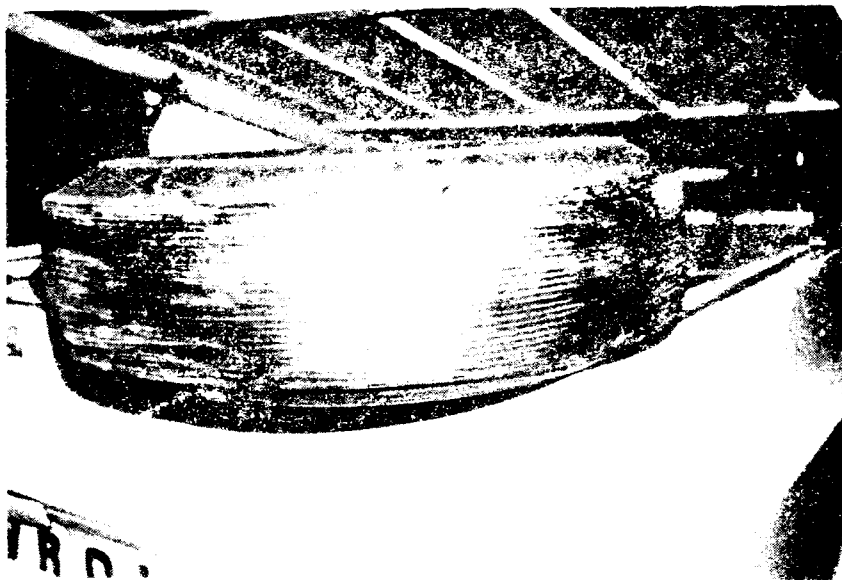
During friction testing, grooves were cut into ribs of the ribbed tire and the smooth tire was grooved full width by the textured surface.

Smooth test tire (ASTM 524) after testing

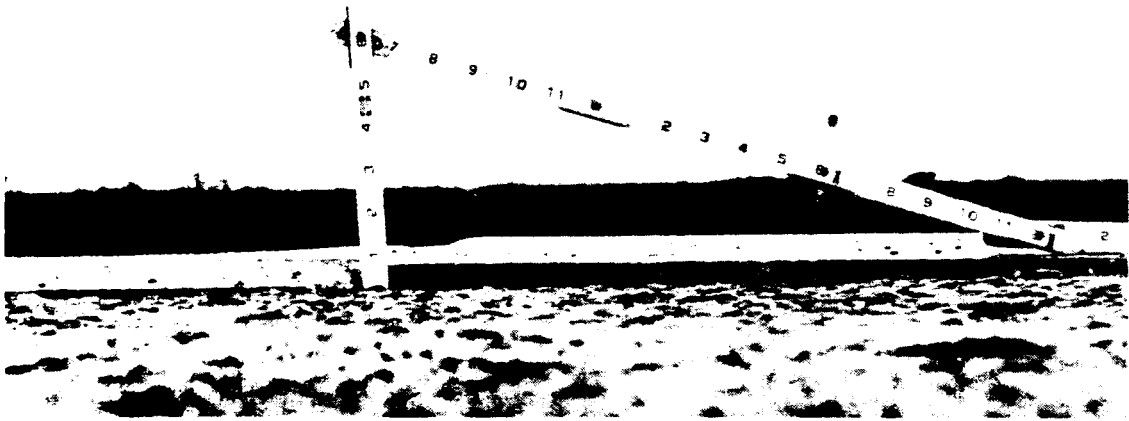
Interstate 80 in Scott County is portland cement concrete pavement with 76 ft between doweled joints. The pavement usually has two cracks between joints which have faulted as much as 3/4".

The pavement was undersealed in 1982 with a fly ash-cement-water slurry. The slabs could not be lifted enough to significantly reduce the faults at the cracks.

Random depth measurements were made with a tire-tread depth gauge. Concrete was being ground as much as 23/32" deep on the high side of a fault.

The longitudinal grinding was very effective in eliminating faults and improving the profile index.

Correction of faulted crack by grinding

The westbound lanes of I-80 between stations 732+00 and 747+00 just west of the IA. 130 interchange were profiled April 5-7, 1983 by Allstate Paving Inc. The same Target Safe-T-Planer used in Iowa County for texturing was used for profiling. Grinding was done in the direction opposing traffic.
