A DIFFERENT PERSPECTIVE FOR INVESTIGATION OF PCC PAVEMENT DETERIORATION

Interim Report for Iowa DOT Research Project HR-2074

Iowa Department of Transportation

January 1995

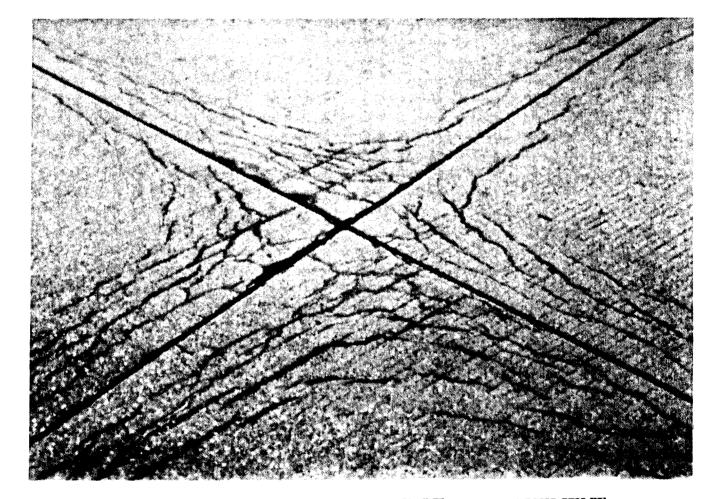
In the late 1950's, Iowa was faced with severe PCC pavement deterioration. Some pavements that were only 15 years old were exhibiting a substantial crack pattern. This deterioration was referred to as D cracking (Figure 1). After substantial research, the cause of this deterioration was related to a certain type of carbonate coarse aggregate. The initiating cause was identified as crushed limestone aggregate containing a predominance and substantial volume of pores in the 0.04 to 0.2 μ m diameter pore size. Since the 1930's, Iowa has maintained an excellent record of the ledges and quarry locations of crushed stone used in Iowa PCC pavement and their performance by time to visible deterioration. The D cracking problem was solved by

FIGURE 1 TYPICAL D CRACKING OF PCC PAVEMENT

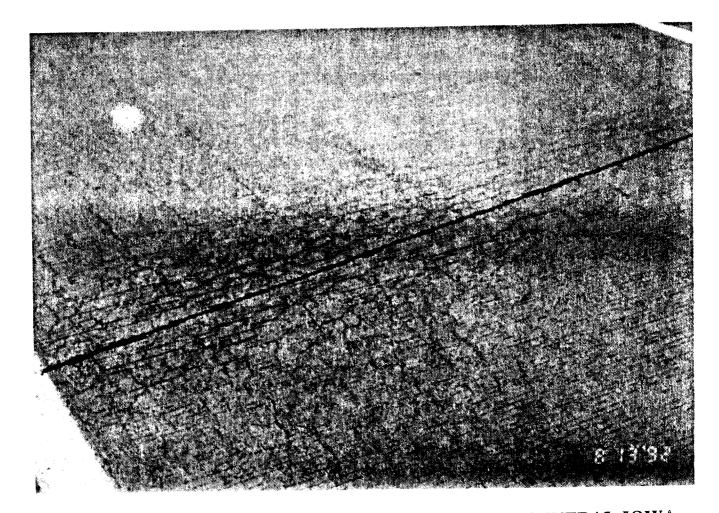
In 1990, the Iowa DOT was presented with a very challenging problem. A ten mile section of new four-lane divided highway in central Iowa (US 20 from Fort Dodge to Webster City) was exhibiting distress cracking (Figure 2) at an age of only three years. In other premature PCC pavement failures, the primary factor relating to the deterioration was the coarse aggregate. In this case, the coarse aggregate was a crushed limestone (Gilmore City Ledge) from the Fort Dodge Mine that had an excellent performance record when used in PCC pavement. An examination of cores from the pavement and particularly one adjacent to the joint (Figure 3) revealed very few cracks passing through the coarse aggregate particles. The cracks were predominately confined to the matrix.

FIGURE 2 THE CRACKING PATTERN OF US 20 IN CENTRAL IOWA

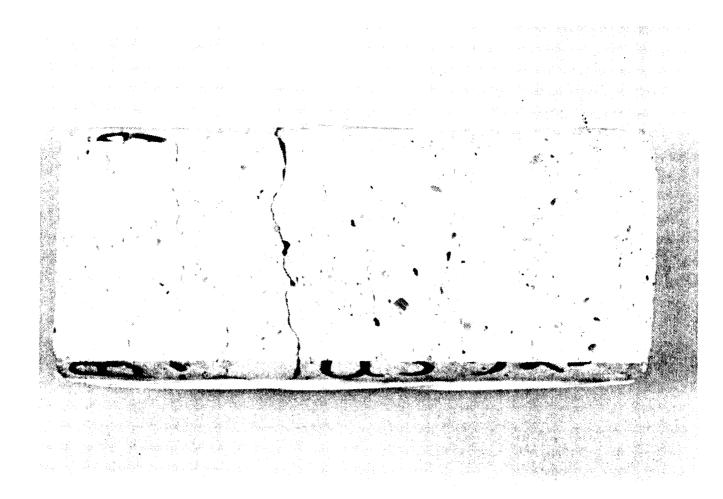
FIGURE 3 A US 20 CORE SHOWING FEW CRACKS IN THE COARSE AGGREGATE Operator: Scott S Client: Iowa Dept. of Trans. Job: HR-358 Task 1 Res: High Label: 3T-2, US 520, EB Iane

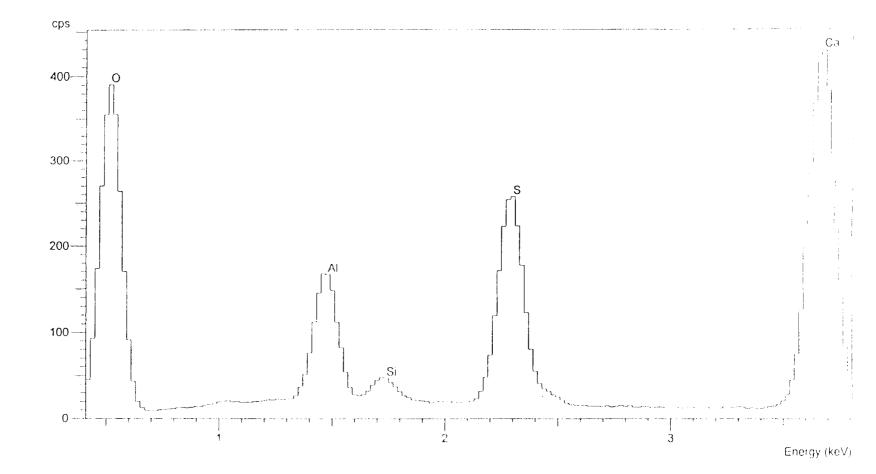
This same sawed and polished piece of PCC was then observed using the Hitachi low-vacuum SEM. A BSE photomicrograph of nice round air voids was obtained (Figure 4). This identified smaller voids nearly filled and larger voids partially filled with the whitish material.

The alkali in silica gel has been determined to be either sodium or potassium or a combination of sodium and potassium. This alkali combines with silicon to produce silica gel (2). Elemental maps were obtained on the US 20 polished sample for sodium, potassium and silicon. In the elemental mapping a dark area would indicate very little of an element was present while a very white area would identify a concentration of the element. The particular interest in this case was "What elements are present in the whitish material filling the air voids?" An energy dispersion spectrum of the whitish material in the air voids was obtained (Figure 5). This spectrum showed major peaks for oxygen, aluminum, sulfur and calcium, supporting the conclusion that the whitish material in the voids is ettringite. There is a minor silicon peak, but no sodium or potassium peak, thereby, supporting the finding that the material in the void is not silica gel.

FIGURE 4 A 200X BSE PHOTOMICROGRAPH OF THE PCC AIR VOIDS ON IOWA US 20

FIGURE 5 AN ENERGY DISPERSION SPECTRUM OF THE WHITISH MATERIAL IN THE AIR VOIDS

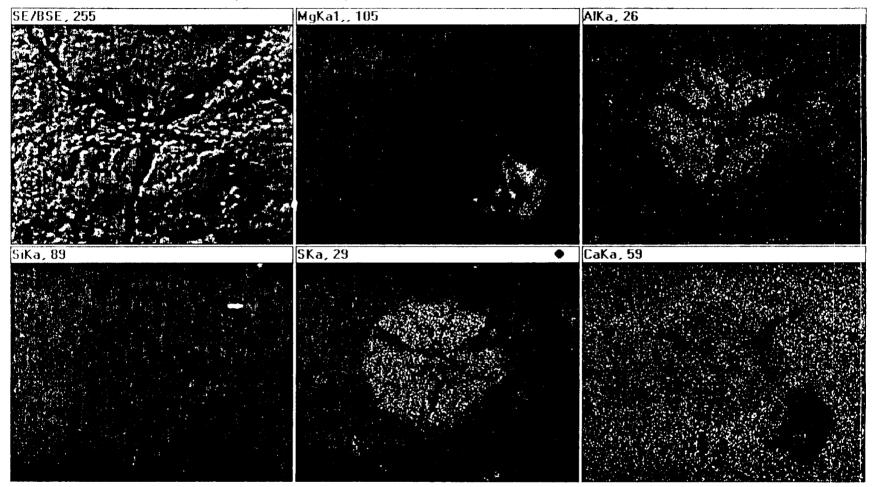
The elemental maps for sodium and potassium (Figure 7) showed a general distribution of the elements and the round air voids could not be identified. The elemental map for silicon was a different story. The round air voids could easily be identified because they were black, showing that there was almost no silicon in the whitish material in the air voids and substantially more silicon in the PCC surrounding the air voids. This led to the conclusion that the whitish material in the air voids is not silica gel.

Elemental maps were obtained for 11 different elements. The map that best outlined the round air voids was sulfur-S. In the map for sulfur, the air voids were very white showing a high concentration of sulfur in the whitish material in the air voids. The aluminum map also showed whiter than the surrounding PCC. The round air voids could also be identified in the calcium map. There was substantial calcium present in both the air voids and

the surrounding matrix, but the whitish material in the air voids had less calcium than the surrounding matrix. These maps led to the conclusion that the whitish material in the air voids was very likely ettringite.

FIGURE 7 THE ELEMENTAL MAP FOR THE FIGURE 6 PHOTOMICROGRAPH

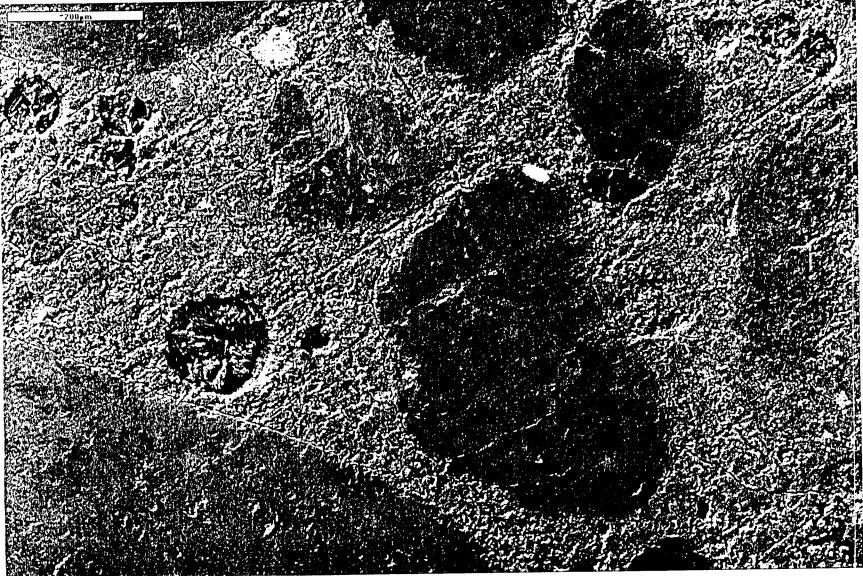
An investigation of the I-80 Aurora PCC (Figures 8 & 9) show a high concentration of sulfur and very little, if any, silicon again leading to the conclusion that the material is ettringite and not silica gel. An interesting note to make on the I-80 Aurora SEM data is that some of the air voids are in close proximity to these so called ASR reactive aggregates. If these reactive aggregate particles are producing silica gel, it would be a reasonable assumption that some of this expansive gel would be forced into the voids in close proximity. No concentration of silicon has been identified in these air voids.

FIGURE 8 A 100X BSE PHOTOMICROGRAPH OF A NEBRASKA I-80 AURORA PCC SAMPLE

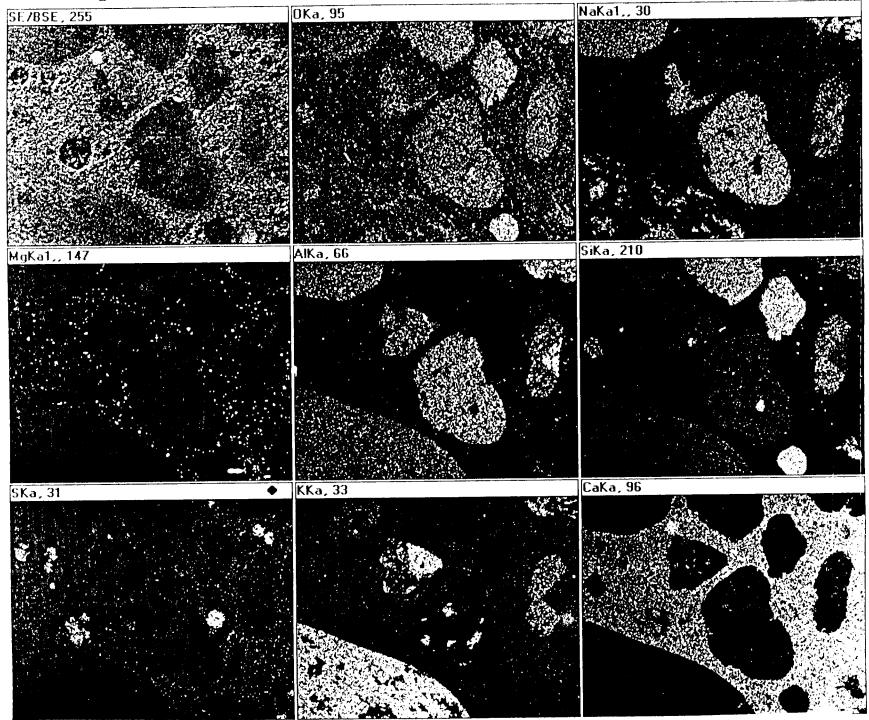
FIGURE 9 THE ELEMENTAL MAPS FOR THE FIGURE 8 PHOTOM/CROGRAPH

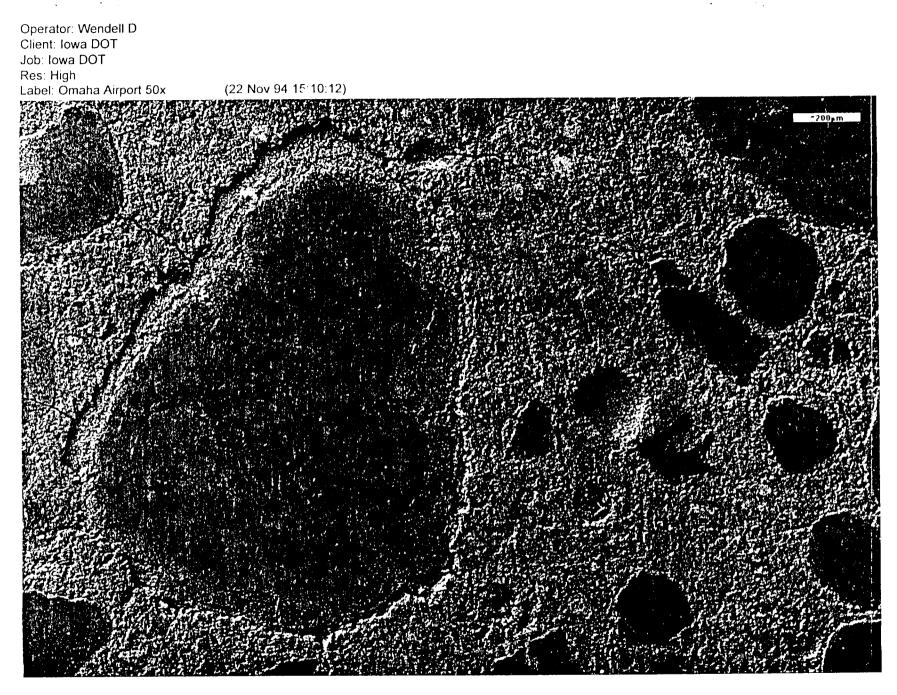
There was also a rim deposit around an aggregate particle (Figure 10). Many petrographic researchers would probably identify this rim as silica gel. The elemental maps of Figure 11 show that this rim does not contain silicon, so it is not silica gel. The rim material contains substantial sulfur and is, therefore, probably ettringite.

FIGURE 10 A 100X BSE PHOTOMICROGRAPH OF A NEBRASKA OHMAHA AIRPORT PCC SAMPLE

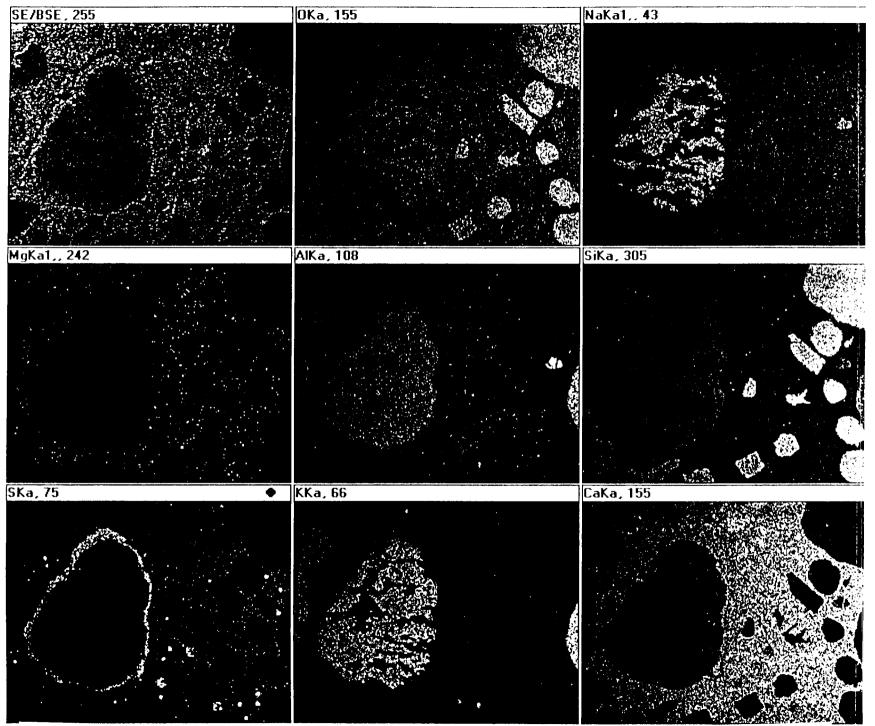
The material in the Omaha Airport voids contains substantial sulfur, but almost no silicon, so it again is not silica gel, but is very likely ettringite.

FIGURE 11 THE ELEMENTAL MAPS FOR THE FIGURE 10 PHOTOMICROGRAPHS
