REINFORCED EARTH AND STONE COLUMNS FOR WEAK SUBSOIL CONDITIONS

Final Report
Project HR - 510

REINFORCED EARTH AND STONE COLUMNS
FOR WEAK SUBSOIL CONDITIONS -
THE IOWA EXPERIENCE

PROJECT: WOODBURY COUNTY
I-IG-F-29-6(13)150--OB-97

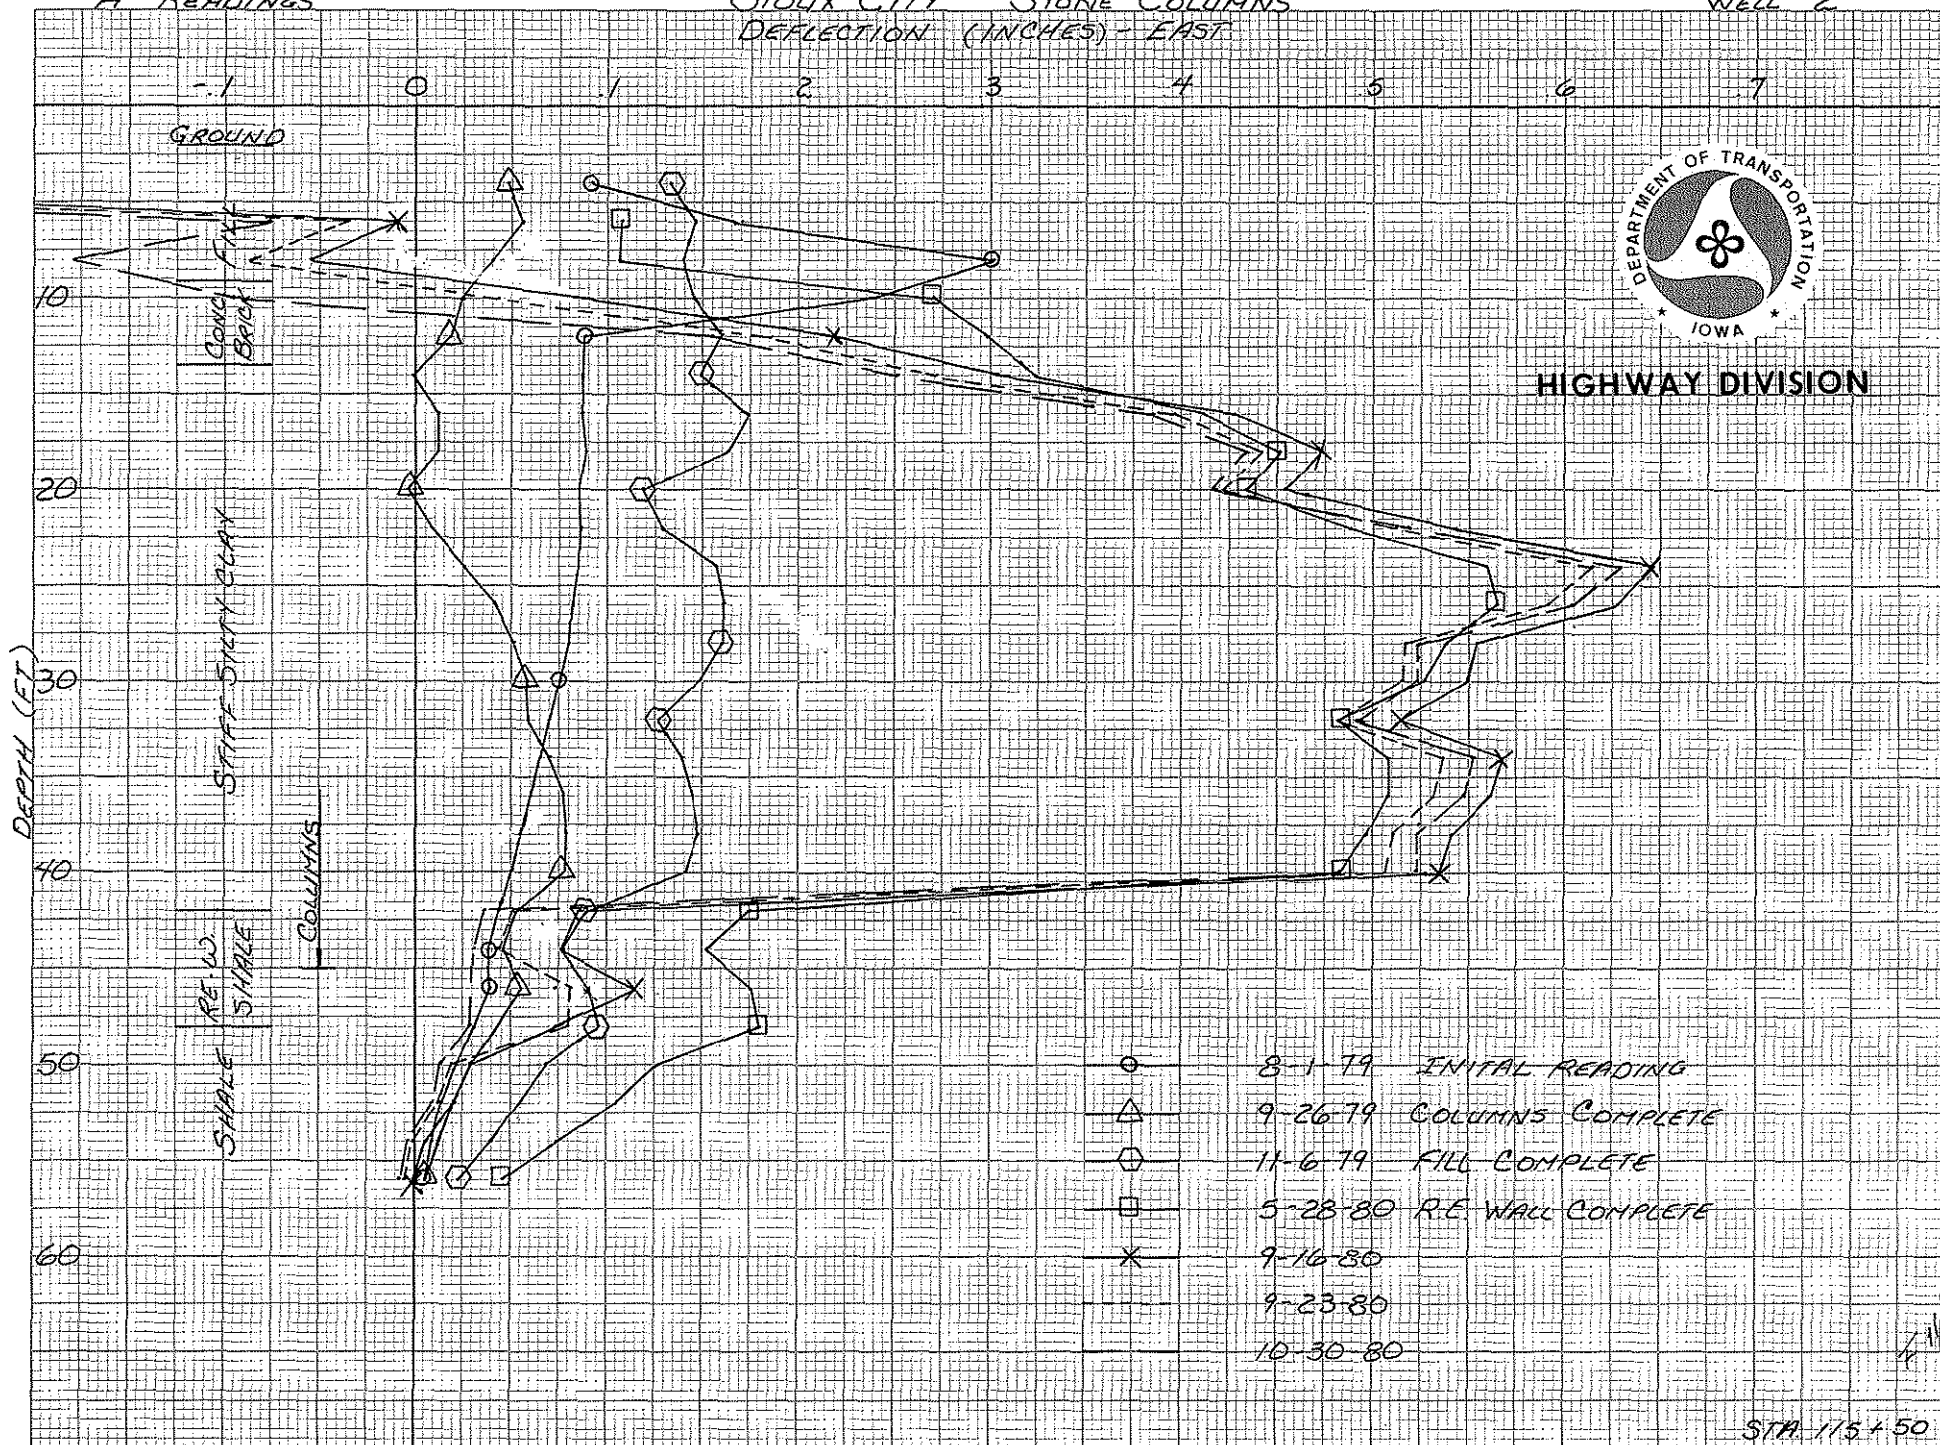
WELL #2

Slope indicator wells were installed before construction and have been monitored at regular intervals throughout. There was more or less uniform strains occurring in the subsoils approximately until completion of Reinforced Earth wall number 4. At that time, deflections on the order of one-half inch started to appear at the surface of the reworked shale. The manufacturer of the instrument states that the magnitude of deflection is not an accurate measurement but that the shape of the deflection curve is of significance. The system of stone columns was, therefore, reanalyzed.

Subsequent inclinometer readings have shown that movement has virtually ceased since fill completion. Excess pore pressures have probably been relieved, and the system has stabilized.

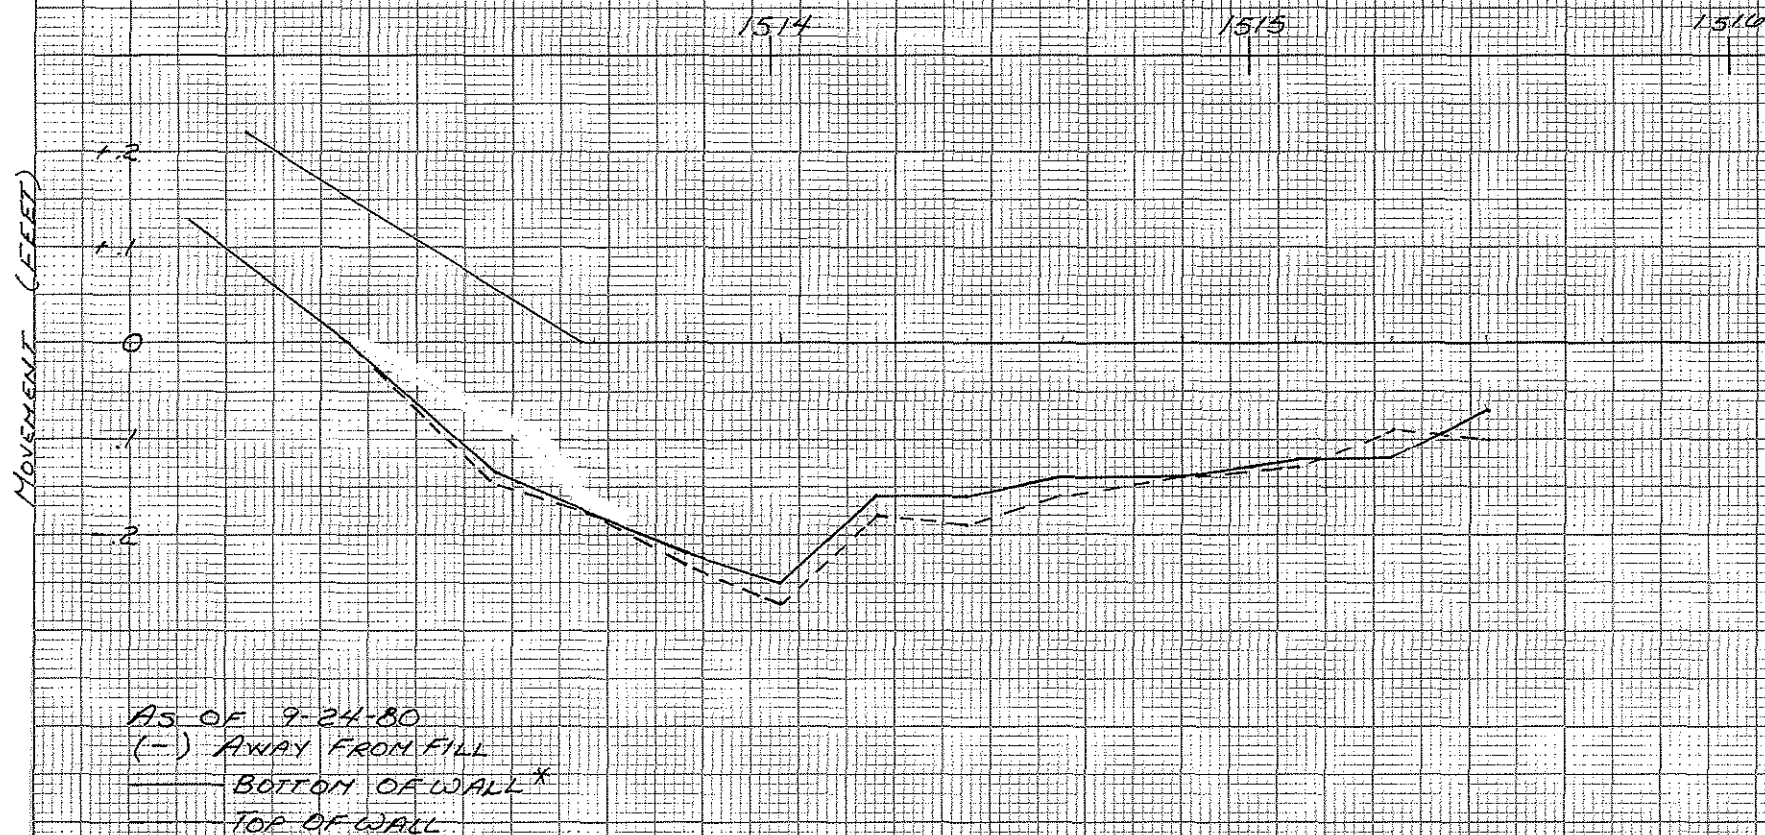
STABILITY ANALYSIS
STA. 1514+00 ±

Both experience with other landslides in Iowa as well as other research had shown that reworked shale has a very low residual strength. In Iowa, this strength is about 200 psf with an internal friction of 0° . This was the strength used in the analysis. Other soil properties used in the analysis were based on Shelby tube cores in the area.

The analysis used was a computer version of the Simplified Bishop Method of Slices. The results were that failure could be expected and this failure would indeed occur in the reworked shale. The stone column strength, cohesion equal 0 psf and angle of internal friction equal 38° , was then added to the analysis. The factor of safety increased to almost 1.4. The weakest plane was still in the reworked shale.

RUN #1
FS = 0.97

RUN #3
FS = 1.36

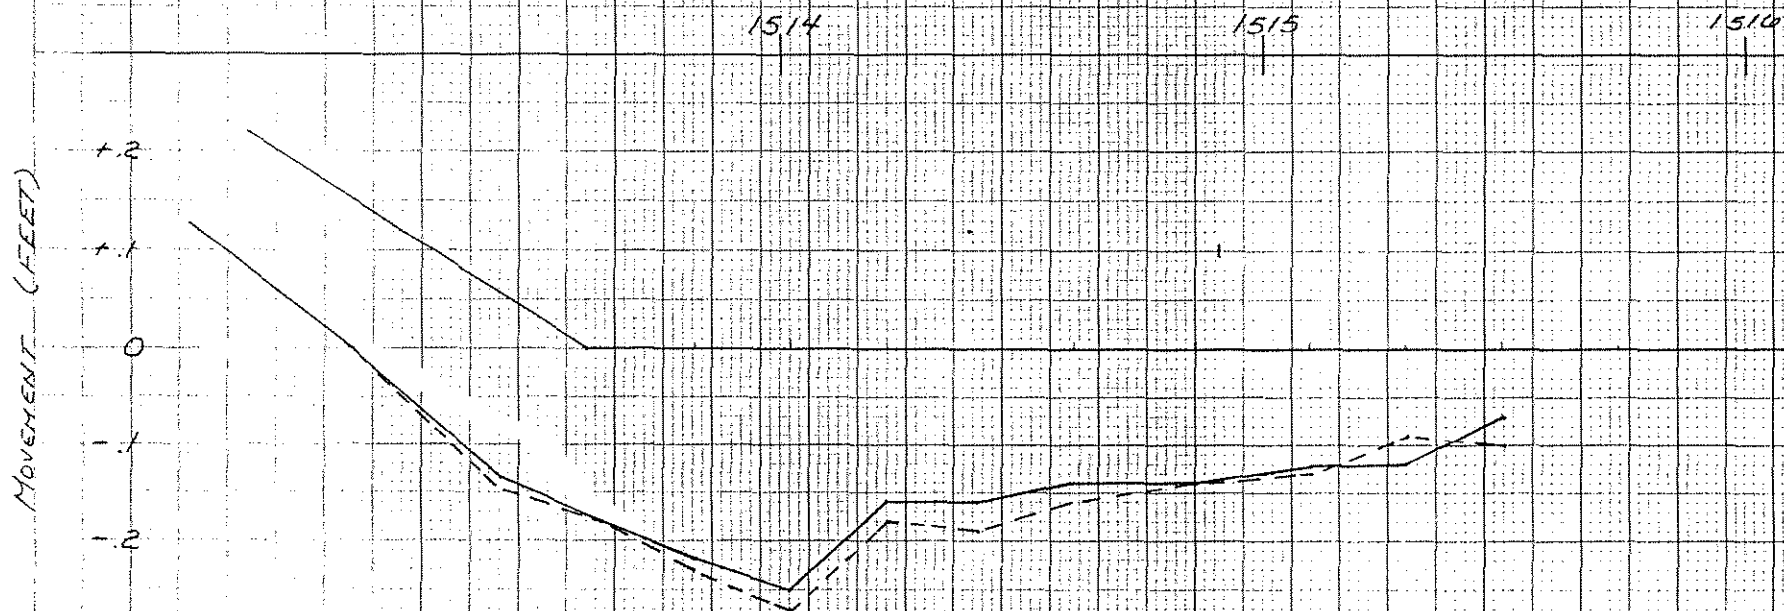
MOVEMENT DIAGRAM

Reference marks were placed on Reinforced Earth wall number 4 as construction proceeded. Most of the deflection occurred during construction and probably can be attributed to a less than optimum staging of construction.

The new Wesley Way is constructed on a sand fill retained by a Reinforced Earth wall. Minor strain, as shown by wall movement readings, were to be expected. The overall factor of safety of the bluff and the road together is in excess of 1.8. The movement can be expected to cease as the long-term bluff failure is eventually stabilized. Appendix C shows the applicable Bishop analysis and wall movement to date.

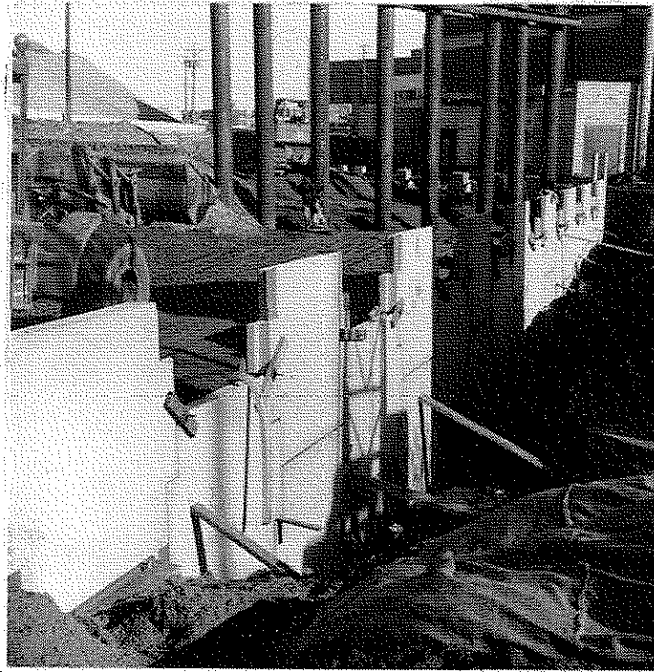
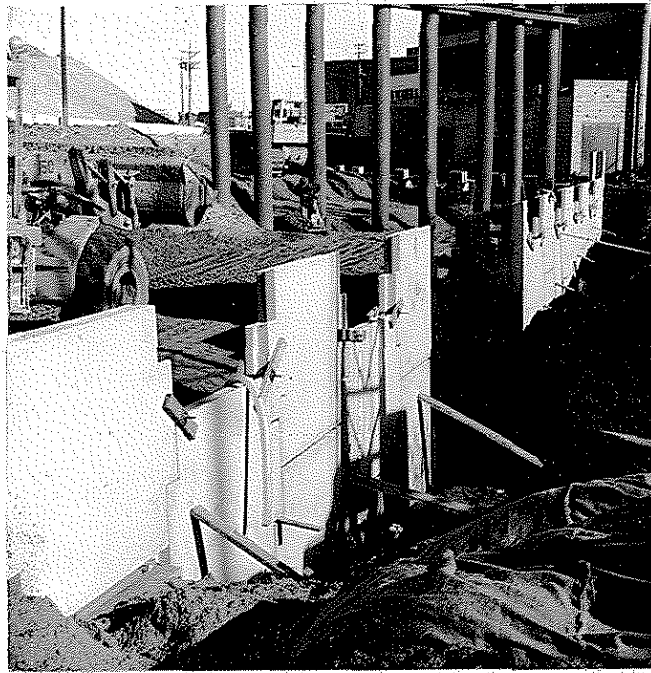
Bridge abutment piling were placed in several of the wall systems. These were encased with a light tubing which was maintained in a "centered" position as the walls were built. These tubes tipped outward (toward the wall face) as much as 6 in. from the constructed position. In one case the movement continued until after the abutment was constructed and the bridge beams had been placed. Fortunately movement stopped before damaging the structure.

Beginning of construction-Reinforced Earth Wall No. 4
Pile covering can be seen (Page 4)

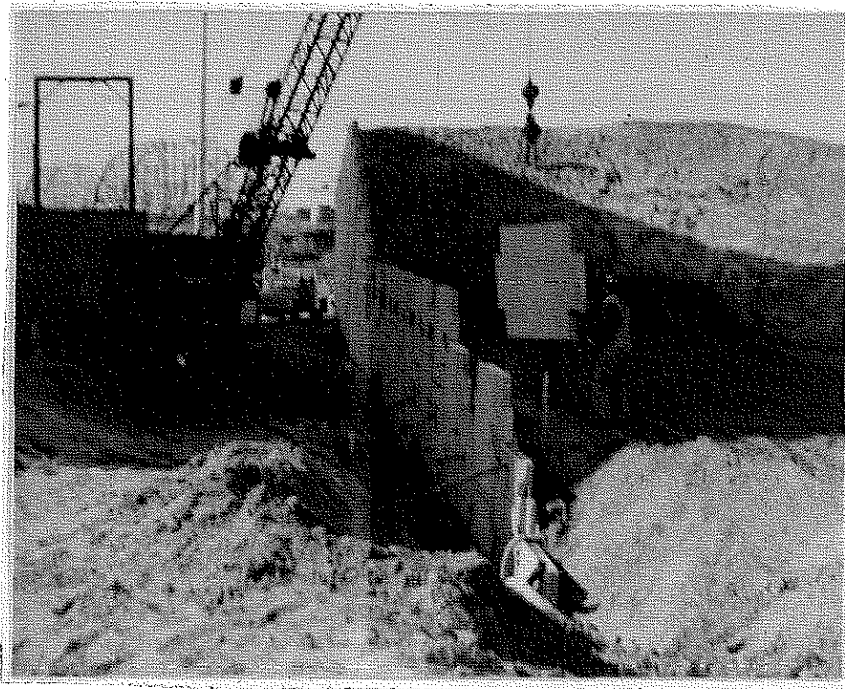
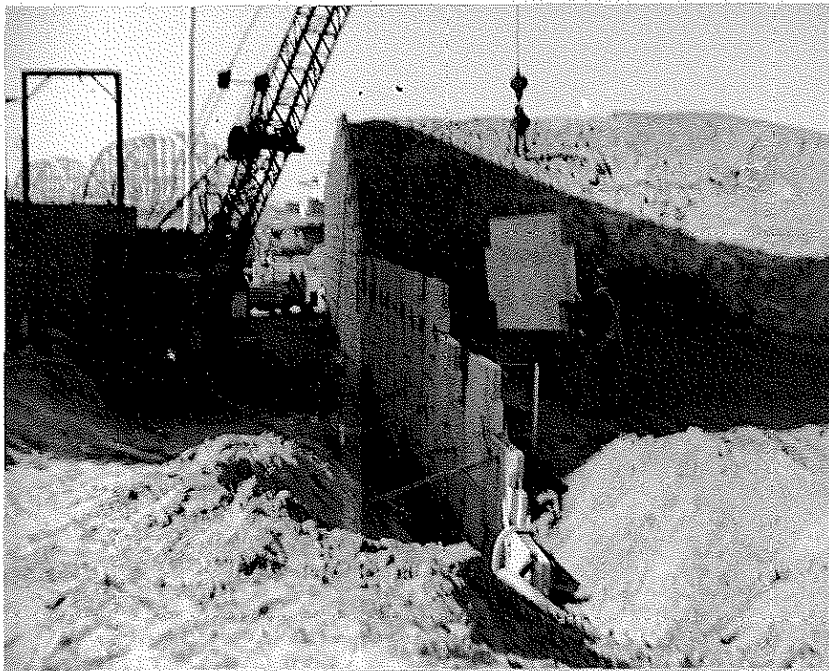
This same problem resulted in some sections of the Reinforced walls eventually obtaining an outward lean of 1 in. to 3 in. from the desired vertical alignment. Wall 4, which was built in conjunction with the stone columns and had only minor settlement, presented the most "movement" problems. This wall was built in several stages in addition to the two which were designed. The wall was built with a one-half inch per panel "construction" batter which proved to be insufficient to maintain vertical alignment. Differential movements occurred between the various stages and at one point the construction contractor yielded to temptation and attempted to straighten a section of wall by pushing inward. This only resulted in breaking several panels. The only other panel breakage, noted to date, has occurred at corners and in two cases alignment rods have broken out of the inside of panels. These breaks have occurred in the lower portion of wall 4 where wood "alignment" wedges were left in place during second and later stage additions. Additional driving of these wedges may have occurred as an effort to maintain vertical alignment.

Reinforced Earth Wall No. 4
Additional Staging (Page 4)

If this project is representative, these walls should have a minimum completed batter of one-half inch per panel to avoid later outward lean.

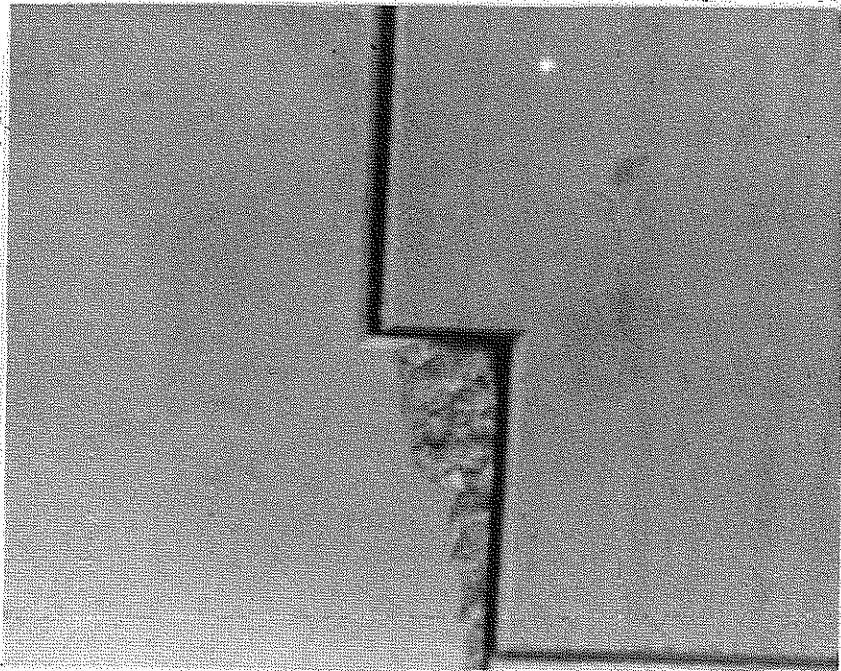
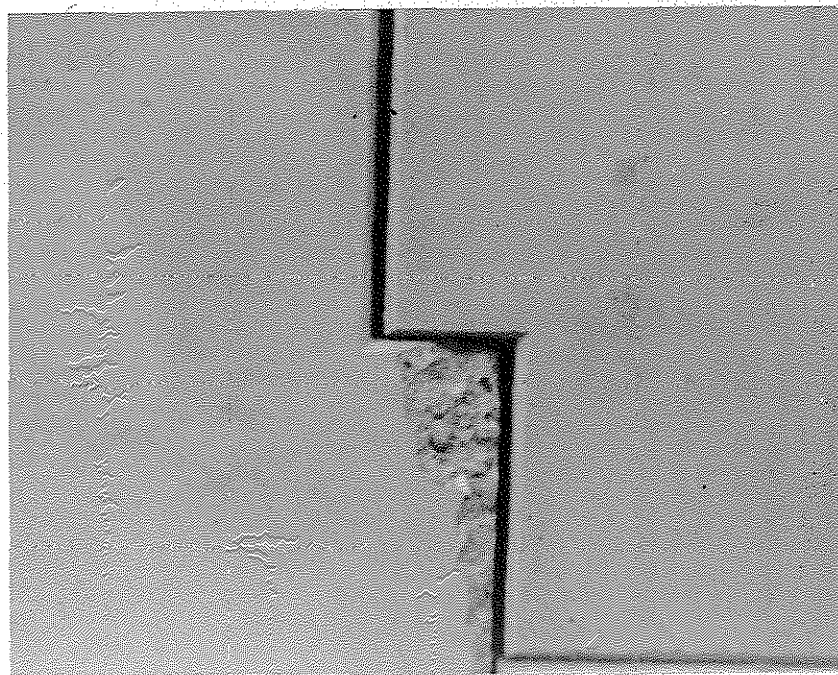
Chipped Reinforced Earth Wall Panel (Typical)
(Page 4)

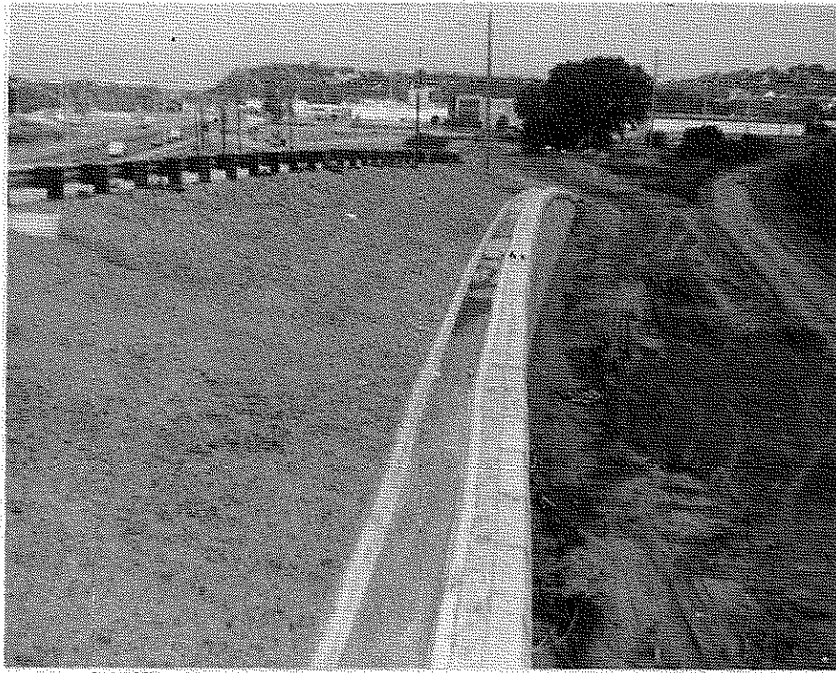
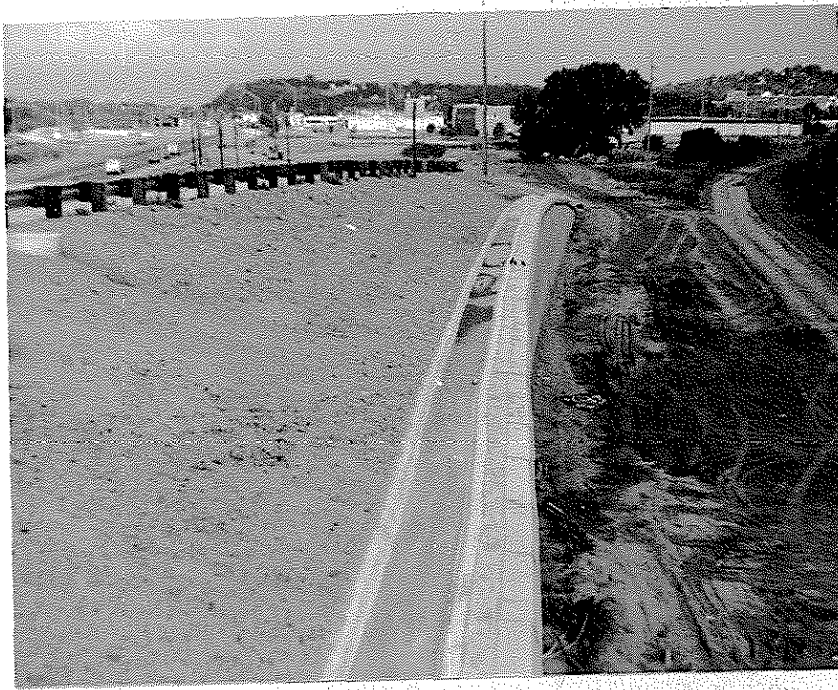
The wall misalignment is not noticeable to the casual observer and since all movements have apparently stopped, does not appear to be detrimental to the structure.

Wall distortion-Reinforced Earth Wall No. 3
West End (Page 4 and 5)

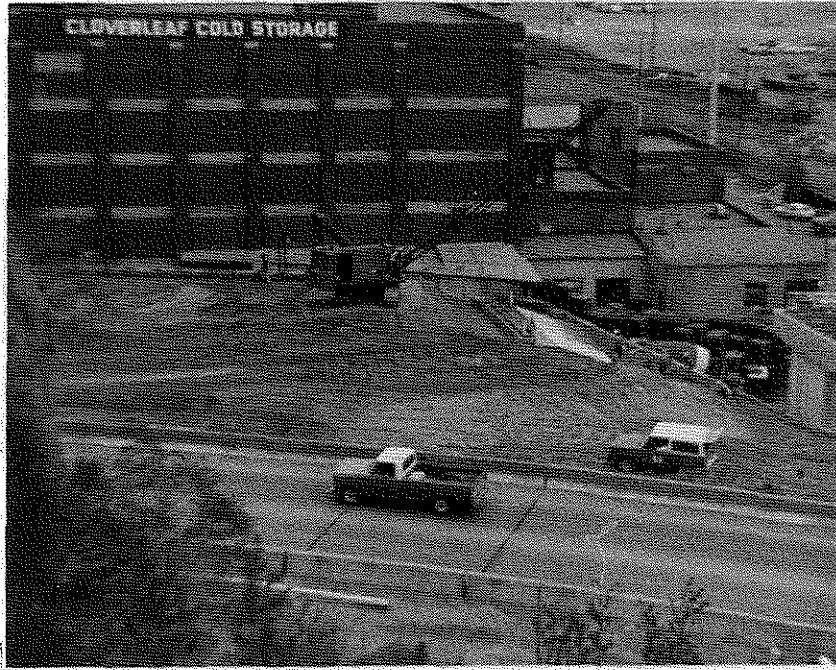
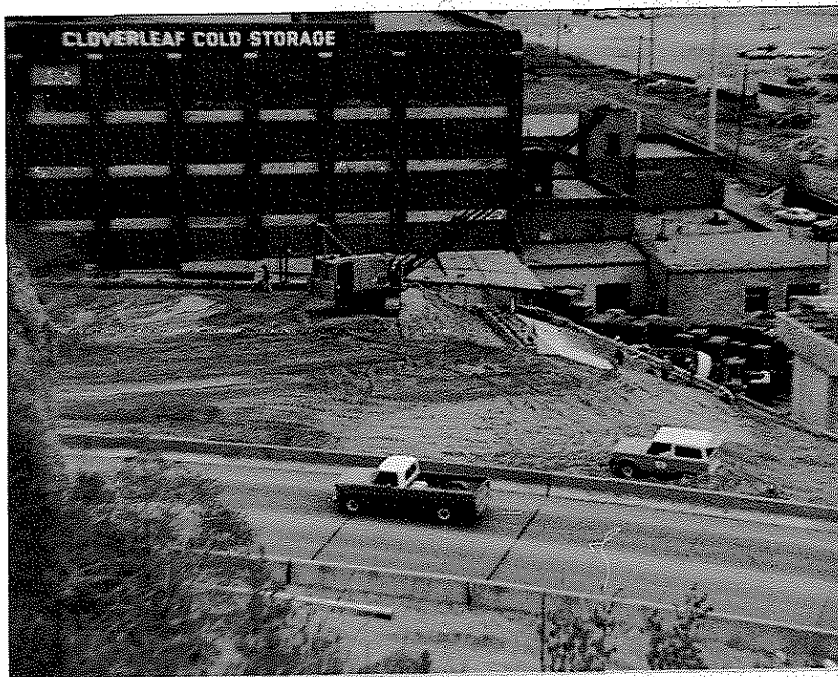
spread footings, and located 15 ft. from the columns has shown no apparent change in crack width or pattern since the project began. A hardware store located 100 ft. from the project reported moving items on the display floor but again no apparent damage occurred in the structure.

Site Condition showing restricted Right of Way
and adjacent structure

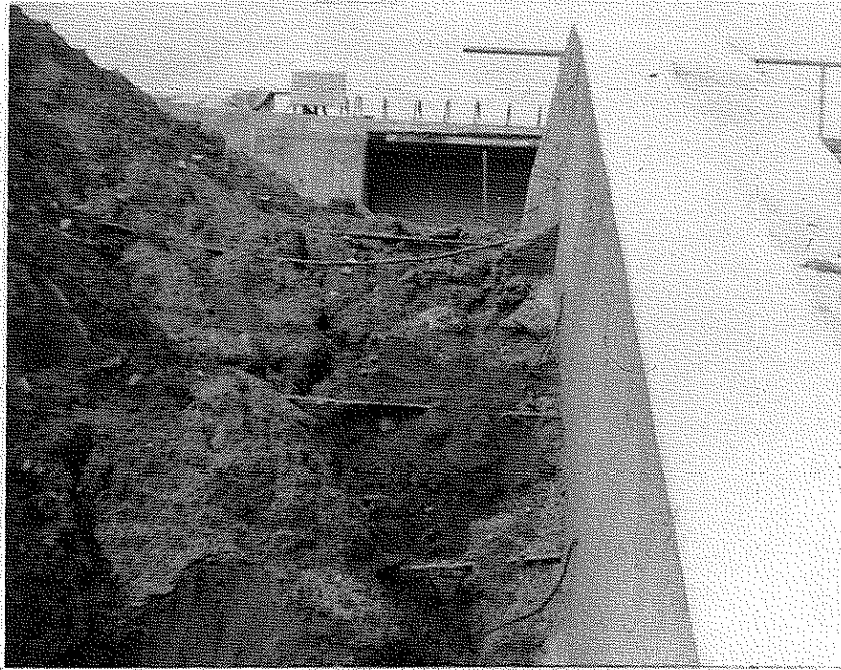
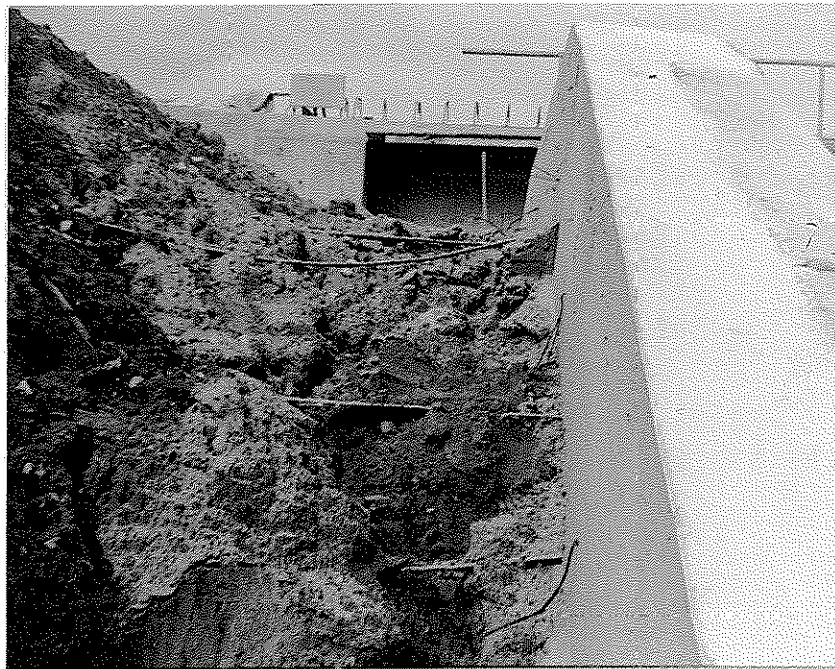
Reinforced Earth Wall No. 3
Strip Exposure from Erosion
between Stages of Construction
