# **A Further Evaluation Of Concrete Bridge Deck Surfacing In Iowa**

Highway Division  
Office Of Materials

March 1979

Bernard C. Brown  
Testing Engineer

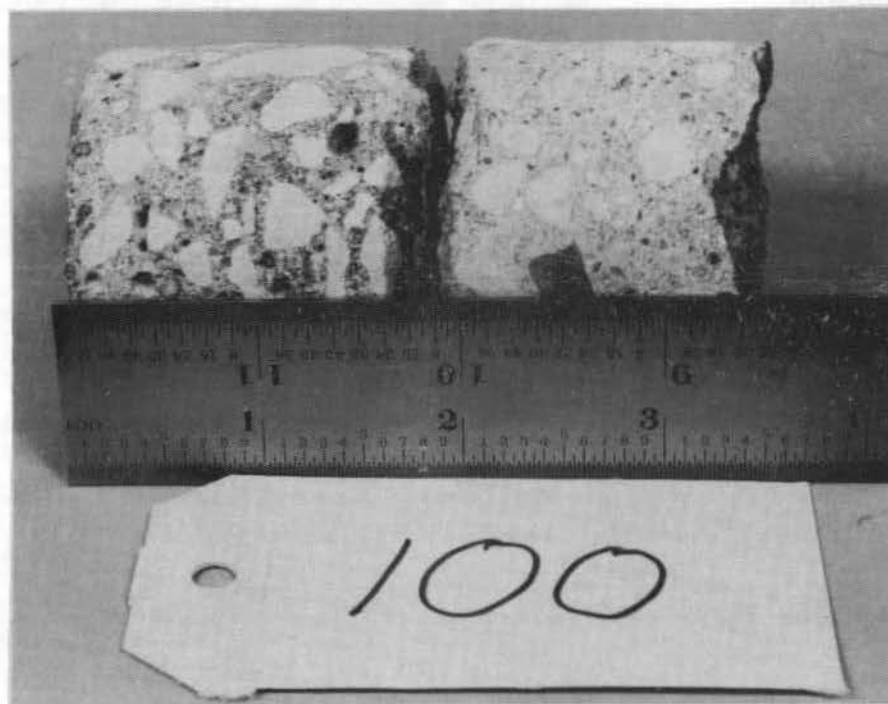
Fig. 1 Delamination core - side view

Most of the delaminations were located in the old concrete within 1/4" of the bonded interface. To better illustrate this type of delamination a core from the Calhoun Co. Design No. 170 bridge is shown in Figures Nos. 1 and 2. Figure No. 1 does not provide sufficient detail to indicate the exact fracture location. Figure No. 2 shows the fracture location in the old deck as evidenced by the separation of the coarse aggregate particle from the old deck.

As mentioned earlier, the majority of the delaminations were located within  $1/4"$  of the bonded interface. It is not unusual to find this type of delamination approximately 2 inches above the reinforcing steel with the concrete between the delamination and the re-bar appearing sound. When these cores were taken directly over the reinforcing steel there was no visual evidence of corrosion on the bar. The exact cause of this type of delamination is not known. There is a distinct possibility that an incipient fracture in the surface of the old concrete may have been created due to the impact of the scarification equipment in use at that time.

6. The majority of the delaminations are within 1/4" of the bonded interface and are probably not corrosion related.
7. The areas of delamination are increasing and may eventually result in distress of the resurfacing.

1. Increased emphasis should be placed upon intensive inspection to insure all delaminated concrete in the decks being resurfaced is removed. If sufficient funds are available, Delamtect testing devices should be purchased and used on decks just prior to scarification of the deck surface. This would result in more objective determinations in locating areas of unsound concrete that should be removed. Delamtect testing should also be conducted after the placement of the overlay.
2. Concrete should be removed to the top layer of reinforcing steel if an electrical corrosion potential measurement of  $-0.35V$  or more is observed.
3. Increased protection of the concrete in the gutter line and curb should be required. This may be done by treating these areas with high quality concrete sealers.
