**Final Report  
for  
Iowa Highway Research Board  
Project HR 203**

# **Transverse Joint Sealing with Various Sealants**

**Highway Division  
September 1983  
in cooperation with  
Dallas County  
Secondary Road Department**

BY  
VERNON J. MARKS  
RESEARCH ENGINEER

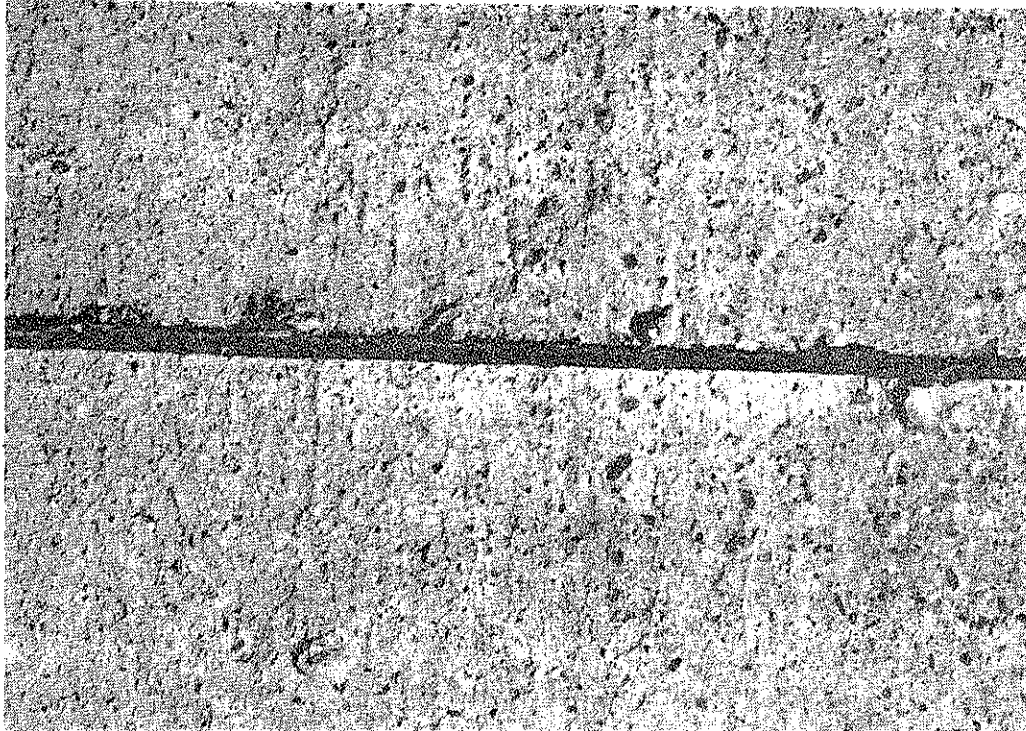
Deterioration of joints and joint related distress of pcc pavements continues to be a major maintenance problem. These joints are constructed to control cracking and provide for movement due to variation in temperature. The difficulty of maintaining these joints in a sealed condition is primarily caused by the opening and closing of the joint, but movement produced by traffic is a contributing factor. Unfortunately, the poured sealants and present joint design and construction practices have not been able to adequately provide for this movement. Even under ideal conditions, the life of most poured sealants rarely exceeds three years.<sup>1</sup> The bond between the sealant and the concrete fails and allows the joint to leak (figure 1).

Figure 1 - Bond Failure of Sealant Material

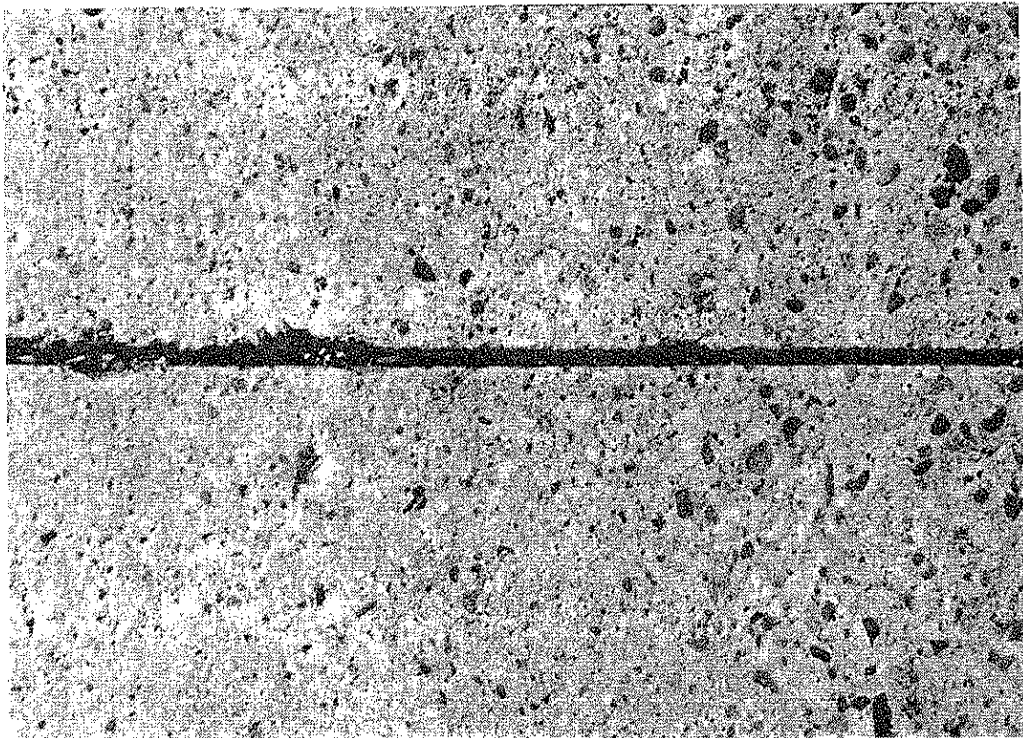
Blowups are the most dramatic of the joint failures. The generally accepted major contributing factor to blowups is incompressibles deposited in the joints (figure 2) during the winter months.

Figure 2 - Incompressibles in Transverse Joint

A combination of thermal expansion during the hot summer months, high moisture conditions and joints plugged with incompressibles results in numerous blowups. To alleviate this problem, the Iowa DOT initiated an extensive program of cutting pressure relief joints. The four inch wide cuts were placed at 1,000-foot intervals. It has been typical for these pressure

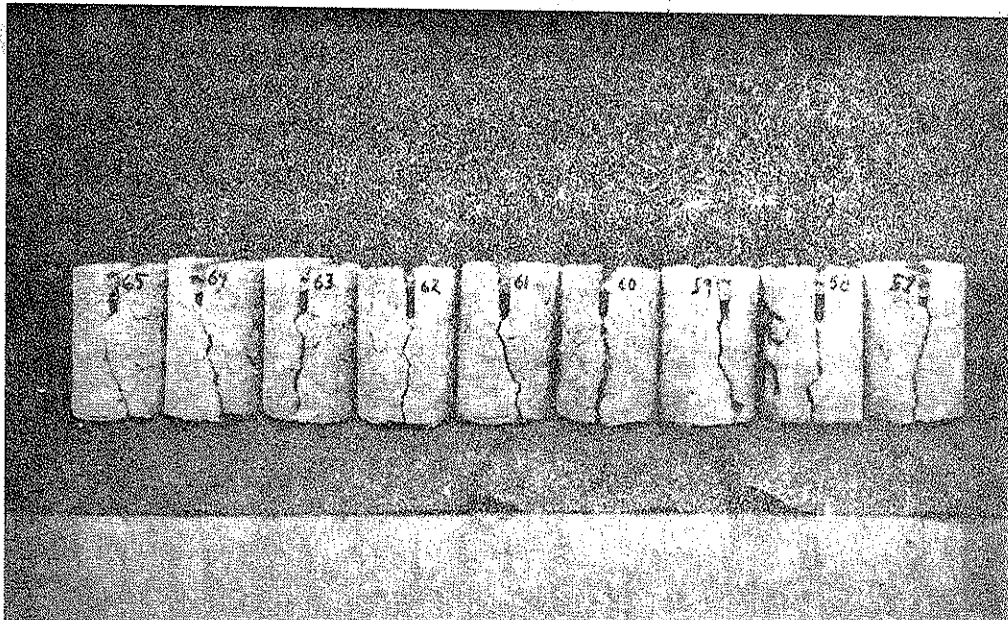
In 1979 one interesting and significant feature was noted while drilling. The cores were drilled with an Acker Drill which supplies cooling and flushing water through a Moyno pump. When drilling the Dow Corning 888 joints, the water was pumped to both edges of the slab where it spurted up in a small stream. This emphasized the tight seal of this joint. This type of spurting was not noted on joints with other types of sealants.

Figure 12 - Cores from Dow Corning 888 Joints

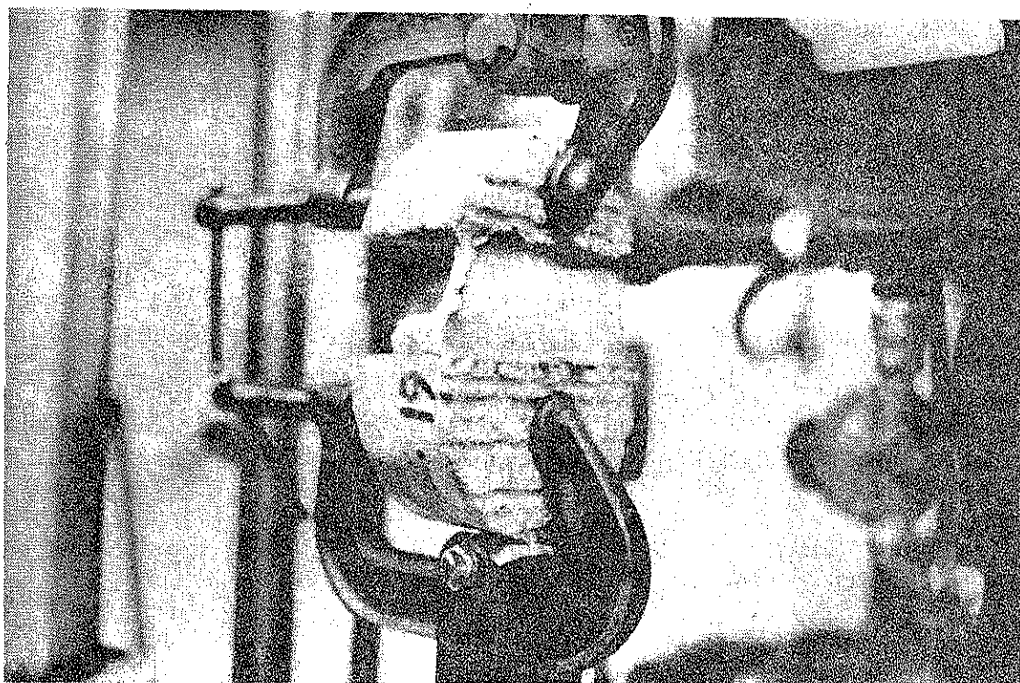
Figure 14 - Elongation of Dow Corning 888

The Dow Corning 888 material exhibited outstanding elongation (figure 14). Some Paraplastic joints had a very deep seal that resulted in a high maximum load (figure 15). A maximum load of 89.5 lbs. was obtained on a Paraplastic joint. The point of failure was somewhat arbitrary but certain criteria were established for this determination. First, if the bond was destroyed on 80% of the 4" length on either interface it had failed. Second, it failed if a load greater than 20 lbs. had been obtained followed by reduction below 10 lbs. The maximum loads and maximum elongations were summarized with respect to the same variables as the visual rating on page B-4. This testing exhibited poor strength and elongation for the Lyon D 200 and High Spec sealants. There was no significant difference due to the cleaning procedure. As expected, the 1/4" saw cut yielded the poorest elongation capabilities.

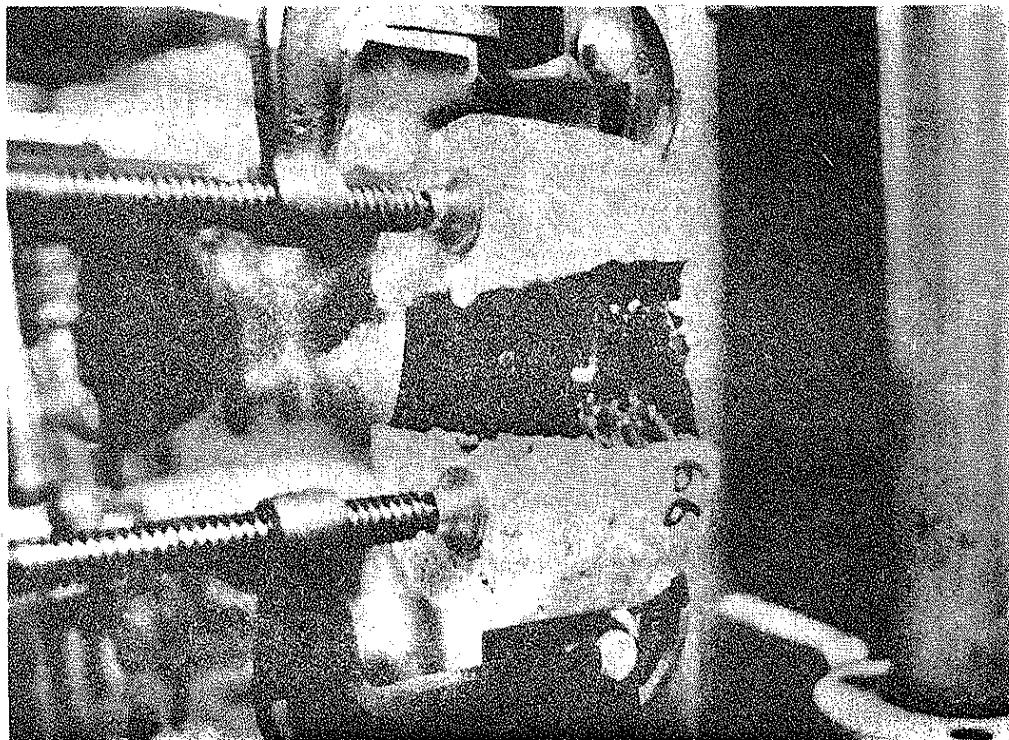
Figure 15 - Deep Seal of a Para Plastic Joint
