# Deterioration of Iowa Highway Concrete Pavements: A Petrographic Study

FINAL REPORT  
HR-1065

Paul E. Stutzman

December, 1999

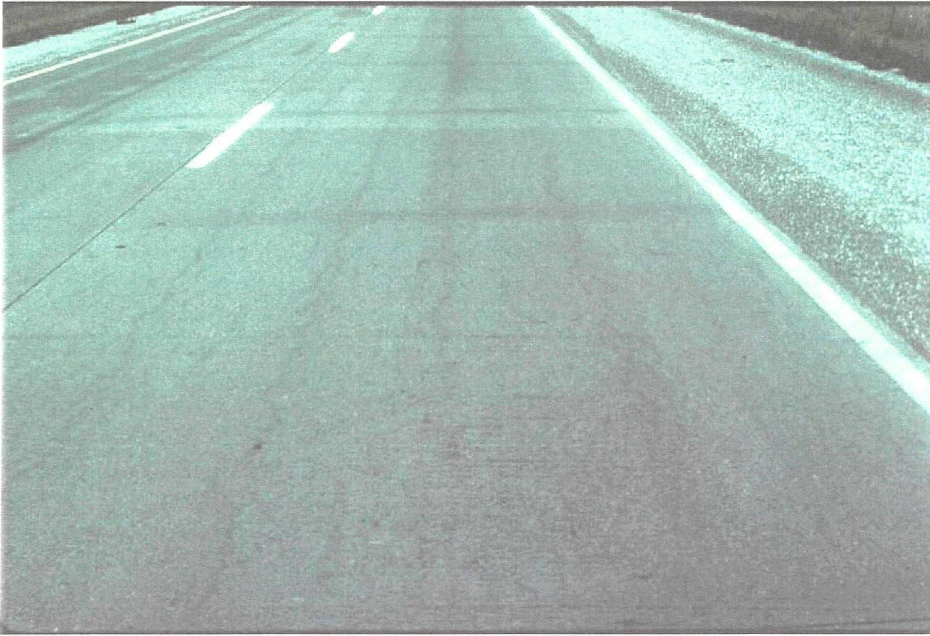
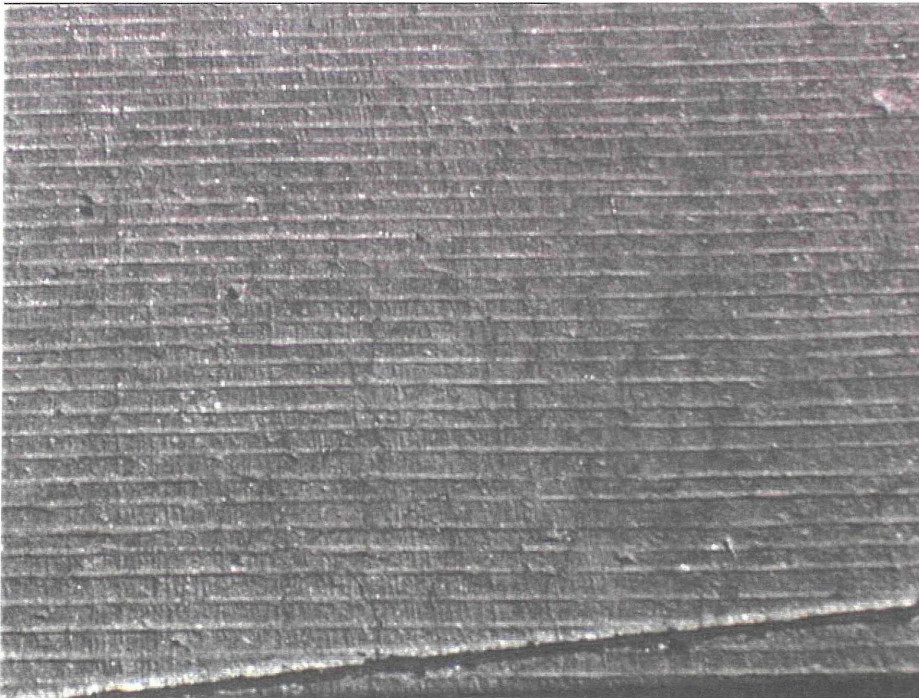
Figure 1. Onset of pavement deterioration is visible as a slight darkening of the concrete in the transverse joint region (top, I-80) and in pavements with advanced deterioration, a tightly-closed pattern cracking (bottom, US 20). Some of these pavements also have vibrator trails.

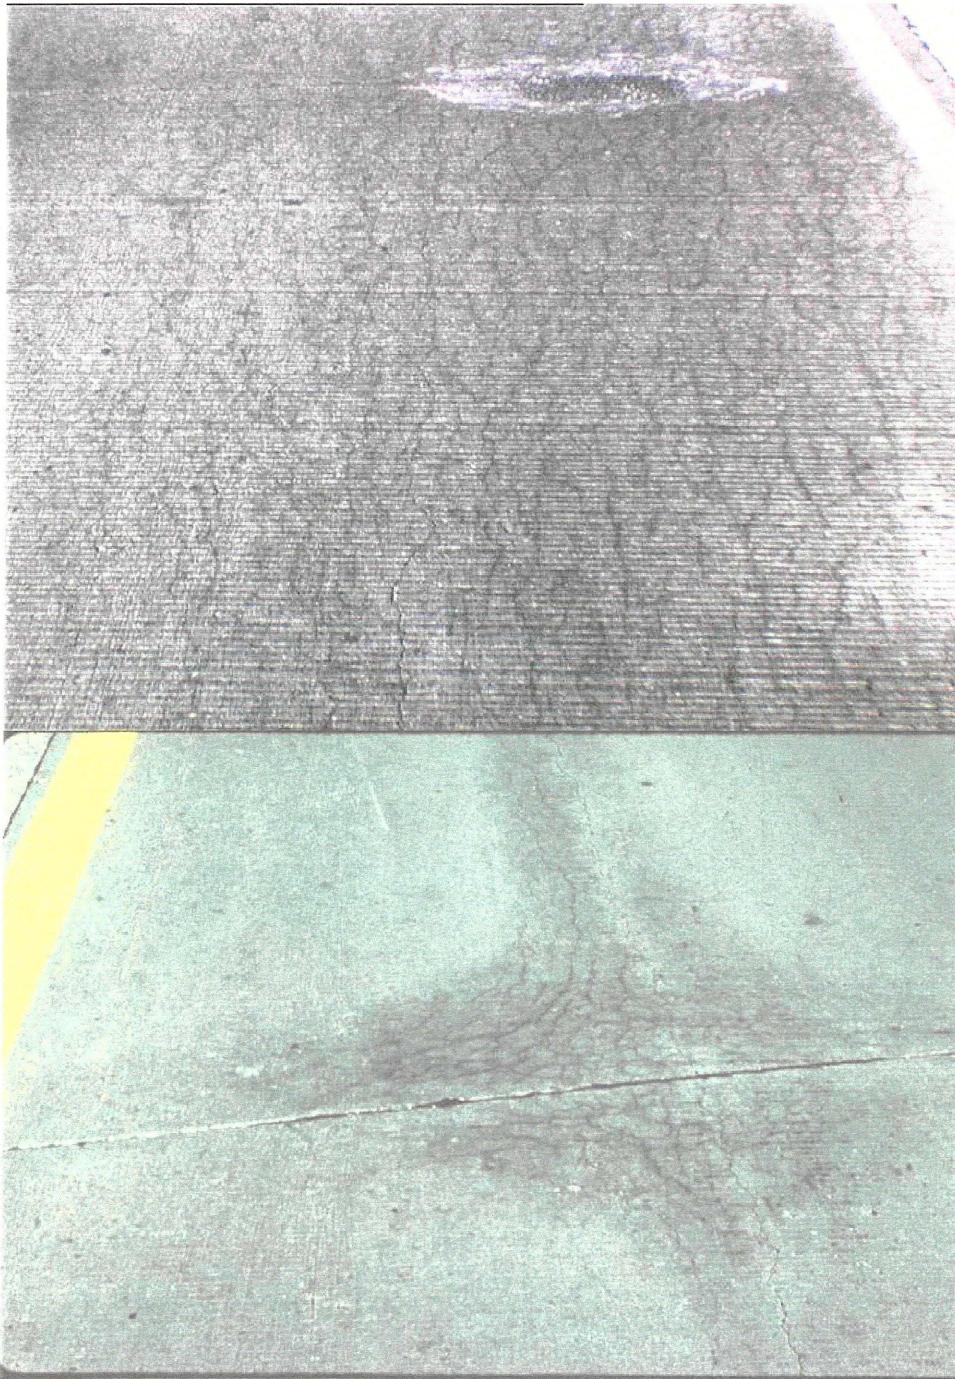
Figure 2. Map cracking oriented in the longitudinal direction of the pavement, interconnected by slightly finer cracks perpendicular to pavement direction becomes more prominent with progression of deterioration (top). Advanced degradation shows cracking paralleling the transverse joint and road edge, and along cracks within vibrator trails. The degradation would be characterized initially as “low” severity according to the SHRP Distress Identification Manual [17] and “moderate” as the deterioration progresses.

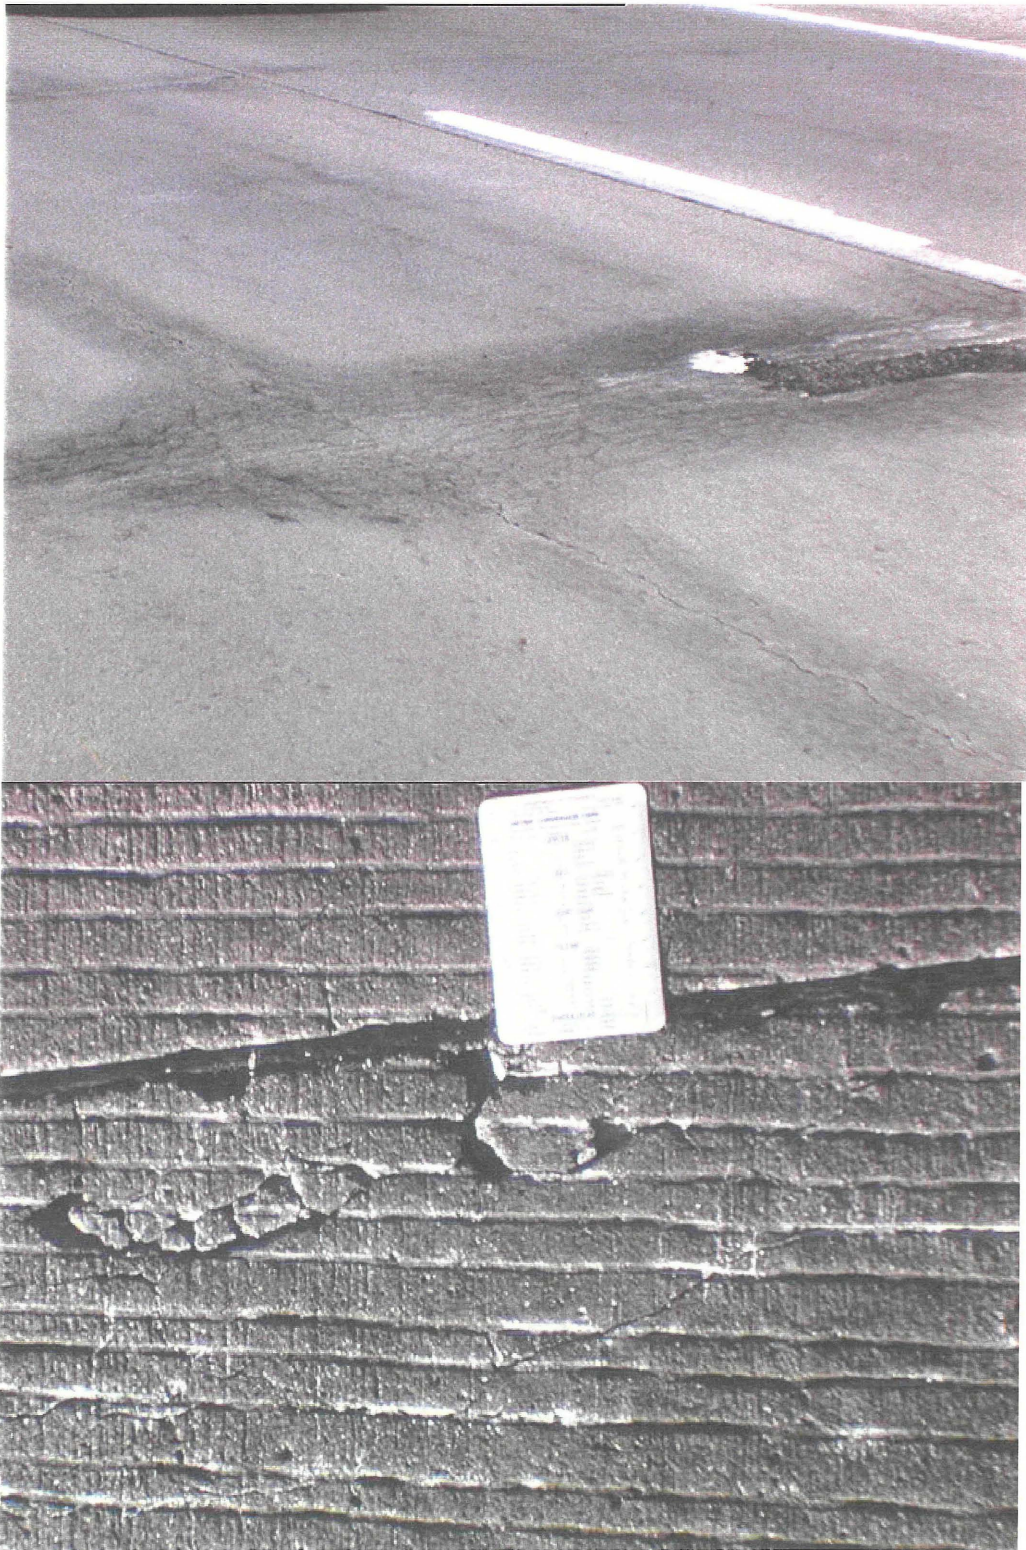
Figure 3. Pavements exhibiting severe deterioration show significant pattern cracking (here accentuated by moisture along the crack), cracking along joints, spalling along joint edges and white efflorescence. Open joints and lack of displacement along pavement slabs provides evidence against permanent expansive processes such as alkali-aggregate reaction and sulfate attack.

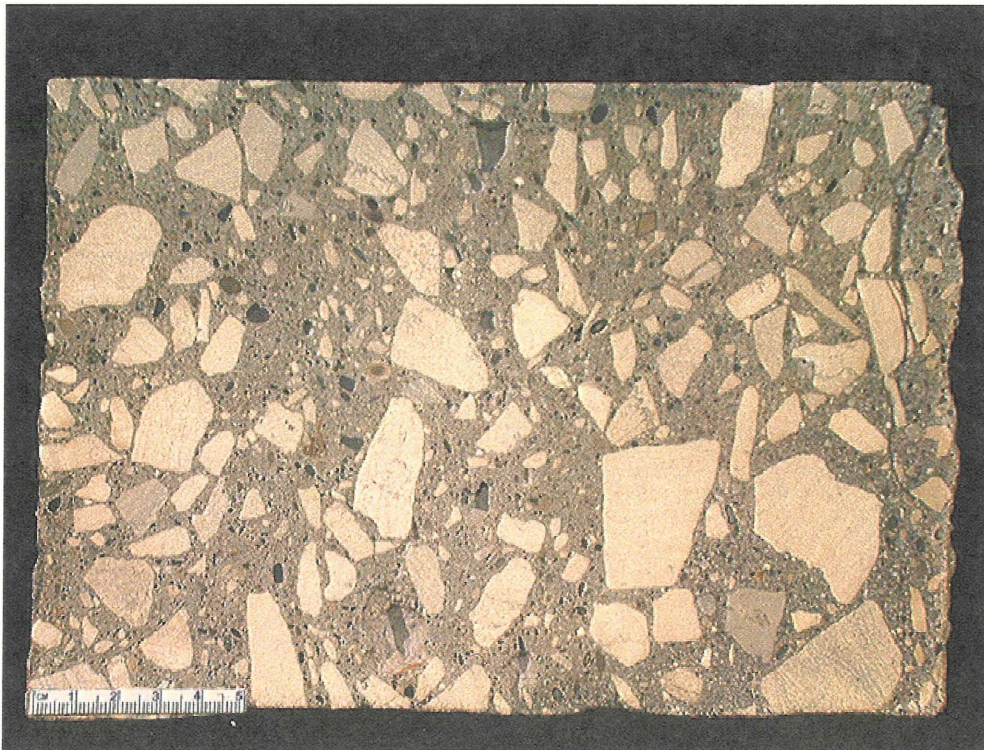
Figure 9: Iowa 175 Core 2 shows some aggregate / mortar segregation and cracking located near the core base (base to the right).

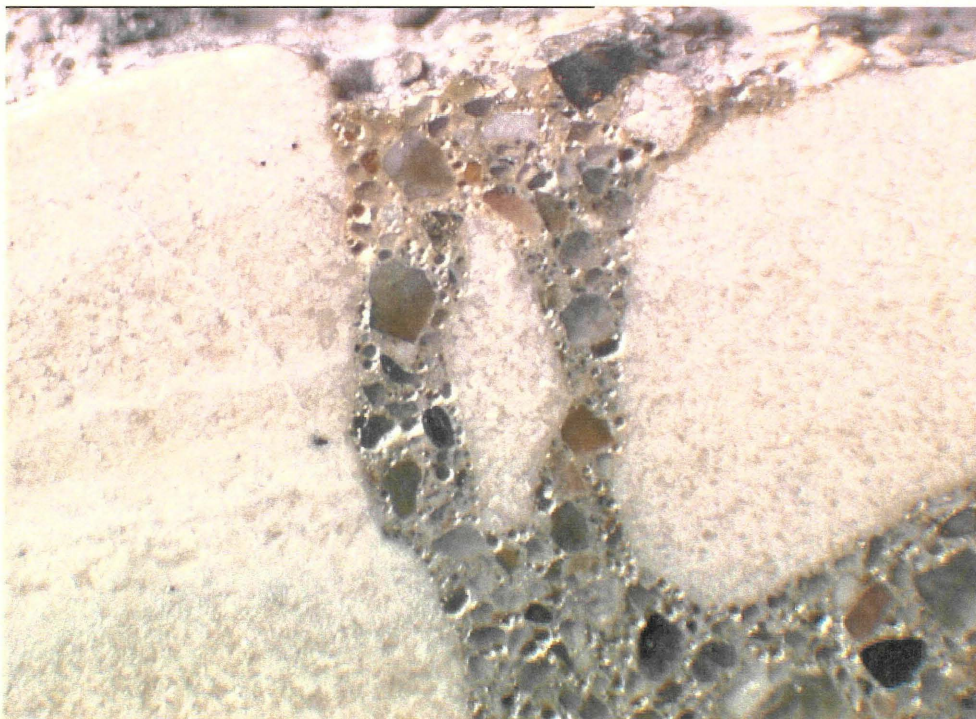
Figure 10. Iowa 175 Core 2 surface microstructure. Slight discoloration in the upper mortar indicates approximate depth of carbonation. Micrograph field width: 14 mm

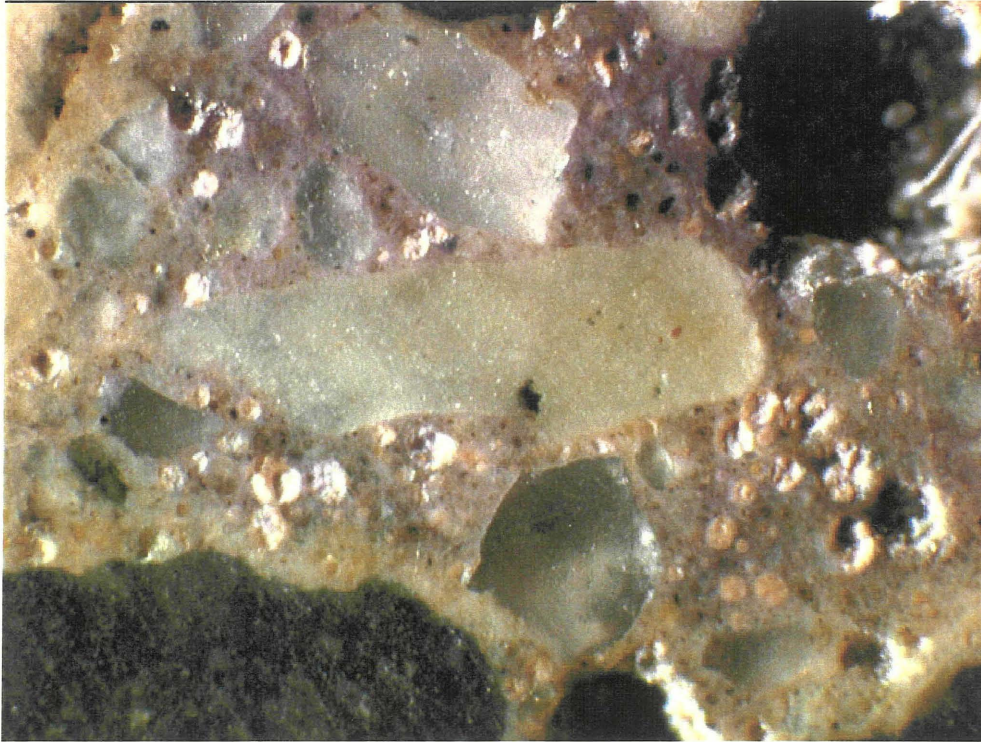
Figure 11. Iowa 175 Core 2 base mortar microstructure exhibiting partial filling of the entrained air void system. Micrograph field width: 4 mm

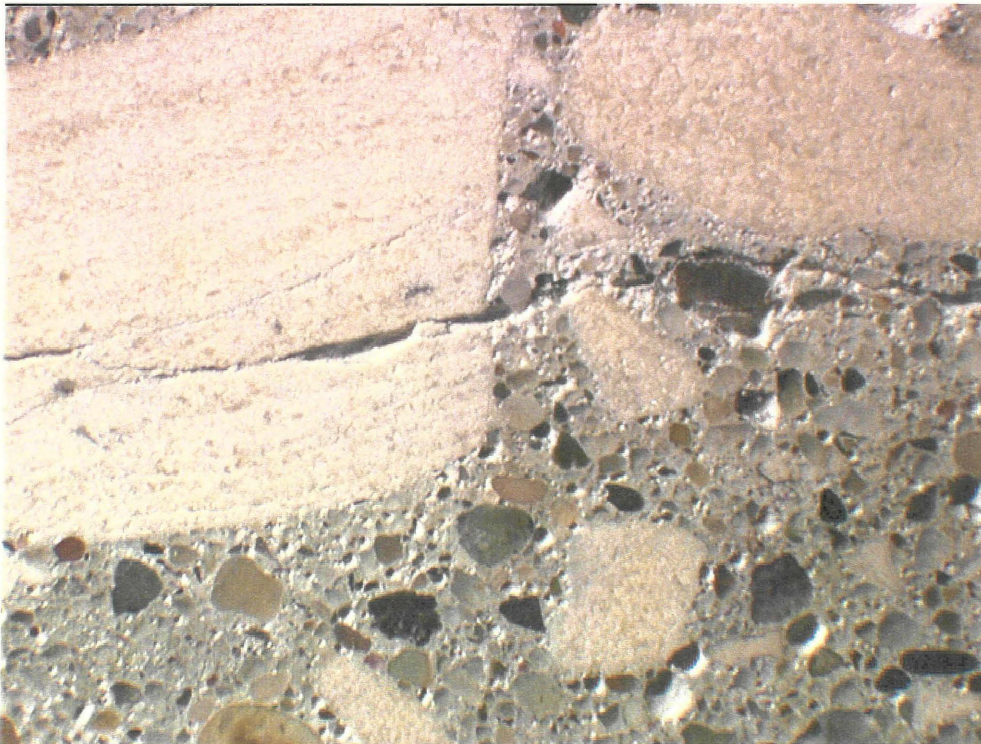
Figure 12. Iowa 175 Core 2 base microstructure exhibits cracking in the mortar and coarse aggregate. Micrograph field width: 14 mm.

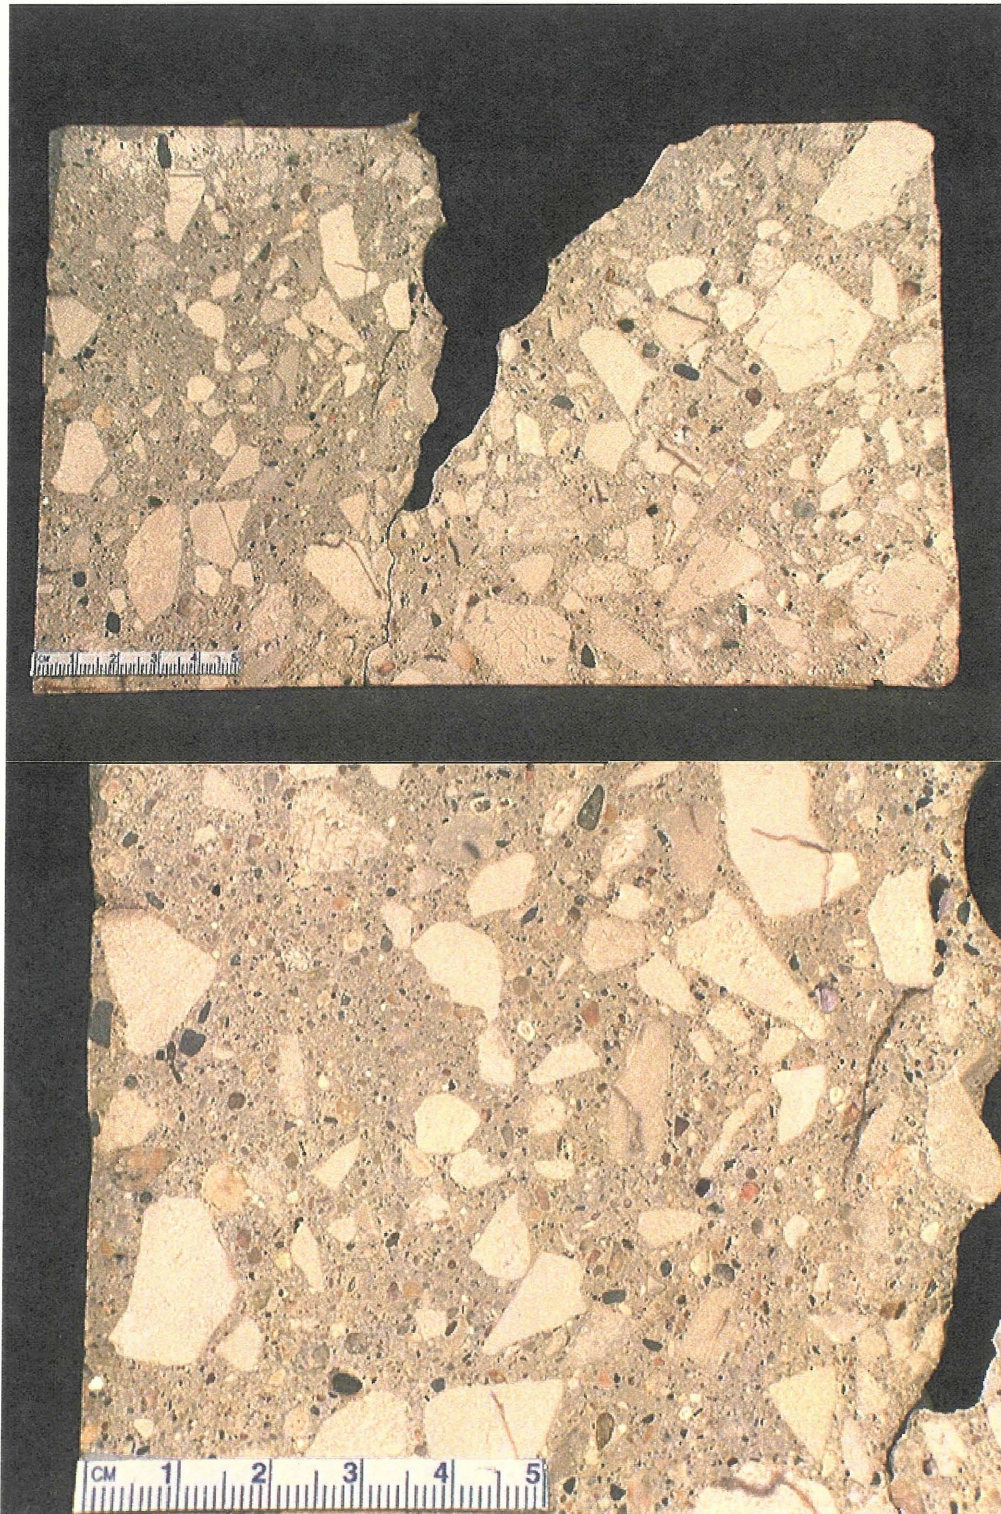
Figure 14. Core 7 (road surface is to the left) exhibits cracking of coarse aggregate, vertical cracks from the surface that are either drying shrinkage or freeze thaw-related. Segregation of mortar and coarse aggregate is visible in the whole core cross section (upper image) and the upper-core microstructure (lower).

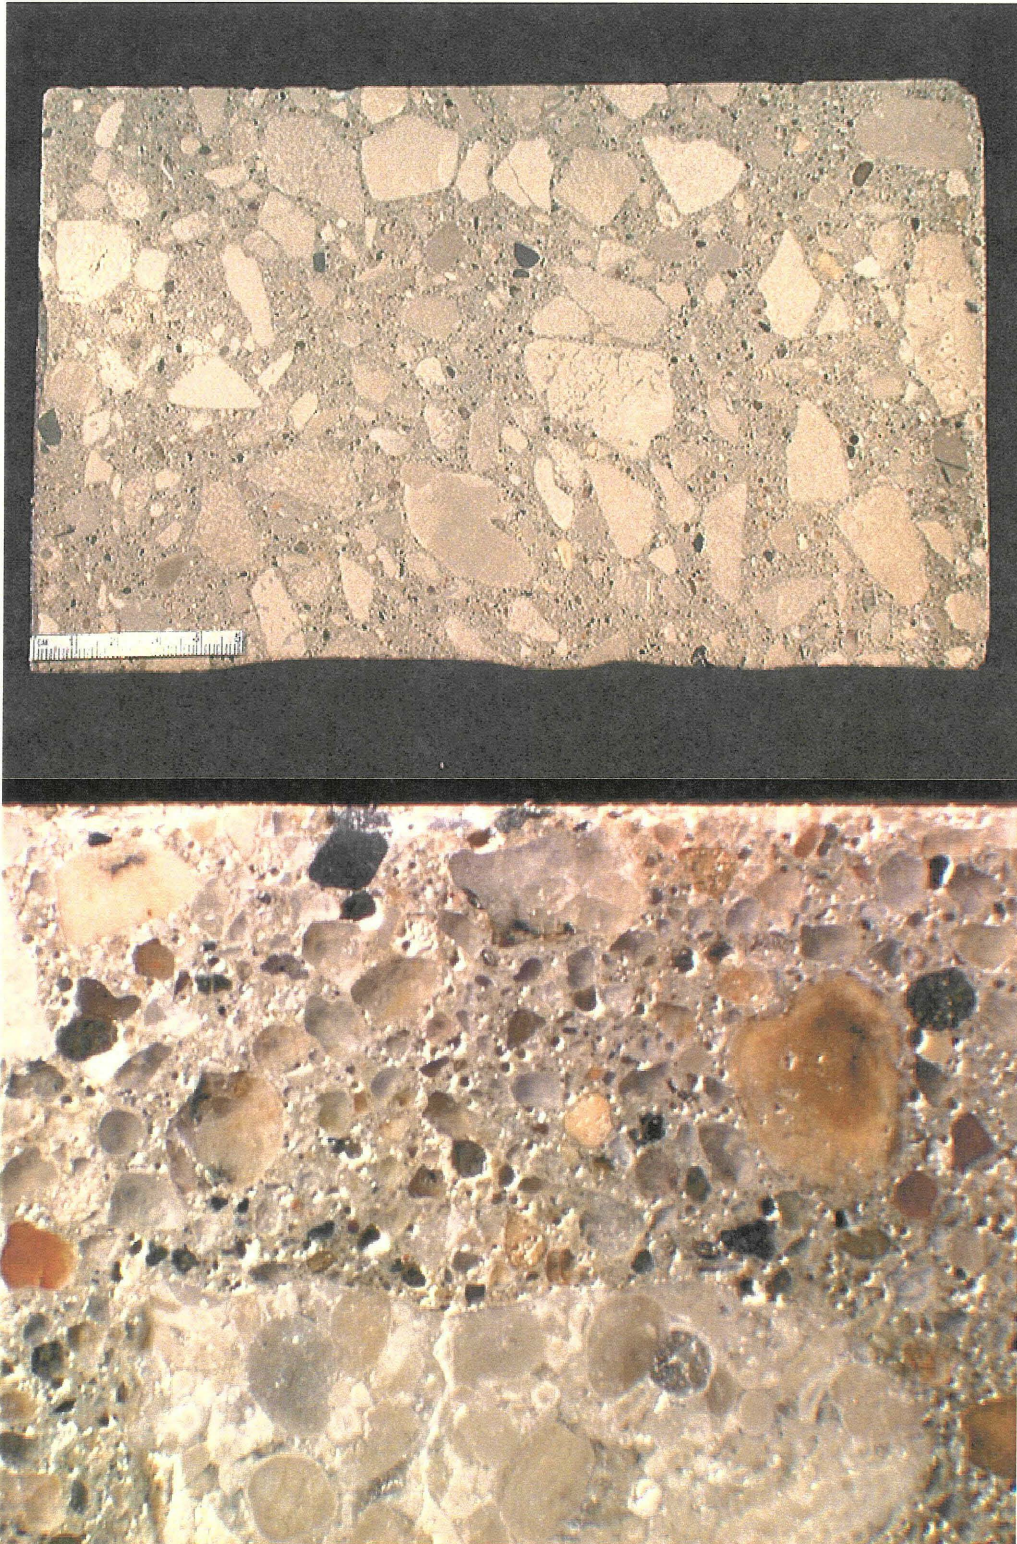
Figure 15. Core 8 exhibits less cracking but does have surface cracking to depths of 20 mm. Some of these cracks as seen in the lower image (13 mm field width) are associated with cracking within the coarse aggregate.

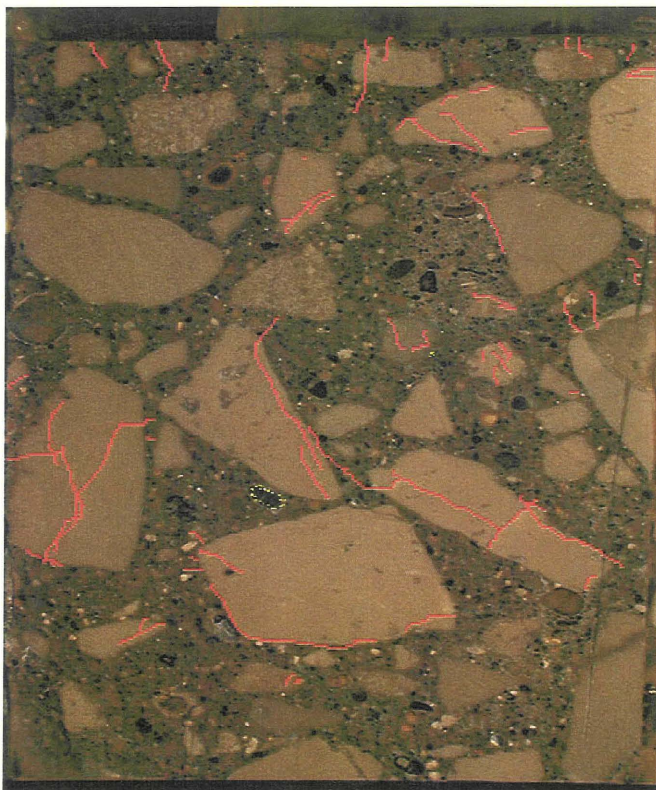
Figure 16. Cracking (red) and ASR (yellow) in Core 7 as observed using SEM. Cracking of aggregate is common. Surface cracks appear carbonated and terminate in both the mortar and the coarse aggregate. Micrograph field width is approximately 10 cm.

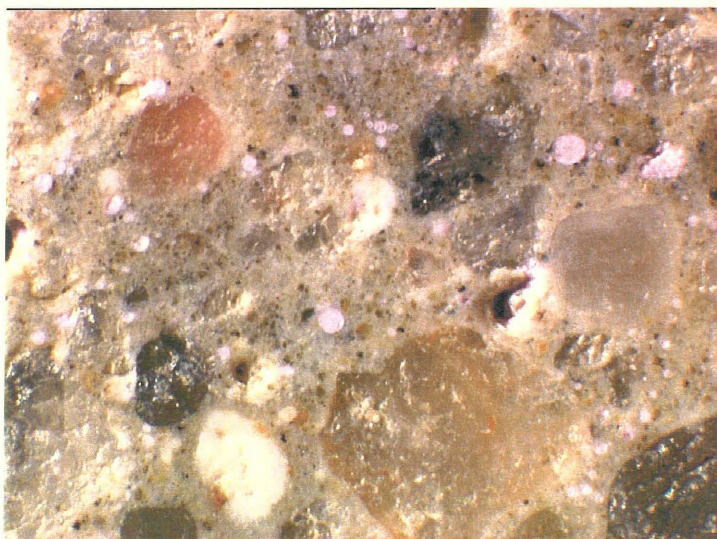
Figure 17. Filling of the smaller entrained air voids (purple) has significantly increased the air void spacing factor while only slightly decreasing the total entrained air void volume for both Cores 7 and 8. Field width: 4 mm.

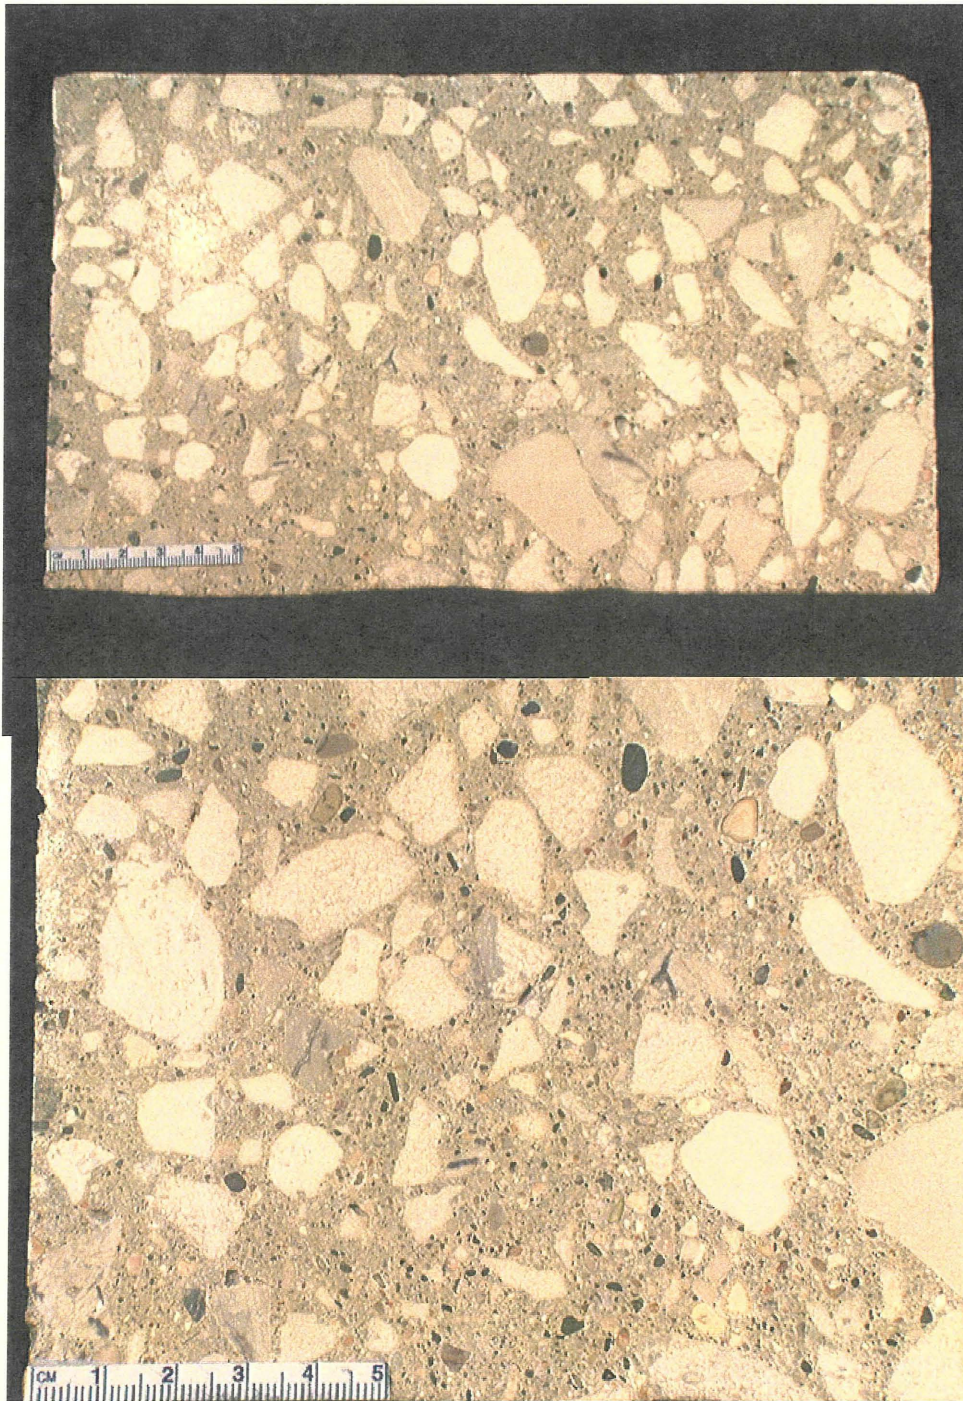
Figure 20. Core 13 cross sections show segregation within the concrete and only minor cracking of the mortar and coarse aggregate.

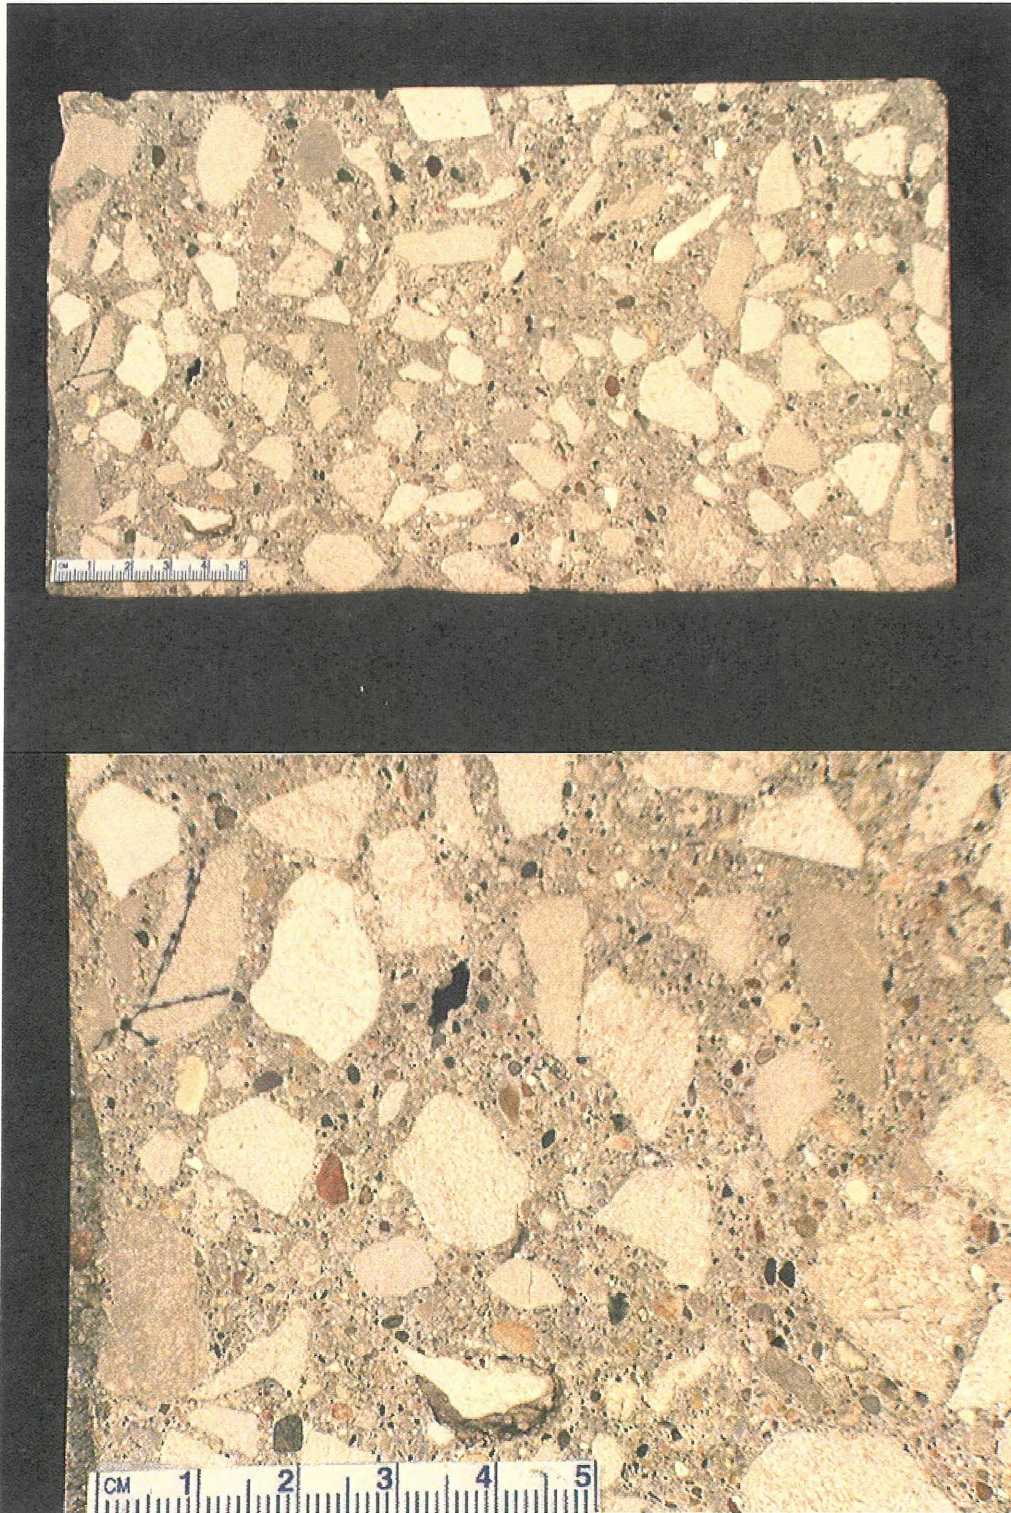
Figure 21. Core 14 exhibits some cracking of both the paste and coarse aggregate and some mortar / aggregate segregation in middle.

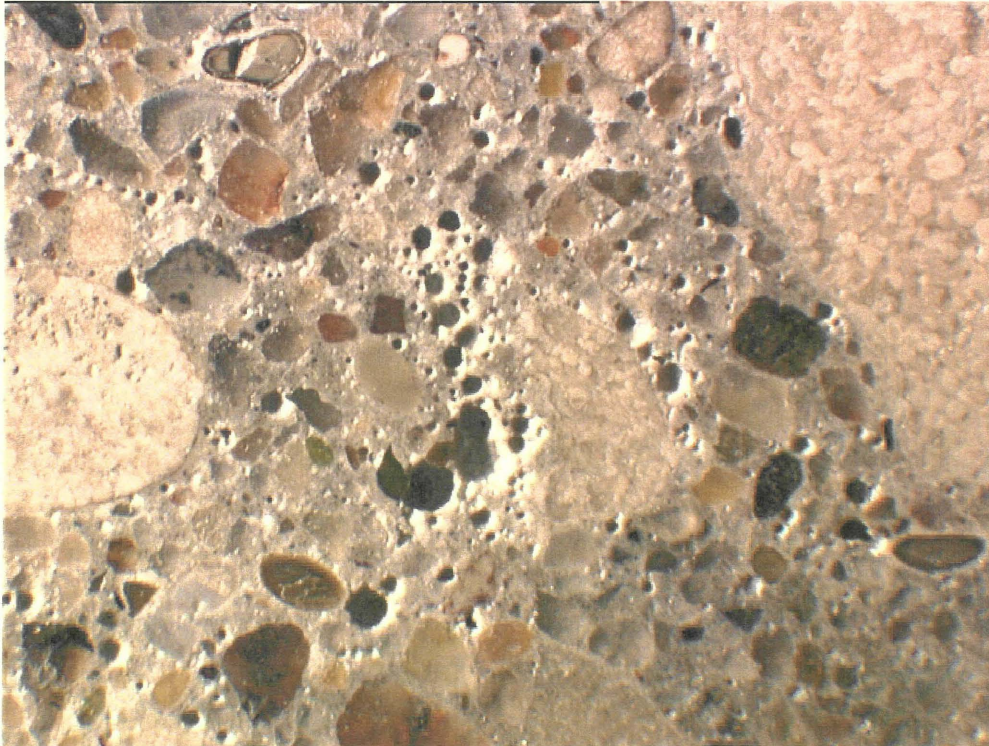
Figure 22. Clustering of air voids may indicate difficulties in mixing and development of a properly sized, disseminated entrained air void system. Field: 7 mm.

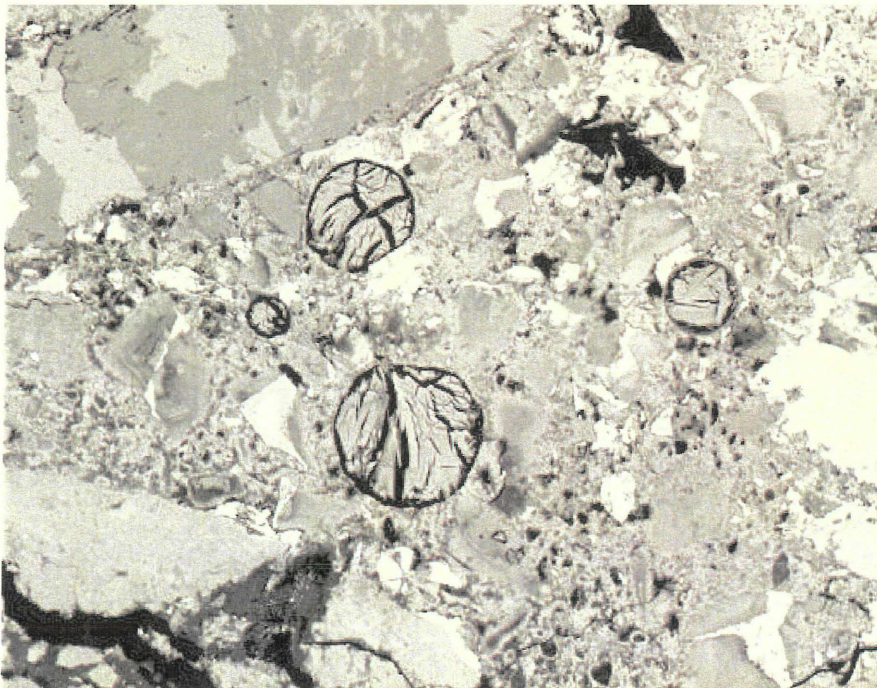
Figure 23. A SEM image of Core 13 paste shows ettringite-filled entrained air voids, the irregularly-shaped capillary voids (black), and a reactive shale grain in the lower-left. Note absence of cracking outside of this shale grain and lack of paste / aggregate gaps that would be typical of an overall paste expansion. Field: 200  $\mu\text{m}$ .

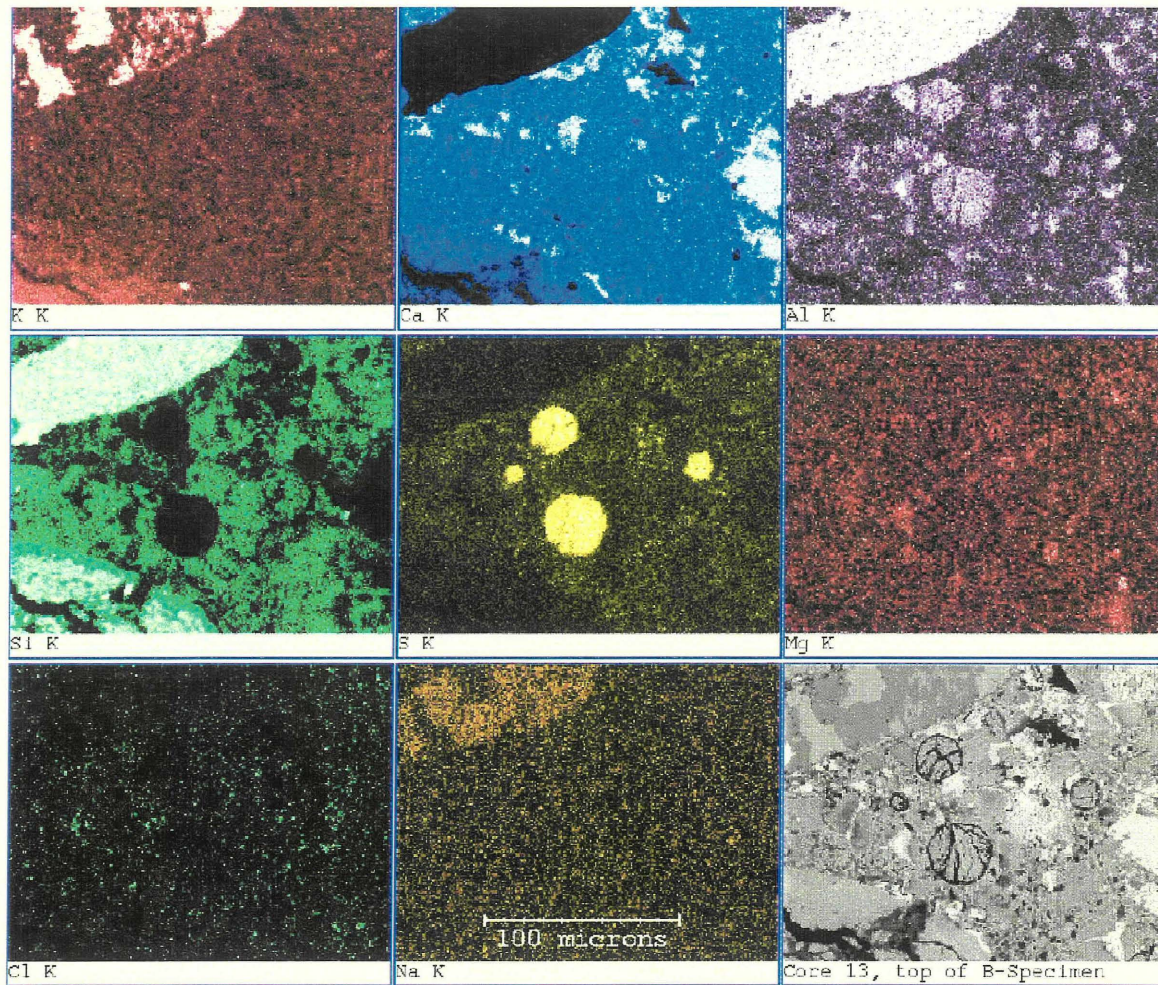
Figure 24. X-ray images corresponding to image in Figure 23. While the shale has undergone alkali-silica reaction, no cracking is apparent within the paste. Common locations of aluminum, sulfur and calcium in the X-ray images delineate ettringite.

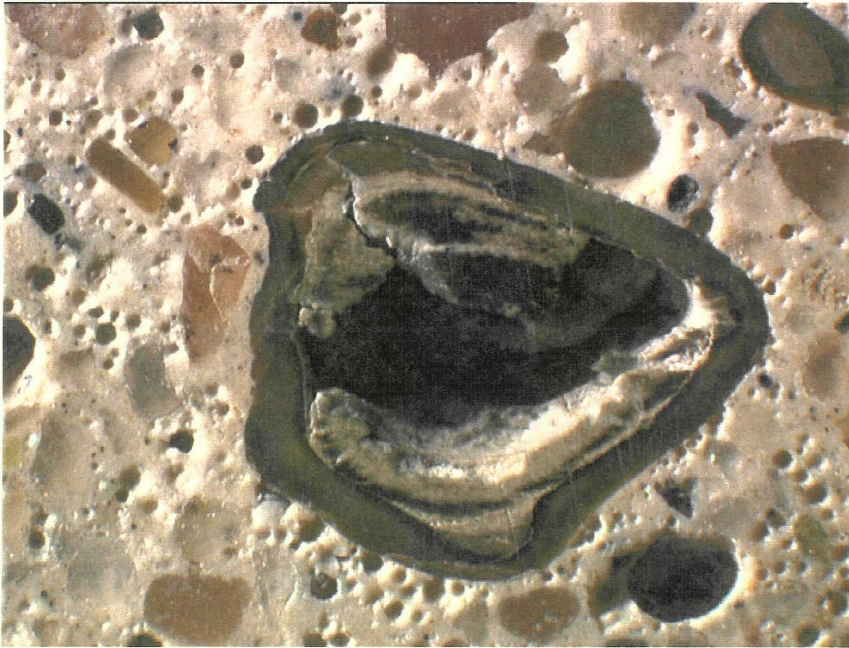
Figure 29. Core 18 mortar microstructure includes numerous shale fragments that appear to have undergone alkali-silica reaction, however little cracking of the mortar was evident. SEM examination indicated that some of the reaction product permeated the paste filling the capillary voids adjacent to the shale. Field width: 10 mm.

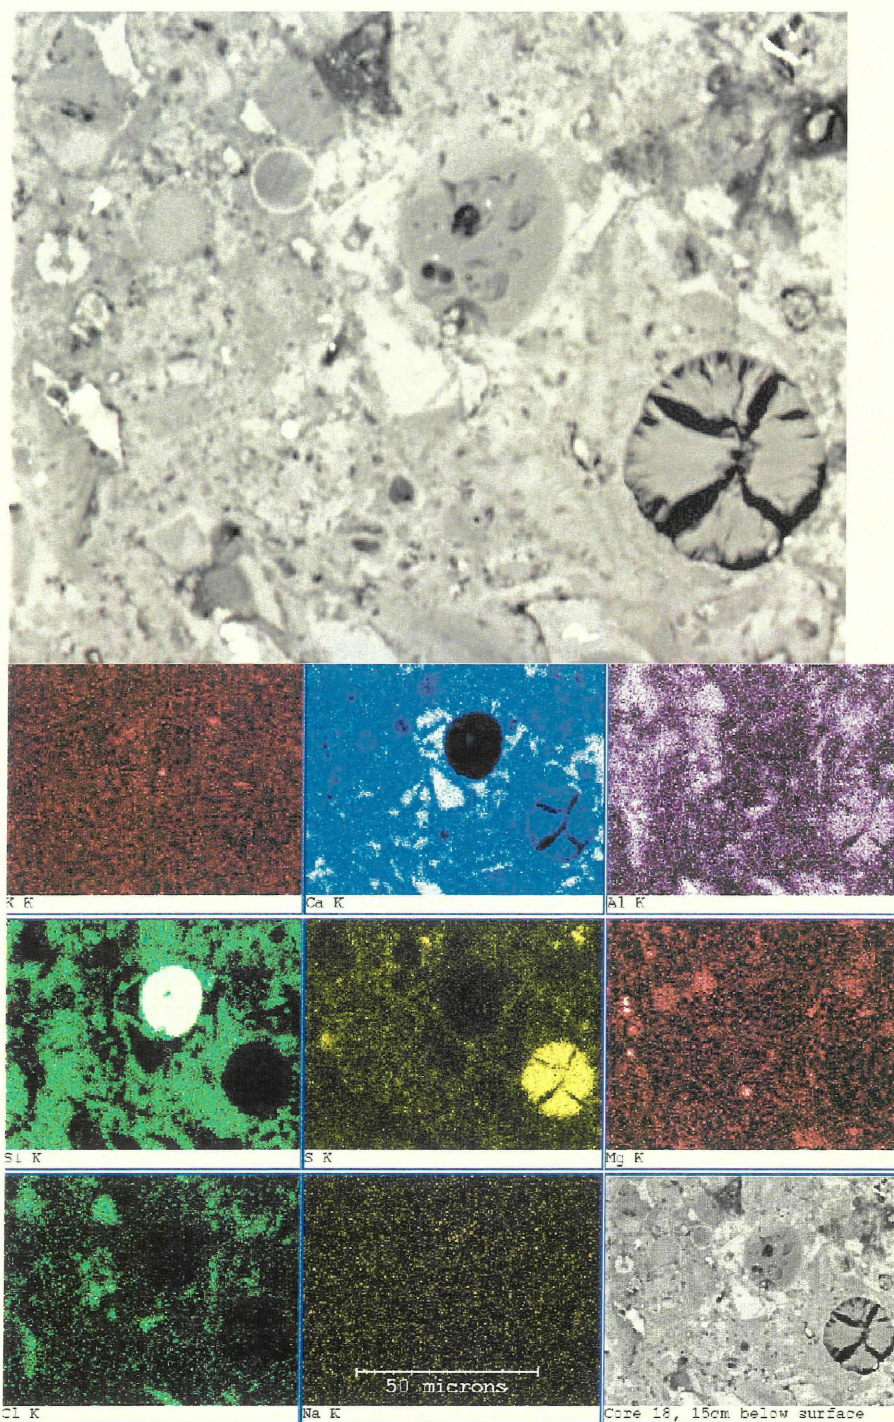
Figure 31. SEM of Core 18 shows an air void partially filled with ettringite (lower-right) and partially reacted fly ash particles (circular). X-ray element distribution (lower image) shows regions of high sulfur and aluminum that delineate locations of ettringite. Regions of chlorine and aluminum delineate regions of chloroaluminate. Field width: 75  $\mu\text{m}$ .

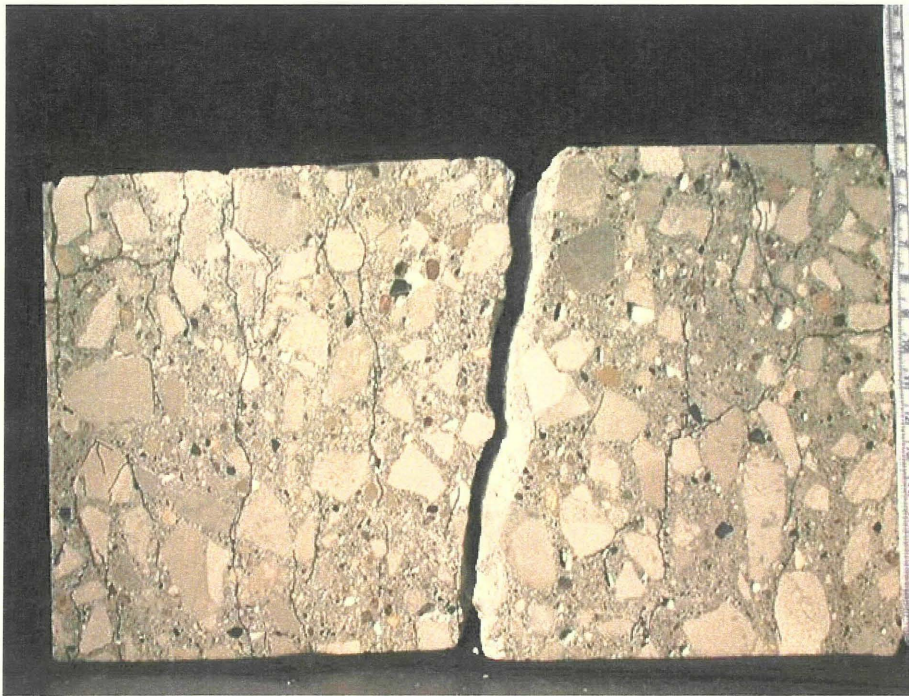
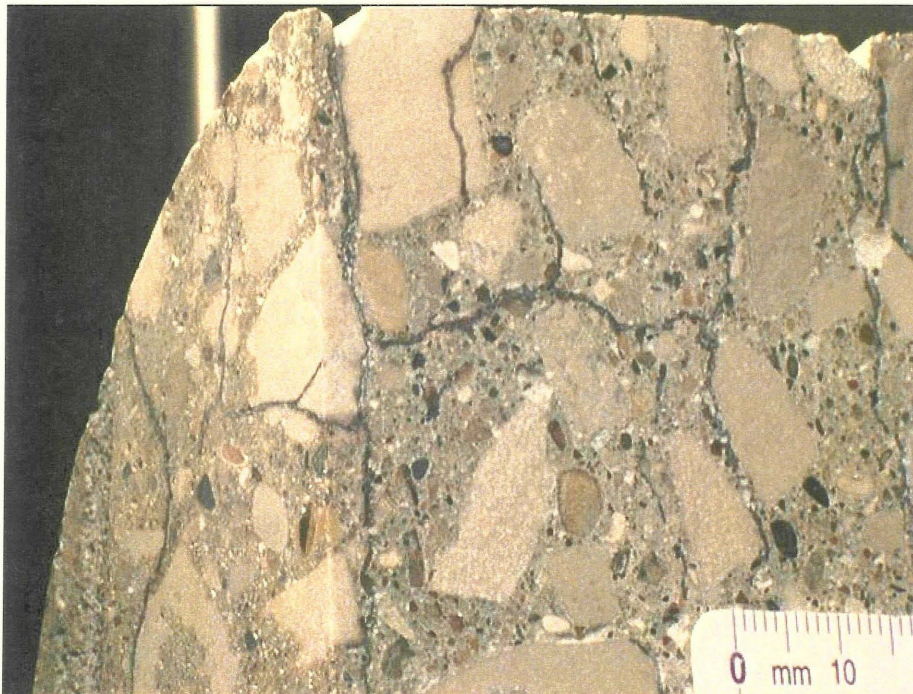
Figure 32. Core 19 exhibits extensive cracking of both the paste and coarse aggregate. Cracks trending parallel to the pavement surface (to the left) intersect perpendicular cracks; features typical of freeze-thaw cracking. The oblique view of the upper portion of core 19 shows cracking in both the surface (polished for clarity) and cross-section orientations.

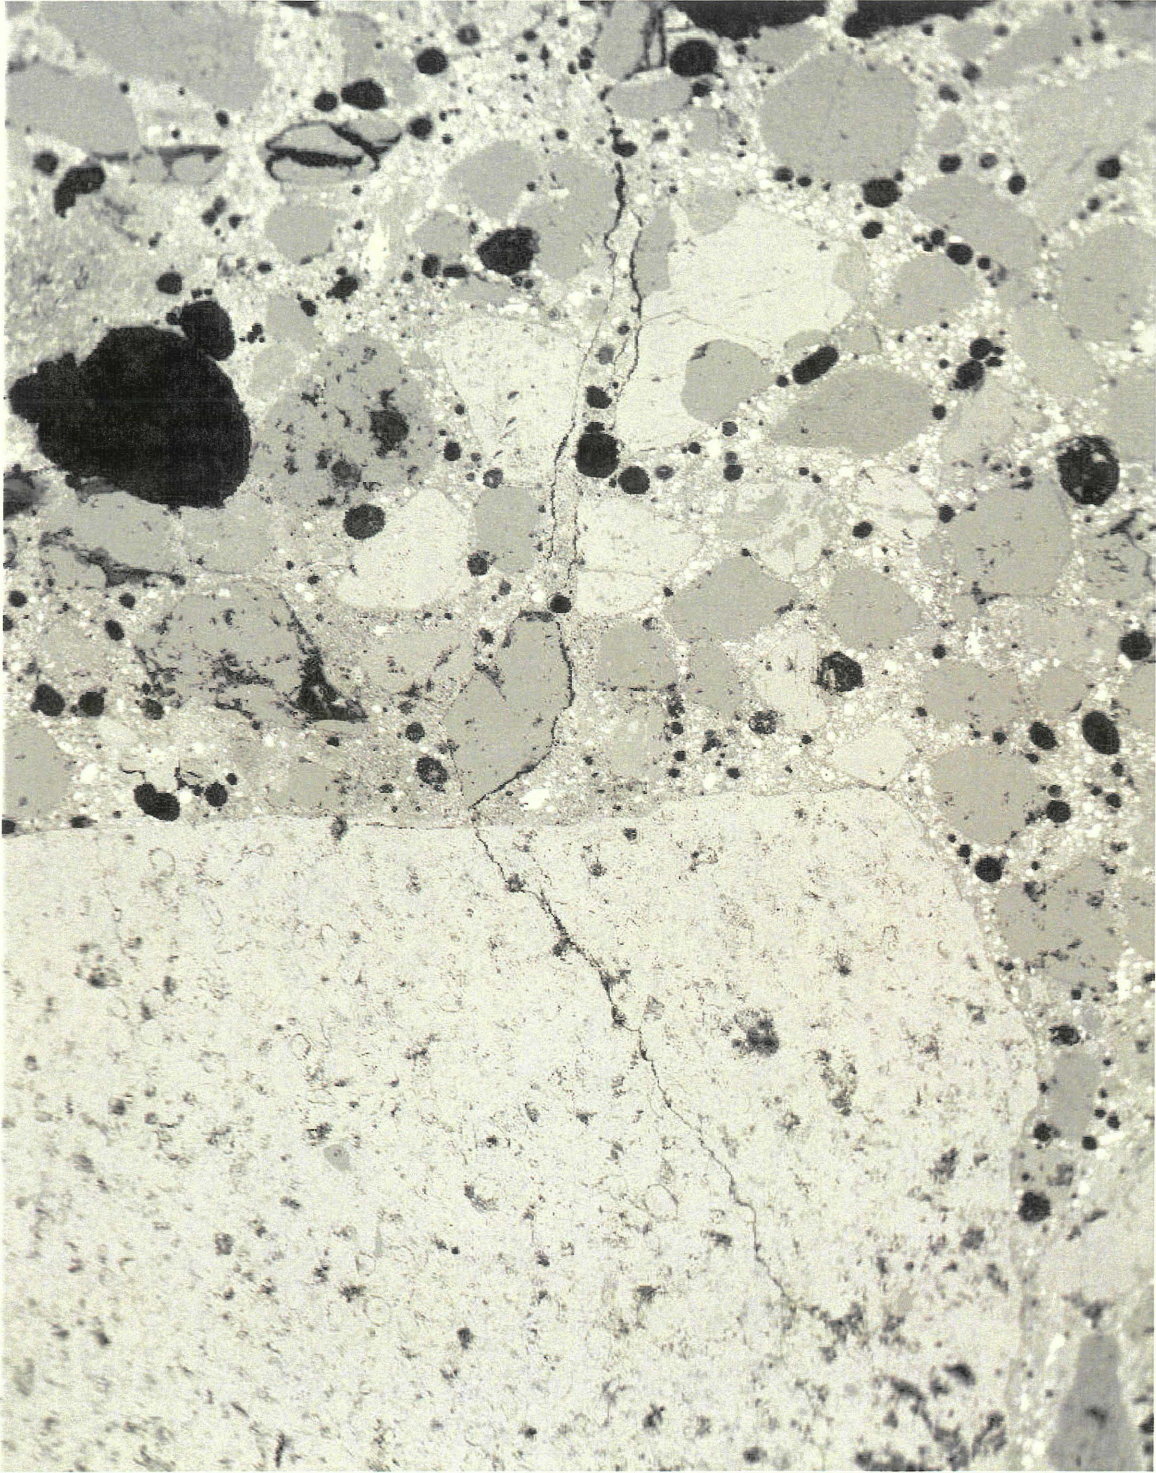
Figure 33. SEM image of a surface crack (road surface is at the top, 5 mm field width) extending through the paste portion of the mortar and terminating in a coarse aggregate.
