# Deterioration of Iowa Highway Concrete Pavements: A Petrographic Study

FINAL REPORT  
HR-1065

Paul E. Stutzman

December, 1999

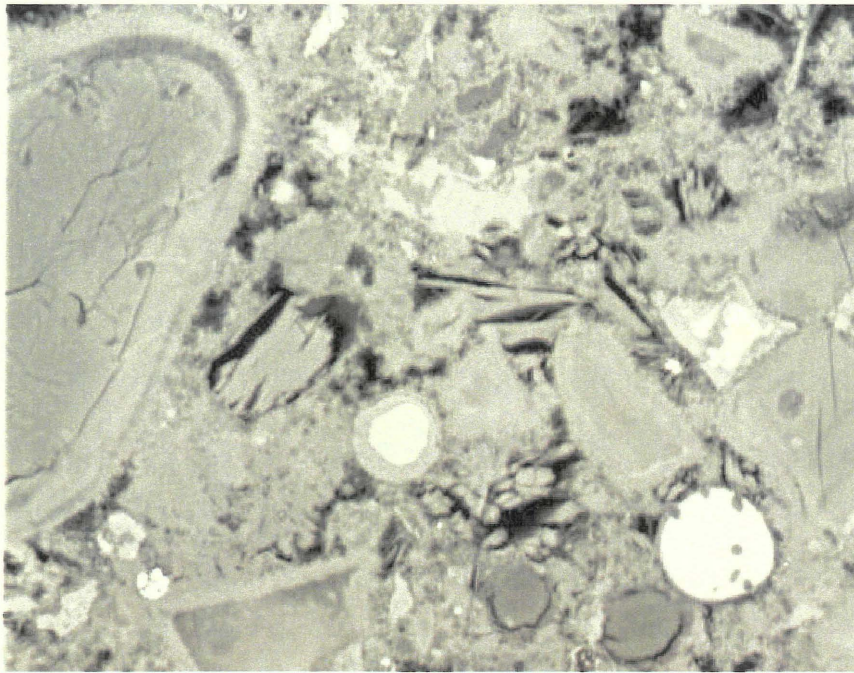
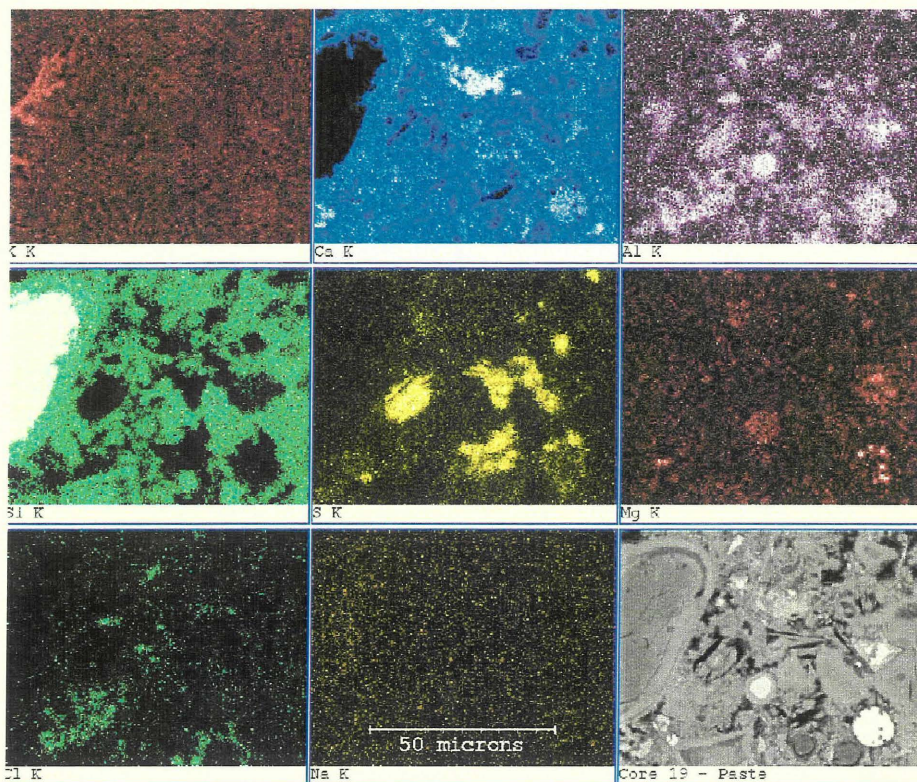
Figure 34 shows SEM images of the cement paste from Core 19. The upper, backscattered electron, image shows a region that includes a shale grain (left side), and hydration products, fly ash (circular), and pores (black). Alkali-silica reaction gel within the aggregate may be located using the potassium X-ray image (upper-left of the nine image series) yet no cracking is seen within the paste. Ettringite in the cement paste may be identified by its platy parting and by the combined X-ray images of intermediate aluminum, high sulfur, and intermediate calcium intensities. The occurrence of ettringite within the cement paste is common and may be either primary or a replacement of monosulfate. The gaps surrounding the ettringite grains are, in part, shrinkage phenomena due to the microscope vacuum but may also be a result of dissolution. The relatively large, irregular-shaped pores (black) may indicate dissolution of monosulfate and calcium hydroxide. Field examinations of this pavement did not find any evidence of overall expansion, making the occurrence of ettringite apparently innocuous. Regions of the chlorine (lower-left) and intermediate-intensity aluminum images delineate chloroaluminate, or Friedel's salt.

Figure 34. Back scattered electron image of Core 19 paste microstructure showing ASR-affected shale (left) and fly ash (circular). X-ray image regions of high sulfur (yellow) and intermediate aluminum (purple) mark locations of ettringite while regions of high chlorine (lower left image) denote locations of chloroaluminate.

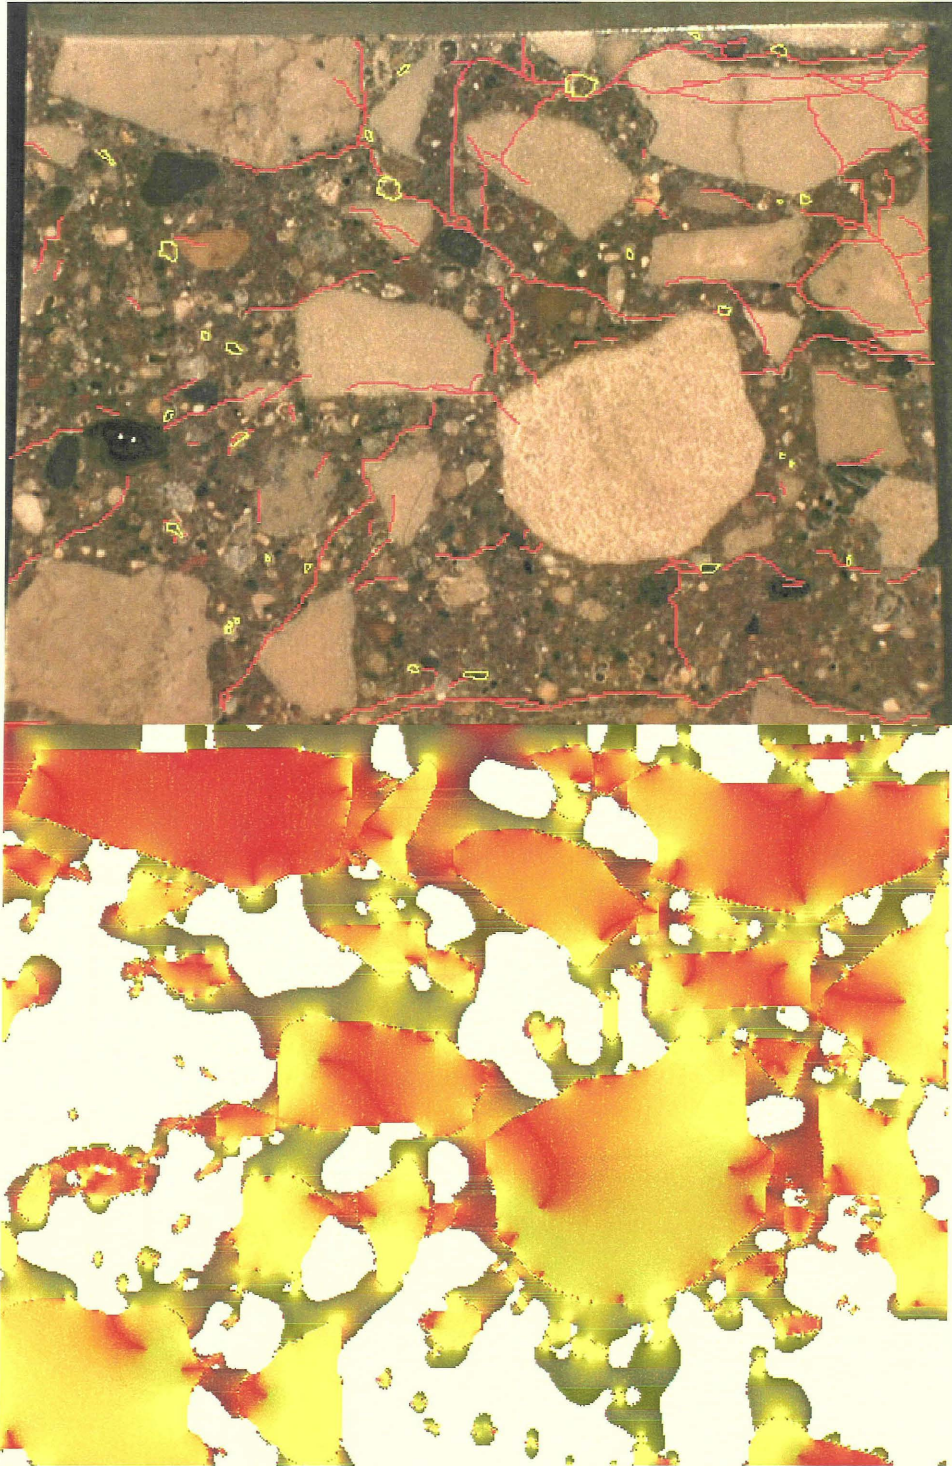
Figure 37. Top portion of core 19 with cracks (red) and ASR-affected shale grain (yellow) shows cracking through both the cement paste and coarse aggregate. A color-coded stress image resulting from a simulation of aggregate expansion showing regions of high stresses in red correlates well with some, but not all of the observed cracking.

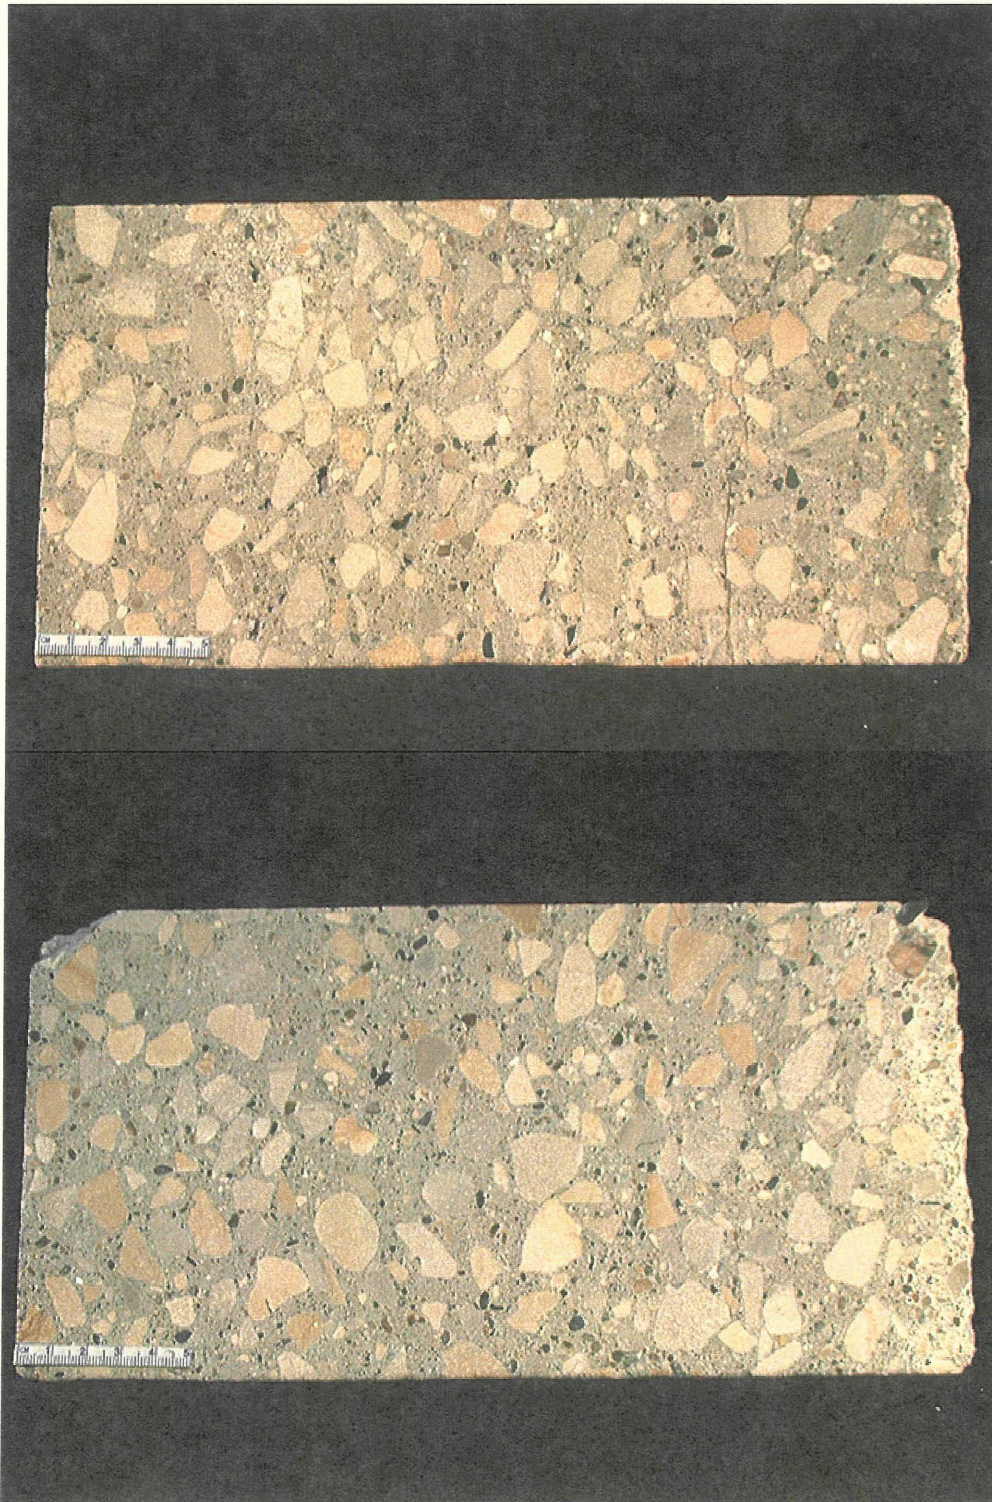
Figure 38. Cores 11, joint (top) and 12, mid-panel (bottom) cross section with horizontal crack in lower-most third. Some segregation is visible in both cores.

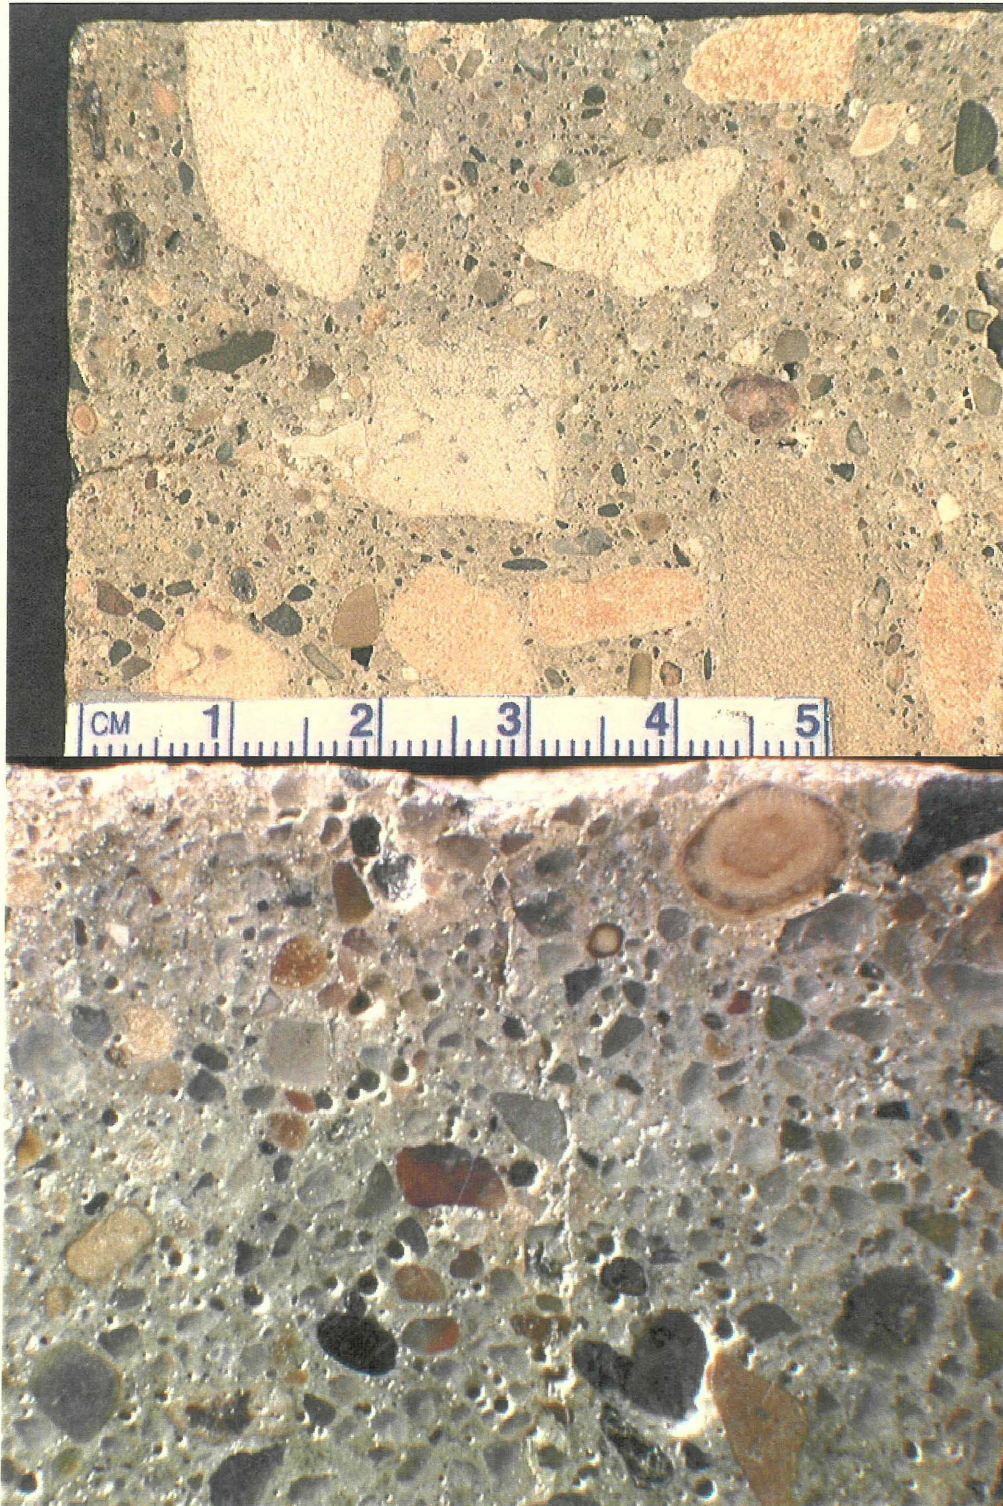
Figure 39. Surface cracking in Core 11 to about 20 mm passes through both the mortar and coarse aggregate. Lower image shows minor surface carbonation and cracking within the mortar. Field width 8 mm.

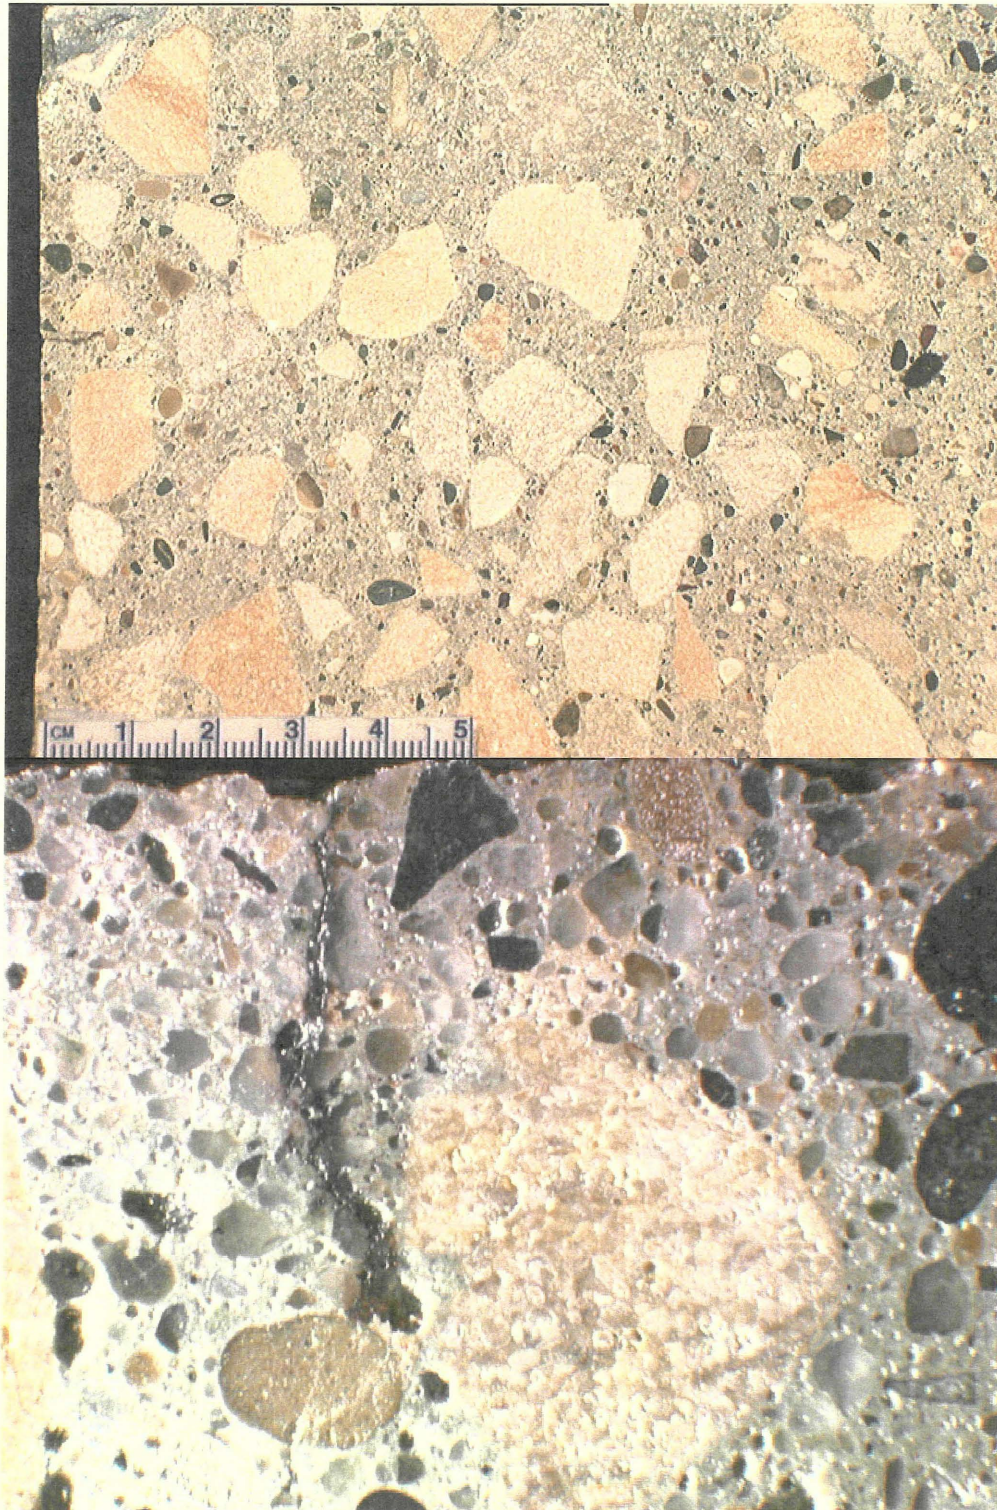
Figure 40. Surface crack in core 12 (approx. center-left) appears to be entirely within the mortar, and the lower image shows the crack plane through mortar highlighted using ink. 8 mm field width.

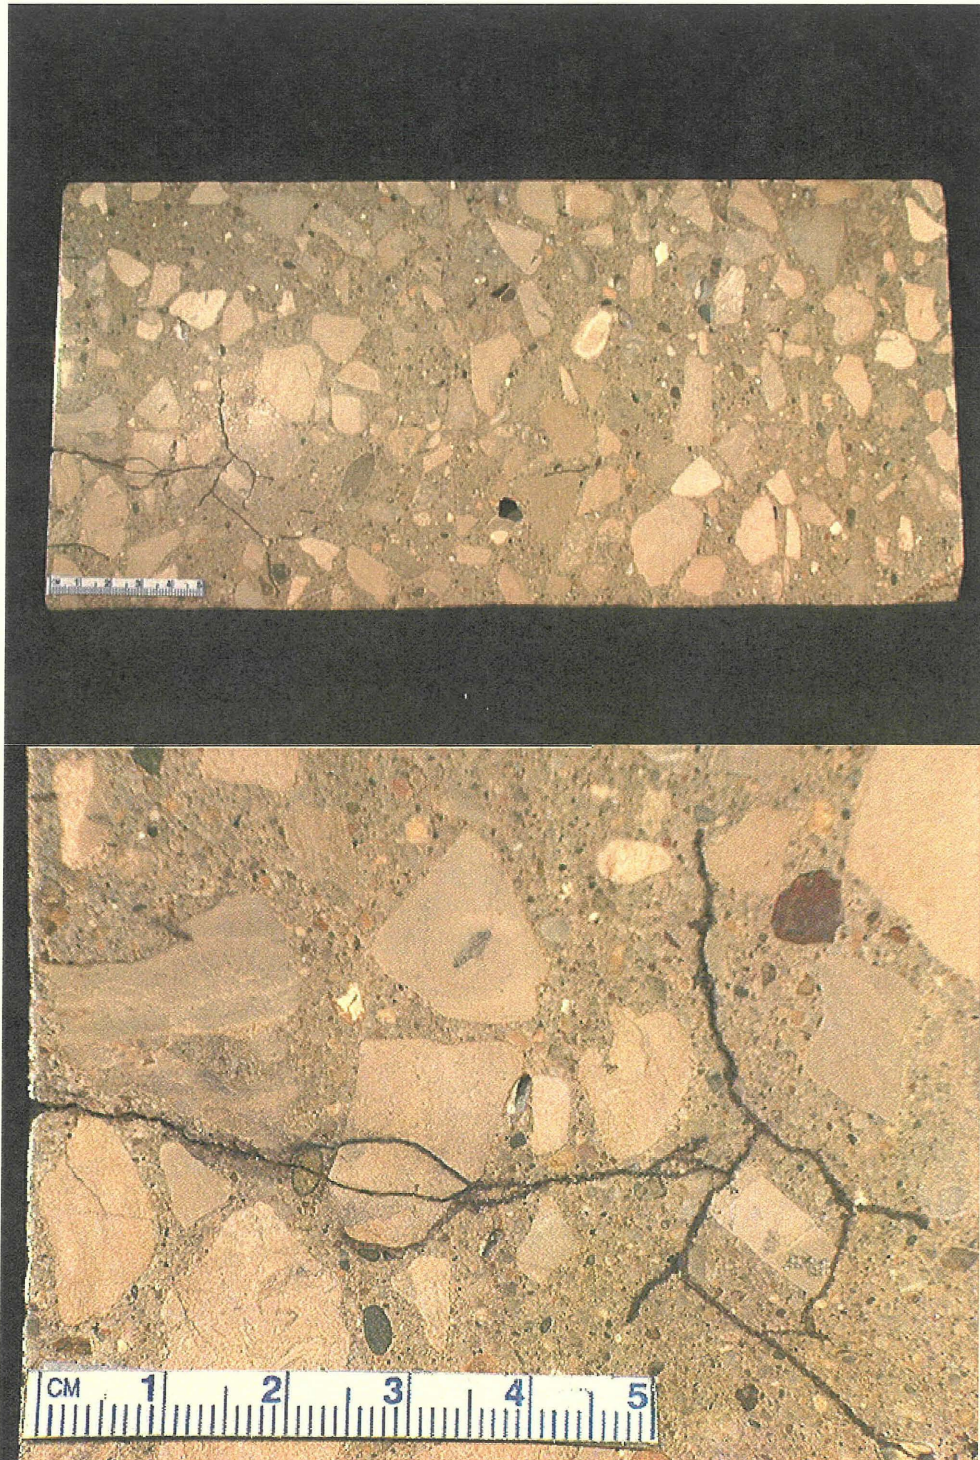
Figure 43. Core 29 cracking near surface passes through both the mortar and coarse aggregate. Cracking also follows close along paste-aggregate interface and is typical of a shrinkage crack. Cracking in aggregate and in the mortar at depth may reflect freeze-thaw damage, as the air void system in the upper half of this core is much poorer than that in the lower half.
