Heavy Agricultural Loads on Pavements and Bridges

Sponsored by the
Iowa Department of Transportation and the
Iowa Highway Research Board

March 1999

Iowa DOT Project HR-1073

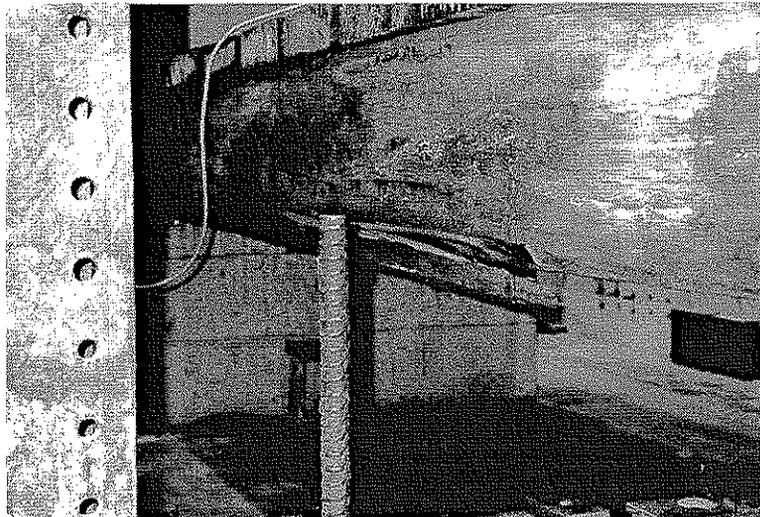
Figures 10 through 13 show splits that took place in some stringers resulting in the failure of the bridge. Note that stringers 1N, 2IN, 3M, and 4IS all exhibited major splits at failure. From the data plot, it appears that stringer 3M failed first and the splitting was most likely initiated by a flaw in the bottom tension fibers near mid-span. Stringer 1N failed next, followed closely by stringers 2IN and 4IS. A visual inspection of the sill plates showed no noticeable crushing of the wood under the stringers. Inspection of the deck planks also indicated that there was no noticeable damage. Failure of the bridge was sudden and was characterized by flexural failure of the stringers.

Figure 10. Stringer 1N failure - Bridge 1.

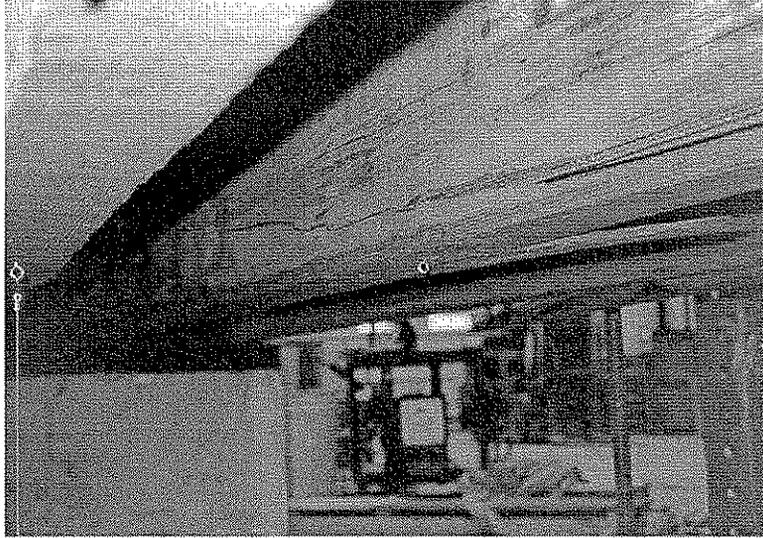
Figure 11. Stringer 2IN failure - Bridge 1.

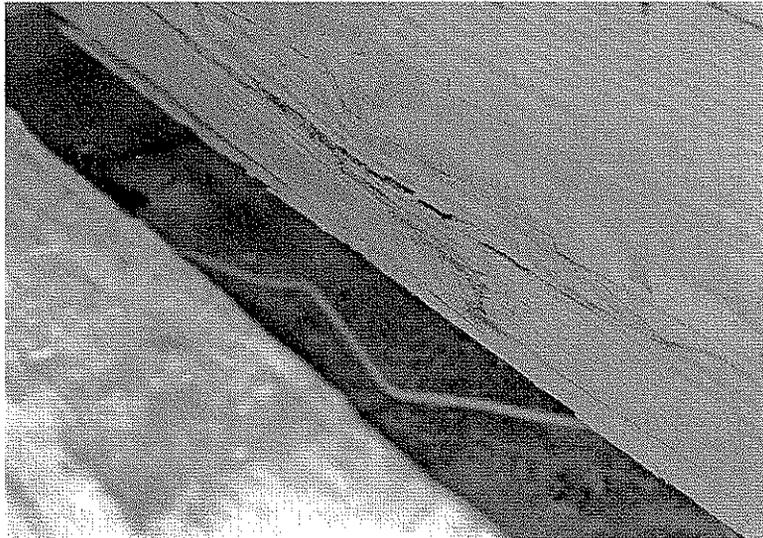
Figure 12. Stringer 3M failure - Bridge 1.

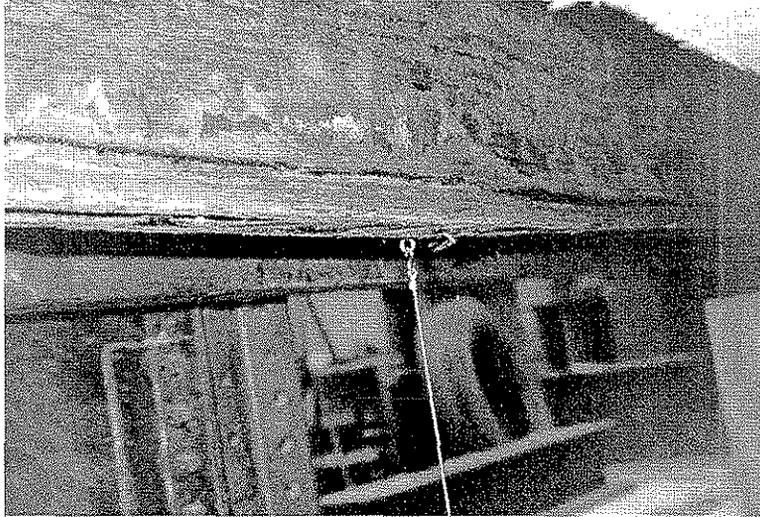
Figure 13. Stringer 4IS failure - Bridge 1.

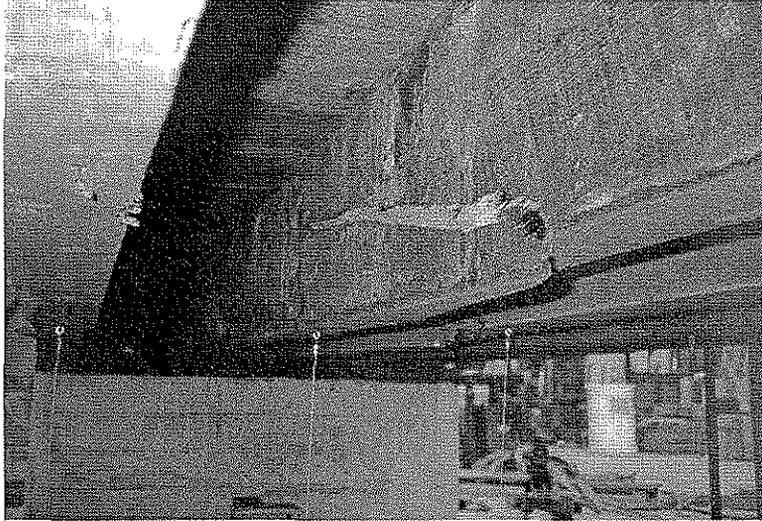
Based only on the observation data mentioned above, it was noted that the first major crack occurred in stringer 4IS at a load of 28,000 lbs. (124.6 kN). Up to that load it was observed that the load/deflection plot was linear with the pairs of symmetrically loaded stringers behaving as in the Bridge 1 test. The two interior stringers (2IN and 4IS) had slightly less load/deflection slopes, indicating they were carrying a larger load compared with the outside stringers. The middle stringer (3M) deflected the most, indicating that it was carrying most of the load. From about 3,000 lbs. to 10,000 lbs. (13.3 to 44.5 kN), typical sounds described as popping and cracking due to the straining of the bridge and bridge stringers occurred. At 18,800 lbs. (83.6 kN), the sounds became more pronounced and distinct, indicating that significant cracking or fiber straining was beginning to occur. At this point, it was observed on the DAS monitor that stringer 4IS was deflecting more than stringer 2IN. At 28,000 lbs. (124.6 kN), a significant crack occurred in stringer 4IS. It appeared that the crack was initiated at a knot in the tension face of the stringer

(Figure 16). From 28,000 lbs. to 35,000 lbs. (124.6 to 155.7 kN), it was observed visually that the crack in stringer 4IS continued to open wider and additional cracking sounds, or fiber straining, could be heard coming from other stringers. At 39,000 lbs. (173.5 kN), the applied load dropped to 35,000 lbs. (155.7 kN) due to a failure in stringer 5S. It was also noticed that string 3M, the middle stringer, had developed a crack. It is believed that this crack occurred after stringer 4IS failed and before the failure of stringer 5S. Again, this crack seems to have been initiated by a knot in the wood close to the stringer tension face (see Figure 17). Additional loading back up to 39,000 lbs. (173.5 kN) resulted in horizontal cracking in stringer 5S (see Figure 18). The real time plot observed on the DAS monitor for the test at this point showed that the stringer mid-span deflections ranged from the smallest in stringer 1N to the largest in stringer 5S. This suggests that the final failure would occur in stringers 4IS or 5S. The ultimate load for the bridge was 40,100 lbs. (178.4 kN). Stringer 5S incurred considerable flexural cracking (see Figure 18). Stringers 1N and 2IN did not show any signs of distress or damage. The deck planks did not show any load distress. Failure of the bridge was sudden and characterized by the flexural failure of the stringers.

Figure 16. Stringer 4IS failure initiated in the vicinity of a knot - Bridge 2.

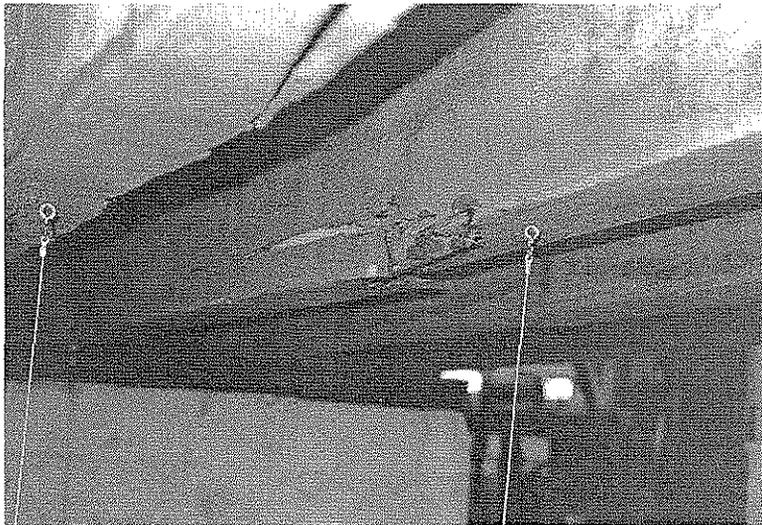
Figure 17. Stringer 3M failure at knot location in tension face - Bridge 2.

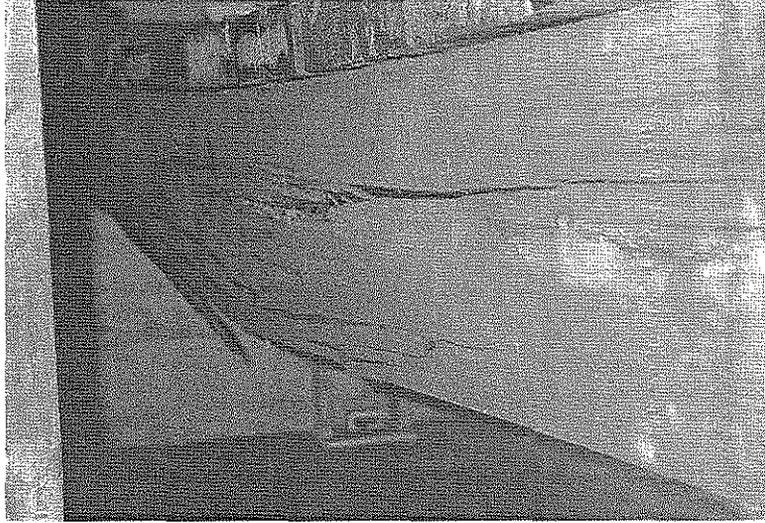
Figure 18. Stringer 5S failure - Bridge 2.

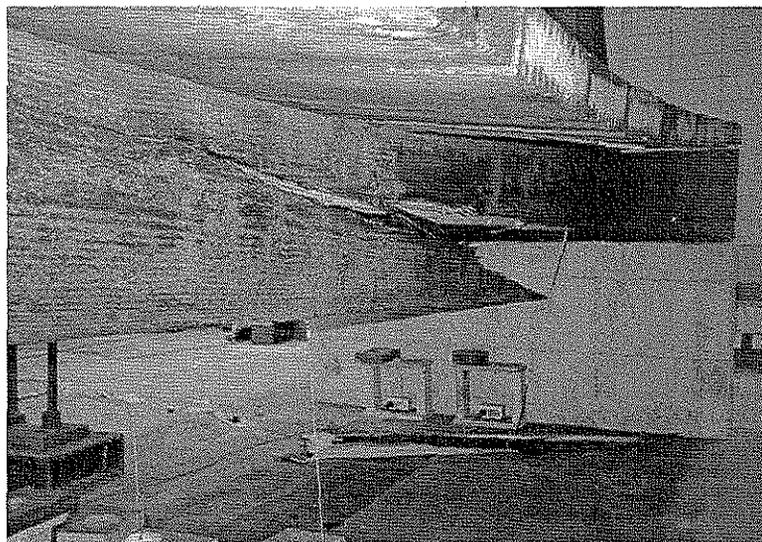
Figure 22. Stringer 3S failure (note piece on floor) - Bridge 3.

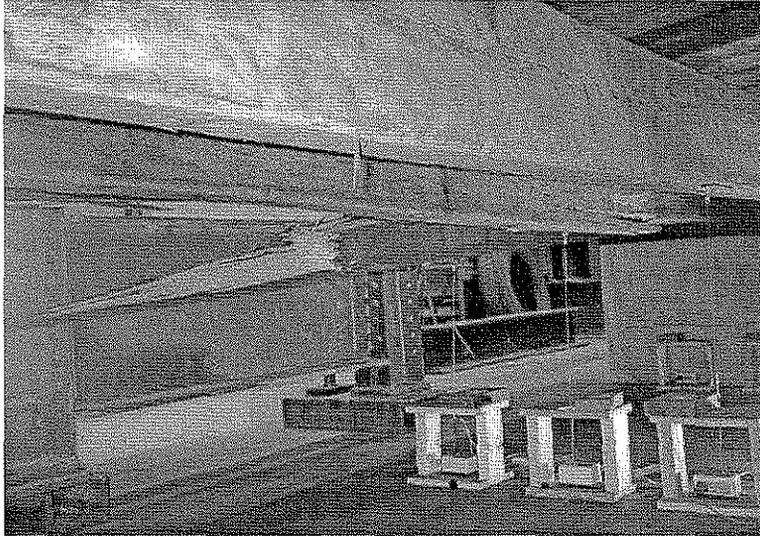
Figure 23. Stringers 1N, 2M and 3S (from right to left) after bridge failure - Bridge 3.

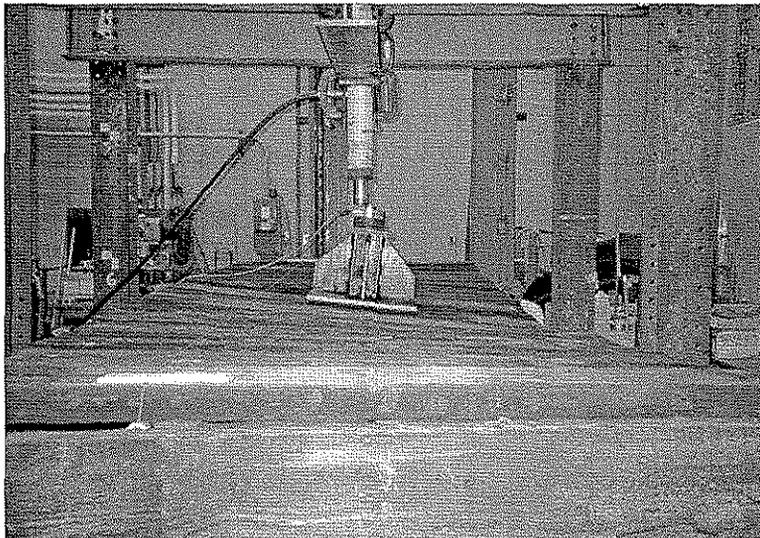
Figure 24. Bridge 3 after failure of stringers (looking east).

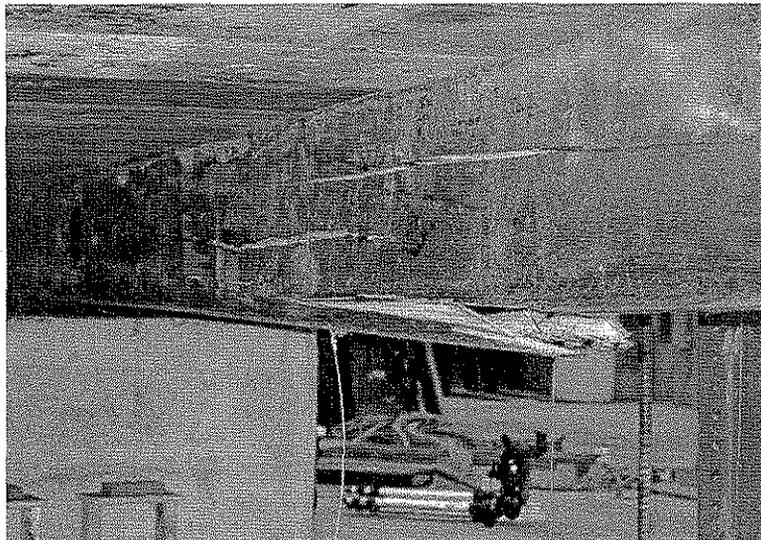
Figure 28. Stringer 3S failure - Bridge 4.

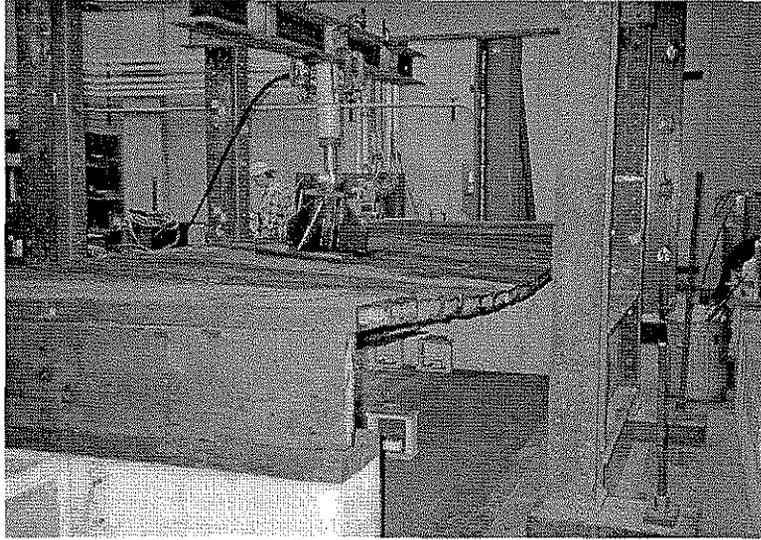
bridge response, stringer 1N exhibited stiffer load/deflection behavior than stringers 2M and 3S (this statement is based on all three stringers carrying an equal percentage of the applied load). At about 17,000 lbs. (75.6 kN), the slope/deflection plot of stringer 1N increased, indicating that there was an increase in the load distribution to stringers 2M and 3S. At 27,000 lbs. (120.1 kN), the slopes of the load/deflection plot became nonlinear. At 34,000 lbs. (151.2 kN), it was observed visually that a crack formed in stringer 3S. The ultimate load was 36,300 lbs. (161.5 kN) with stringer 3S developing a major flexural crack and some major horizontal cracking (see Figure 28). Some cracking also occurred in stringer 2M at mid-span. Inspection of stringer 1N showed that some noticeable cracking was beginning to develop near the knot in the tension fibers, evident by the splitting of the wood around the knot. The final condition of Bridge 4 after the failure is seen in Figure 29. None of the deck planks were damaged. Failure of the bridge was sudden and was characterized by flexural failure of the stringers.

Figure 29. Bridge 4 after failure of stringers (looking east).
