Performance of Poly-Carb, Inc. Flexogrid Bridge Overlay System

Final Report
for
MLR-86-4

December 2001

**Iowa Department
of Transportation**

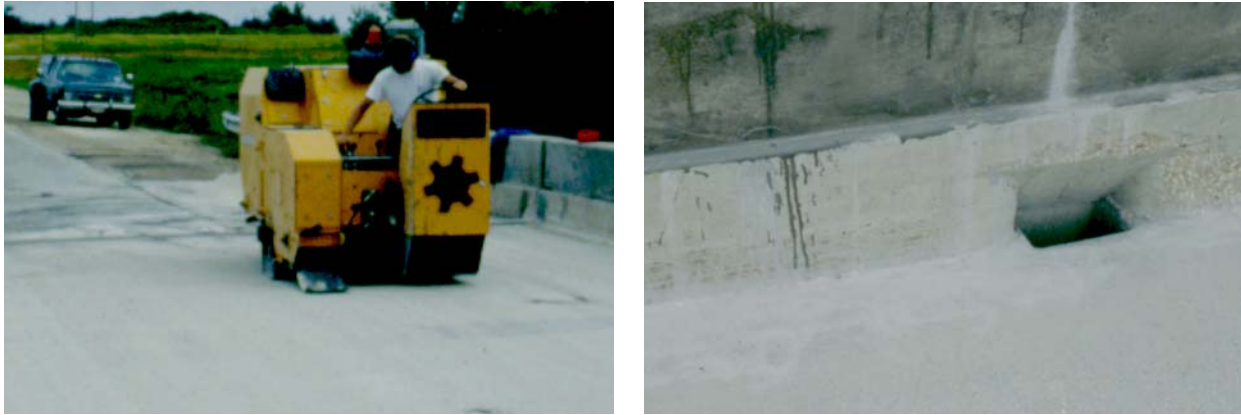
Sudarshan Sathe directed the use of pneumatic grinders to clean these areas by hand. It appeared that sandblasting would have been easier and cleaned these areas much better; however, Mr. Sathe was satisfied with the results produced by grinding. Close attention should be paid to curb and gutter condition throughout the overlay evaluation period due to the questionable quality of preparation in these critical areas.

Photographs showing Turbo Blast shot blasting machine (left), and grinding of curb and gutter (right).

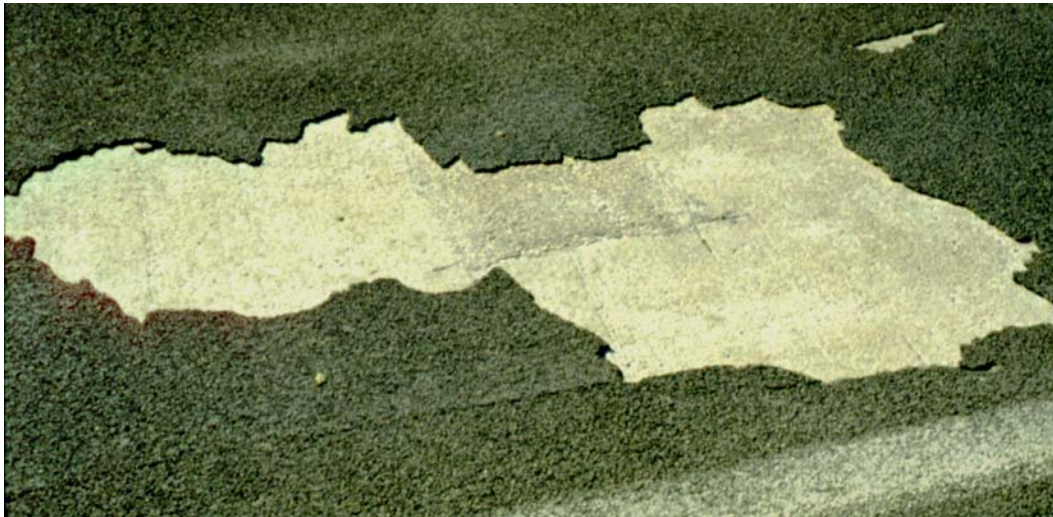
Friction tests were performed before and after the installation of the Flexogrid overlay system. The results concluded that the friction rating increased from an average of 36.5 to 67.5. The friction rating was tested each year after completion of the project and changed very little during the test period. The results for each year are listed in the table on the next page. Several delamination tests were also performed. These tests showed that the overlay was delaminating from the deck surface. The tests in 1986 and 1987 were performed using a Delamtec machine. The results were that in 1986 and 1987, 0.03 and 0.09 percent of the overlay, respectively, had delaminated. It was also discovered that the Delamtec was not detecting all of the areas in the bridge that delaminated so in addition to the Delamtec, the chain drag method of detection was used in the following years. The following years tests showed an increase in delamination, and by 1991, 3.8 percent of the deck area had delaminated. As the delamination progressed the Flexogrid blistered and broke free from the remaining material leaving many small areas of the concrete surface of the bridge deck exposed to water and de-icing chemicals.

In 1988 several cores were taken from the bridge deck. When they were examined it was found, in some cases, that the delamination was occurring up to 1” below the interface between the Flexogrid and the deck surface. Another delamination test was done in 1989 to help determine the cause of failure.

Photographs showing delamination of Flexogrid.

This bridge deck overlay did not perform as expected. A possible cause for the delamination that this project experienced is that moisture was being trapped below the impermeable Flexogrid layer. This moisture could cause delamination as the bridge deck undergoes freeze-thaw action.

Initial delamination failures were detected at the age of one year and were becoming serious failures by the age of three years. The remaining overlay areas were finally stripped off the deck, by the use of a front end loader, at the age of six years.
