Thin Maintenance Surfaces for Municipalities

Final Report
May 2007

Sponsored by
the Iowa Highway Research Board
(IHRB Project TR-507)
and
the Iowa Department of Transportation
(CTRE Project 03-161)

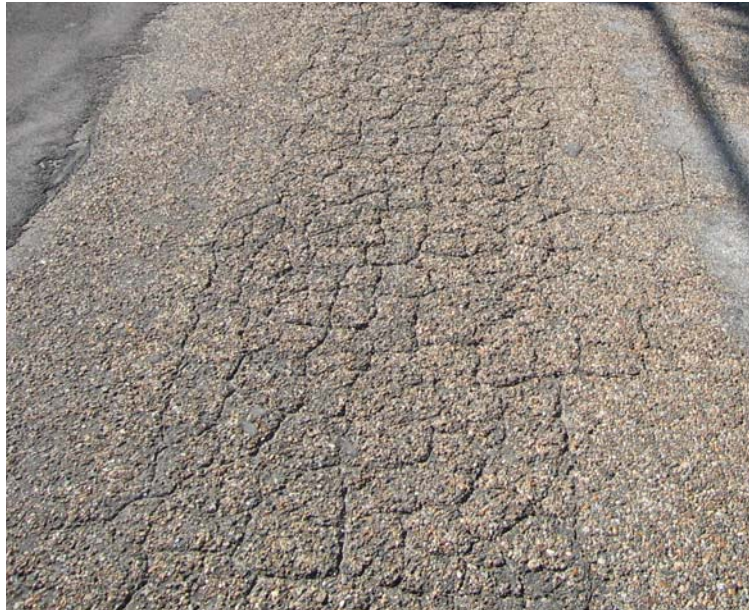
Figure 4. Alligator cracking on Vermont Avenue

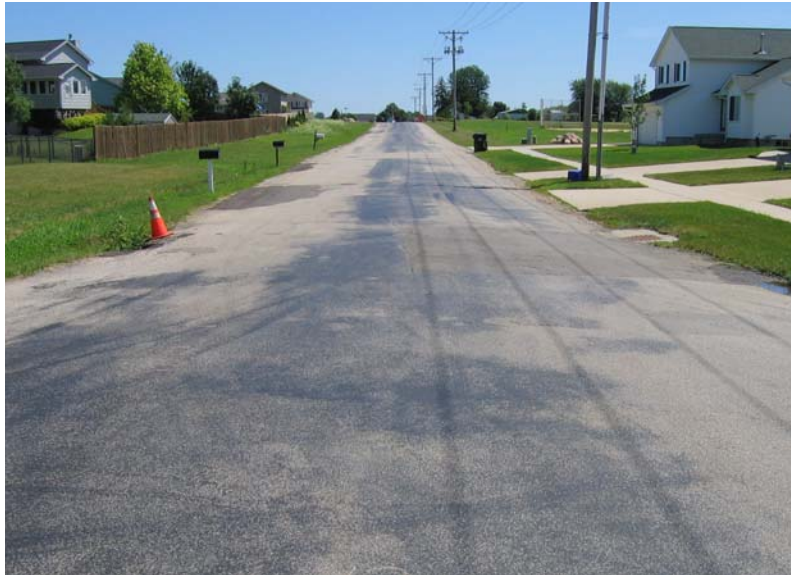
Figure 8. 74th Street (dark areas are bleeding)

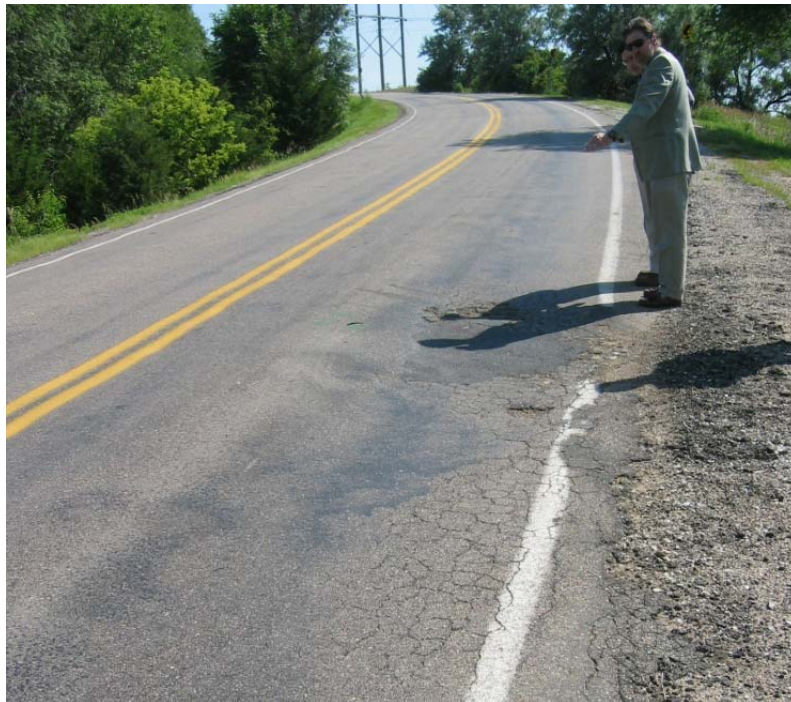
Figure 13. College Road alligator cracking, potholes, and bleeding

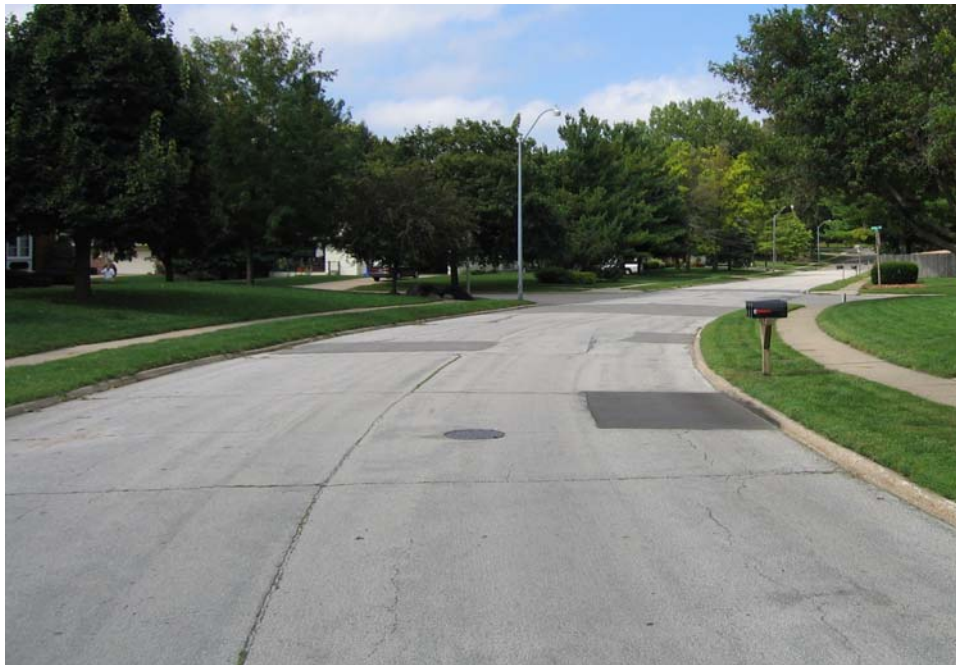
Aspen Drive is a residential street located in north-central West Des Moines (see Figure 15 and Figure 16). Before construction, Aspen Drive was a Portland concrete cement (PCC) pavement with an asphalt concrete cement (ACC) overlay of unknown thickness. The street has concrete curbs, gutters, and storm sewers which provide excellent drainage. The major distresses previous to construction were low- to medium-severity reflective cracking and L&T cracking (see Figure 17). Many of the reflective cracks had been sealed in 1991. The test section is located in a subdivision and, based on previous experience, city officials estimated an ADT of approximately 500. The PCI of the test section was 49. Citizen complaints about aesthetics were the main reason that a new surface was desired.

Figure 17. Aspen Drive before construction

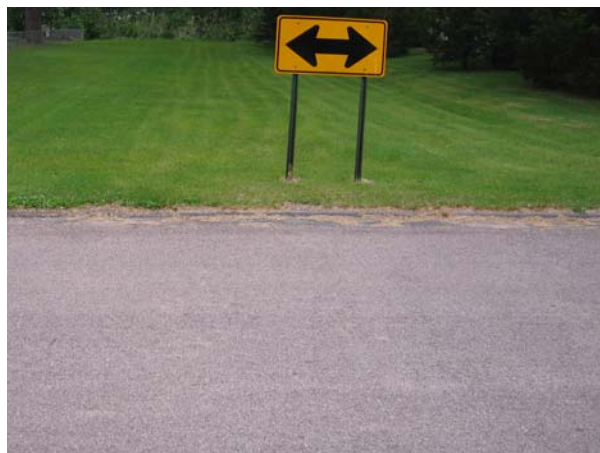
There were a few concerns with the chipmat: (1) it would not prevent reflective cracking, (2) it would not bond well to the existing seal coat, and (3) there would be noticeable bleeding over the chipmat. Inspection after the first winter indicated no such distresses had developed. The city engineer, very pleased with the chipmat, is considering the possibility of using it again in the future.

Figure 24. No reflected alligator cracking (chipmat)

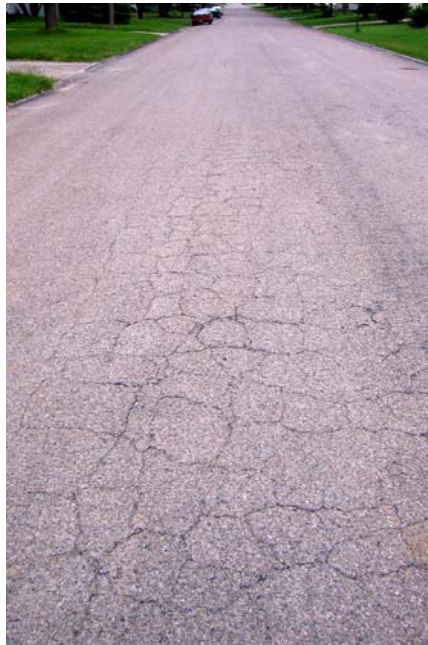
Figure 25. Reflected alligator cracking (no chipmat)

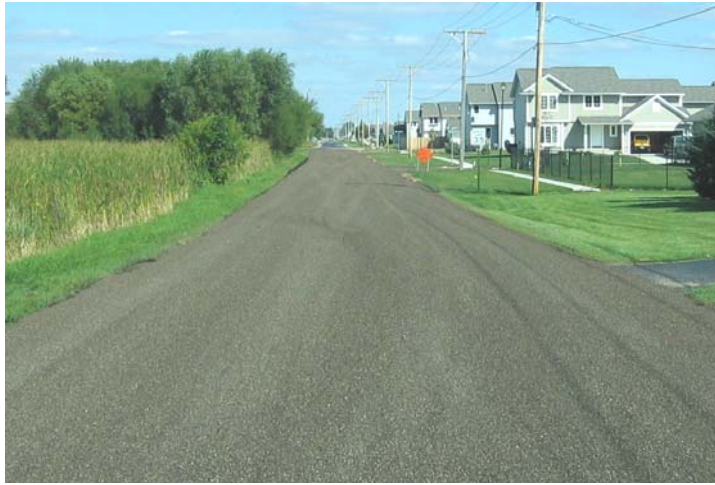
The section of seal coat that performed the best was the Section I (see Figure 28) with the 3/8-inch pre-coated aggregate. This section yielded a PCI of 81 (very good). Other than slight raveling, the seal coat was performing with no visible distress. The seal coat lost many PCI points because of rutting and other distresses that existed before construction of the new seal coat. Because a seal coat does not add any structure to a pavement, a seal coat does not address structural distresses. It is interesting to note that Section I included the 1000-foot section of the pre-coated aggregate that was not rolled until the day after the aggregate was applied. This is an indication that the emulsion and the pre-coated chips bonded to one another and is evidence of the robustness of the pre-coated chip and high-float emulsion combination.

Figure 28. 74th Street pre-coated chips

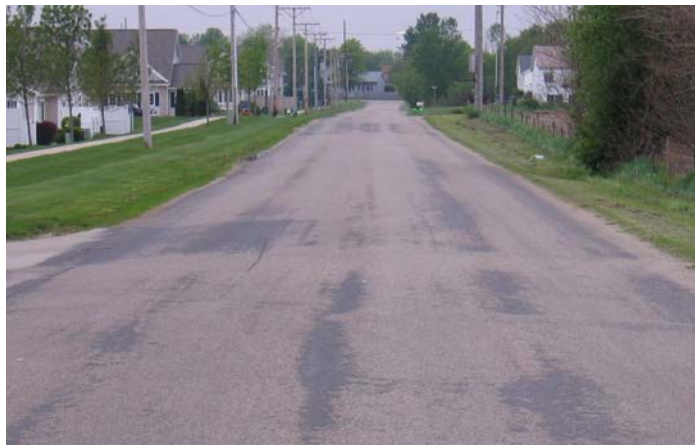
The 3/8-inch washed limestone chip section (see Figure 29) did not perform particularly well; its PCI rating was 63 (good). The relatively low PCI was caused by the large amounts of high-severity raveling. Other minor distresses included dips and low-severity rutting which were pre-existing. A large area of the seal coat was heavily raveled due to snowplow damage. The raveling problem might be attributed to poor bonding, caused by the dustiness of the aggregate that was used and the lack of the compaction by the pneumatic tire roller. The aggregate had been placed for three to four hours before the roller seated it. It is possible that the raveling may have been less severe had a roller been used immediately after placement, because much of the raveling was outside the wheel paths. (This is because the chips in the wheel path were seated in the emulsion by the passing traffic.) The city engineer also mentioned that this portion of the test section created large amounts of dust for several days after construction, which caused numerous citizen complaints. The city attempted to reduce the dust by washing the section with a water truck, but this effort resulted in limited success.

Figure 29. 74th Street washed limestone chip

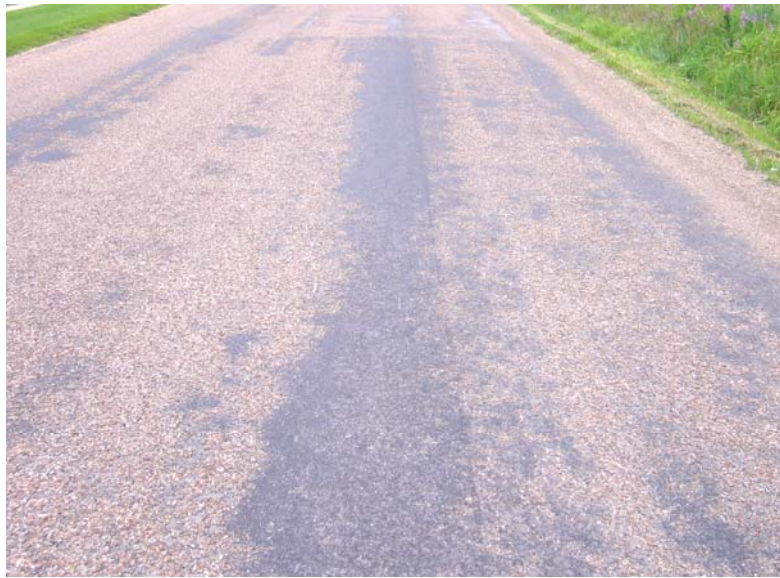
The 3/8-inch pea rock test section (see Figure 30) had more raveling problems in comparison to the test sections that used pre-coated limestone aggregate for the top course. The PCI rating for the 3/8-inch pea rock test section was 66, which is in the performance category of “good.” Most of the distress deducts resulted from large amounts of high-severity raveling. Other minor distresses included dips and low-severity rutting which pre-existed construction. This section was similar to the washed limestone chip section, in that there was considerable medium- to high-severity raveling. Again, the raveling in this section may have been caused by dirty aggregate and a lack of rolling by the pneumatic tire roller. Figure 31 shows how much fine material was on the chips, evidenced by the dusty residue left on a hand after handling the aggregate. This section was also the target of complaints by neighboring property owners regarding excessive dust generation.

Figure 30. 74th Street pea rock

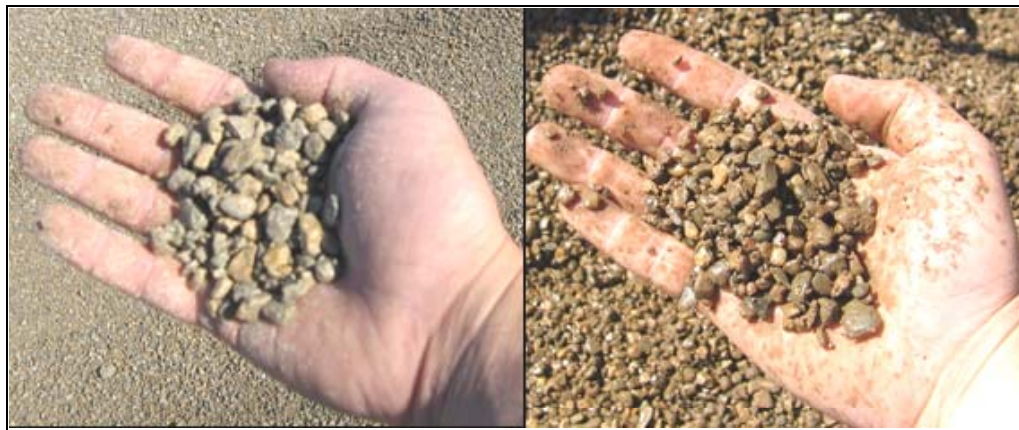
Figure 31. Dusty washed limestone and dirty pea rock chips

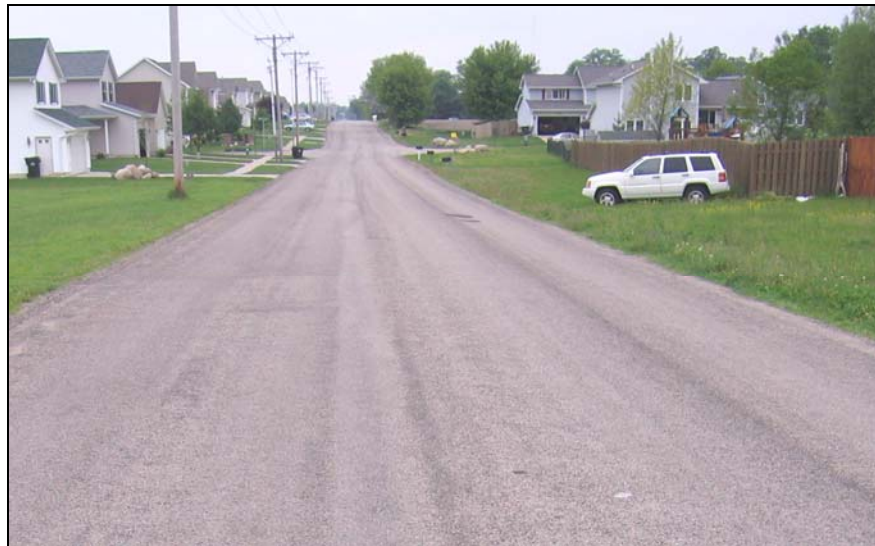
The double seal coat section—1/2-inch washed limestone chip base with a 3/8-inch pre-coated limestone chip—performed quite well, with an “excellent” PCI rating of 95 (see Figure 32). This section experienced only slight bleeding and other distresses that were present before construction, which cannot be addressed by seal coating. There was one area with medium-severity alligator cracking and rutting; however, these distresses were not included in the survey because they were outside the sample boundaries. The lack of raveling can be attributed to the fact that this test section was rolled by the pneumatic tire roller immediately after the application of both layers of chips. There were concerns that this section would have issues with bleeding; however, as of May 16, 2005, there was no bleeding on this section.

Figure 32. 74th Street double seal coat

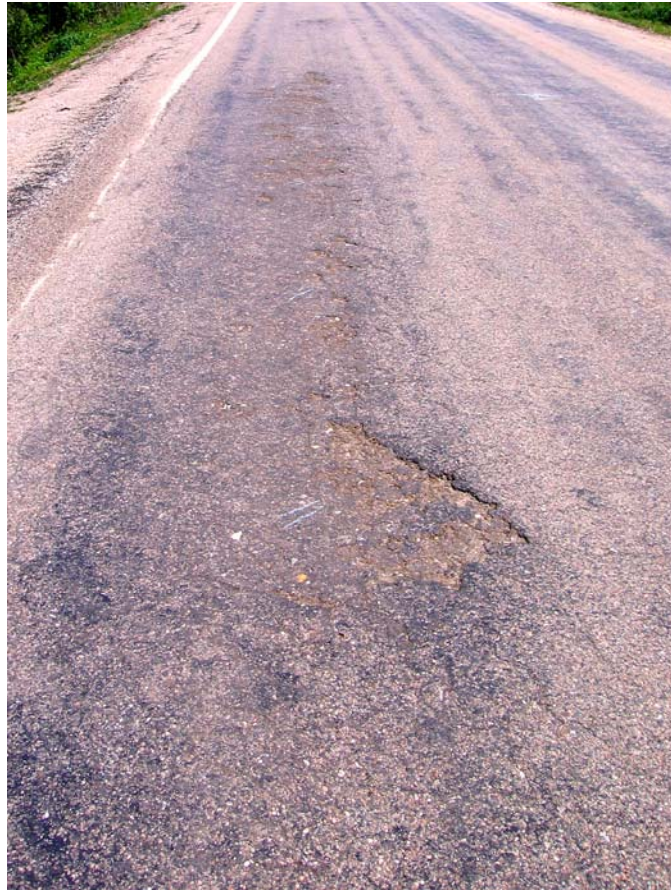
The distresses in the new seal coat were similar to that of the pre-construction condition (see Figure 34). Low- to high-severity rutting, alligator cracking, bleeding, and potholes had developed. When researchers compared a photo log of the test section before construction to the condition of the test section after construction, it was determined that the distresses in the new seal coat were located in the same regions as those of the original seal coat even though the entire road was re-stabilized. As with the original seal coat, the majority of the distresses were located in the outer lane, especially in the outer wheel path. The area adjacent to the entrance of the construction site had failed due to the heavy truck traffic. High-severity rutting, alligator cracking, bleeding, and raveling were the most prominent distresses near the entrance. Interestingly, the areas that were in excellent condition before construction were the same areas that were in good condition for the post-construction survey.

Figure 34. College Road alligator cracking

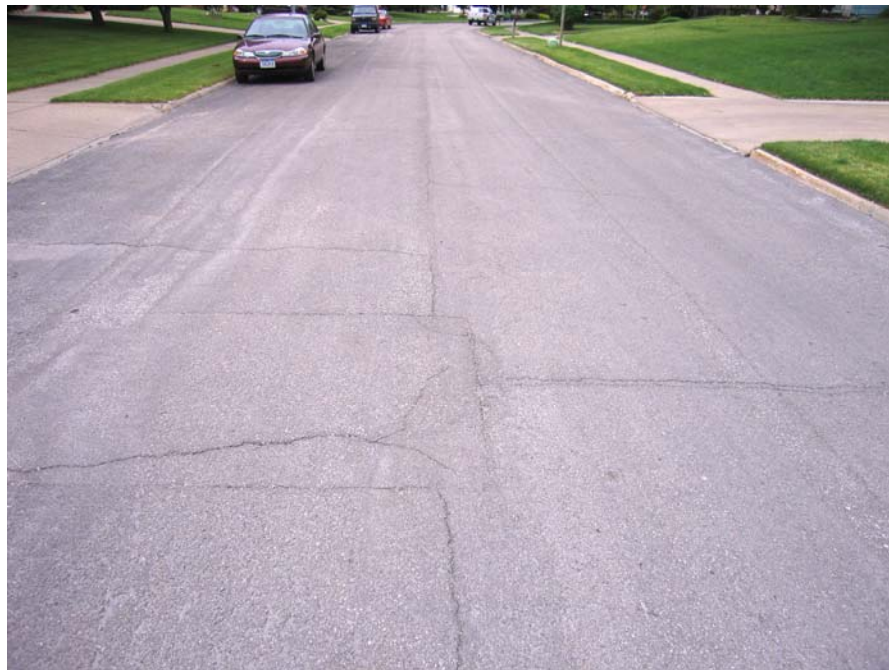
Figure 38. Reflective cracking on Aspen Drive

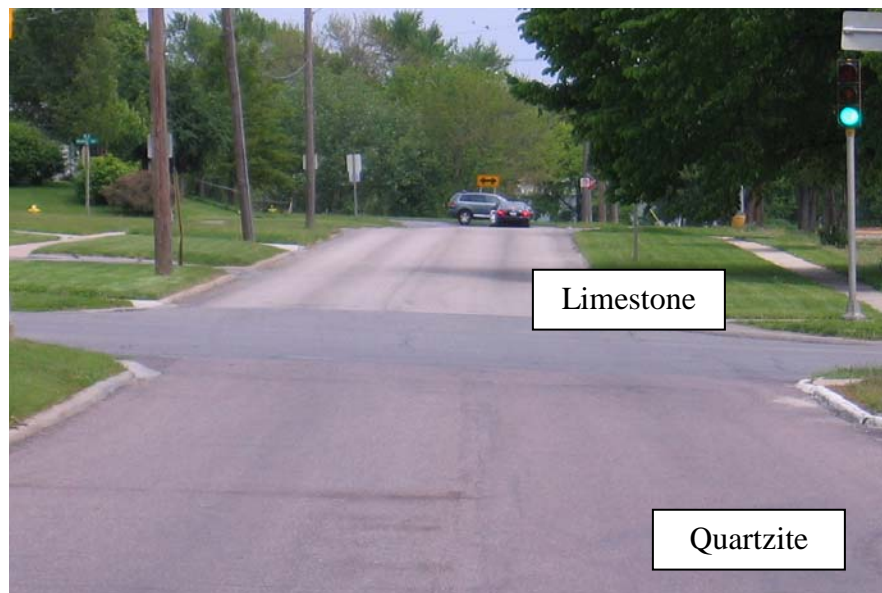
Both types of aggregate—quartzite and limestone—were used for both streets, and there was no noticeable difference in performance. The two mixes of micro-surfacing using different aggregates are experiencing the same types and amounts of distresses. The sections of micro-surfacing with limestone aggregate seemed to have a tighter surface texture because there were a higher proportion of fines in the limestone gradation. Figure 41 shows the color of the limestone aggregate in comparison to the quartzite aggregate, which has a pink color.

Figure 41. Micro-surfacing on Fourth Street

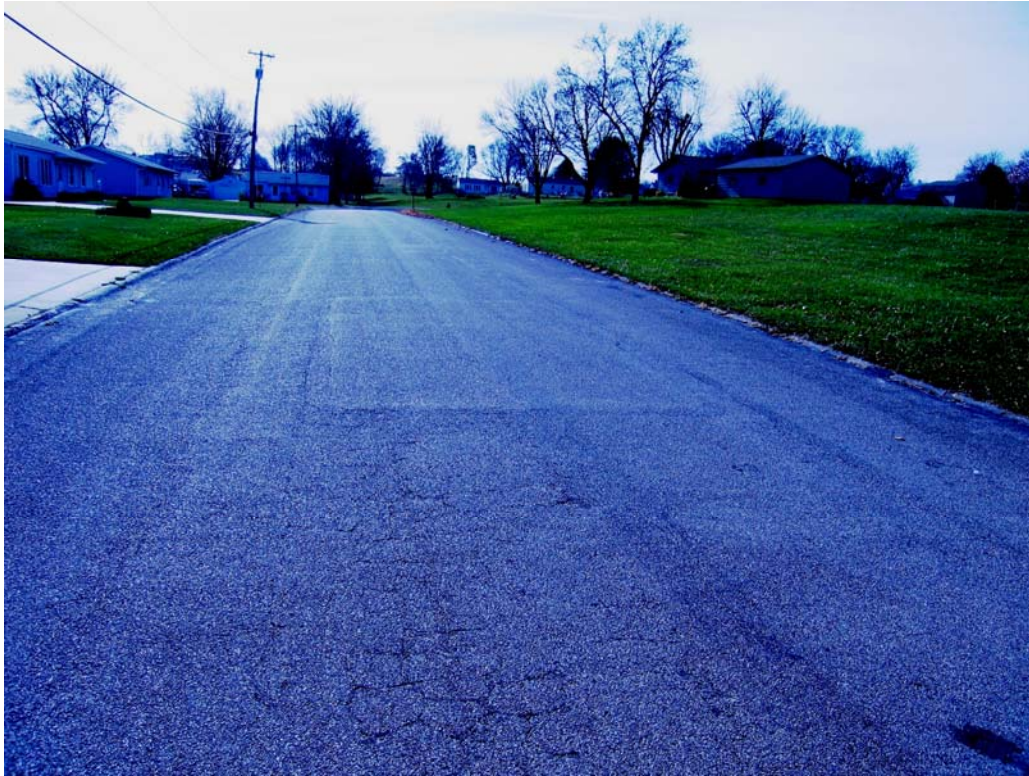
The PCI of Vermont Avenue in November of 2005 was 83, unchanged from that of May 2005. Figure F.1 summarizes how the PCI changed over the pre- through post-construction cycle. As the November 2005 survey was being conducted, the researchers noted the locations of the chipmat repairs and noted that alligator cracking had not yet reflected through in these locations. In contrast, the May 2005 survey had indicated that alligator cracks had reflected through in locations where chipmat was not applied (Figure F.2).

Figure F.2. Vermont Avenue in November 2005 (digitally enhanced photo)

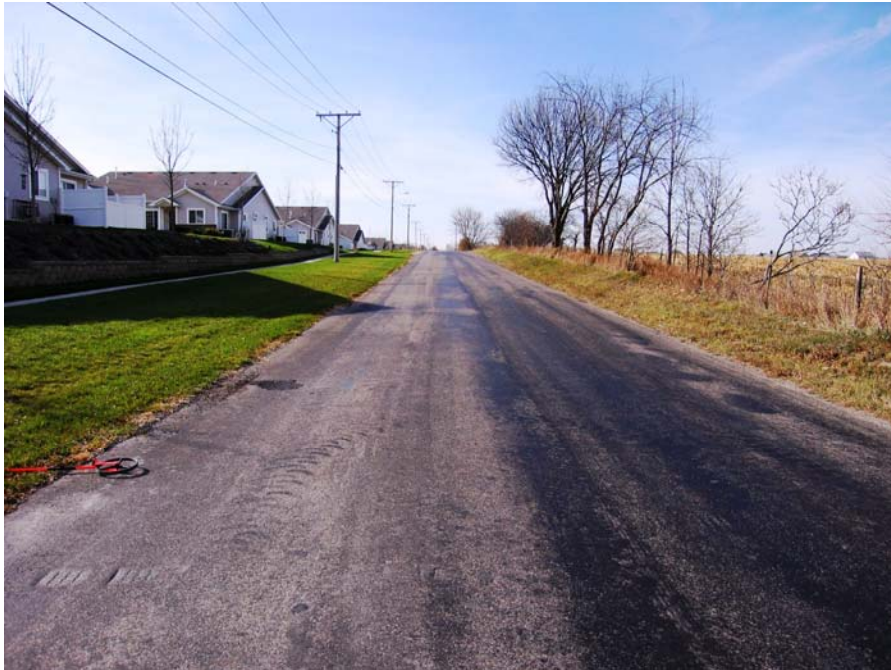
The washed limestone and pre-coated pea rock had the lowest PCIs (61 and 68, respectively), while the single pre-coated limestone and the double seal coat had the highest (76 and 75 respectively). Figure F.3 summarizes how the PCIs changed over the pre- through post-construction cycle, while Figures F.4 through F.7 provide representative images of each of the sections. In comparing these sections, the effects that rutting had on the PCI calculation were not included. This is because a seal coat is not intended to improve road performance with regard to rutting and because there were noticeable differences in the amount of rutting from one road section to another, which would have made comparisons difficult.

Figure F.5. Typical view of washed limestone on 74th Street (digitally enhanced photo)

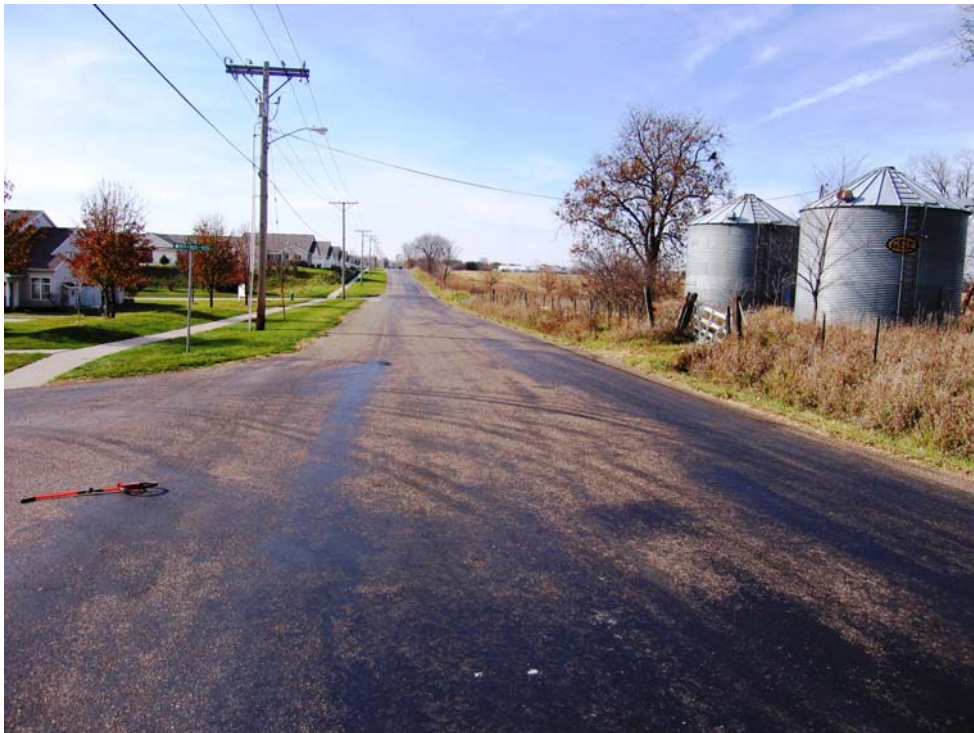
Figure F.6. Typical view of pre-coated pea rock on 74th Street (digitally enhanced photo)
