Rehabilitation of Concrete Pavements Utilizing Rubblization and Crack-and-Seat Methods: Phase II - Performance Evaluation of Rubblized Pavements in Iowa

National Concrete Pavement
Technology Center

Final Report
April 2008

Sponsored by
the Iowa Highway Research Board (IHRB Project TR-550)

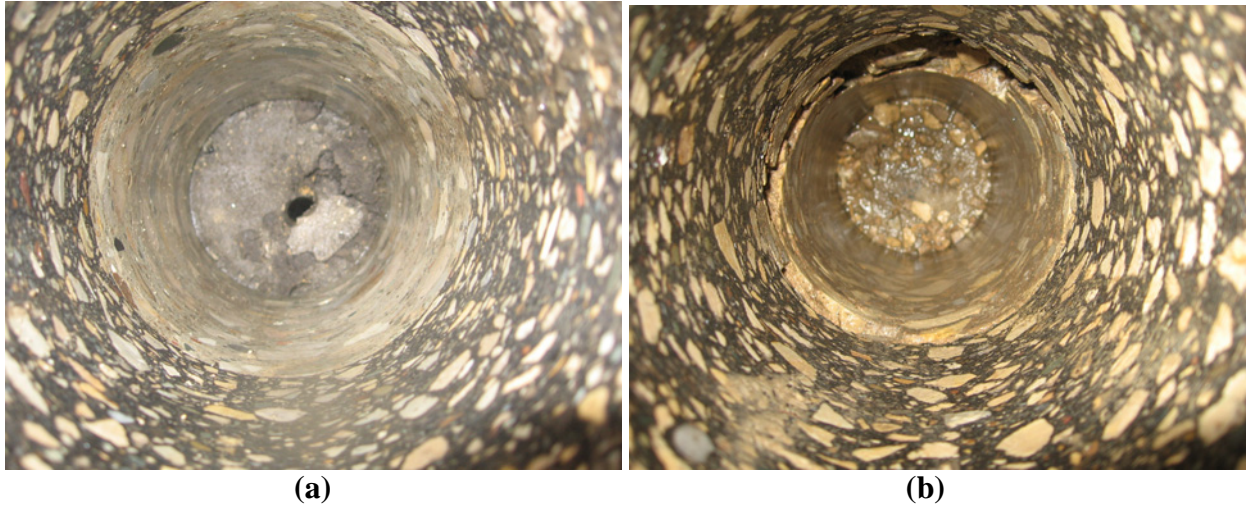
Figure 7. Layer condition underneath HMA after coring; (a) PCC layer without rubblization (IA-139 in Winneshiek County), (b) Rubblized PCC layer (IA-3 in Delaware County)

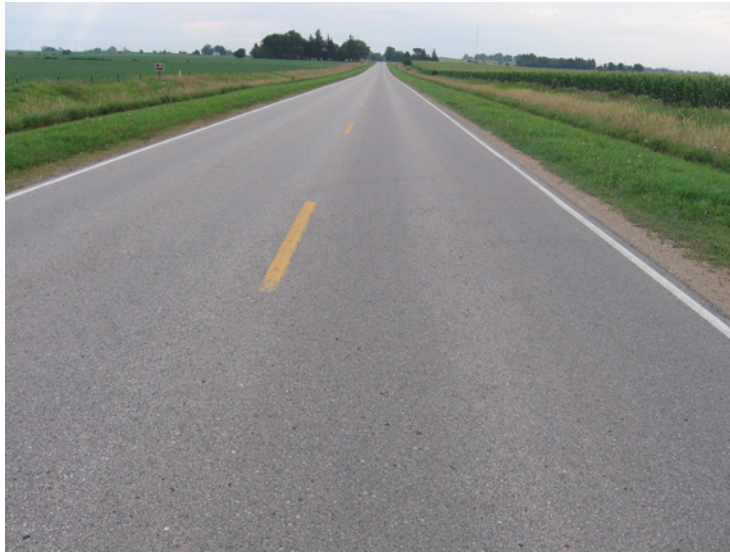
Figure 11. Picture of distress-free HMA surface on rubblized PCC (I.D. No. 12: C23 in Franklin County)

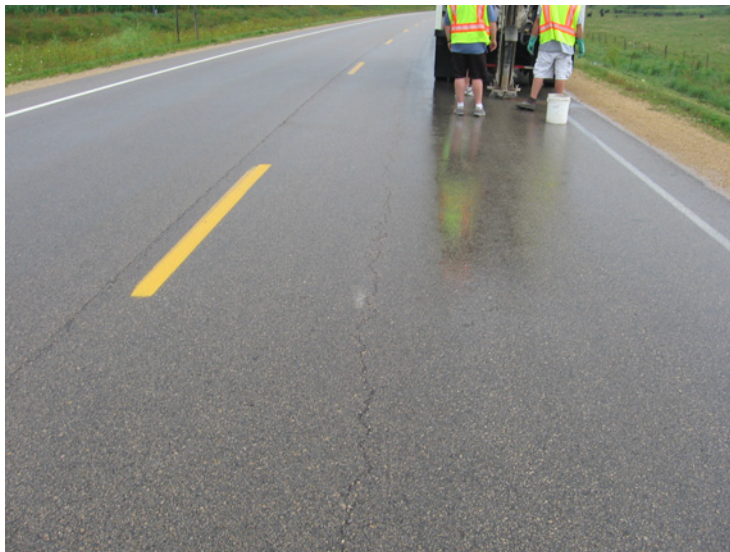
Figure 12. Picture of longitudinal cracking on HMA-overlaid rubblized PCC (I.D. No. 21: IA3 in Delaware County)

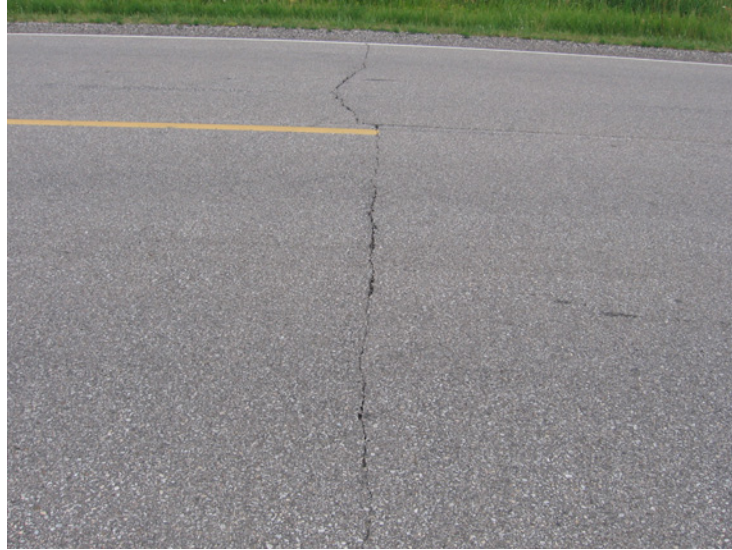
Figure 13. Picture of low-temperature cracking on HMA-overlaid rubblized PCC (I.D. No. 12: D16 in Blackhawk County)

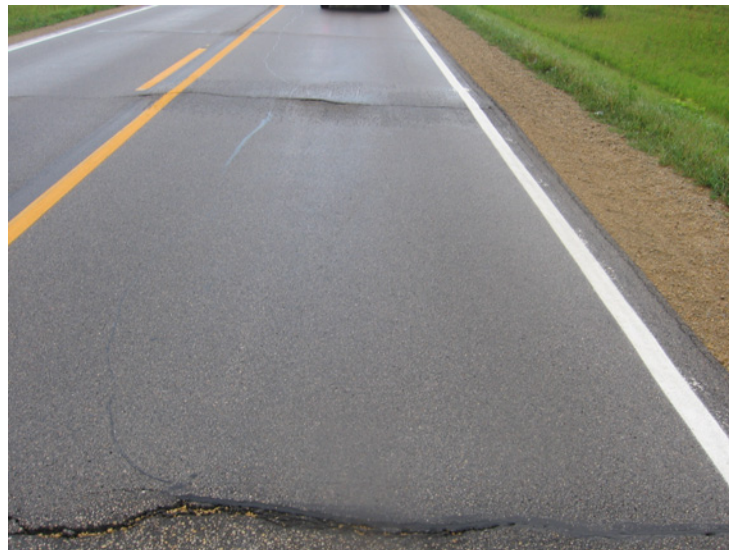
Figure 14. Picture of reflection cracking on HMA-overlaid PCC pavement (I.D. No. 47: IA139 in Winneshiek County)

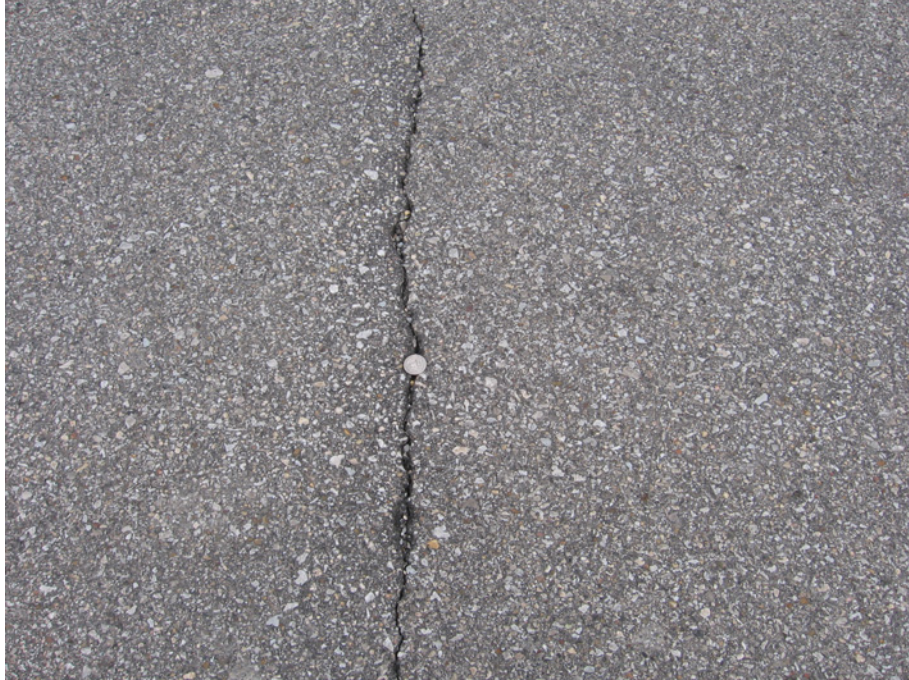
**Figure C.5. Low Temperature Crack on D16 in Black Hawk County, IA (I.D. No. 12):
Rubbblization**

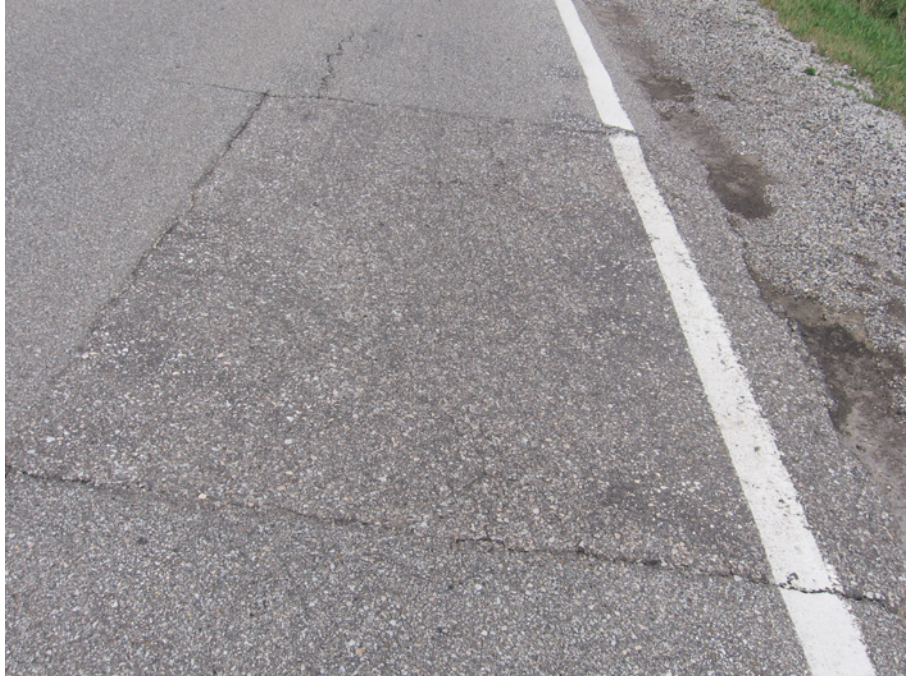
Figure C.10. Block Crack on V43 in Black Hawk County, IA (I.D. No. 13): Rubblization

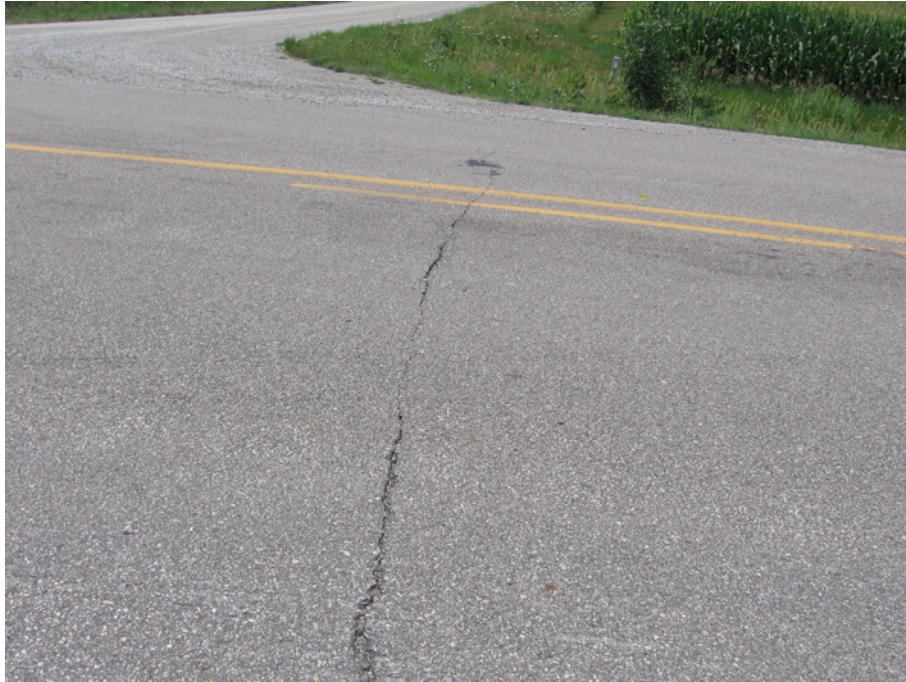
**Figure C.11. Low Temperature Crack on V43 in Black Hawk County, IA (I.D. No. 13):
Rubblelization**

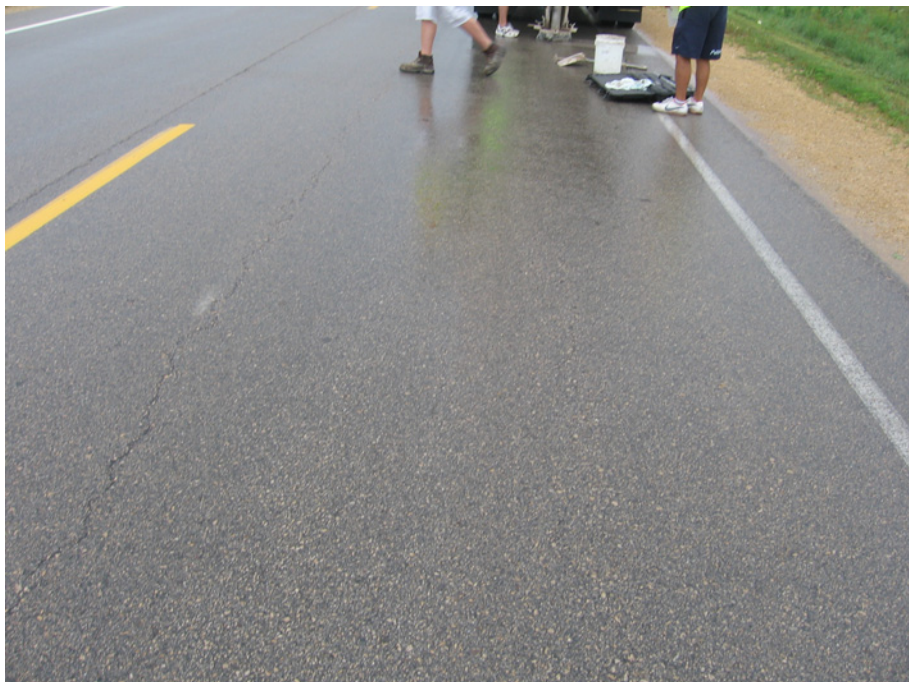
**Figure C.16. Longitudinal Crack on IA3 in Delaware County, IA (I.D. No. 21):
Rubblization**

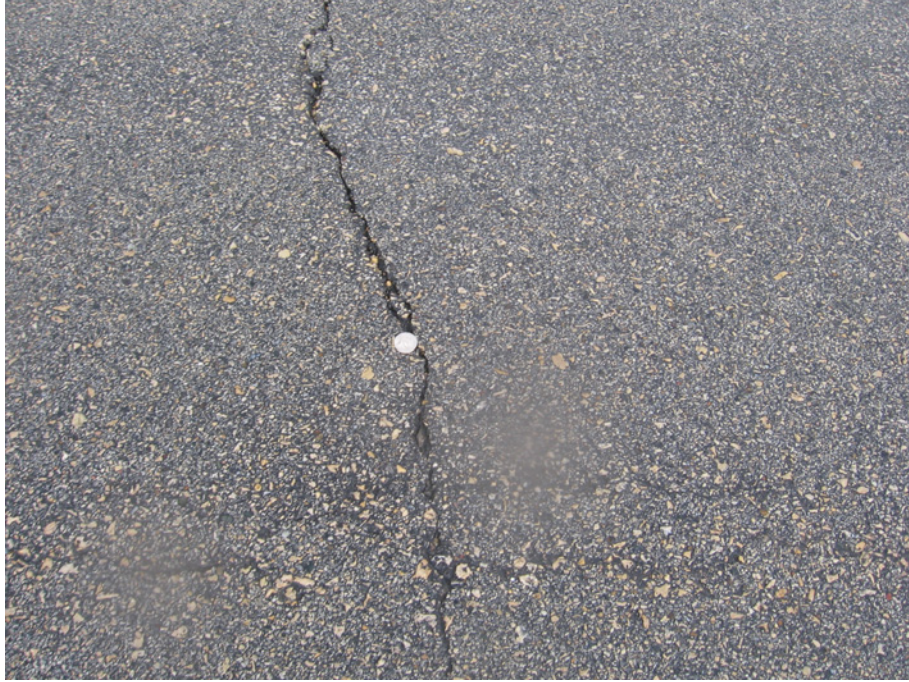
**Figure C.17. Low Temperature Crack on IA3 in Delaware County, IA (I.D. No. 21):
Rubbblization**

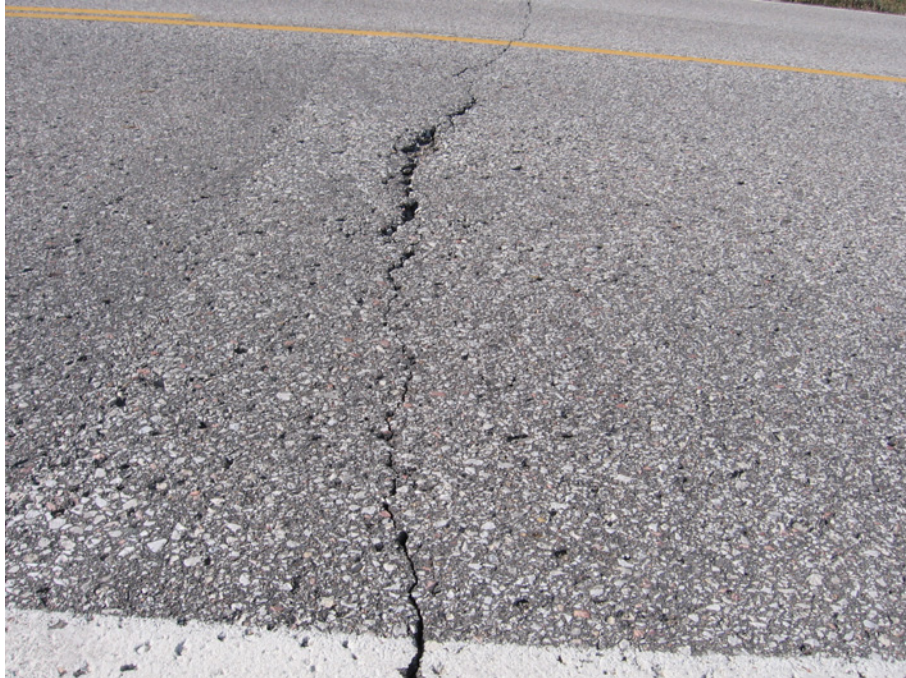
**Figure C.26. Low Temperature Crack on L55 in Mills County, IA (I.D. No. 32):
Rubblization**

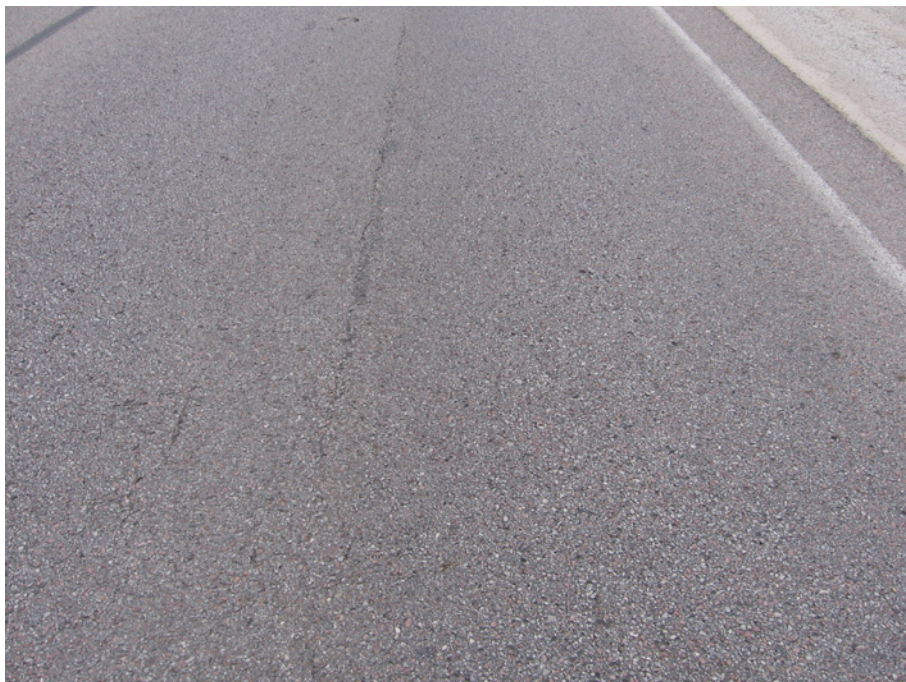
Figure C.30. Longitudinal Crack on IA141 in Polk County, IA (I.D. No. 33-1): Rubblization

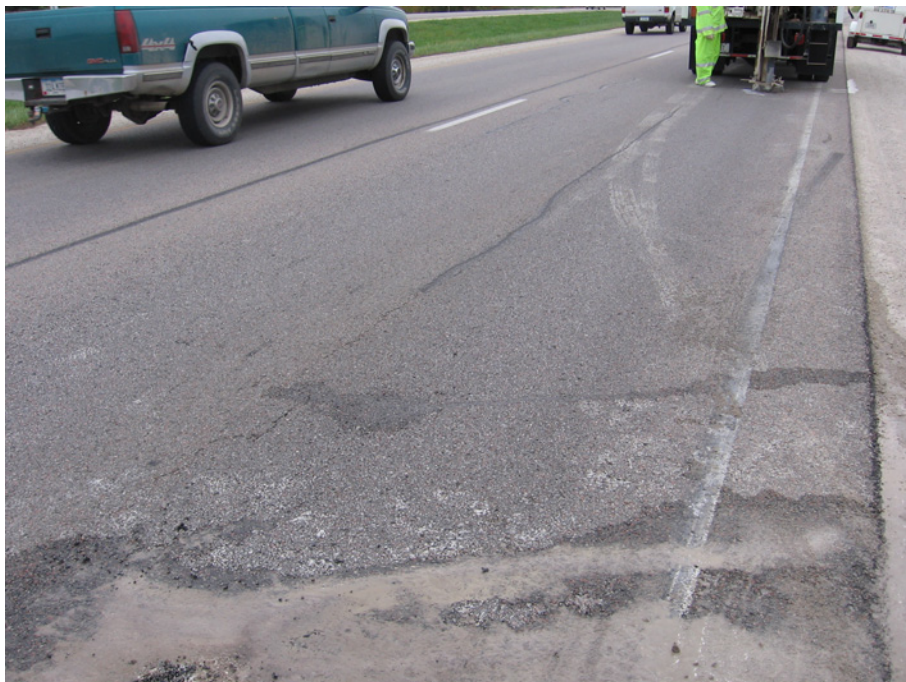
Figure C.34. Longitudinal Crack on IA141 in Polk County, IA (I.D. No. 33-2): Rubblization
