Investigation of Improved Utility Cut Repair Techniques to Reduce Settlement in Repaired Areas, Phase II

Final Report
December 2010

Sponsored by
Iowa Highway Research Board
(IHRB Project TR-566)
Iowa Department of Transportation
(InTrans Project 06-282)

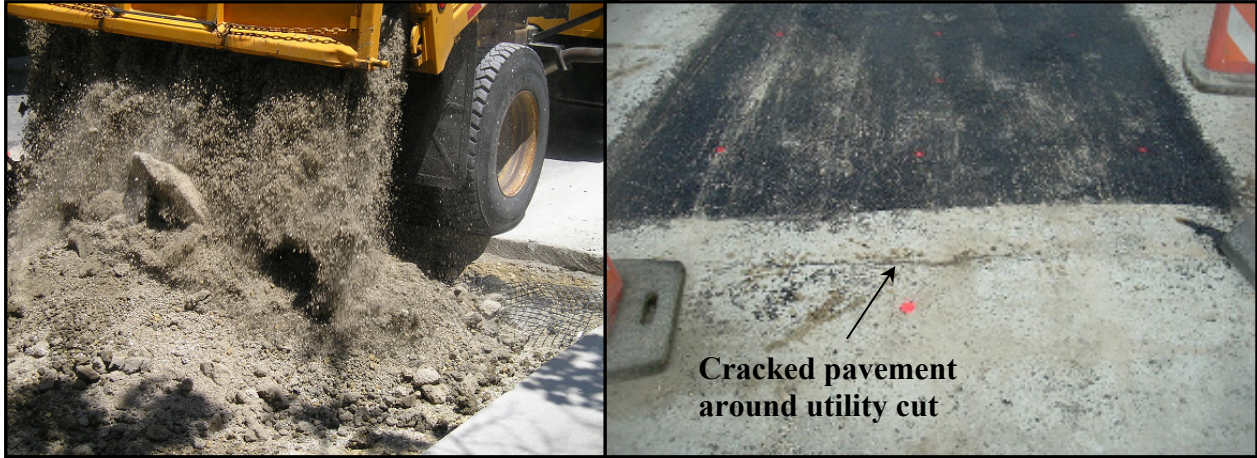
Figure 2.1. Cracking pavement surrounding the utility cut area because of construction equipment getting too close to the edge of open cut

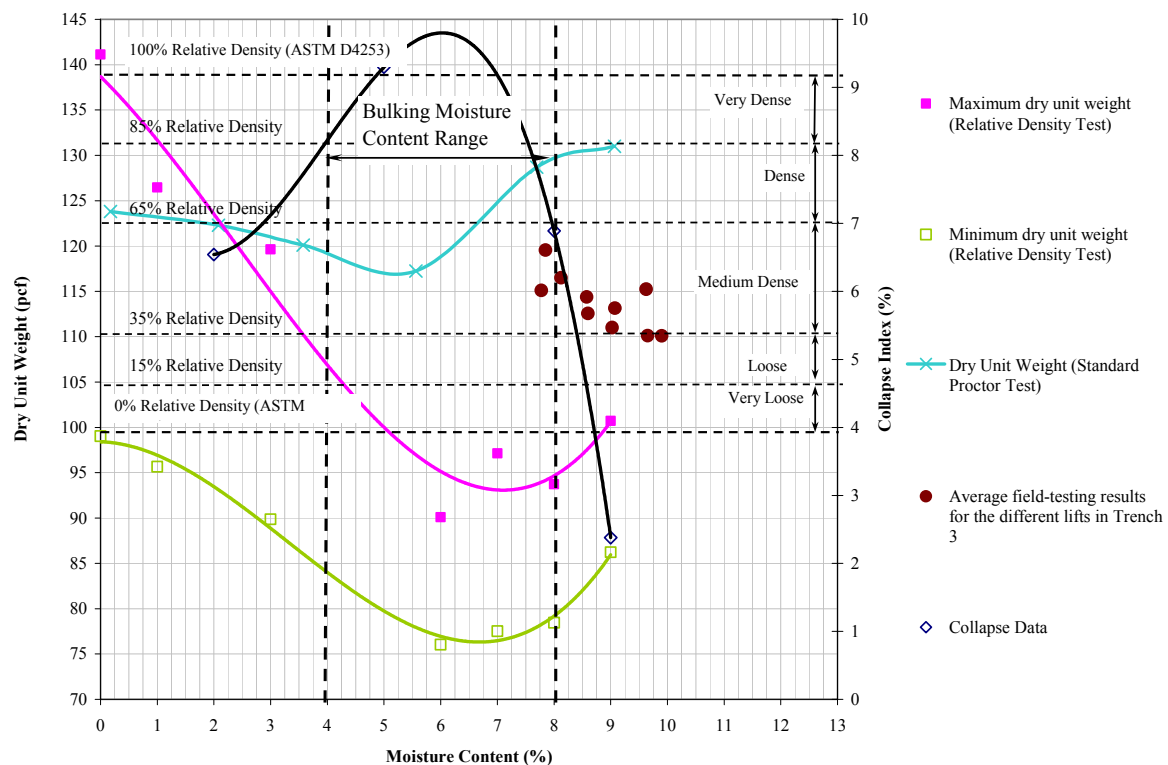
Figure 2.3. Measured densities compared with maximum and minimum densities, showing loose backfill material after compaction

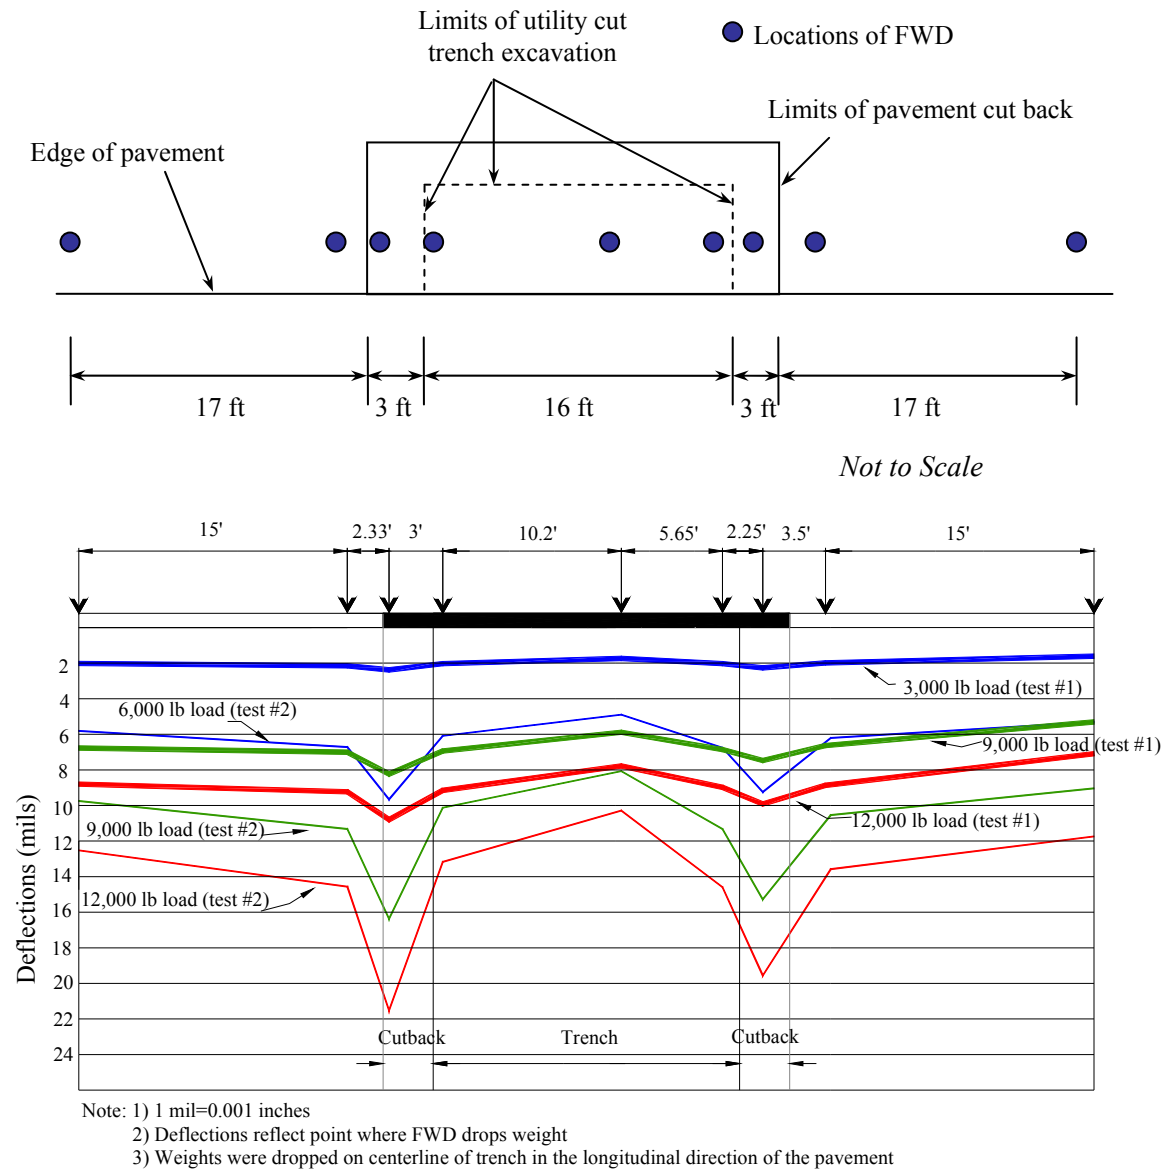
- Soil surrounding the utility cut weakened during excavation because of the loss of lateral support (affected region around trench known as the zone of influence—during Phase I, it was determined that the FWD tests can detect the weakened zones of soil; see Figure 2.4)

Figure 2.4. Locations and results of FWD tests performed at a utility cut location in Ames, Iowa, showing deflection within the zone of influence

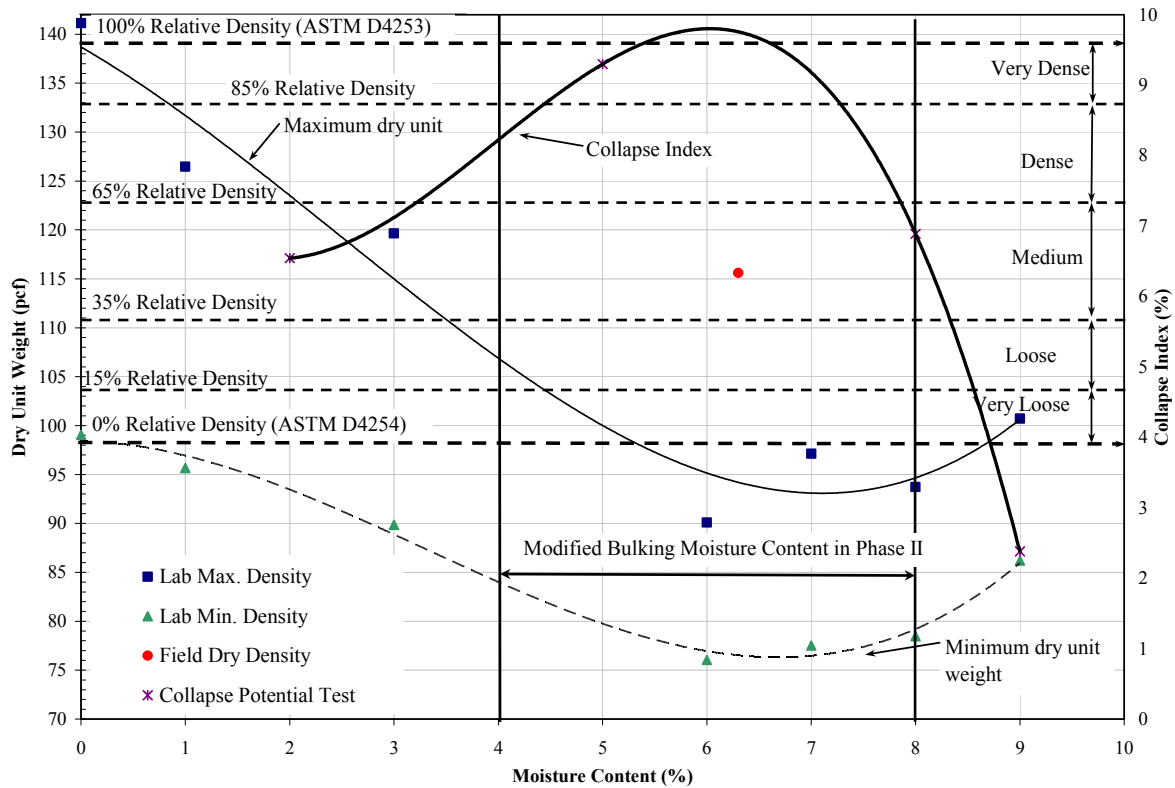
The CBR values from the Clegg Hammer ranged from 5.8% to 7.6%, with an average CBR value of 6.7%. The reported CBR values from the DCP test ranged from 3.7% to 17.4%, with an average CBR value of 11.3%. The CBR values from the DCP and Clegg Hammer tests were below the typical CBR values of 20% to 40% indicated by NAVFAC in Table 2.5.

Figure 3.3. Relative density and average field-testing results for the trench backfill material for the Ames site

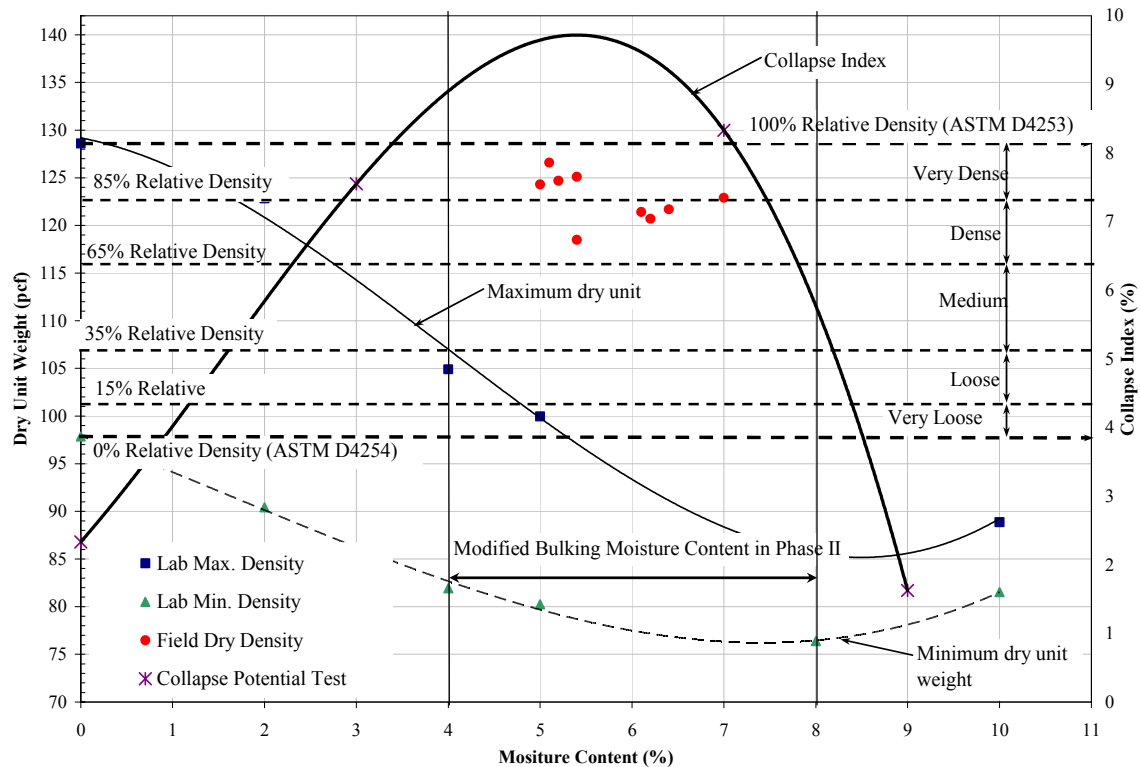
The CBR values obtained from the Clegg Hammer test ranged from 8.2% to 12.9%, with an average CBR value of 12.9%. The CBR values from the DCP tests ranged from 4.9% to 25.0%, with an average CBR value of 13.3%. These values were “just above to below the typical CBR values of 10% to 20%.” Complete CBR data is in Table 15 of the Phase I report.

Figure 3.12. Relative density and average field-testing results for the trench backfill material for the Cedar Rapids site

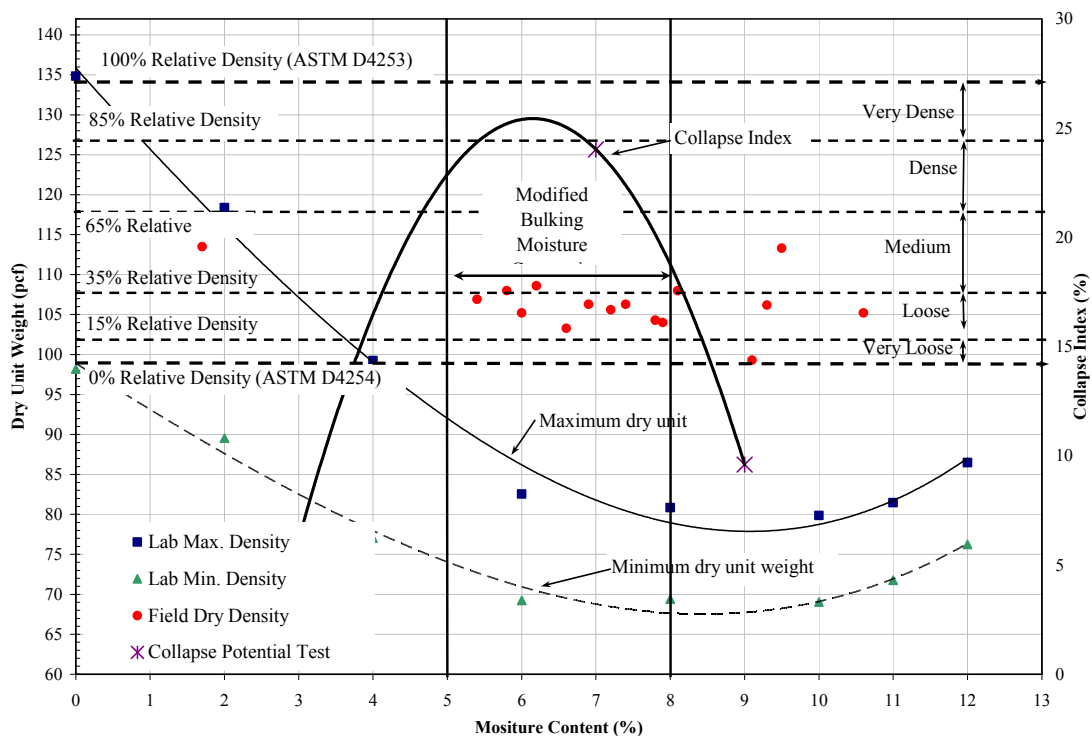
The CBR values from the Clegg Hammer ranged from 4.6% to 15.1%, with an average CBR value of 8.6%. The CBR values from the DCP test ranged from 2.7% to 34.9%, with an average CBR value of 12.5%. Complete CBR data is in Table 15 of the Phase I report.

Figure 3.22. Relative density and average field-testing results for the trench backfill material for the Des Moines site

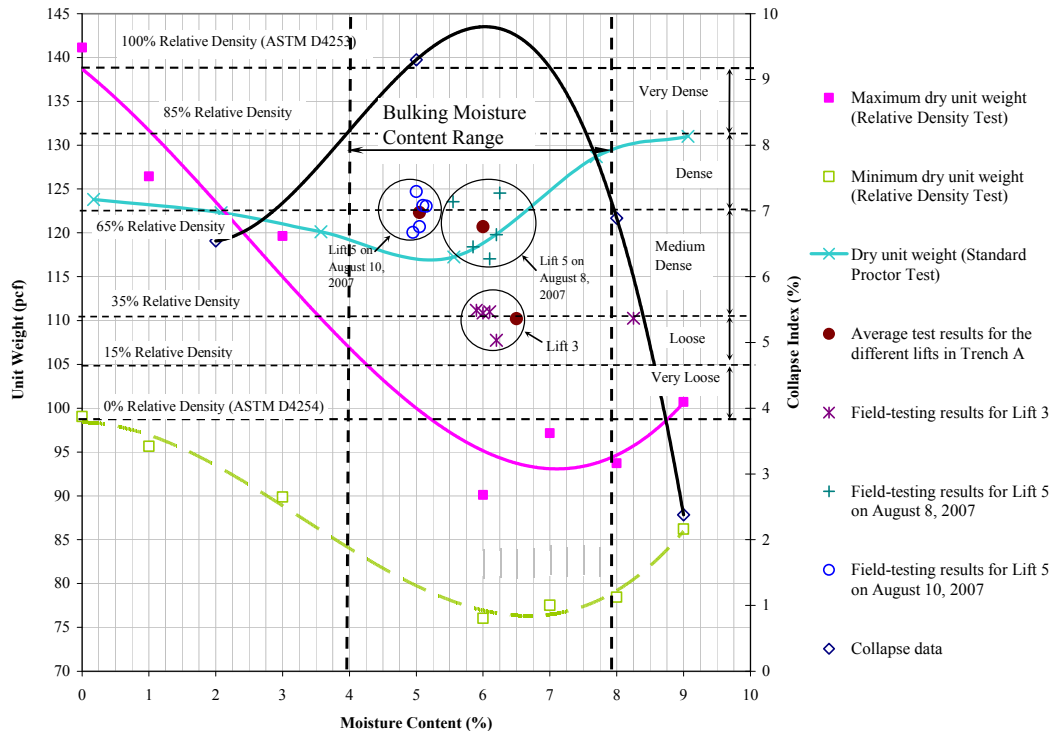
Figure 4.31 shows the results from the relative density laboratory testing compared with measured dry unit weight and moisture content using the nuclear density gauge. The figure also shows the collapse potential index for the 3/8-inch minus limestone. The figure clearly shows the backfill was placed at a relative density ranging from 27% to 69% with moisture contents ranging from 5.0% to 8.3%, which was within the bulking moisture content range. This shows the backfill was placed at average moisture content with the highest collapse potential. This increased the trench's susceptibility to settlement. The circles around each lift show on which lift the various test points occurred and that the moisture content and dry unit weights were similar within each lift. There is one outlier point; this point corresponded to test point 1 on lift 3.

Figure 4.31. Relative density test results for 3/8-inch minus limestone with field-testing results for Trench A

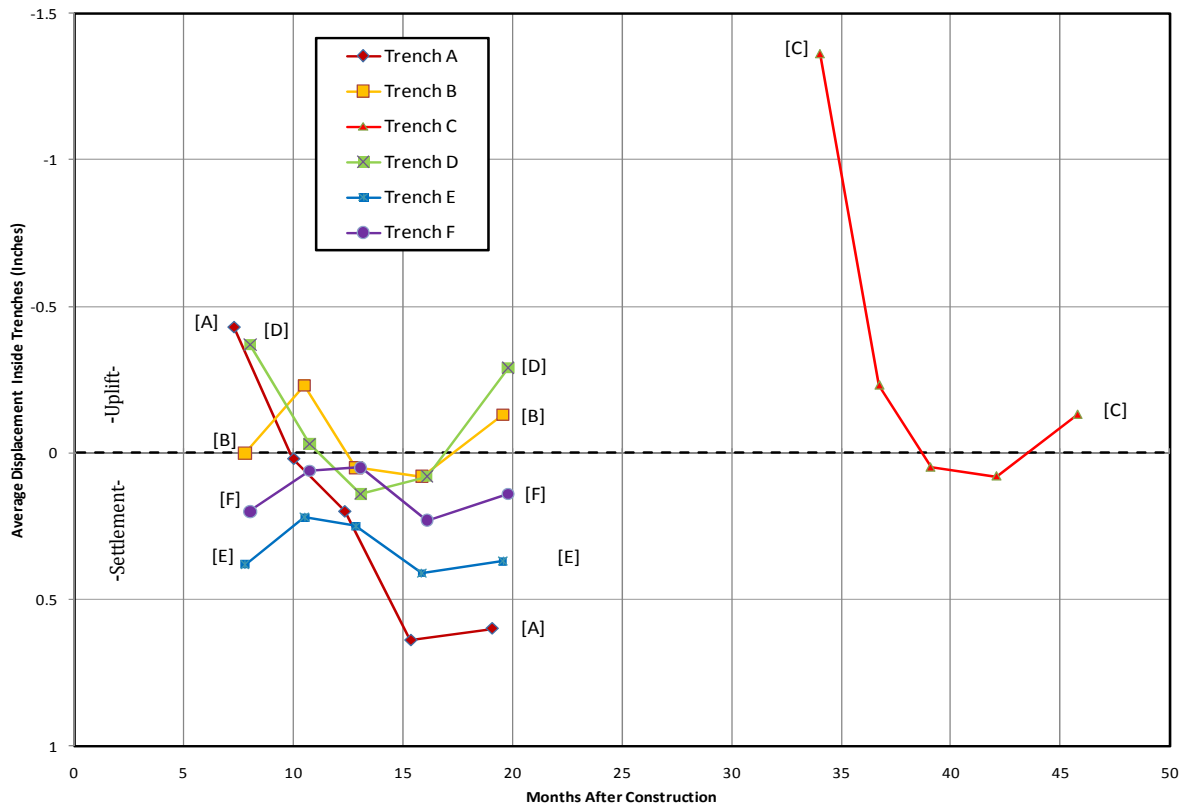
Figure 4.115. Settlement as a function of time for the six recommended trenches
