Stabilization Procedures to Mitigate Edge Rutting for Granular Shoulders – Phase II

Final Report
January 2011

Sponsored by
Iowa Highway Research Board
(IHRB Project TR-591)
Iowa Department of Transportation
(InTrans 08-319)

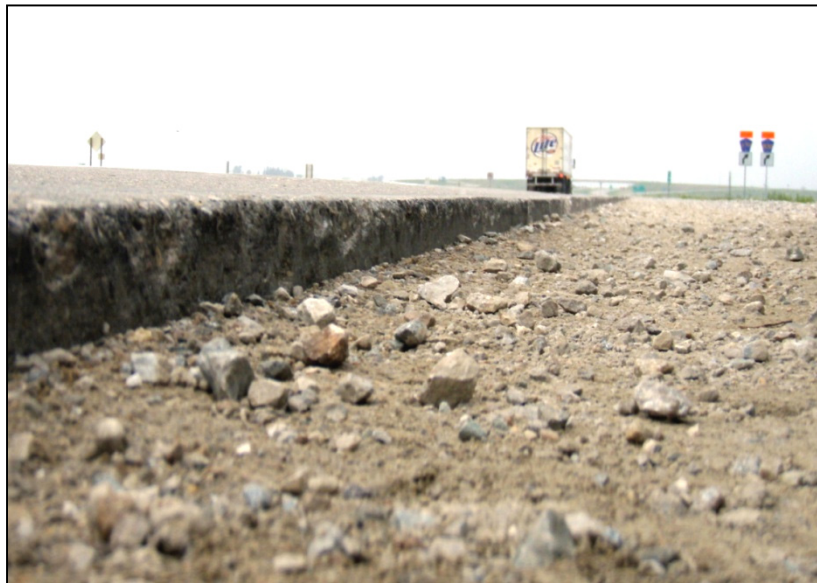
Figure 1. Shoulder drop-off near pavement edge Highway 18 milepost 195.95-196.2 westbound June 4, 2008

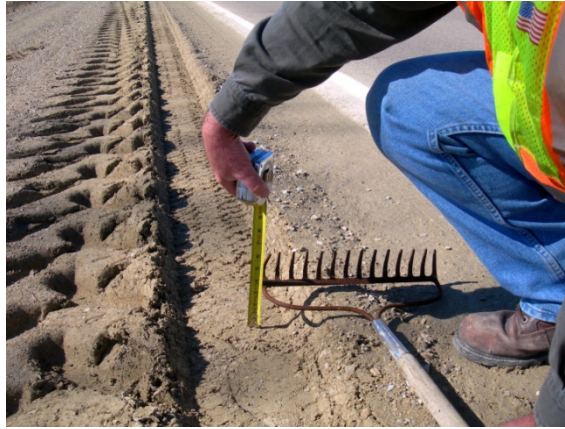
Immediately after construction, the full-depth reclaimed sections were sufficiently soft so that the rear tires of an unloaded 3/4-ton pickup truck sunk 3 to 4 in. into the shoulder surface (See Figure 16). The pull-behind compactor could not provide enough passes quickly enough, nor to the depth of compaction required, to stabilize the road surface. Because the truck could not back up with the compactor, it was necessary for the truck to take very long round trips from one exit to another on Highway 20 (with its controlled access design). Thus, few passes could be made in the available time.

Figure 16. Pickup truck tire rut that indicated the typically soft conditions one day after full-depth reclaiming

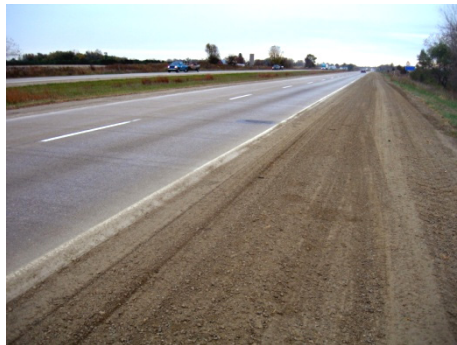
By the following week, much of the shoulder had stabilized, so it could support a 3/4 ton pickup truck (See Figure 17), but a few soft spots remained (See Figure 18).

Figure 17. Magnesium chloride full-depth after one week

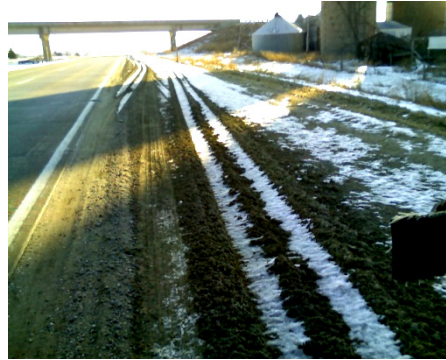
In February 2009 maintenance personnel notified the research team that some areas included in the test sections were experiencing heavy rutting during winter thaw periods. These areas were documented with photos. The locations were the full-depth reclamation areas for each of the stabilizing agents. In addition, Control Section 1 experienced some rutting (See Figure 20).

Figure 20. Rutting on Control Section 1 in February

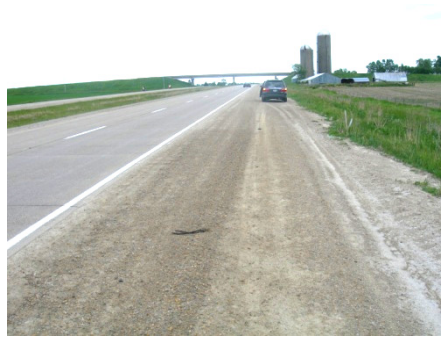
Figure 21. Mostly good calcium chloride full-depth 8 ft wide June 2009

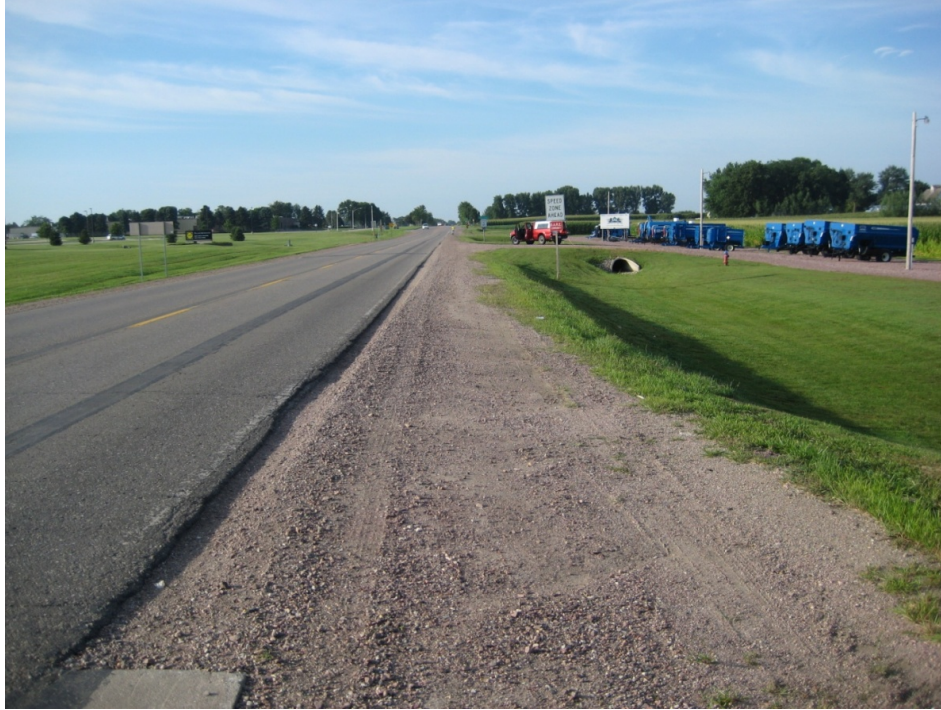
Figure 49. Shoulder condition at Test Area I before stabilization

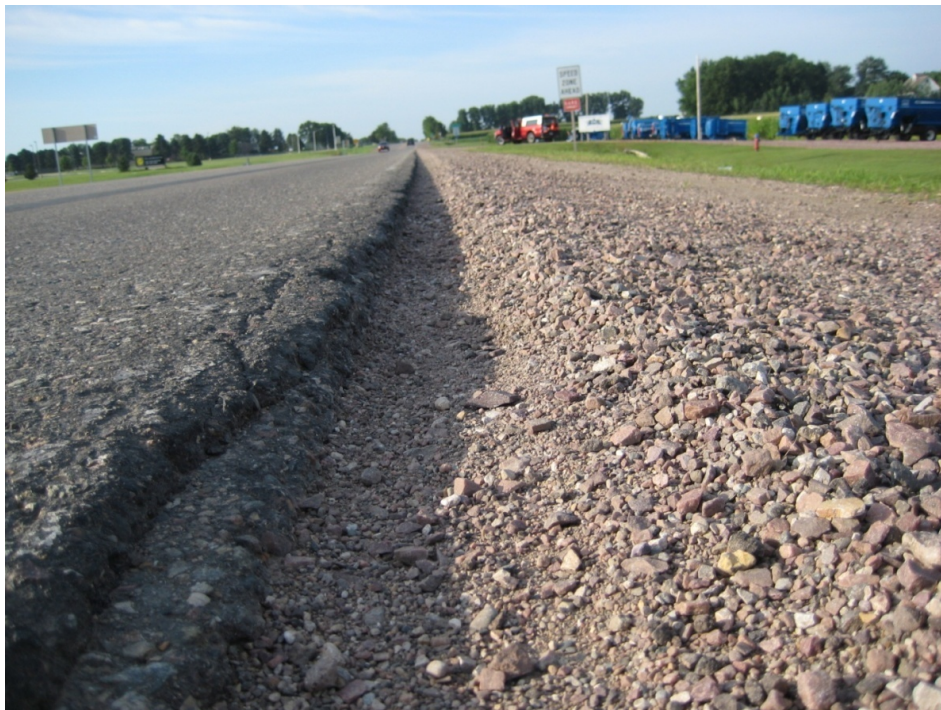
Figure 50. Shoulder rutting at Test Area I before stabilization July 28, 2009

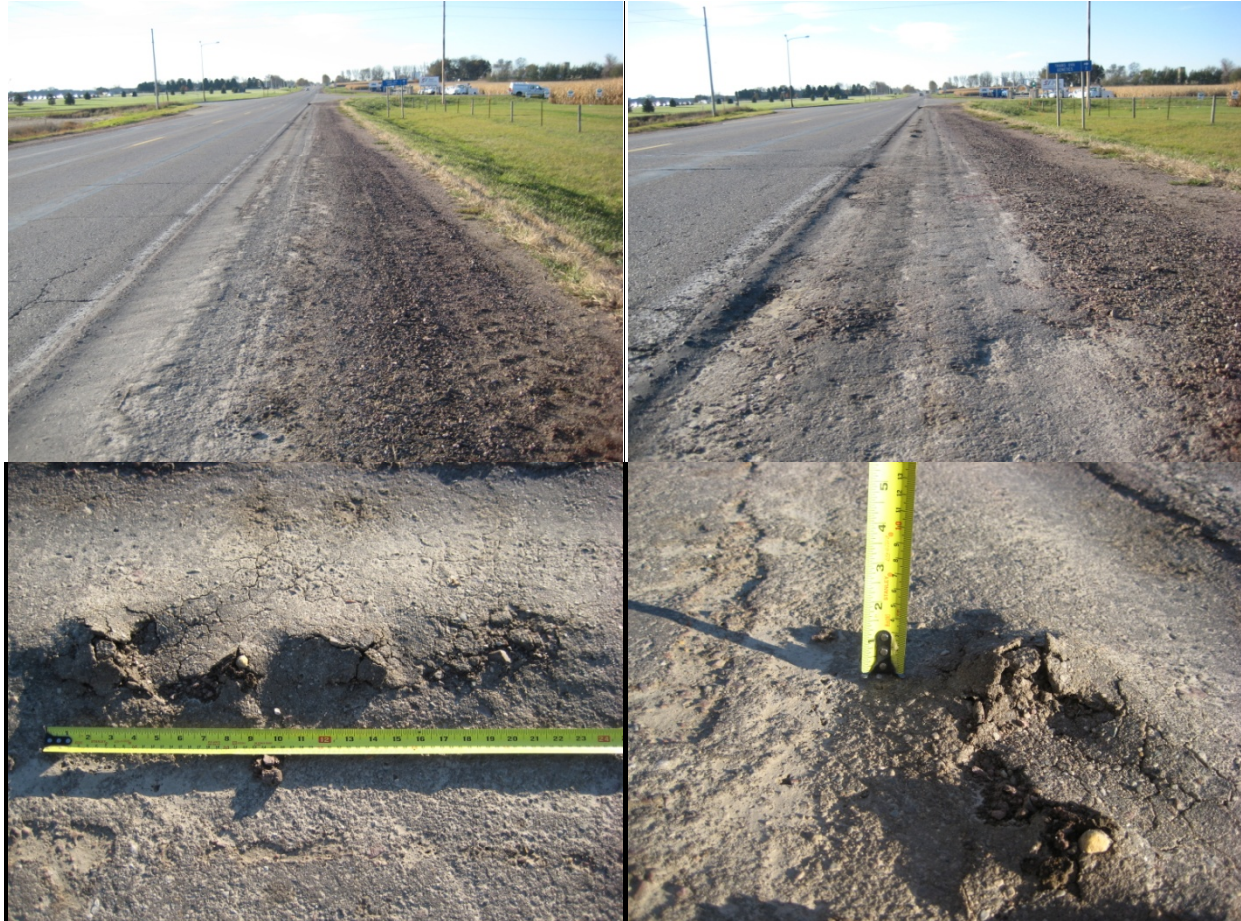
Figure 62. Stabilized shoulder surface October 27, 2009

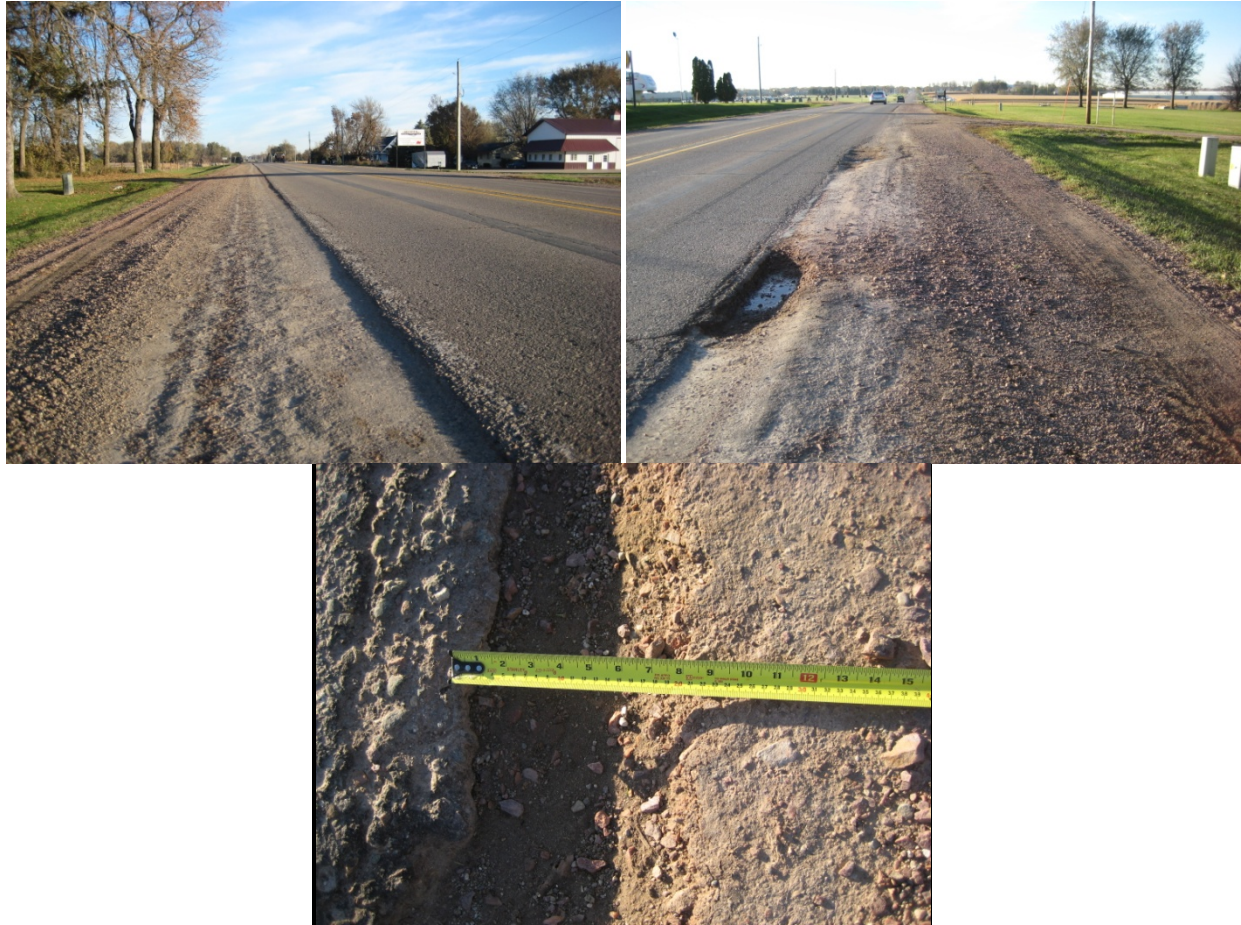
Figure 68. Shoulder condition of the Test Area III on the southbound shoulder of US 75 near Sioux Center, Iowa October 27, 2009

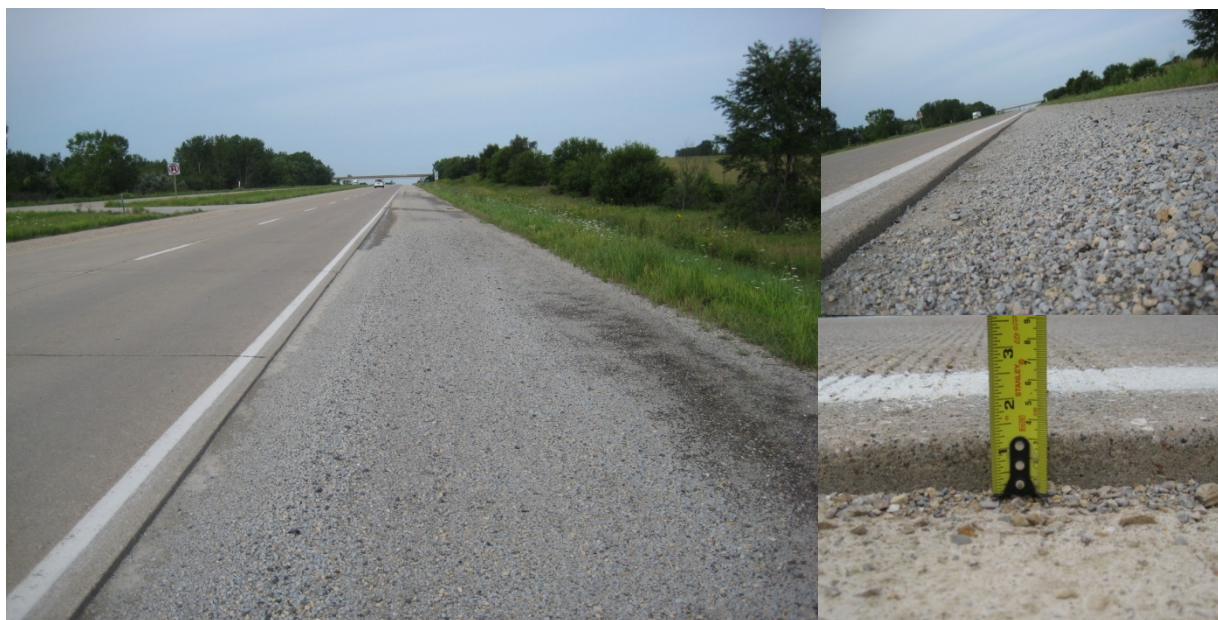
Figure 72. Shoulder conditions and edge ruts along the pavement slabs August 17, 2009

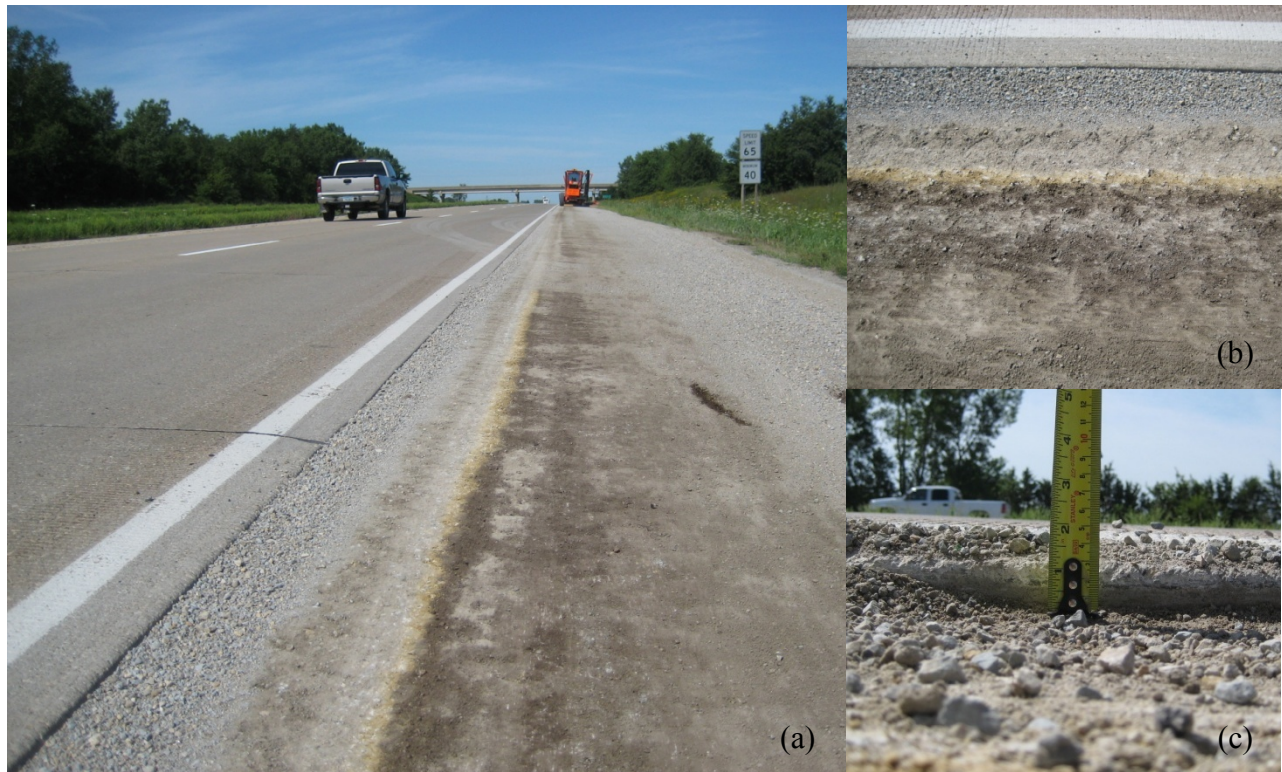
Figure 82. Section III: a) graded surface, b) side view of graded surface, and c) pavement edge drop off August 18, 2009

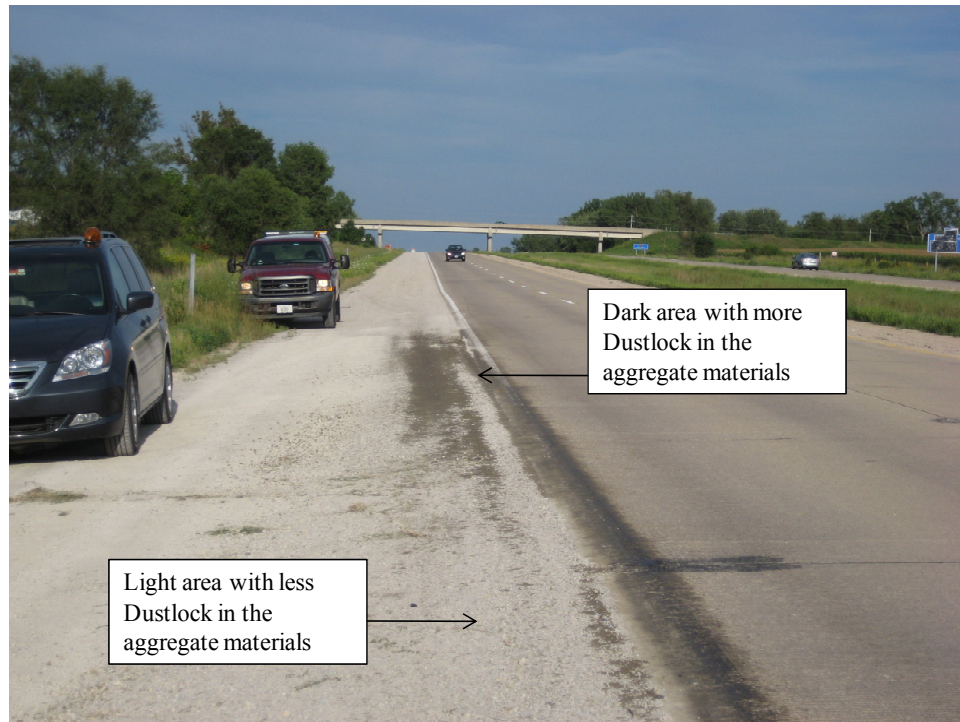
Figure 86. Uneven mixed of DUSTLOCK due to grading process in Section V August 18, 2009

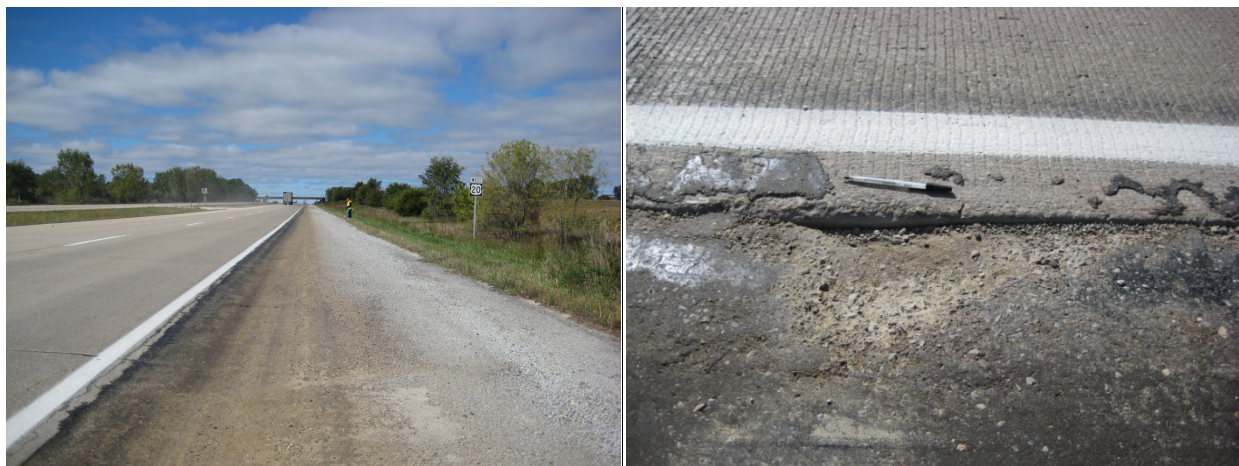
Figure 87. Stabilized shoulder using DUSTLOCK on US 20 westbound September 29, 2009

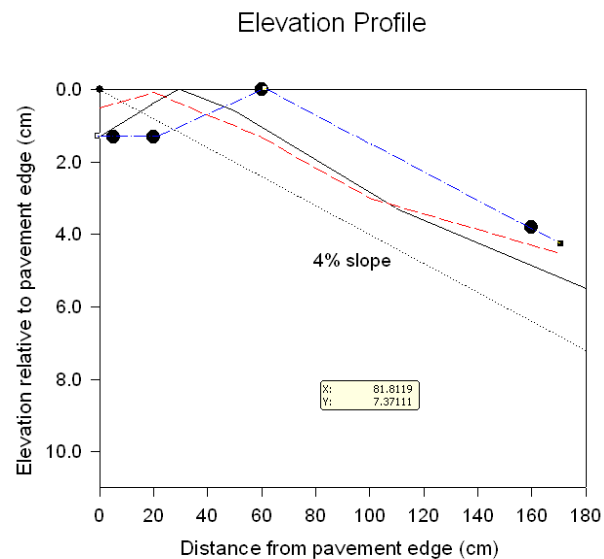
Figure 88. Elevation Profile of Section I Point 6 showing removal of DUSTLOCK from edge-rut area

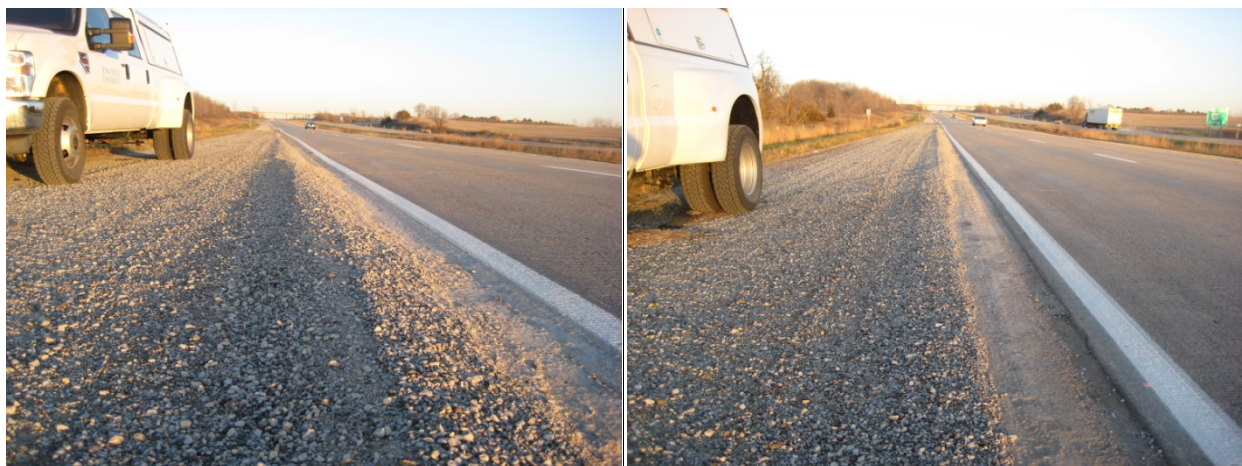
Figure 89. Stabilized shoulder using DUSTLOCK on US 20 westbound covered with course aggregate beyond edge-rut area November 7, 2009

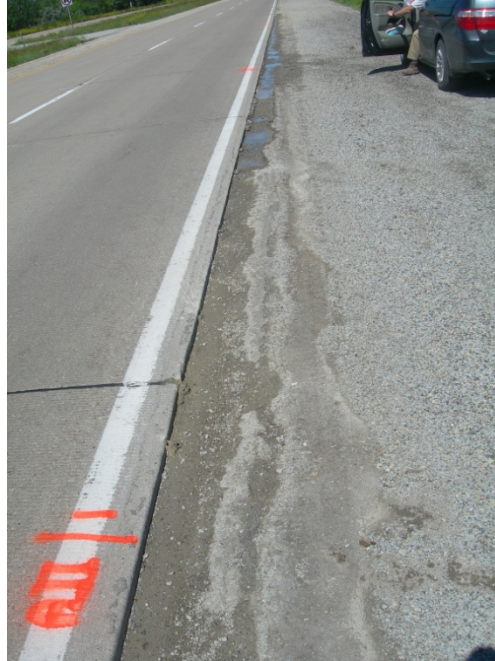
**Figure 90. Looking west from Area II Test Point I milepost 245 June 9, 2010
(approximately same location as in Preconstruction Figure 72)**

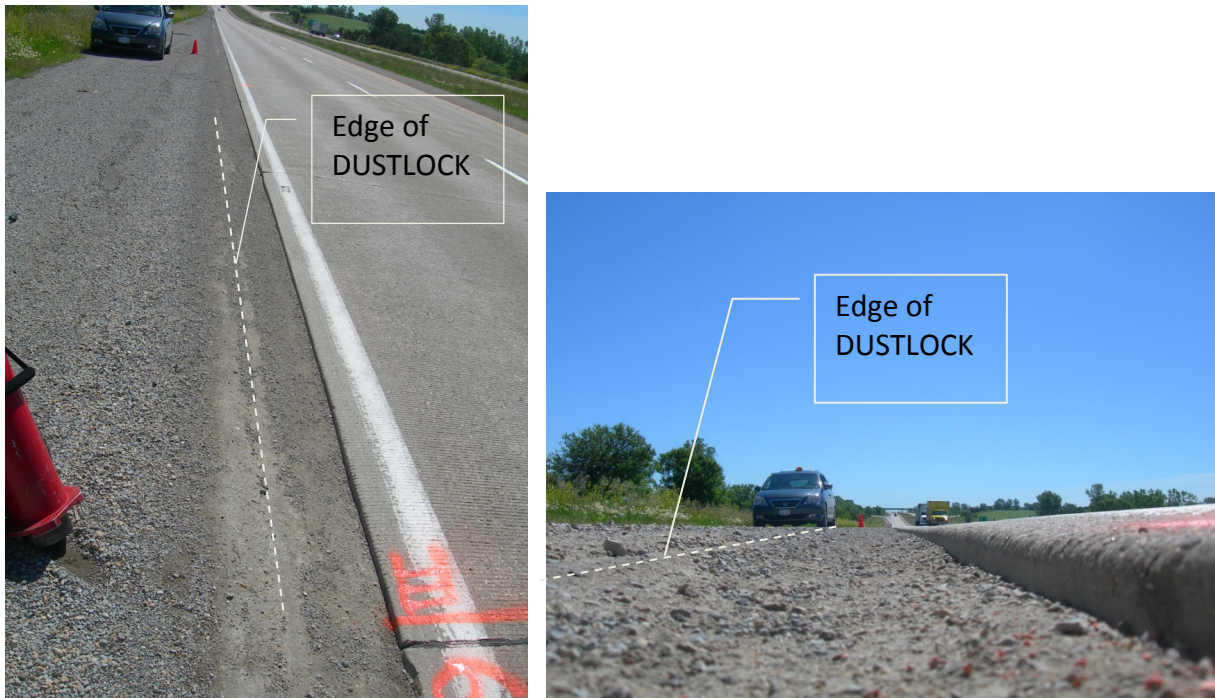
Figure 91. Removal of DUSTLOCK from edge rut area
