Road Safety Audit for Intersection of US 218 and County Road C-57 (West Cedar Wapsi Road) in Black Hawk County, Iowa

**Final Report
July 2009**

Beginning on June 22, 2009, a road safety audit was initiated for the intersection of US 218 and County Road C-57 in Black Hawk County, Iowa. Due to the traffic volumes and the number of conflicting traffic movements on these two roadways, this intersection has developed a crash history that concerns the Iowa Department of Transportation (Iowa DOT), Iowa State Patrol, and local agencies. This intersection is ranked seventh in Iowa for the highest number of at-grade expressway intersection crashes. Considering this, Black Hawk County and the Iowa DOT requested that a road safety audit be conducted to address the safety concerns and recommend possible mitigation strategies.

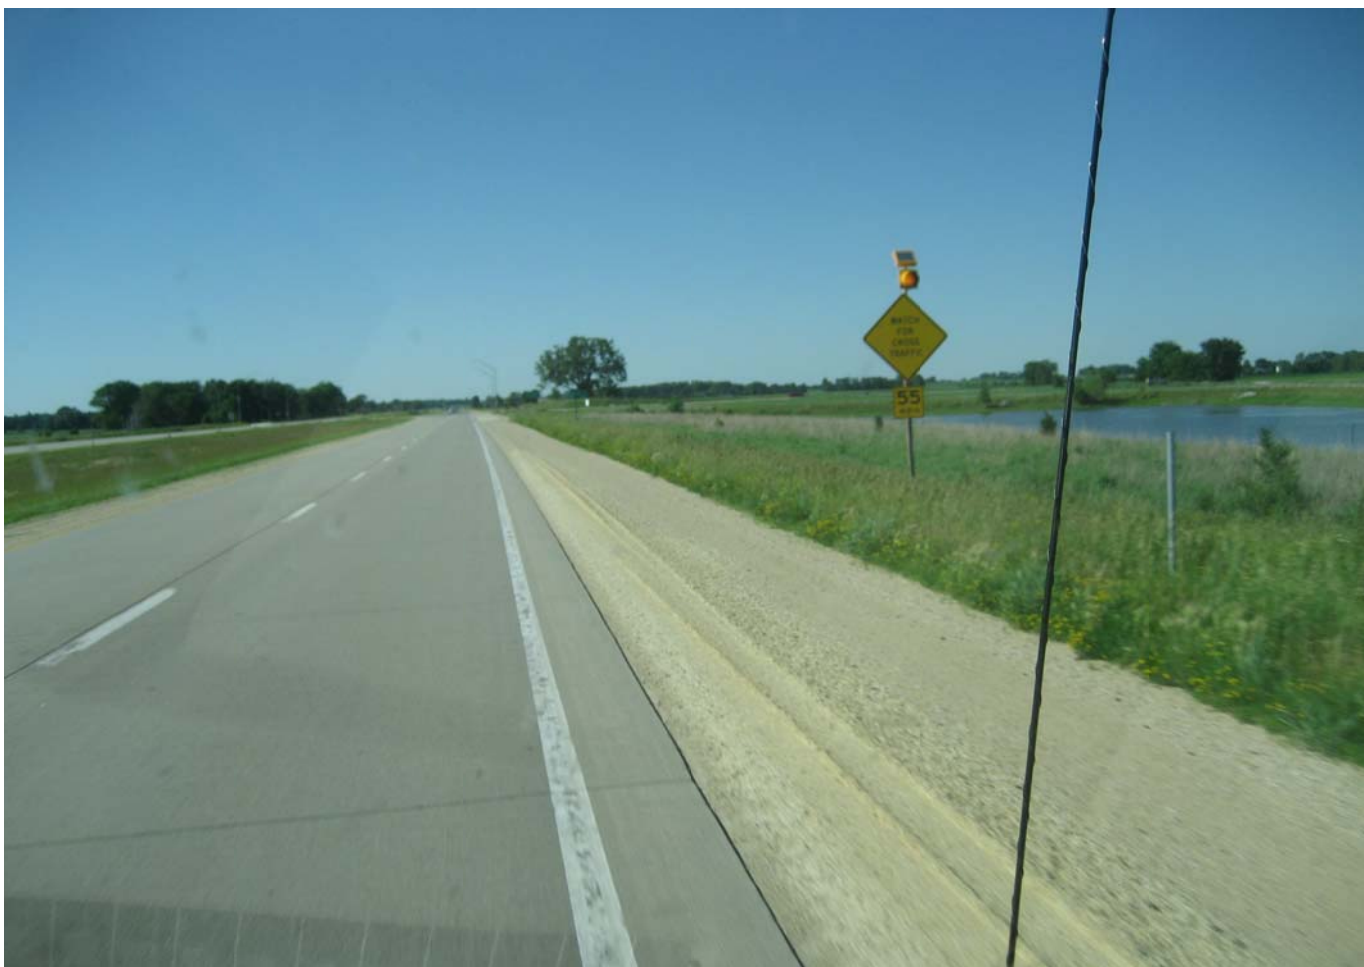
Figure B.3. Advance warning sign for intersection of C-57 and northbound US 218

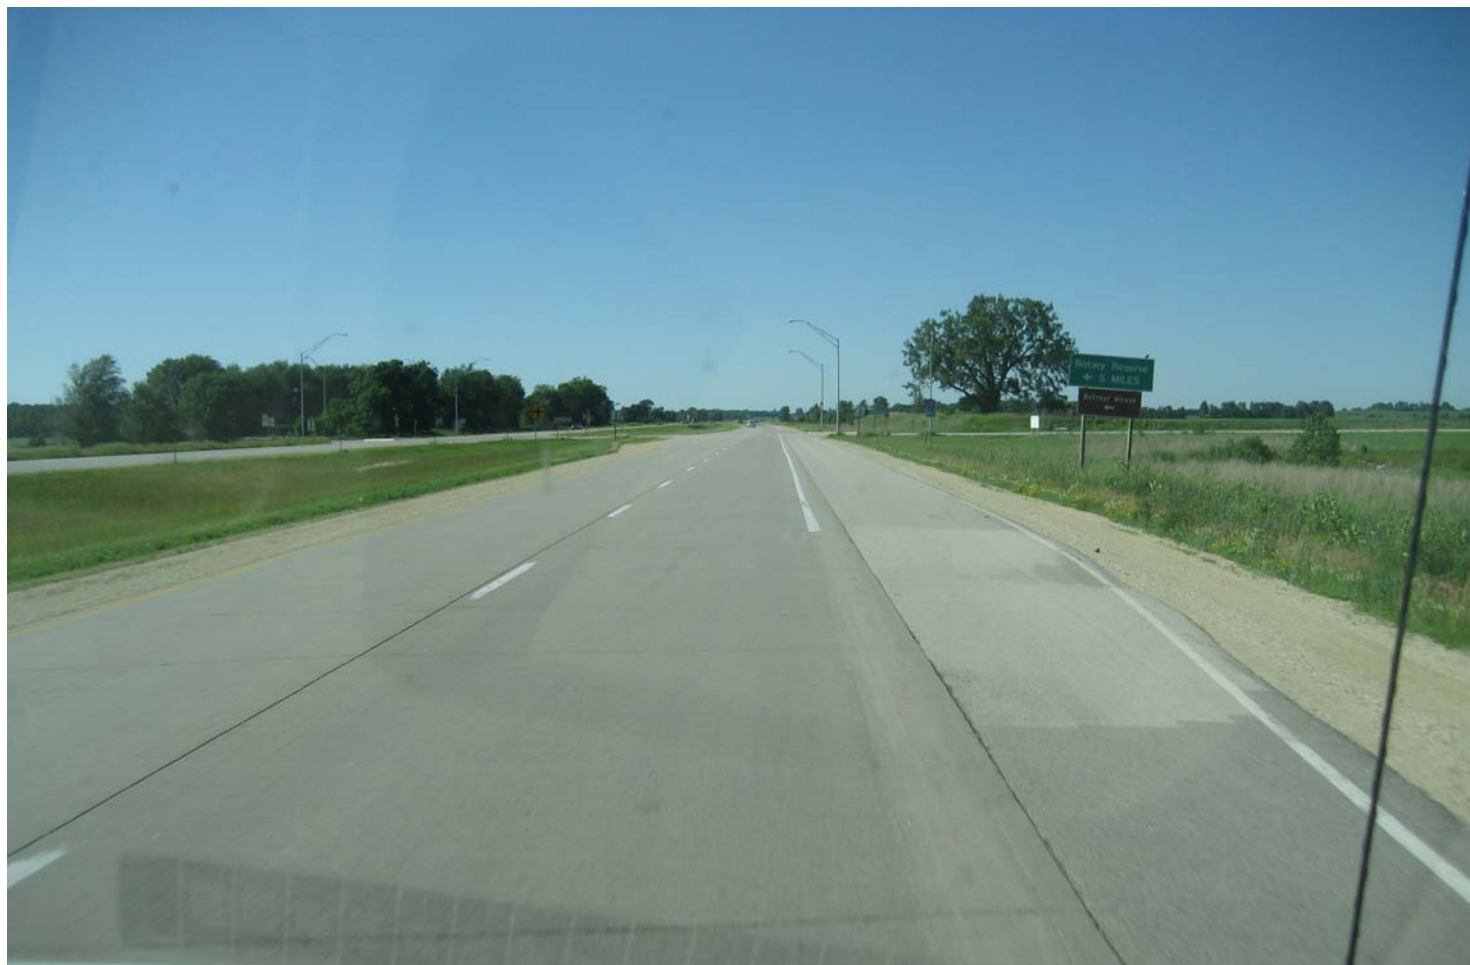
Numerous broadside collisions have occurred on the near side of the intersection following the installation of the right-turn deceleration lane in 2006. A possible contributing cause was noted as “shadowing vehicles,” impacting visibility of oncoming US 218 traffic. This could potentially be addressed by offsetting this turn lane, and this action was suggested for consideration. A supplemental enhancement for westbound C-57 traffic might be the installation of additional roadway lights south of the intersection, with one at the deceleration lane taper and another about 300 feet further south. In addition to enhanced lighting at night, these poles can provide reference points for waiting drivers to judge acceptable gaps in oncoming traffic.

**Figure B.4. Right-turn deceleration lane on northbound US
218**

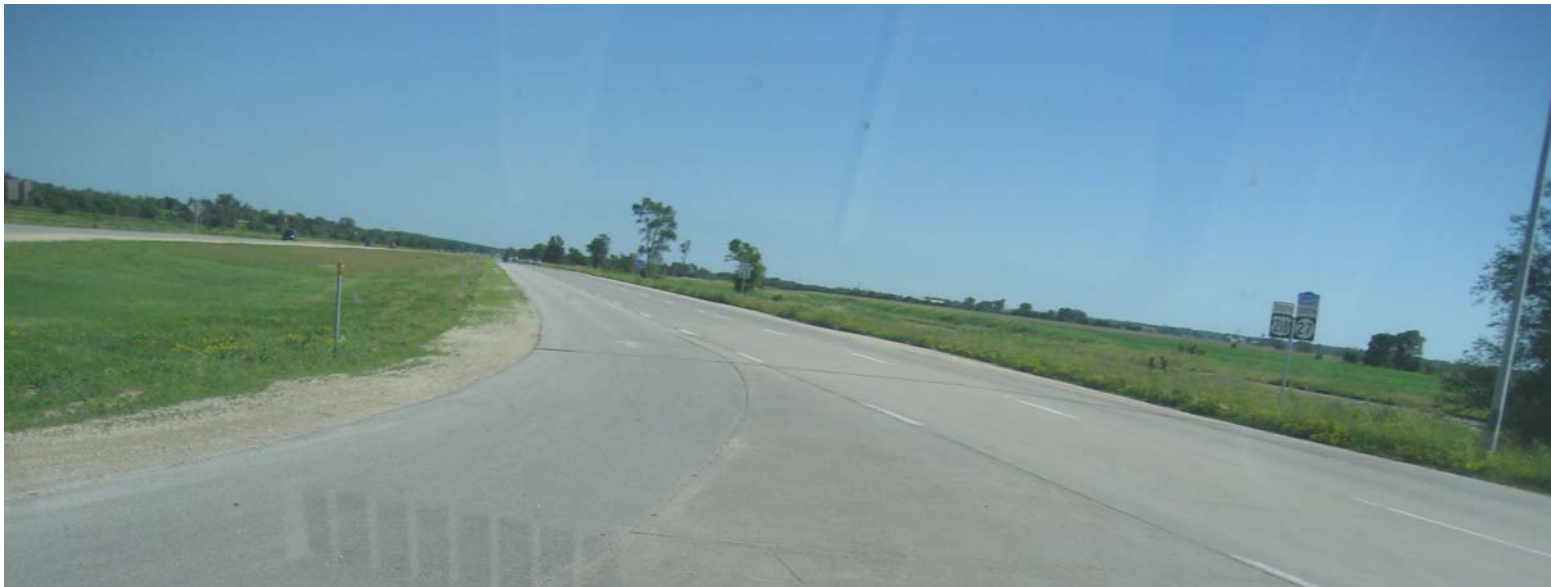
Figure B.11. Left-turn acceleration lane on southbound US 218

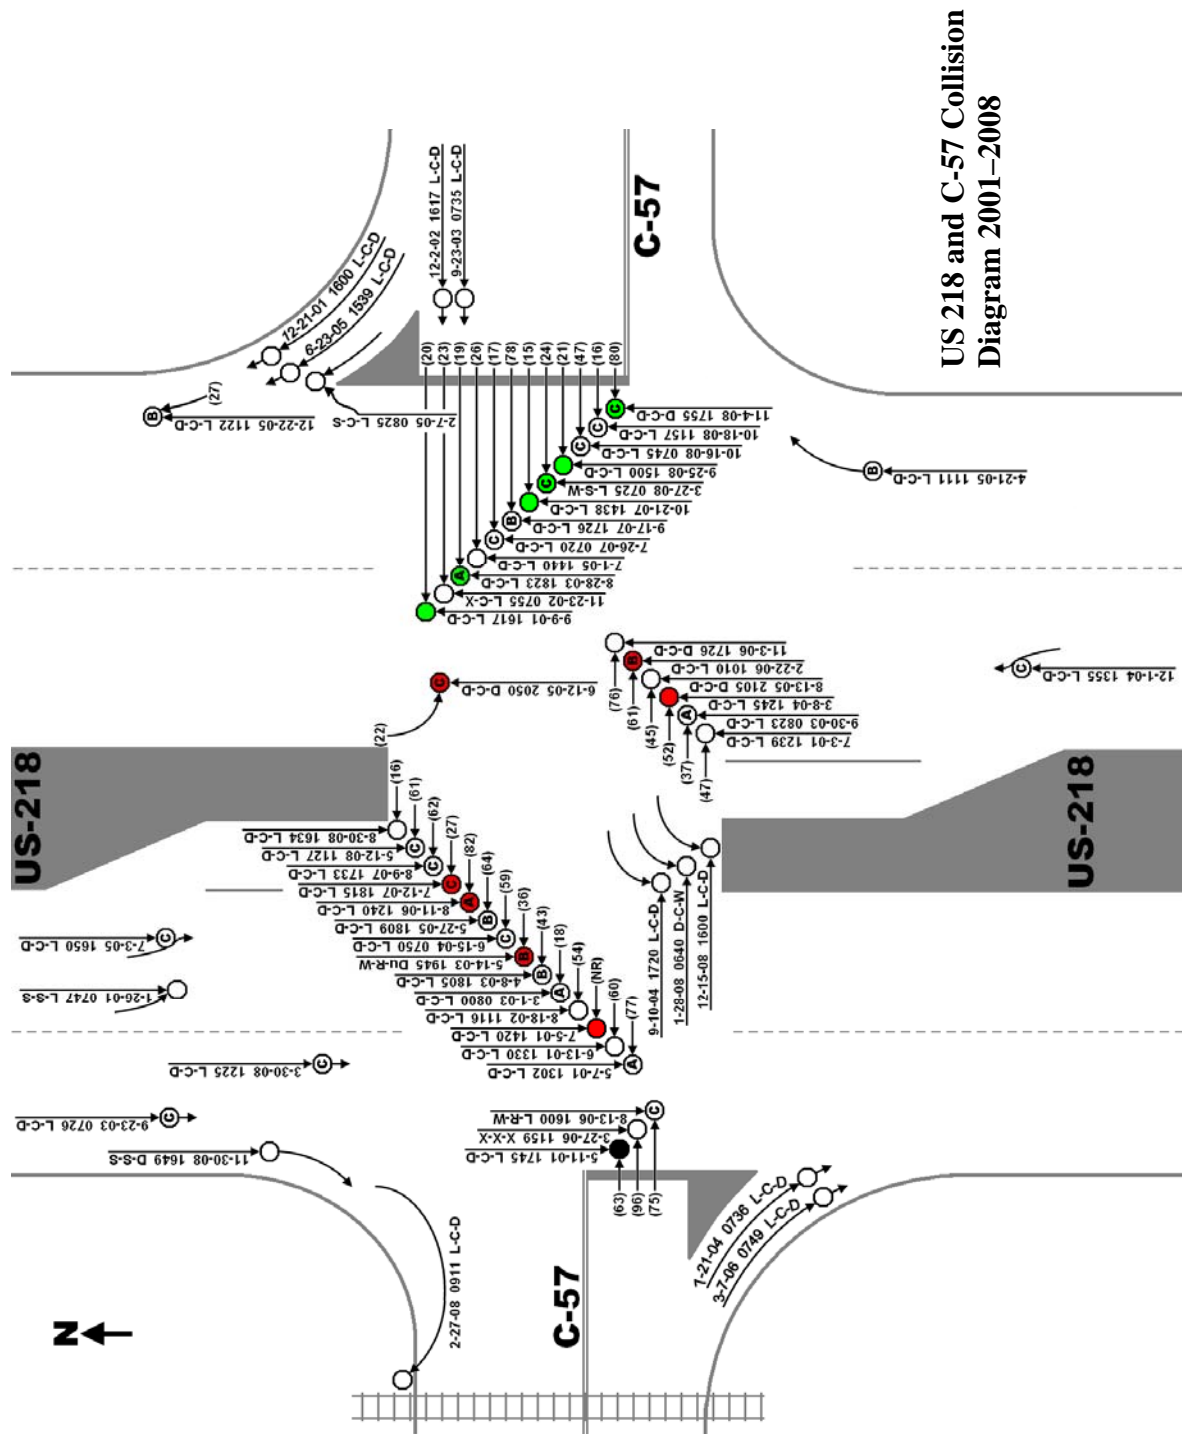
Using the latest five years of data, the crash rate for this intersection is 1.23 crashes per million entering vehicles. A complete summary of crash data and the collision diagram are included in Appendix E.

Figure E.1. Collision diagram for 2001 to 2008
